Thistle Alpha Platform Upper Jacket Decommissioning Programme

Consultation Draft

Document ID:	M3525-ENQ-THI-DN-0000-REP-0008		
Document Classification:	PUBLIC		
Document Ownership:	Decommissioning		
Date of Document:	22/06/2022	Signature	Date
Prepared by:	S. Axon	<i>S. Axon</i>	20/06/23
Reviewed by:	K. Langworthy	<i>K. Langworthy</i>	20/06/23
Approved by:	N. Tulip	<i>N. Tulip</i>	20/06/23

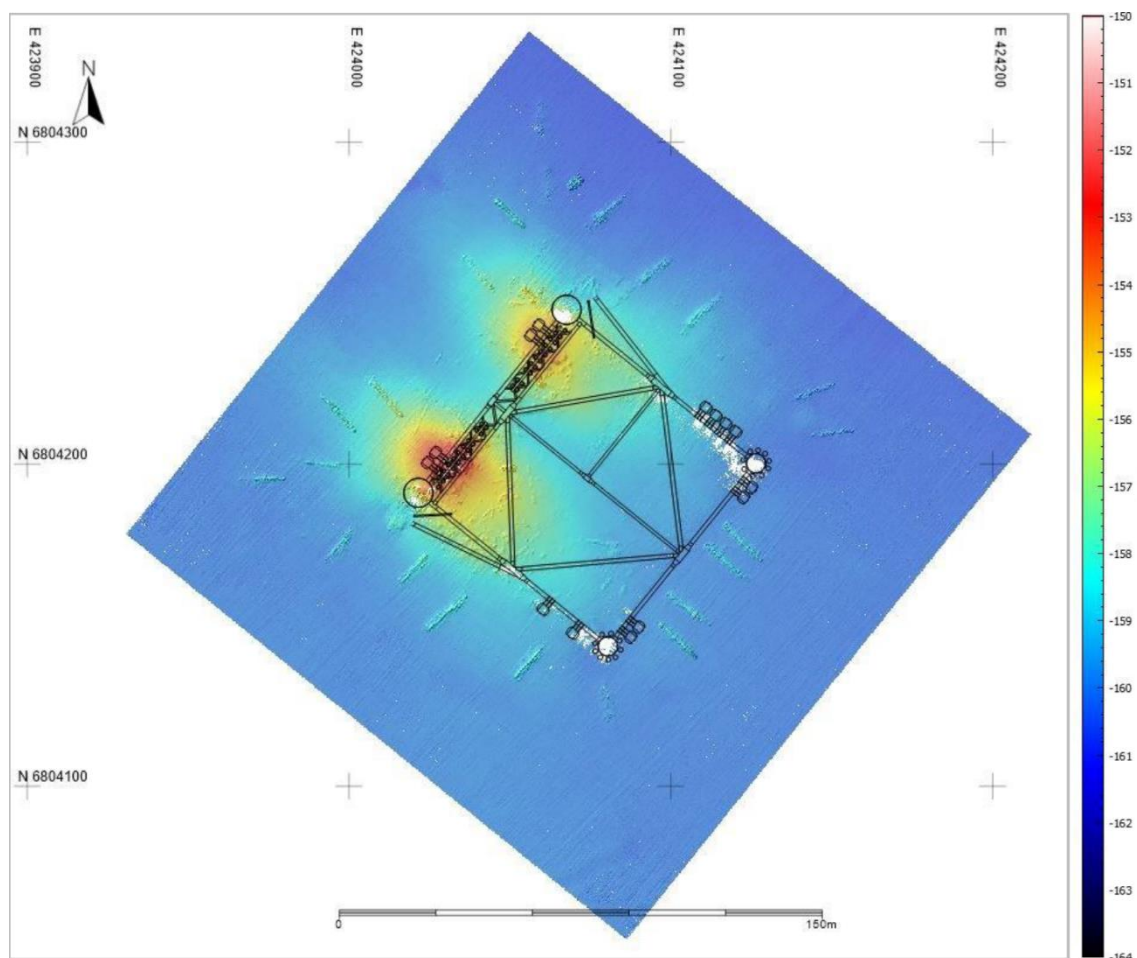
Figure 1.4.1: Drill cuttings mound - plan view of MBES data (2021)

There is a drill cuttings mound underneath the jacket structure. During a survey in 2021 multibeam echosounder ('MBES') mapping recorded the cuttings mound geometry [2]. The natural seabed profile was extrapolated from the surrounding background and two overlapping drill cuttings mounds could be identified. As they merge in the middle they are treated as a single

drill cutting mound with an estimated maximum drilling discharge deposition depth of 8.3 m for the South Western peak and 5.8 m for the south eastern peak. The volume and footprint of mound has been calculated to be 31,651 m³ and 26,422 m², respectively.

The surface of Thistle cuttings mound is generally covered in a veneer of mussel of varying densities. Mussel shell cover was prevalent throughout, with the thickness of the layer reducing with distance away from the jacket [3].

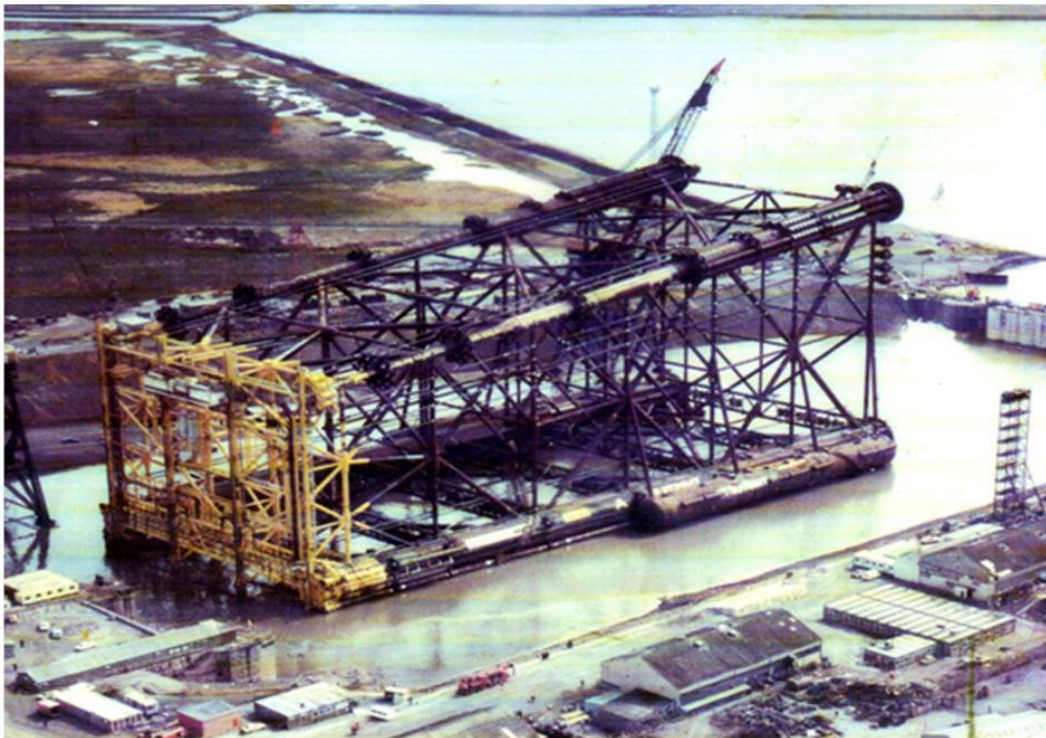
Figure 2.1.5: Thistle jacket fabricated at Greythorpe Dry Dock, Middlesbrough

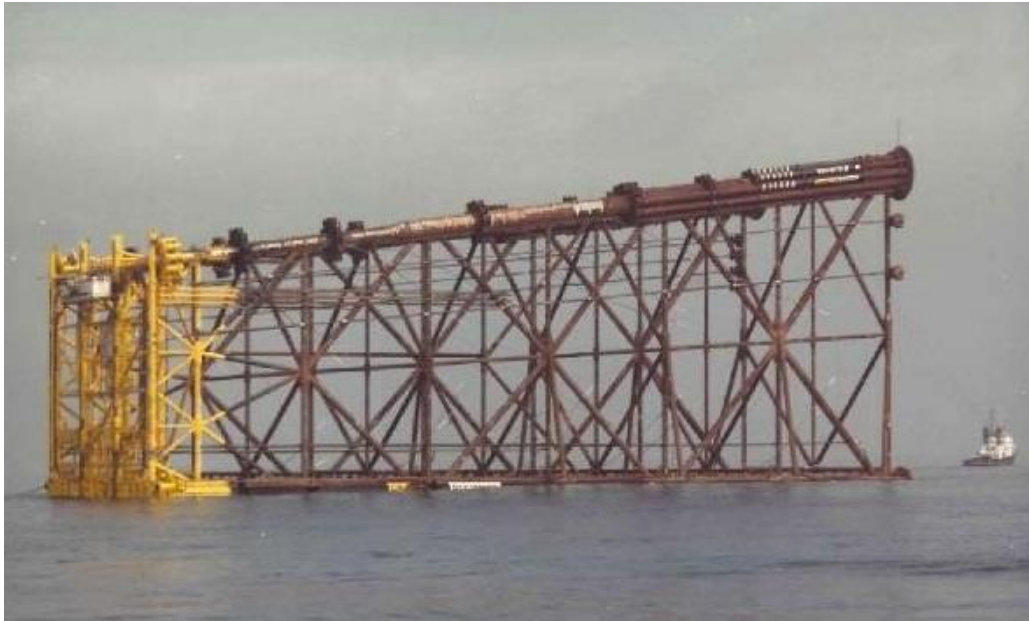
Figure 2.1.6: Thistle jacket immediately prior to upending

Although Thistle jacket was towed to field using integral buoyancy, upend and set down of the jacket is not a reversible operation. The pontoon leg base plates and intermediate diaphragms on Thistle were pierced during installation of foundation piles and in preparation for installation of the in-leg conductors. Thistle ballast and vent systems were removed and/or isolated on set down and those elements of these system remaining on the jacket will have degraded since 1976. In addition to flooding, venting and grout line leg penetrations, the Thistle jacket leg shells have suffered various damage incidents (such as the cracking associated with COS tank movement). The COS tanks provided necessary buoyancy during jacket installation, however due to the integrity of the tank connections, both tanks were removed in 2020 and wet stored within the Thistle 500 m zone Figure 3.2.1.
