Construction Noise and Vibration Monthly Report – June 2023

Lichfield District Council

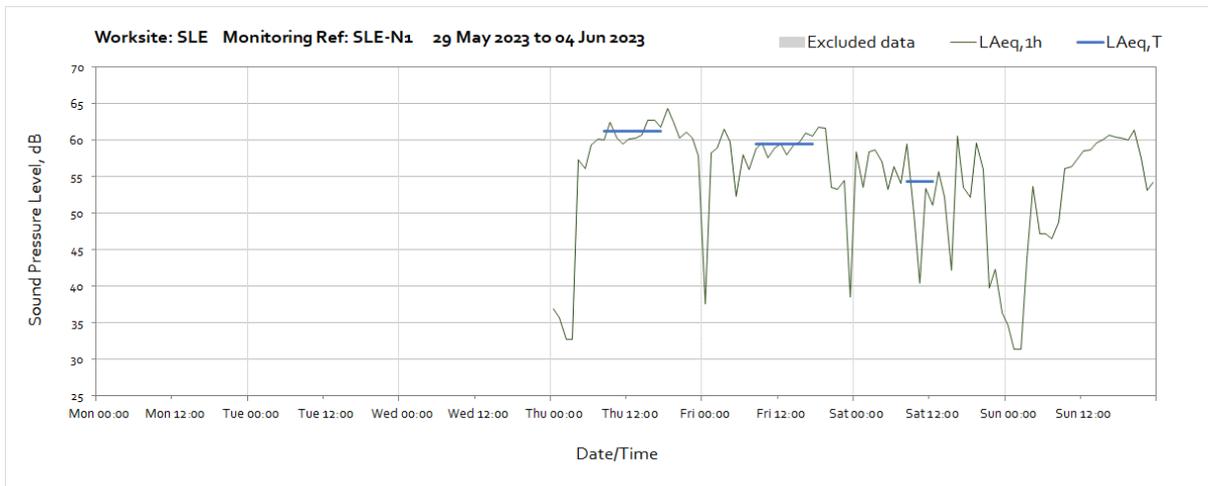
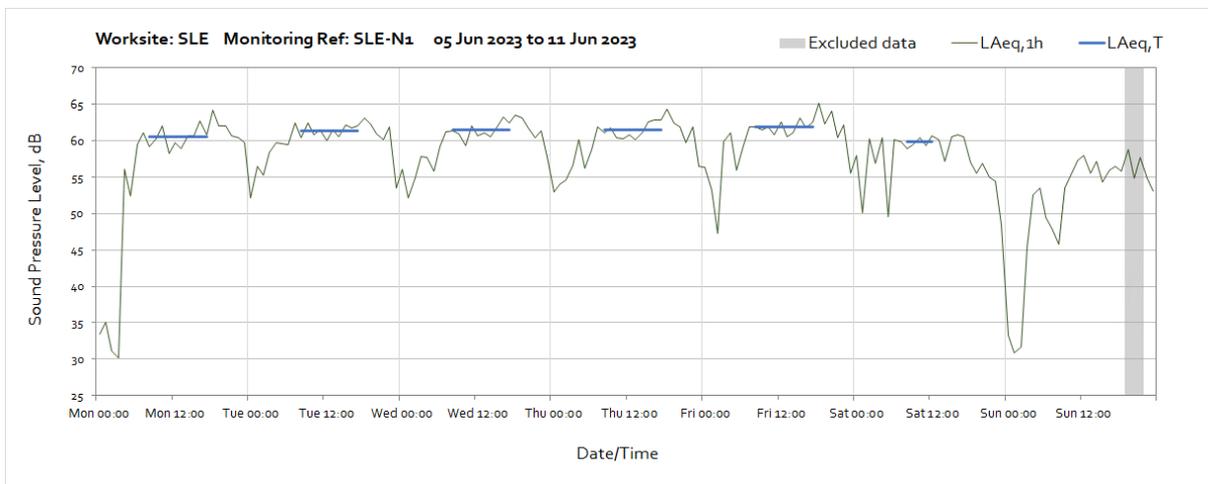
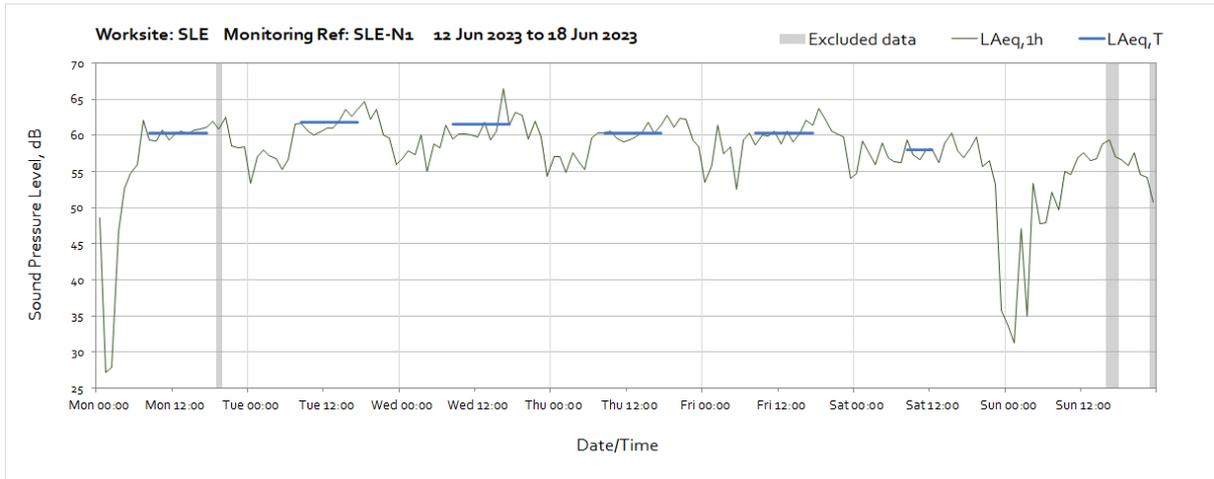
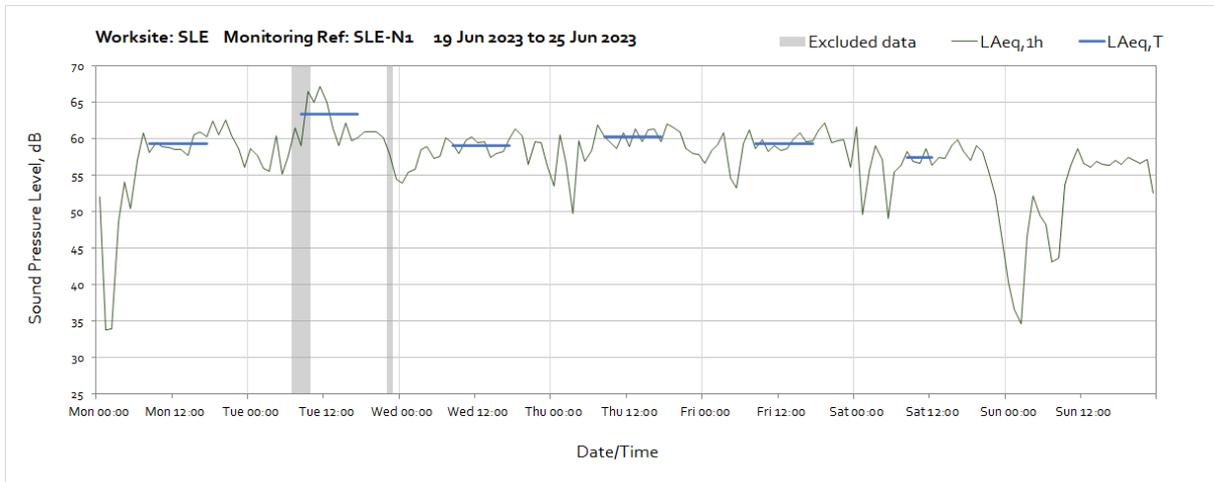
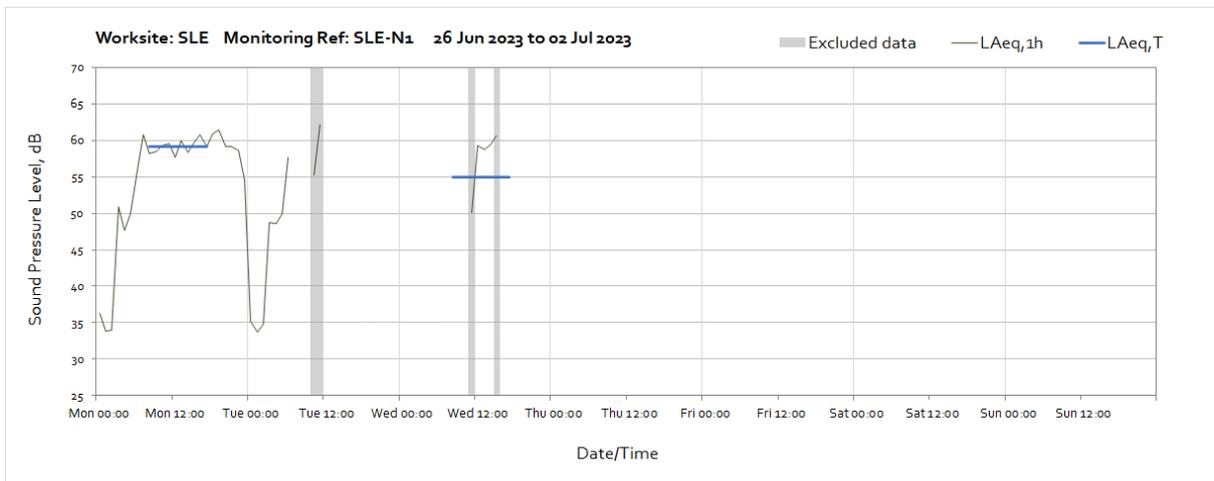
Worksite:SLE - Monitoring Ref: SLE-N1

Note: Missing data between 07:00 on 27th June to 23:00 on 30th June was due to monitoring being paused for vegetation clearance.

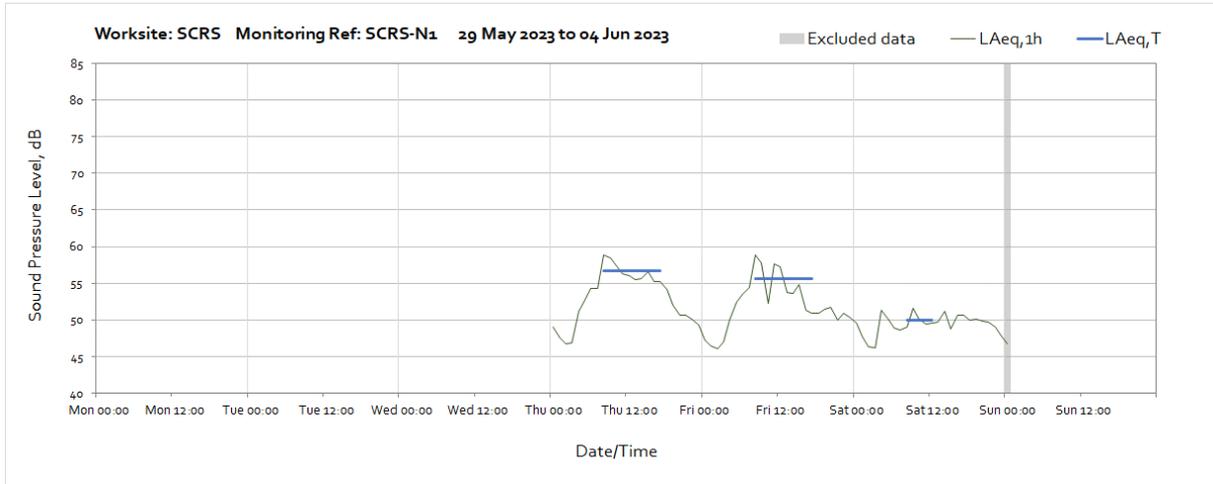
Worksite:SCRS – Monitoring Ref: SCRS-N1

Note: Missing data between 01:00 on 4th June and 00:00 on 30th June were due to monitor being paused for vegetation clearance. Through the vegetation clearance was complete, the monitor required a full battery replacement which delayed the reinstallation of the monitor.

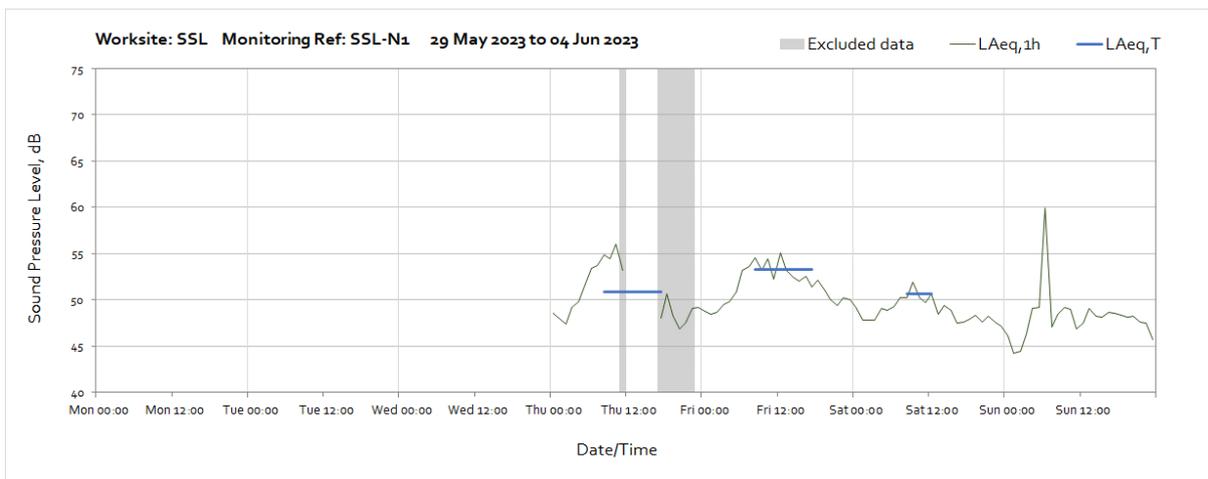
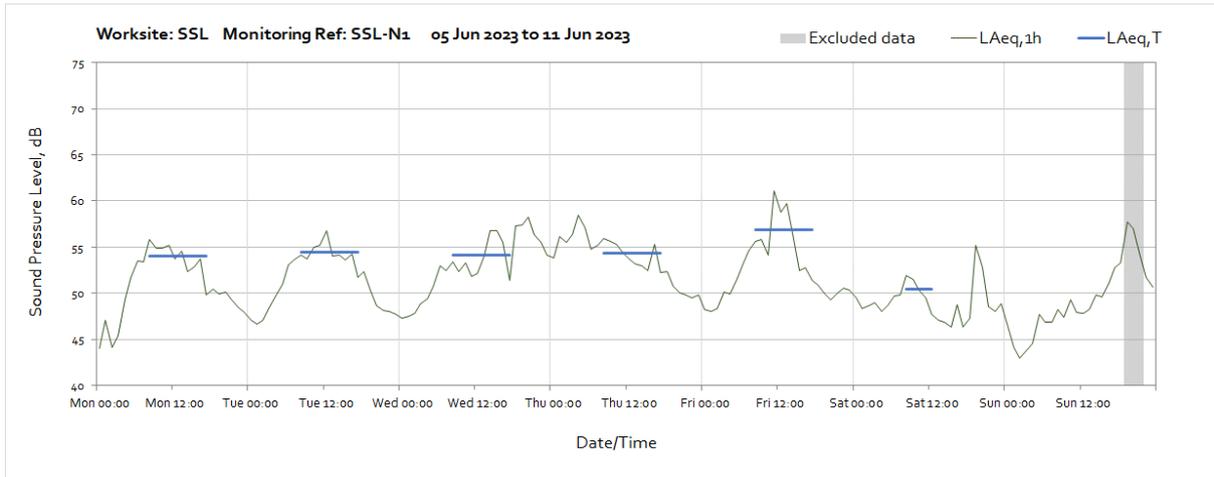
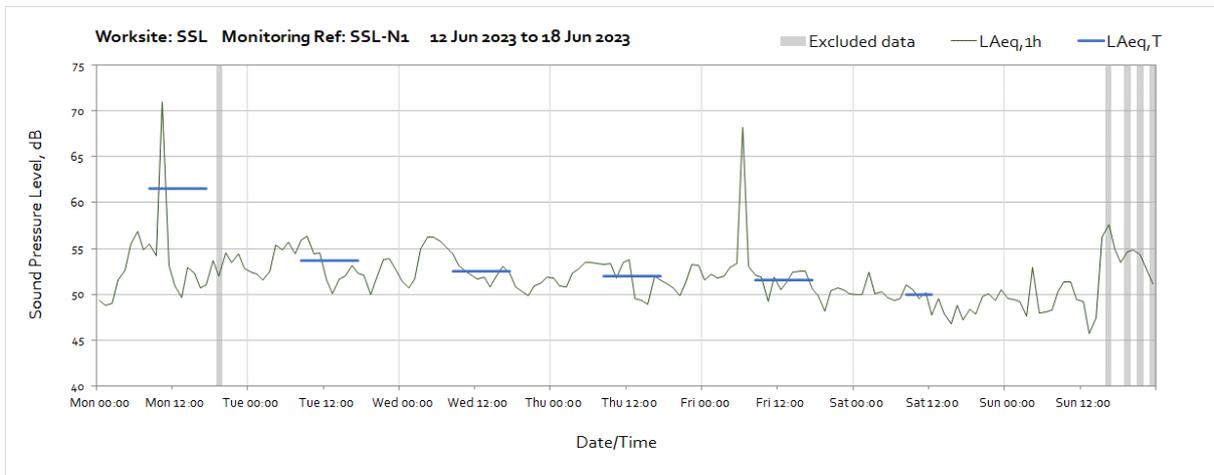
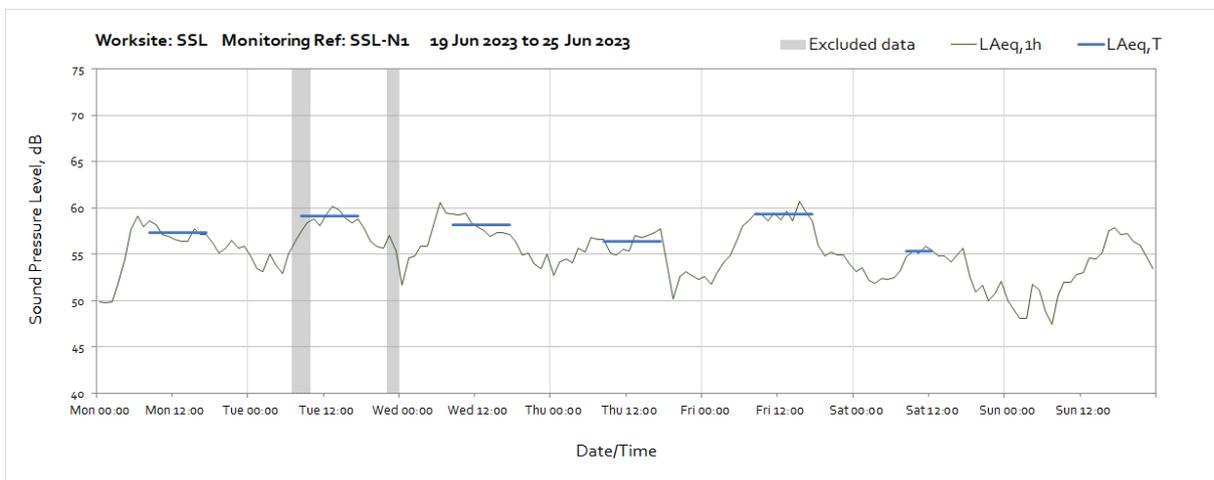
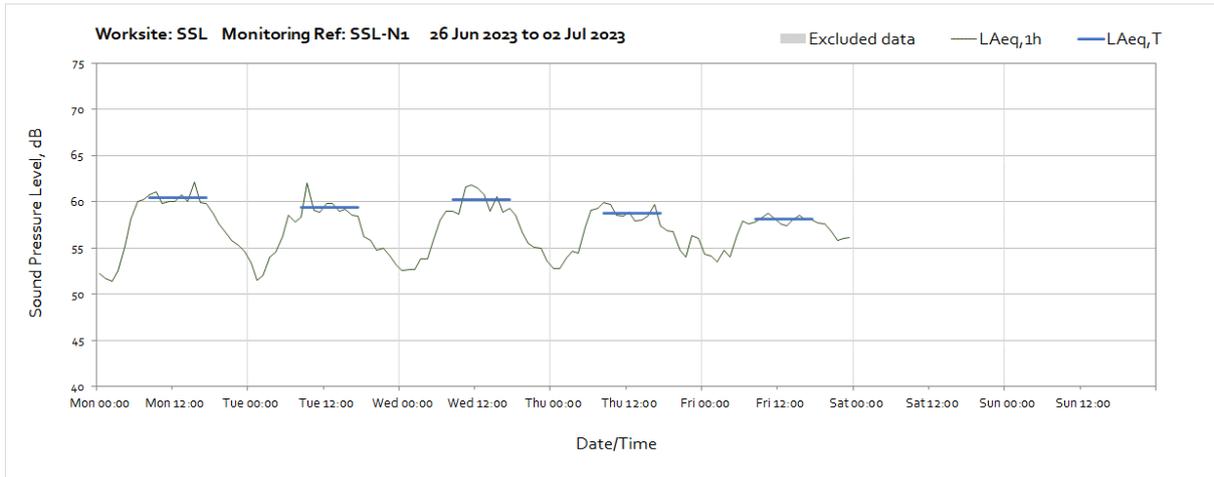
Worksite: SCRS - Monitoring Ref: SSL-N1

Note: Missing data between 12:00 and 16:00 on 01st June were due to data buffering which has since been resolved.

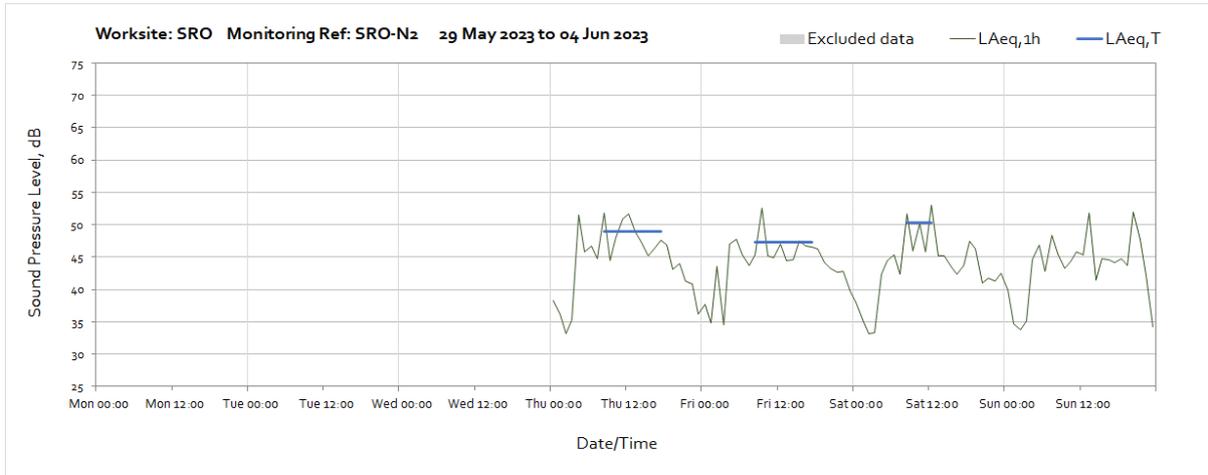
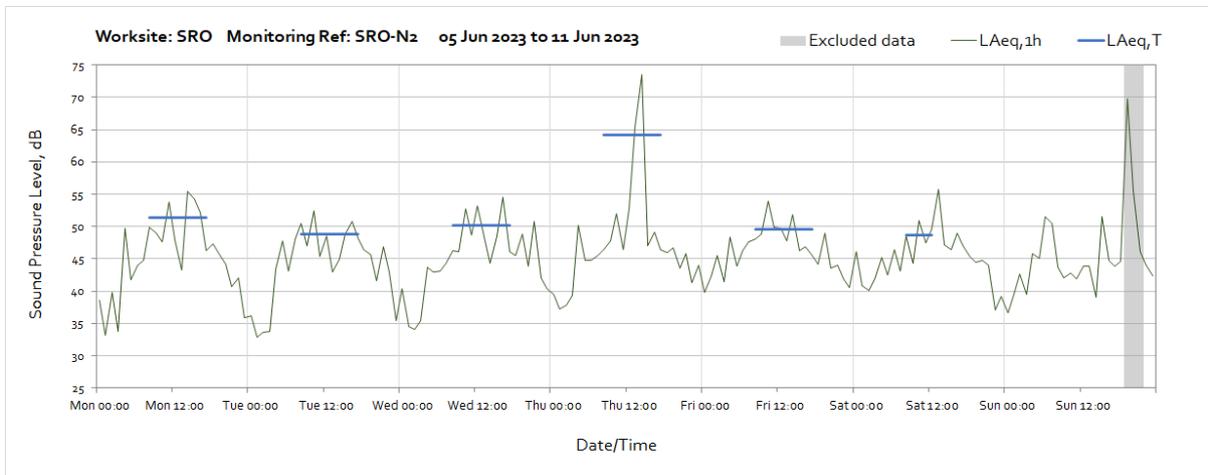
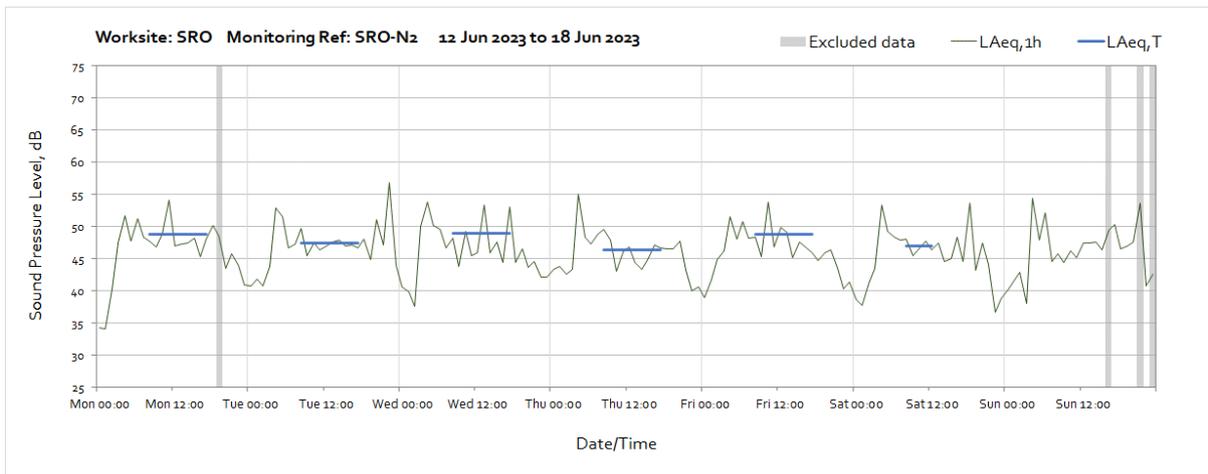
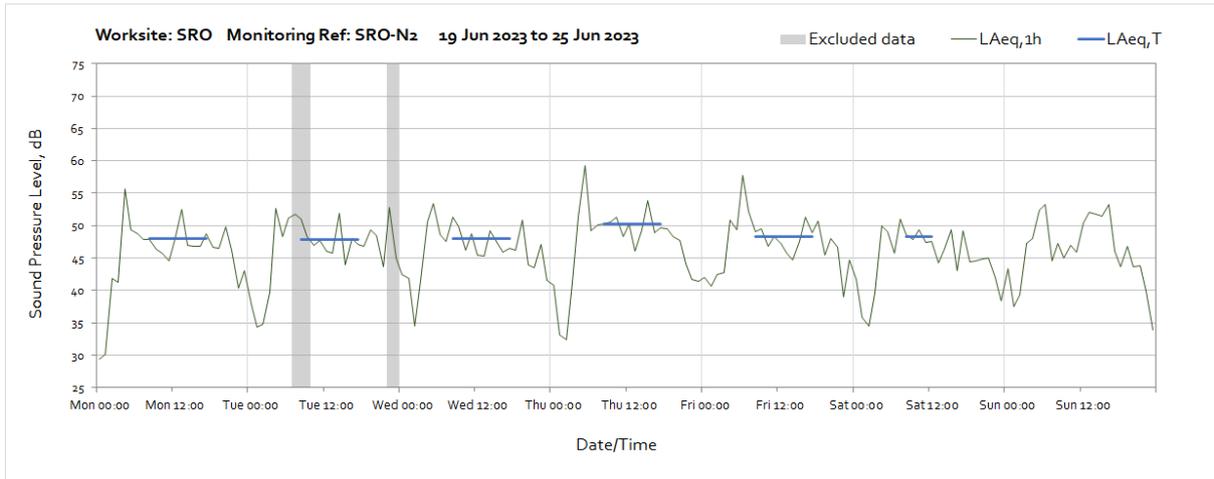
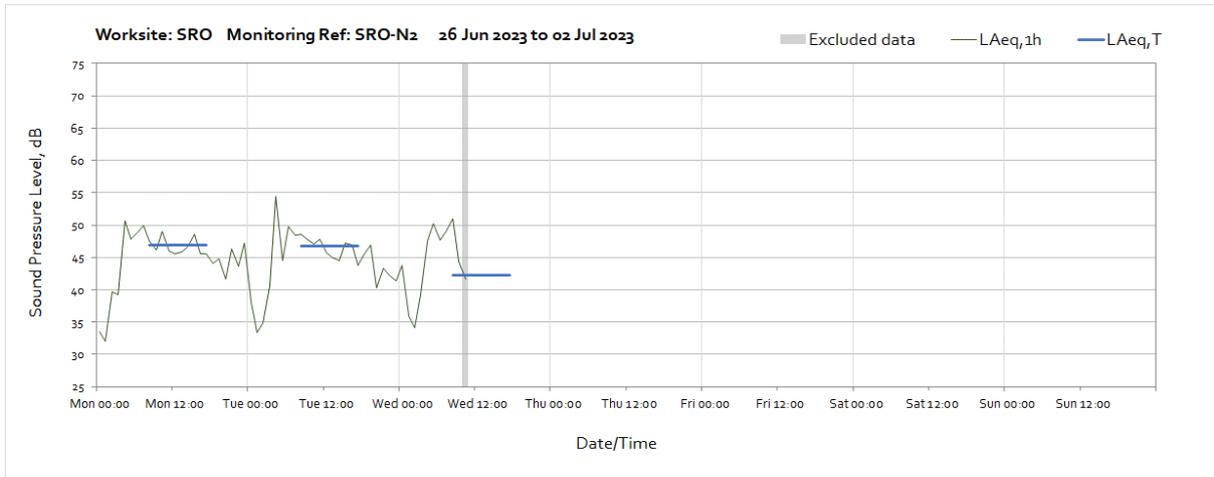
Worksite: SRO – Monitoring Ref: SRO-N2

Note: Missing data between 11:00 on 26th June and 00:00 on 30th June were due to stolen solar panels which is currently being resolved.

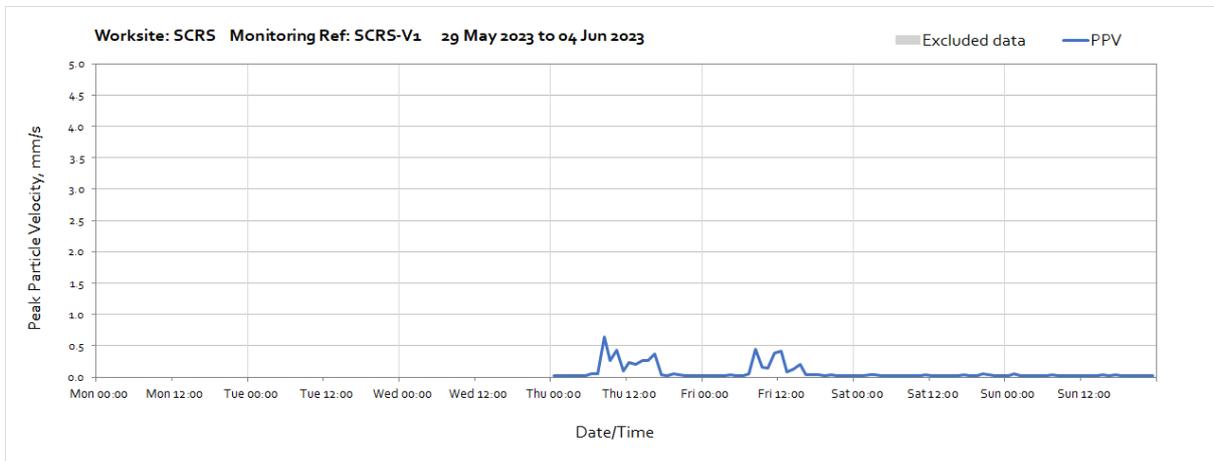
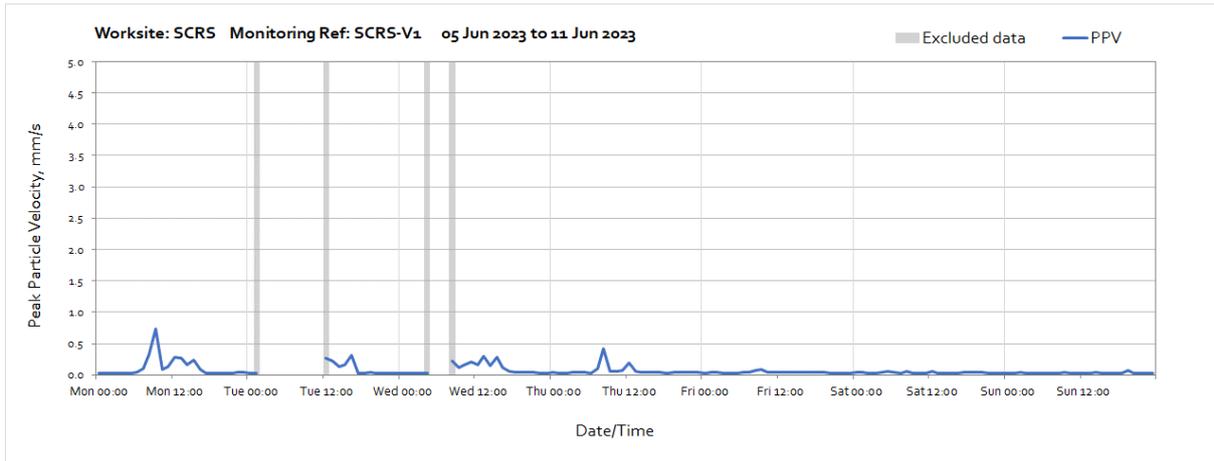
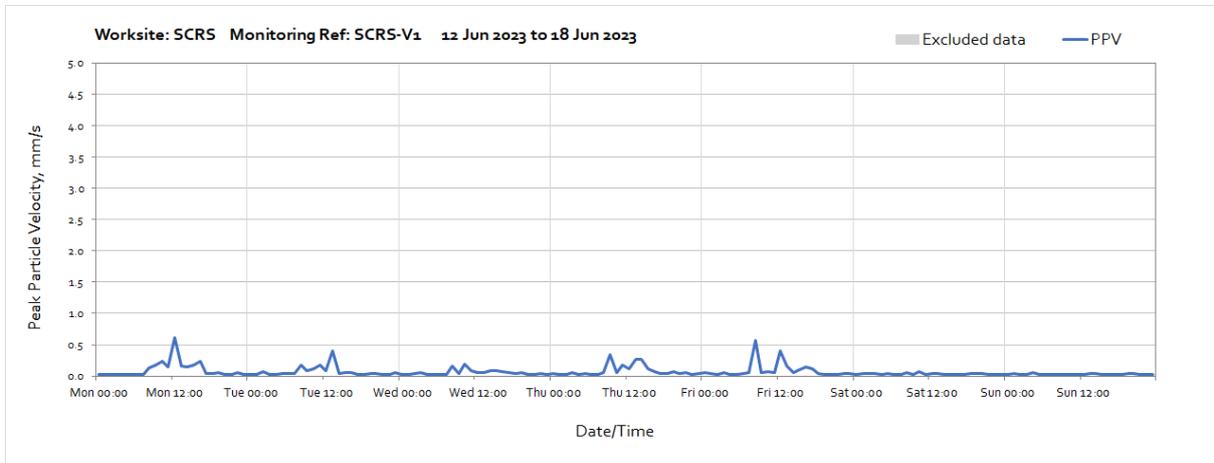
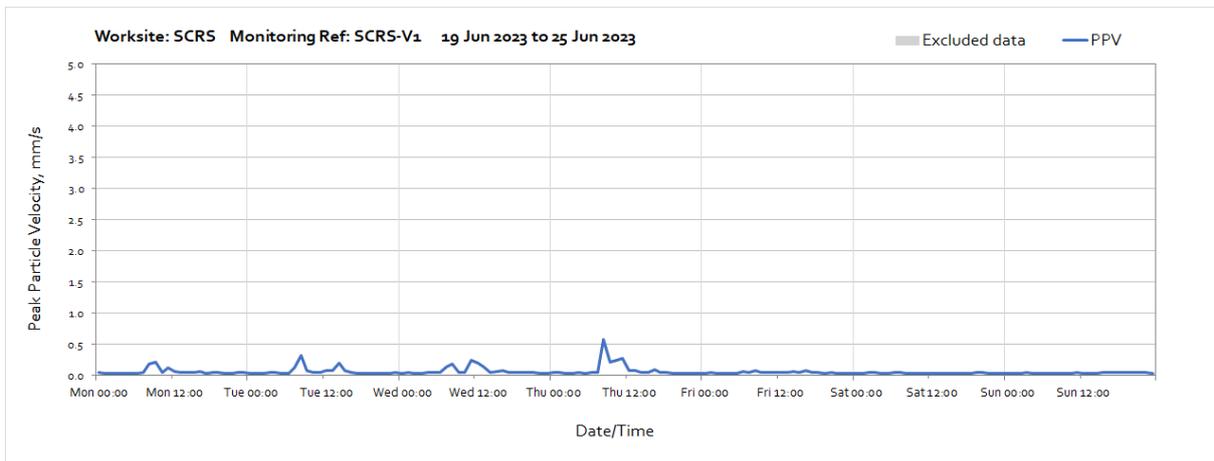
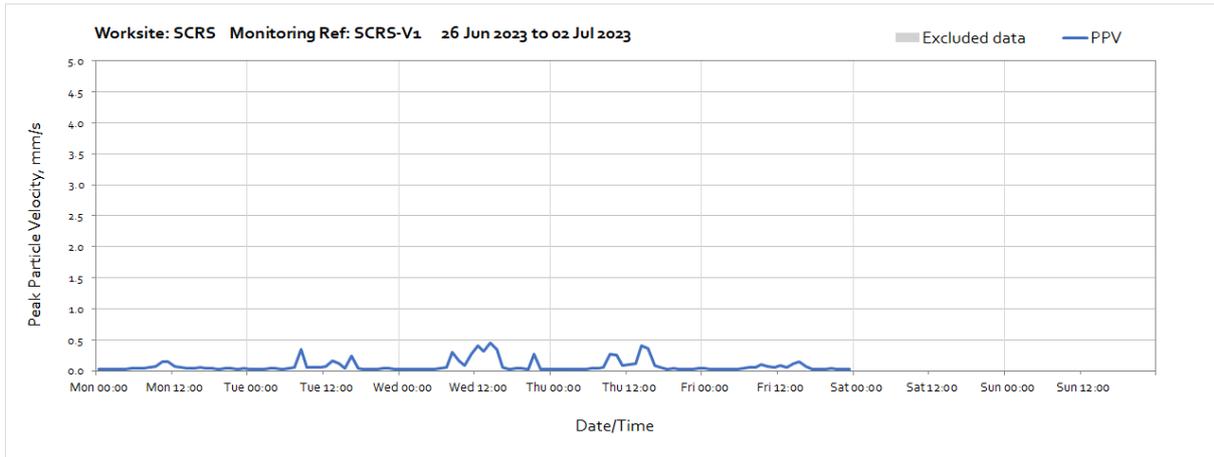
Worksite: SCRS – Monitoring Ref: SCRS-V1

Note: Missing data between 02:00 and 11:00 on 6th June, and between 05:00 and 07:00 on 7th June was due to vegetation clearance.
