A Condition Survey of the Archaeological Sites of the Willsworthy Freehold, Dartmoor Training Area

County:	Devon
District:	West Devon
Parish:	Peter Tavy
NGR (Centre):	SX 546833
Surveyed:	Nov 2012-Feb 2013
Contractor:	S Probert
Client:	Landmarc/Defence Infrastructure Organisation

A CONDITION SURVEY OF THE ARCHAEOLOGICAL SITES OF THE WILLSWORTHY FREEHOLD, DARTMOOR TRAINING AREA, DEVON

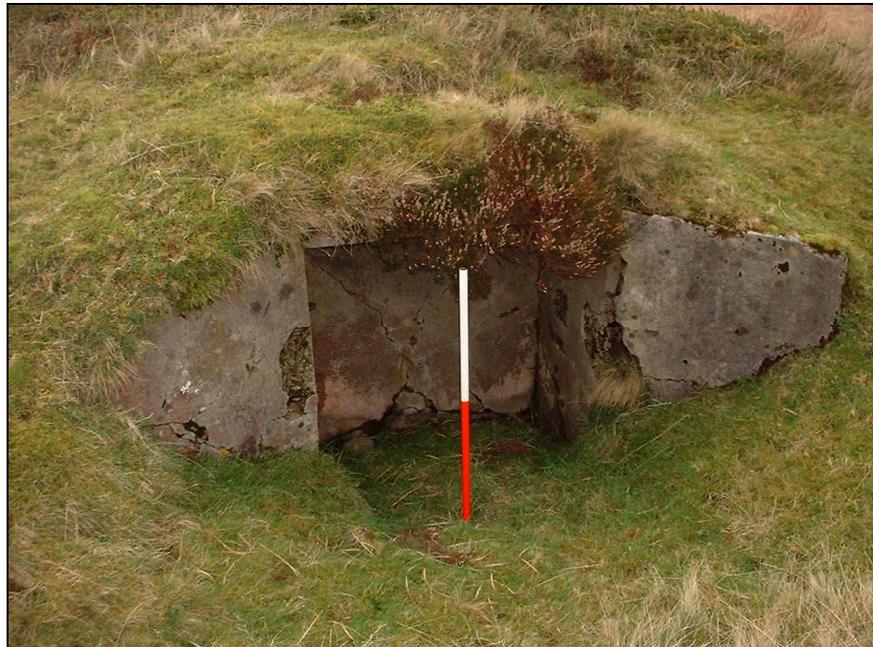
Fig 3 Spalling concrete and render on former battlefield range 1156692

The majority of the 20th century military remains are constructed from concrete and/or blockwork often with significant ferrous components. These structures were probably envisaged as short life assets and have not been used for several decades. Given the Dartmoor environment it is inevitable that without a sustained maintenance programme the materials from which these features are constructed will decline. Cement rendering and blockwork are spalling while ferrous components such as tramway rails, sleepers and target mechanisms are rusting. It is envisaged that most of the components will reach a state of stability while the ironwork will disappear in the fullness of time. In the majority of cases the actual rate of decline appears to be minimal. Indeed the changes visible on the small battlefield range, 1159777, that lies within the Yellowmead area are so small as to move the features into the stable category. The ruined cottage, 1147055, within Standon Farm has been cleared of vegetation since the 2007 Condition Survey which has removed a considerable threat to its structural integrity though the unmortared walls may suffer further collapse until a state of stability is achieved.

Of the 10 monuments in this classification four are of military origin and are best subject to a policy of benign neglect as is the cottage at Standon Farm. In the long term the peat mounds on Standon Hill will disappear. The exclusion of livestock would make a significant change to the stability of the boundary stones while the levelling of the visitors' cairn from the prehistoric feature north of Hare Tor would resolve this issue in the short term.

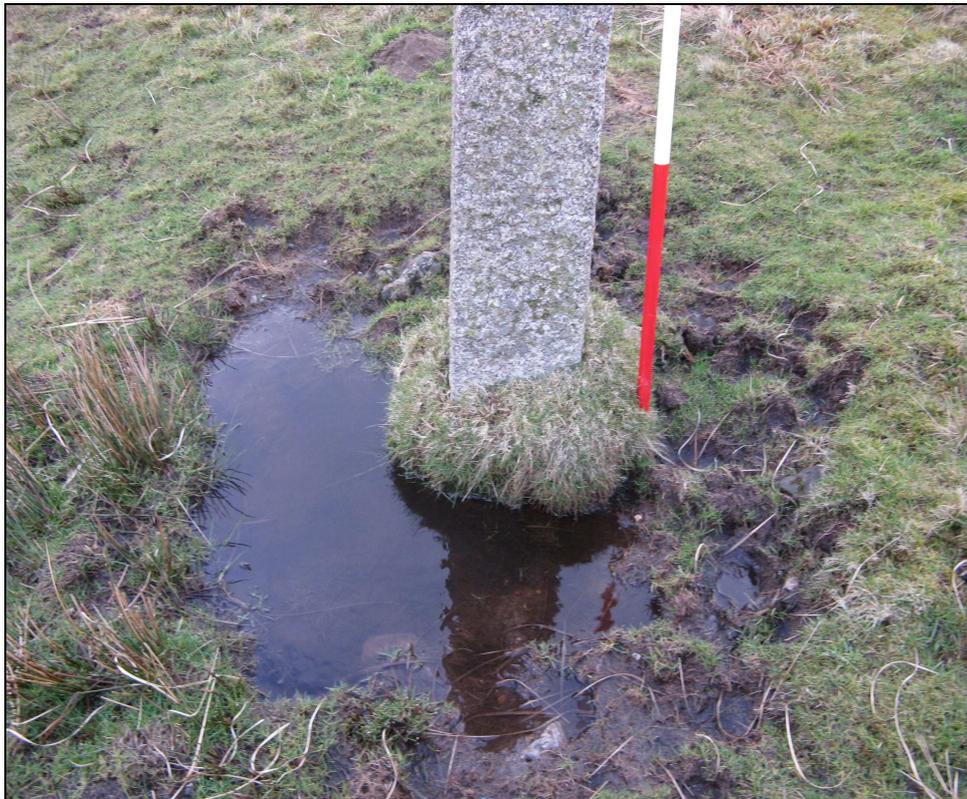
Fig 4 Boundary stone 1150912. Erosion hollow again active as a result of livestock using it as a rubbing post

Although the greater part of the Freehold is supposedly livestock free there has been a change in the amount of damage caused by cattle. A number of sites, all boundary stones, are still used by straying cattle as rubbing posts and as such the hollows at their bases are actively eroding. In extreme circumstances the stones may become unstable and topple. Examples are boundary stones 1150912 and 1150941 in the area of the old camp at Willsworthy. In 2007, these stones were assessed as improving, in that the vegetation within the hollows was regenerating. The most recent assessment has returned them to the gradual decline category as the hollows are again devoid of grass and display hoofprints.

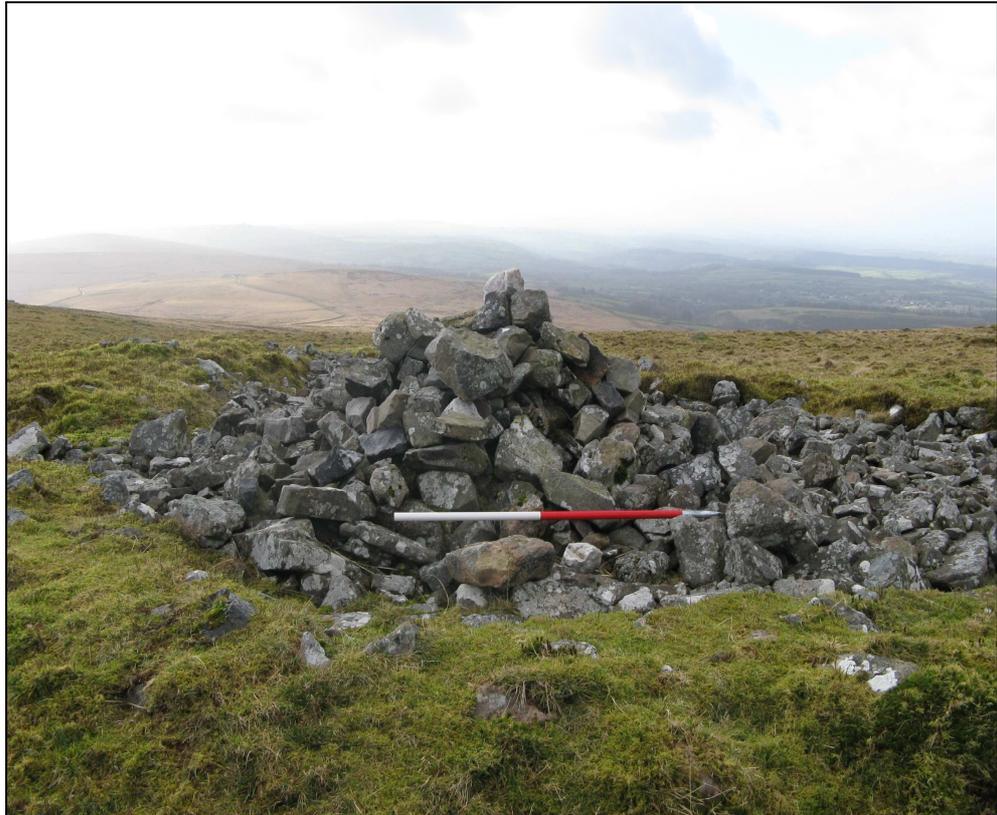
Fig 5 Detail of recently constructed cairn on prehistoric monument 440579 north of Hare Tor

The stony matrix of the large prehistoric cairn, 440579, to the north of Hare Tor, has been rearranged to form a secondary cairn on top of the existing feature. This feature was reported in the 2001 and 2007 assessments and the damage rectified. However, the cairn has been rebuilt in the intervening years. Such action is in contravention of the Ancient Monuments and Archaeological Areas Act of 1979. It is not thought that this is a result of the military use of the area.

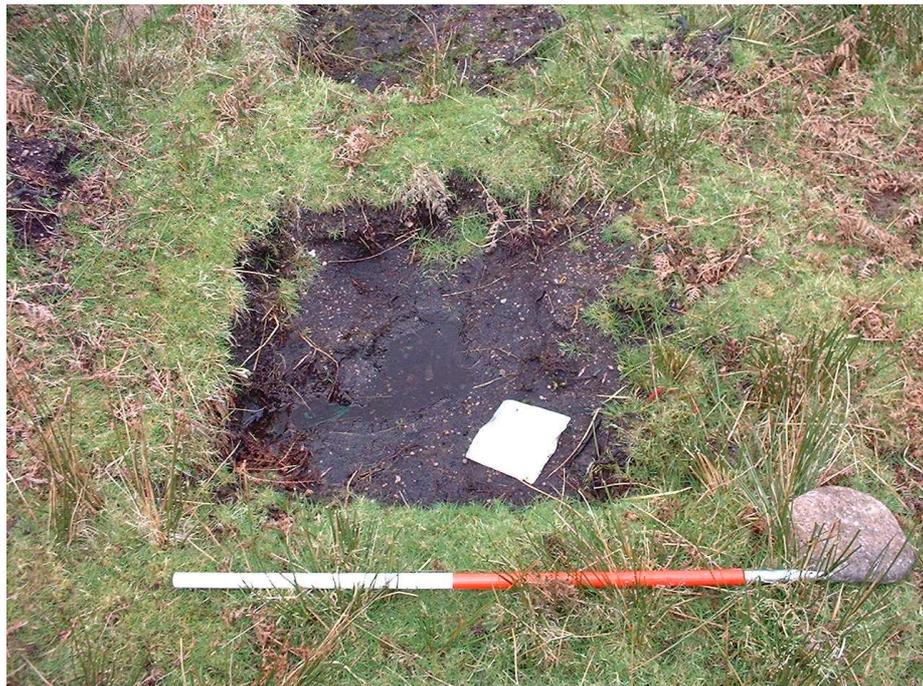
Fig 7 Interior of small unidentified structure 1159602. Area of turf removed and discarded ration pack

The remains of a small rectangular structure, 1159602, on the right bank of the River Tavy has suffered from digging activity. Two small areas have been disturbed in the interior and one adjacent to the exterior of the southeast corner. It is thought that this is the result of ground preparation prior to cooking in the field. There is also military litter on the site. The reinstatement of the excavated material should be considered and, if further activity is planned in this area, the presence of the site mentioned at briefings.
