**LINNHE FIELD**

**SUBSEA FACILITIES  
DECOMMISSIONING**

**CLOSE OUT REPORT**

**Document Number: BB/07/M010/20/MP/012**

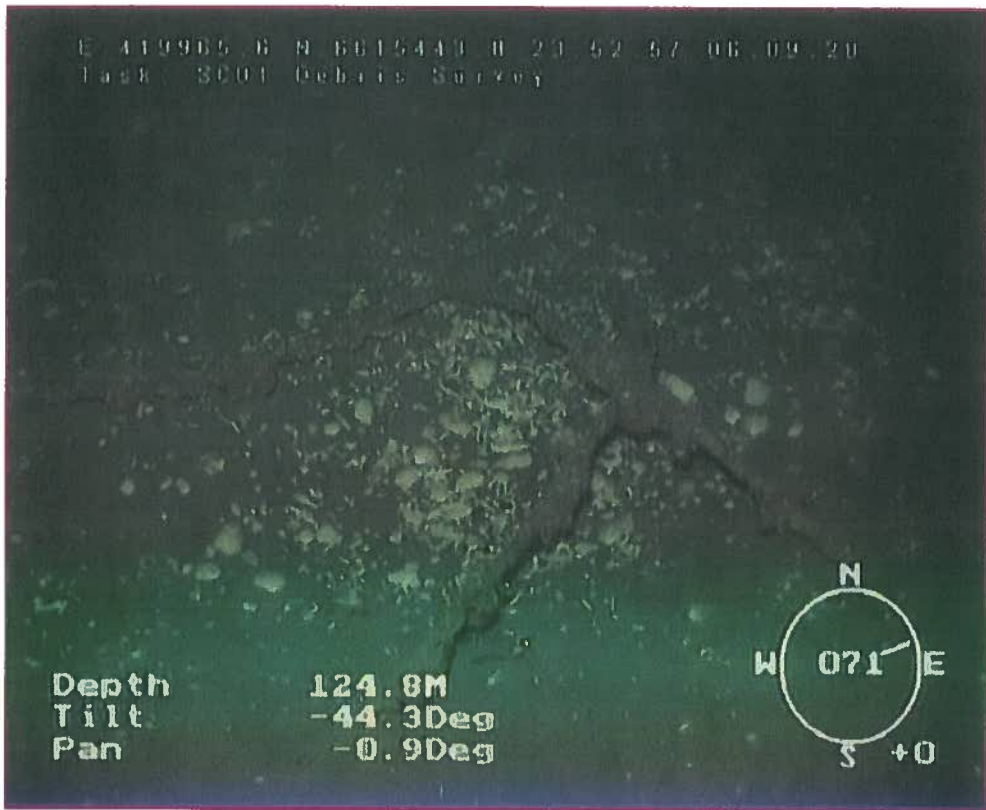
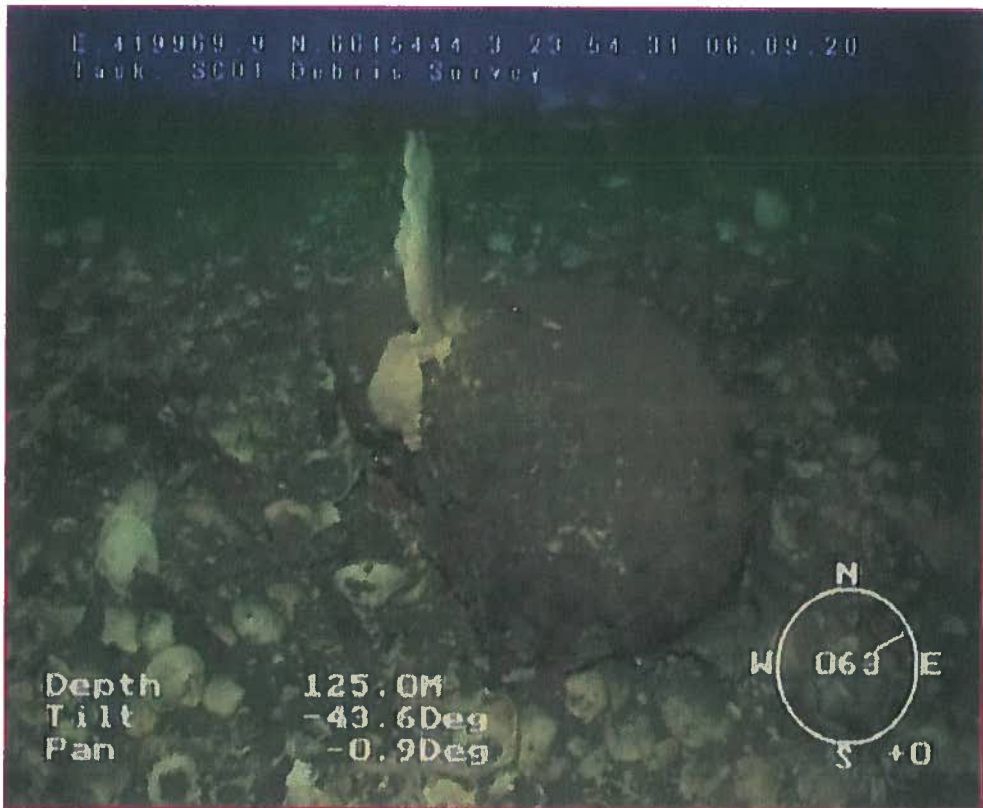
**Metallic and boulder debris at 419966E, 6615444N.**

Six small metallic items of debris were attempted to be recovered by ROV but due to the severe corrosion the debris disintegrated whenever recovery was attempted; their position is given in drawing EM-16772-DR-001, contained in section 8. The debris is too small to be detected by trawl sweep. In addition, MV Moray Endeavour lost some of its gear after snagging on a large boulder which had not been previously identified (see photograph below). The position of this boulder has been advised to Seafish Marine Services and is listed in the Hazard List within the Kingfisher Bulletin. The MV Moray Endeavour did not report any snags at the positions of the debris shown on the following photographs.

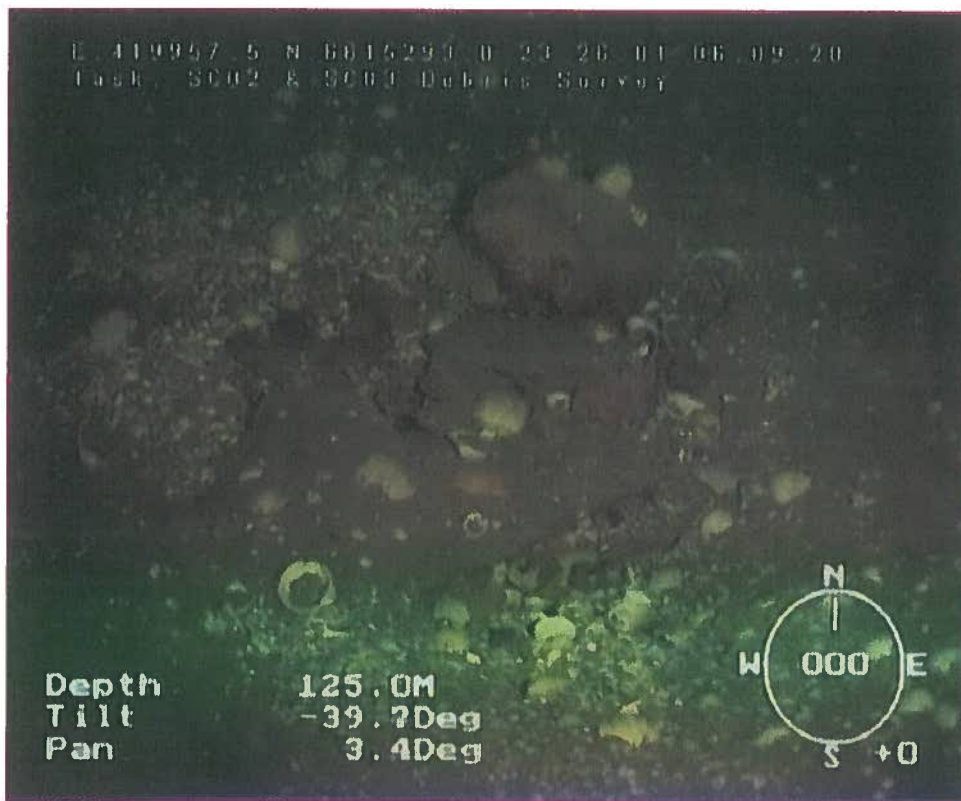
**Metallic plate debris at 419958E, 6615293N.**

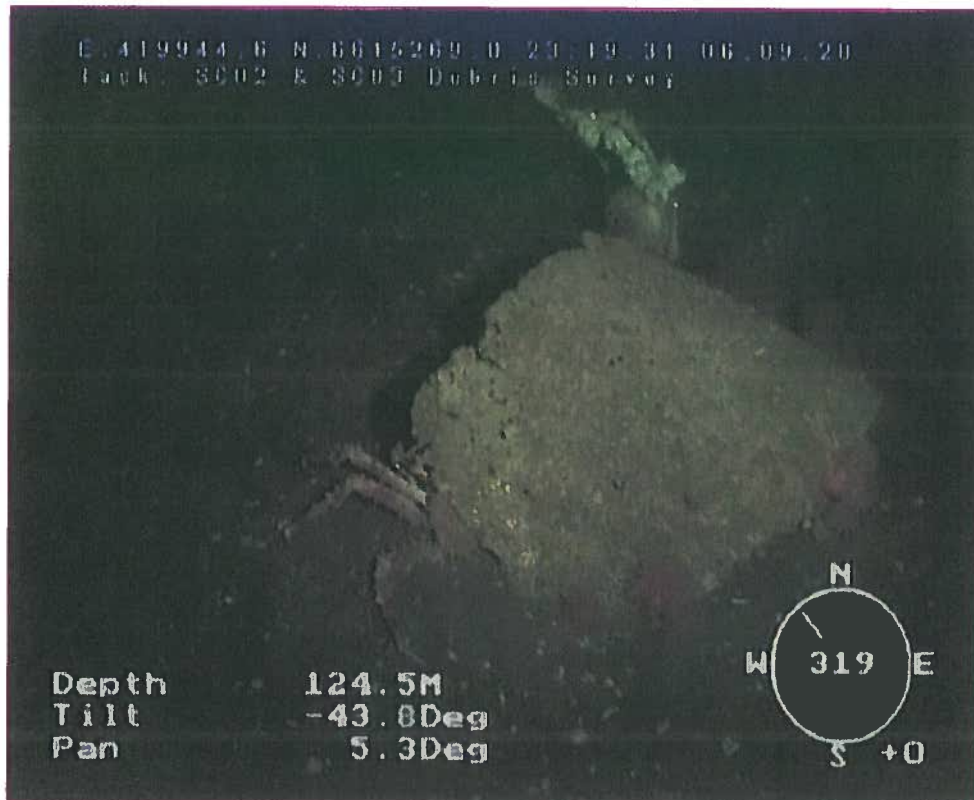
**Remains of oil drum at 419945E, 6615269N.**

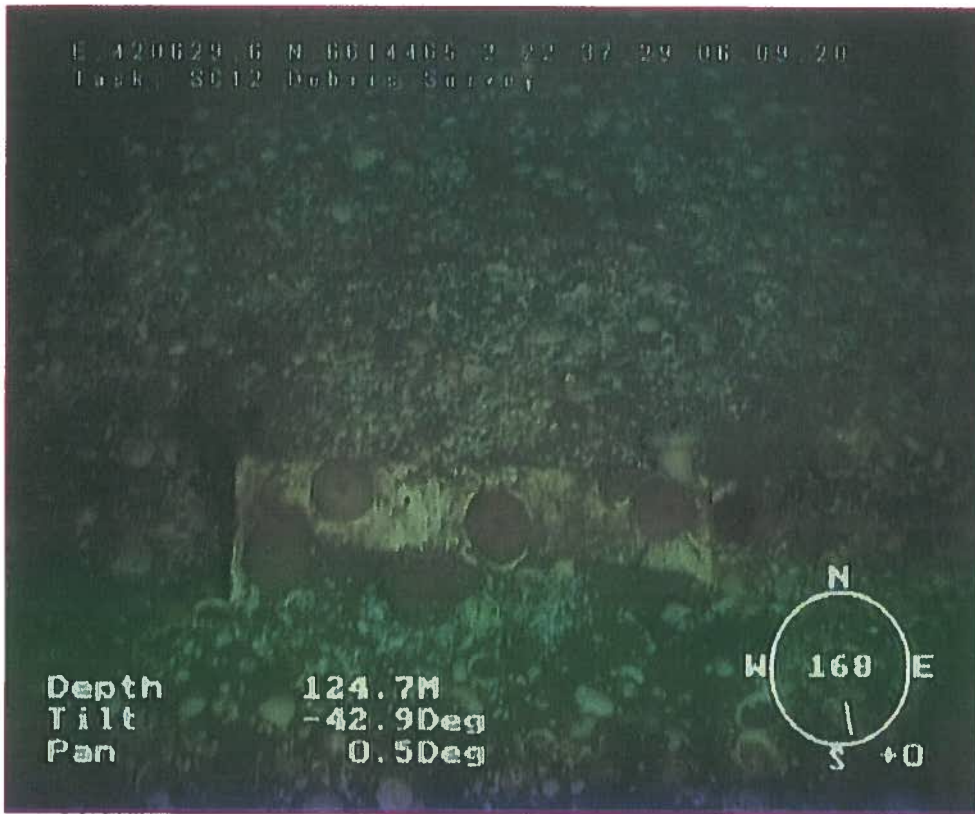
Partially buried box debris at 420630E, 6614465N.

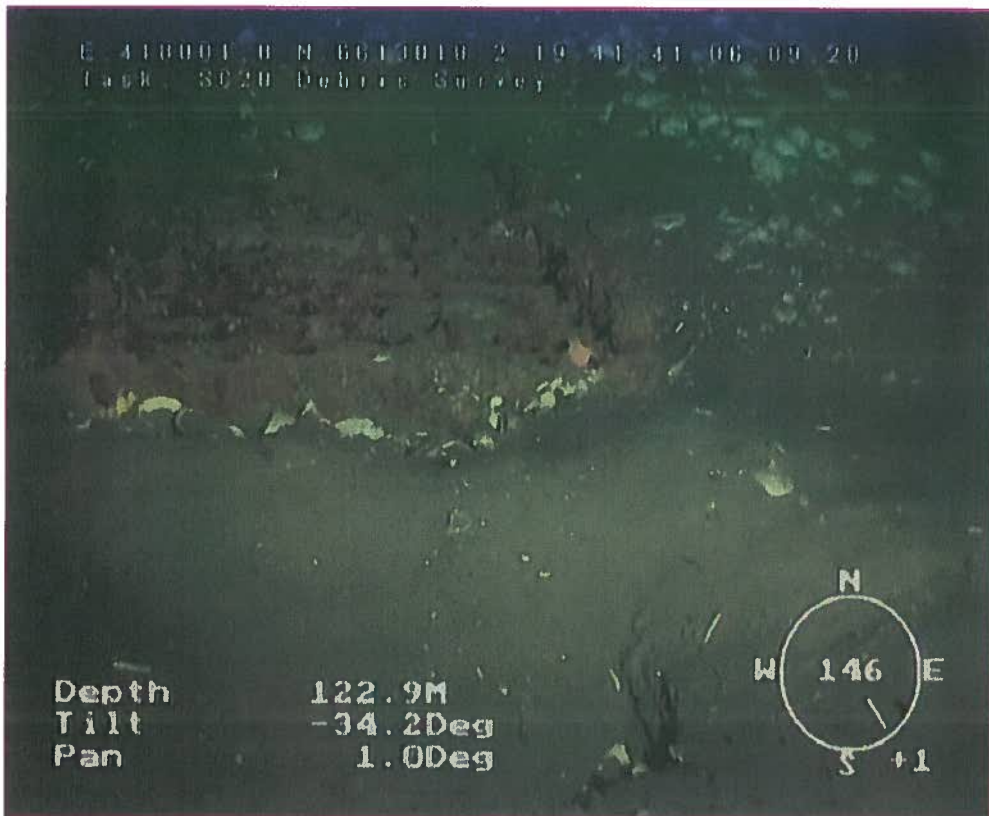
Grating debris at 418002E, 6613010N.

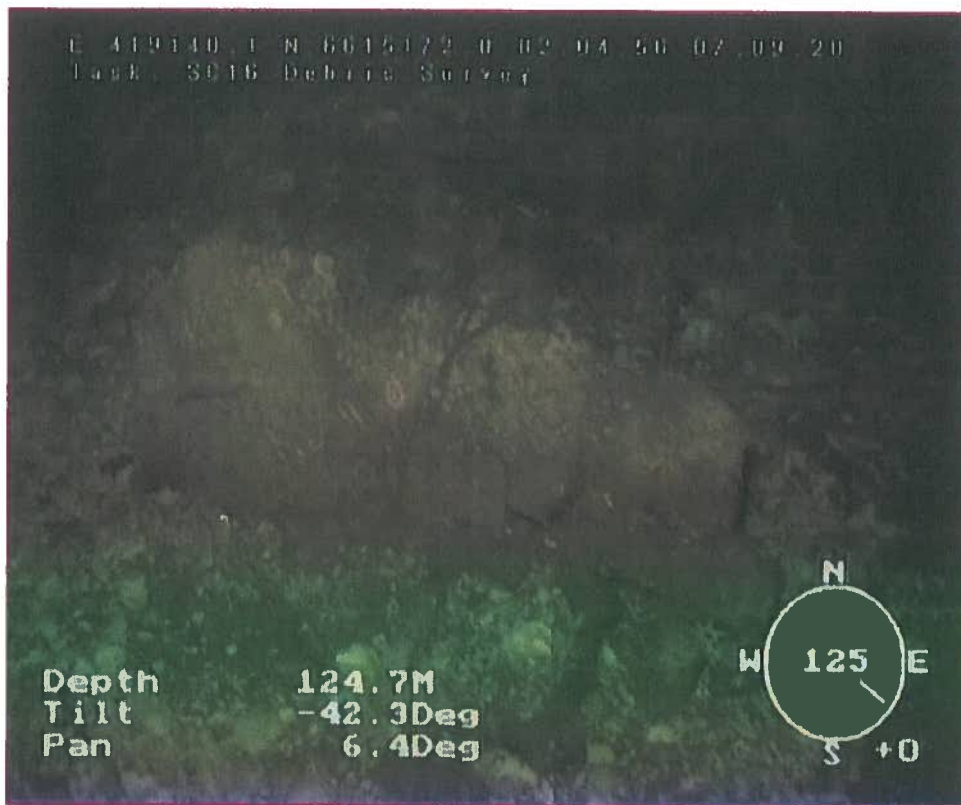
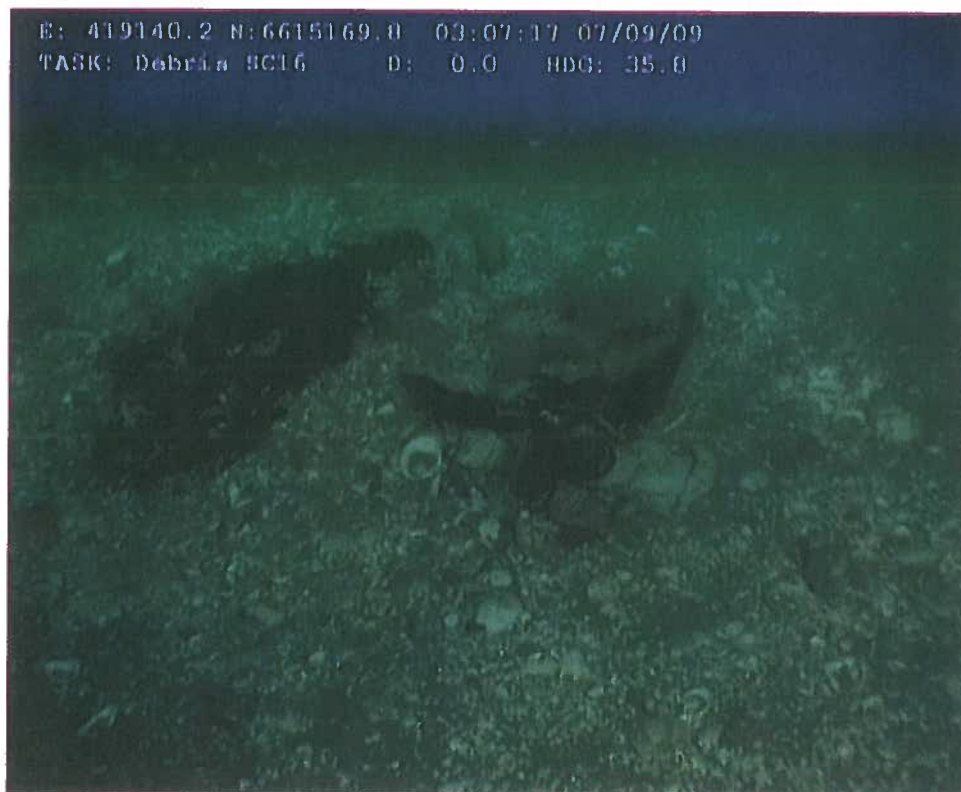
**Metallic debris at 419140E, 6615170N. The lower photograph shows the debris after it disintegrated when recovery was attempted by the ROV.**

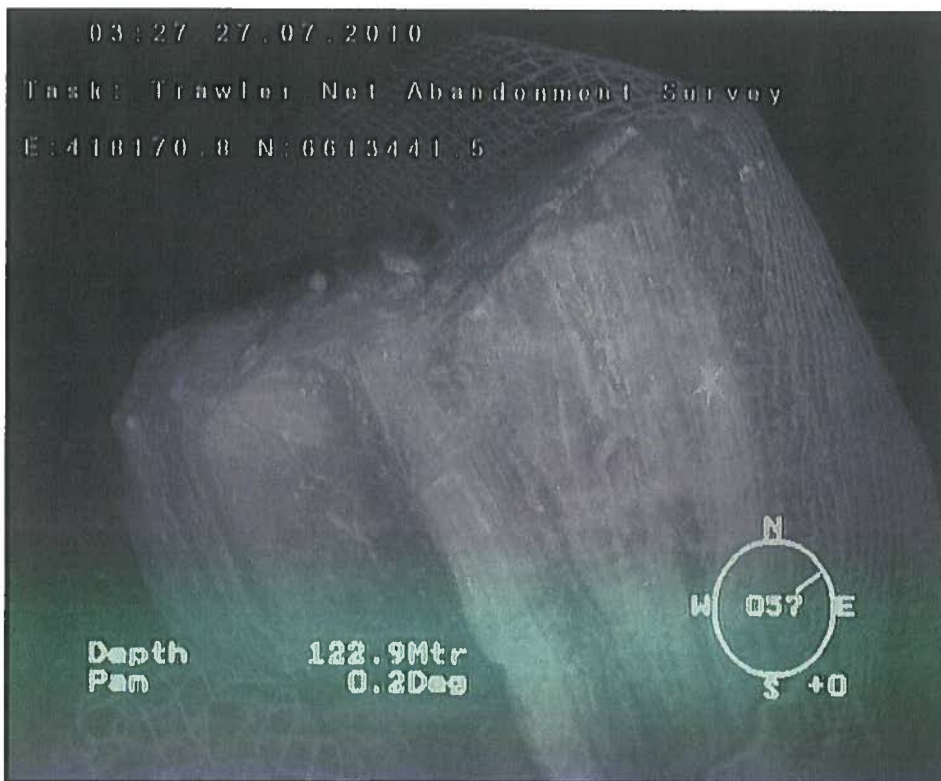
**Large, approximately 3m x 3m x 2m, boulder and lost fishing gear at 418170E, 6613442N.**

Note (1): A Severe Fast was encountered at position 59 deg 38.950 N, 01 deg 32.820 E. Subsequent investigation by an ROV Vessel contracted by Mobil North Sea LLC identified a naturally occurring feature at said location described as a large boulder (3 metres by 3 metres by 2 metres). Mobil North Sea LLC promulgated information to Fishermen on this natural hazard through the Kingfisher Fortnightly Bulletin.

After completion of the removal works in July 2010 the MV Moray Endeavour carried out a trawl sweep over the Linnhe Safety (500m) Zone and the extents of the remaining pipeline, up to 100m either side of the trenches. Two items of debris were found and removed during the sweep. The trawl sweep snagged on a large, ~3m diameter, boulder, losing the net. This has been added to the Seafish Kingfisher Fortnightly Bulletin.
