# Prioritisation of abandoned non-coal mine impacts on the environment

**SC030136/R13 Hazards and risk management at abandoned non-coal mine sites**

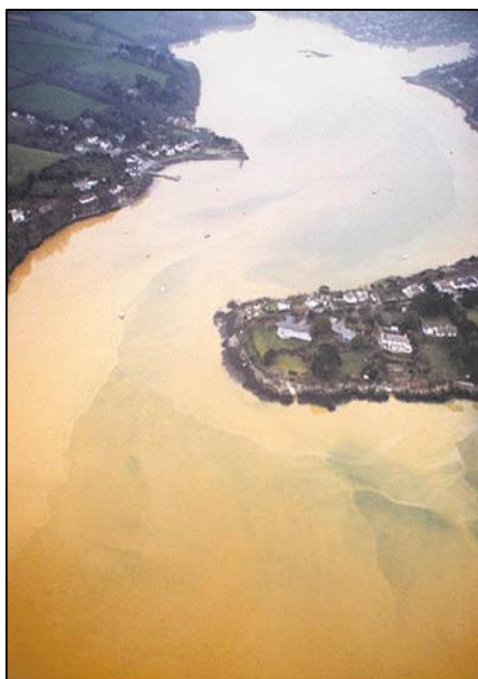
**Figure 1. Aerial view of the Fal Estuary following the 1992 Wheal Jane outbreak**

Nangiles Adit (e.g. NRA, 1994; Bowen et al., 1998), subsequent investigations have shown that no such plug existed and the abruptness of the outburst was actually due to the sudden failure of a pile of roof-fall debris which had been impounding the acidic water above the invert level of the Nangiles Adit (Younger, 2002). The released water contained in excess of 3500 mg/l of dissolved metals / metalloids (principally iron, zinc, cadmium, arsenic, aluminium, plus other traces of toxic metals) which led to downstream Environmental Quality Standards being substantially breached and completely overwhelmed the dilution capacity of all recipient water courses. A highly conspicuous ochre-rich orange plume of contaminated water developed subsequently in the Fal Estuary (Figure 1).

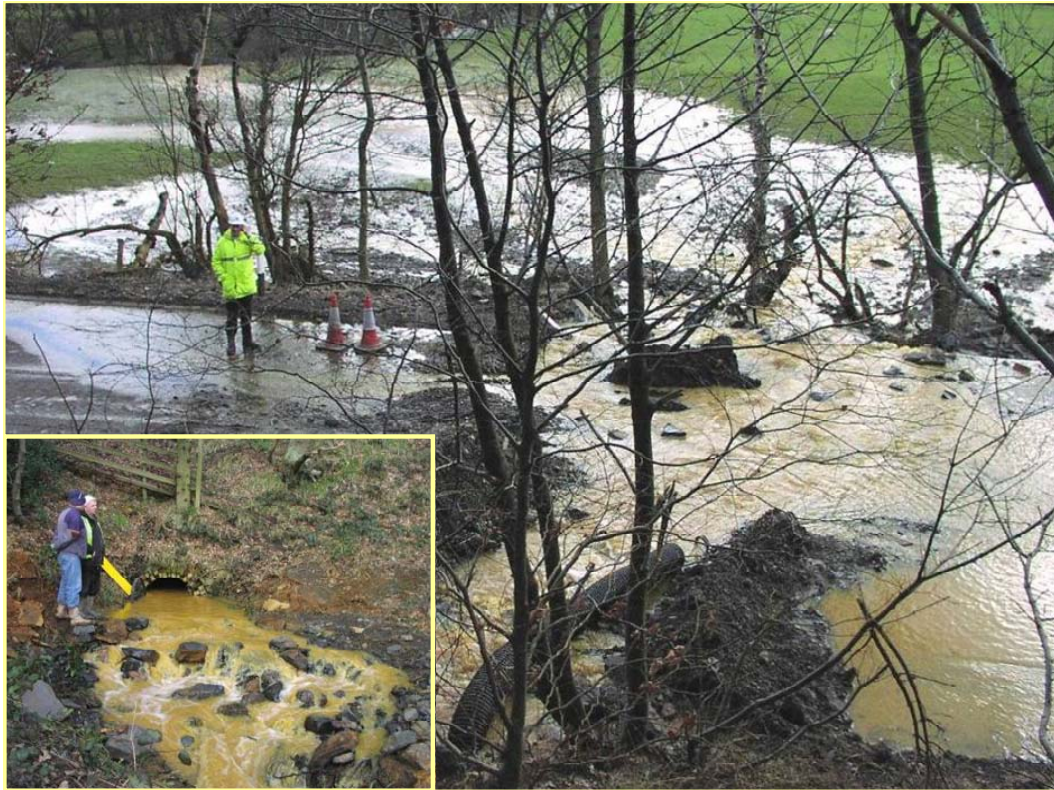
**Figure 2. Outbreak of coal mine water at Sheephouse Wood on the 28<sup>th</sup> February 2002 showing impact on A616. Photos courtesy of IMC Consulting Engineers.**

There have been numerous other examples of recent outbreak from abandoned mines (both coal and non-coal) in the UK. The Sheephouse Wood discharge near Stocksbridge (South Yorkshire) provides one of the best examples of the potential impacts of such events. In February 2002, a sudden outburst of contaminated water and rubble occurred from Sheephouse Wood into the Little Don River, presumably the result of water building up behind a temporary blockage in the adit, and resulted in a section of the A616 Stocksbridge by-pass being destroyed, and then closed for three days for repairs (Figure 2). Adjacent farm land was also damaged by the outbreak. Fortunately the outbreak occurred overnight when the road was not in heavy use. A range of short term measures to limit immediate impacts of the

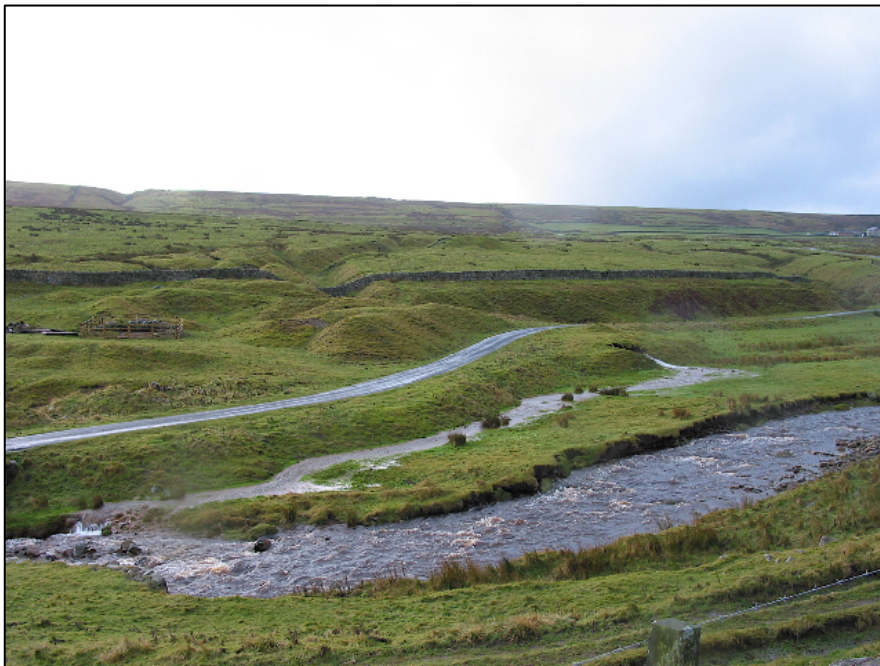
**Figure 4. Outbreak from Rispey siderite mine in County Durham which occurred following heavy rainfall in December 2006.**

The Rispey site in the Rookhope Burn is also mentioned as a site with history of outbreak. The metal mines of the North Pennines have experienced several incidences of recent mine water outbreak which usually follow extreme rainfall events. The Rispey outbreak occurred in December 2006 and was considered to be due to obstruction of the adjacent (and hitherto flowing) Tailrace Level discharge. This forced the collapse of a nearby crown hole from which the discharge newly emerged to the Rookhope Burn (Figure 4). This new discharge is now the second most severe metal mine water in the North Pennines in terms of zinc loading, discharging in the region of 4.5 tonnes of zinc per year into the Rookhope Burn and subsequently the River Wear.

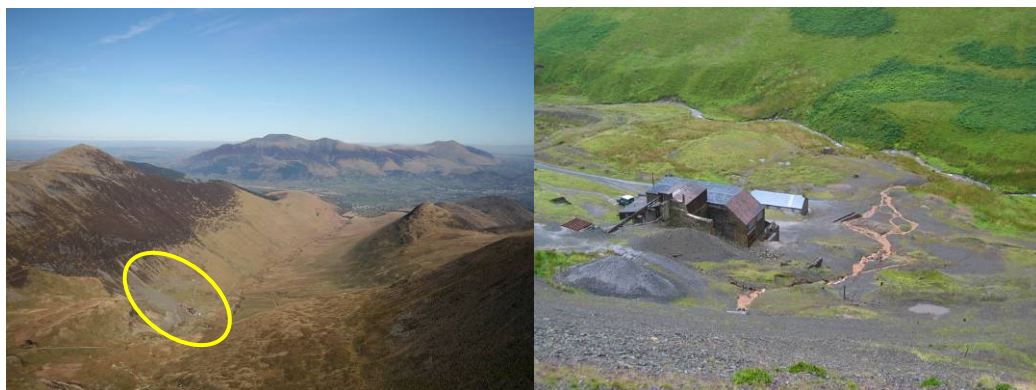
**Figure 5. The Force Crag lead mine (circled) in the Coledale Valley (left) showing the steep terrain and mine buildings (right)**

An example of current management of outbreak risk at a non-coal mine is at the Force Crag lead mine in Cumbria where the site owners (National Trust) have

commissioned investigations to assess options to relieve impounded mine water. Some 20 metres of mine water has built up behind a collapsed adit in the lowest level of the workings. Along with evidence of physical instability in saturated slopes and recent changes in flow at the site, the blockage has prompted fears of a sudden slope collapse which could release at least a portion of the  $\sim 400\text{m}^3$  of zinc-rich mine water that is thought to be impounded in the mine into the adjacent Coledale Beck (and subsequently into Bassenthwaite Lake). While such an outbreak would be of particular concern in such a sensitive setting with downstream conservation sites (Figure 5a), directly beneath the area of impounded water are preserved mine buildings and a public footpath / roadway so there are also concerns for public safety (Figure 5b). As such, the National Trust has initiated investigations to reduce the head of mine water. These have comprised detailed review of mine site hydrogeology, water quality and engineering options. The proposed option for relieving the mine water build-up is temporary pumping of water from the lowest mine level via a new borehole, to then allow drilling of a new replacement adit entrance which would permit long term gravity-driven drainage of the mine.
