## Health & Safety Alert

**Operating Unit: M25 Section 2**

**Location: Works Access A50 M25**

**Cause: Variations in ground surface**

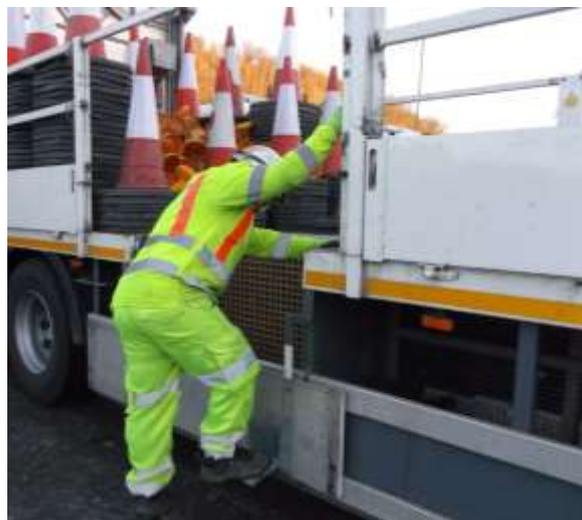
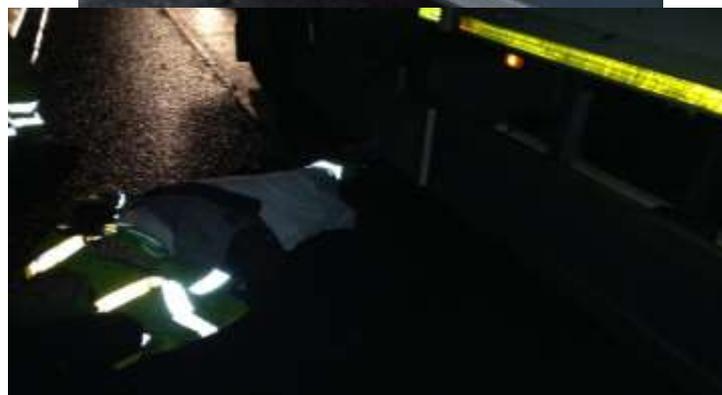
Whilst applying a night time 1 & 2 lane closure on the M25, an experienced Traffic Management Foreman stepped down from the coning well of an Impact Protection Vehicle and inadvertently stepped on to the edge of a 50mm change in the road surface level, which had been left by the road planer. This unstable footing caused him to go over on his ankle and fall to the ground, causing him to suffer severe strain injuries to his ankle.

- *Always, face the vehicle, maintaining a 3 point contact when alighting fom vehicles and item of plant.*
- *Always wear safety footwear incorporating good ankle support.*
- *Where practical to do so, park at a distance that avoids stepping onto any changes in levels, or unstable ground.*

- Ensure lighting levels are adequate (see [B15 Task Lighting](#) )
- Ensure the correct footwear is worn
- Ensure steps and grab handles are in good condition
- Consider demarcating step with marking / cones.
