Shell UIE United Kingdom

# **Indefatigable Field Platforms and Pipelines Decommissioning Programme Close Out Report**

Document Number: **EP201401220888**

**INDE Decommissioning Programme Close Out Report**

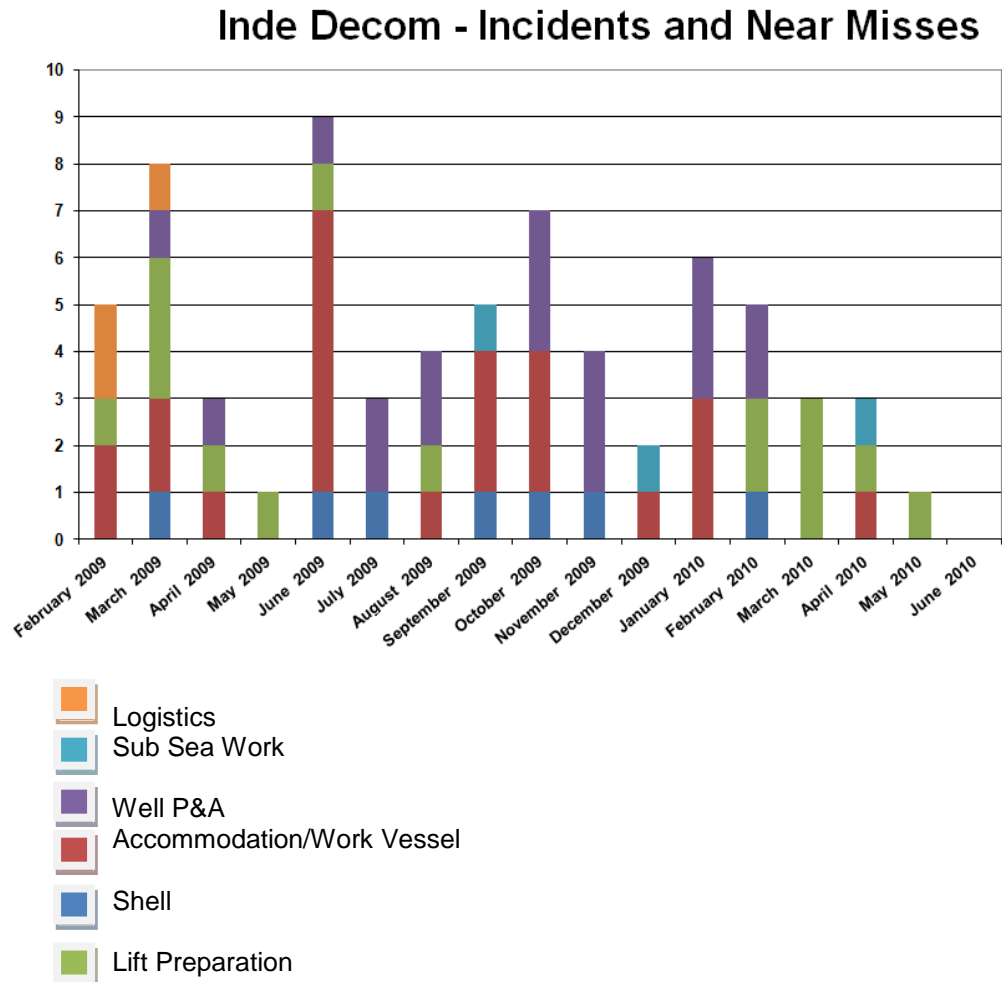
Incidents and near misses over time are as per below diagram. The total number of exposure hours is 1.090.000.

The total number of incidents plus near misses was 70. Broken down as follows: 53 near misses, 11 first aid cases and 6 incidents. There were no Lost Time Injuries (LTI's).

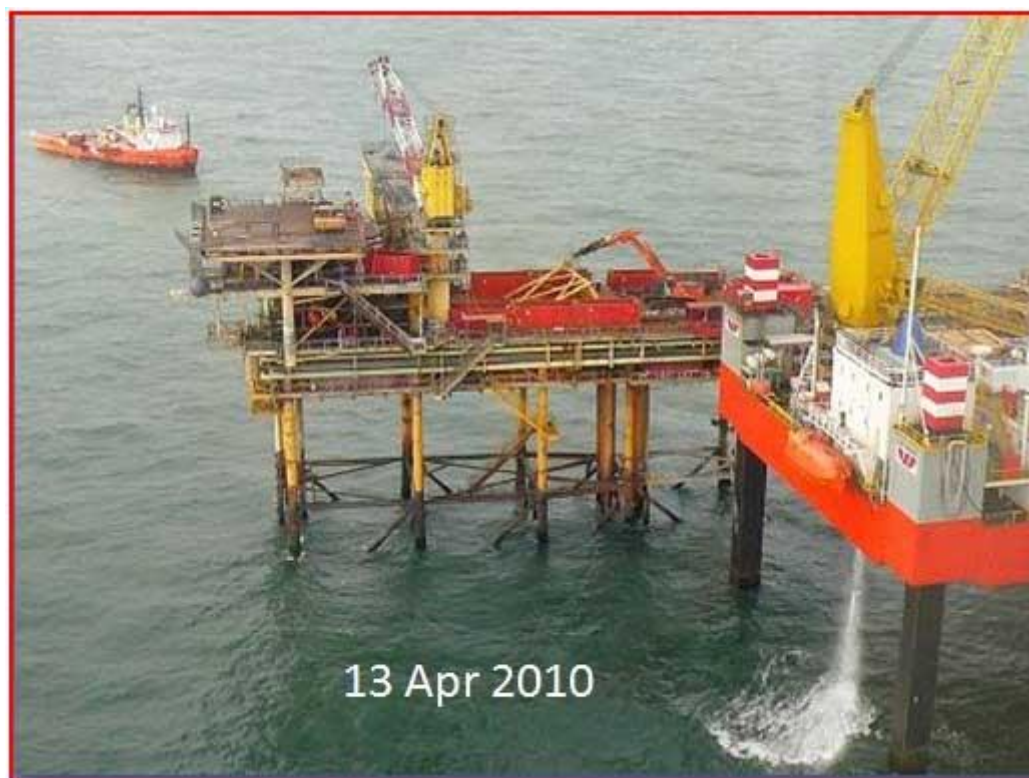
**Piece Small in progress on Juliet D**

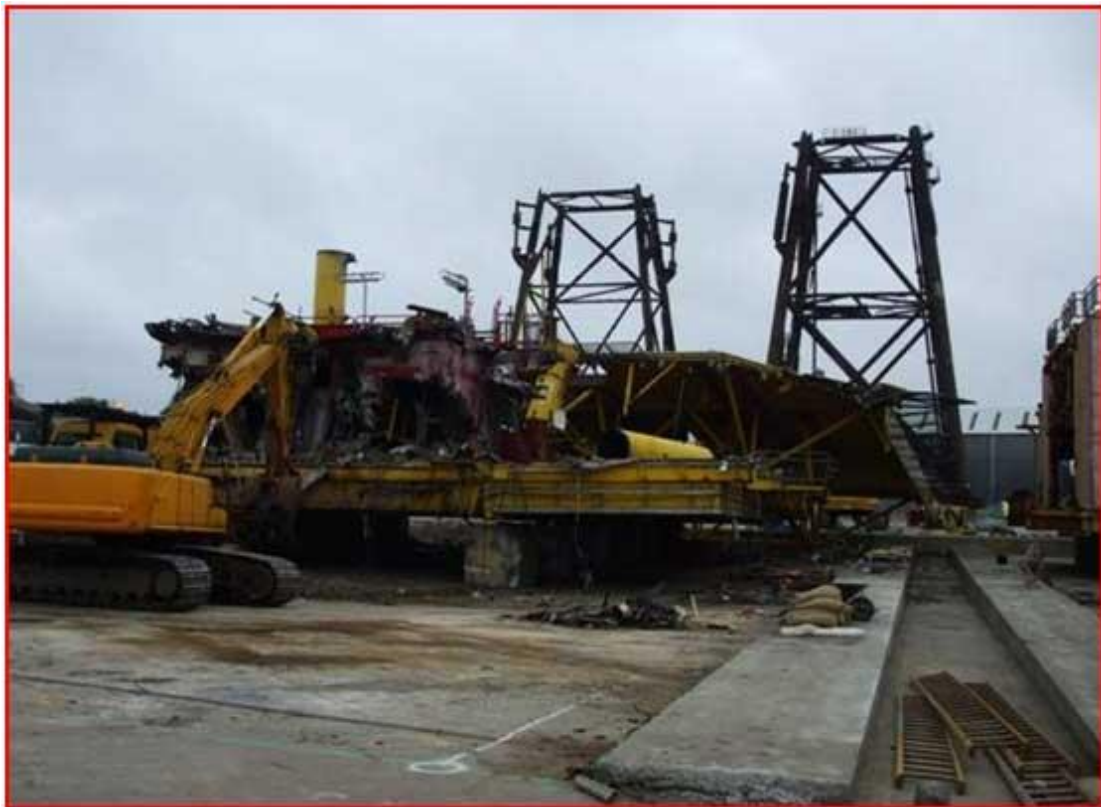
The marine growth on the jacket, which was about 65% less than predicted, was removed by means of high pressure cleaning. The jacket structure has been weakened by taken out bracings followed by toppling of the jacket structure on a sand bed. Jacket was weakened by pre-cuts and pulled by the onside excavators, Smaller diameter parts have been cut into pieces by means of an excavator and the bigger parts have been cut by flame cutting.

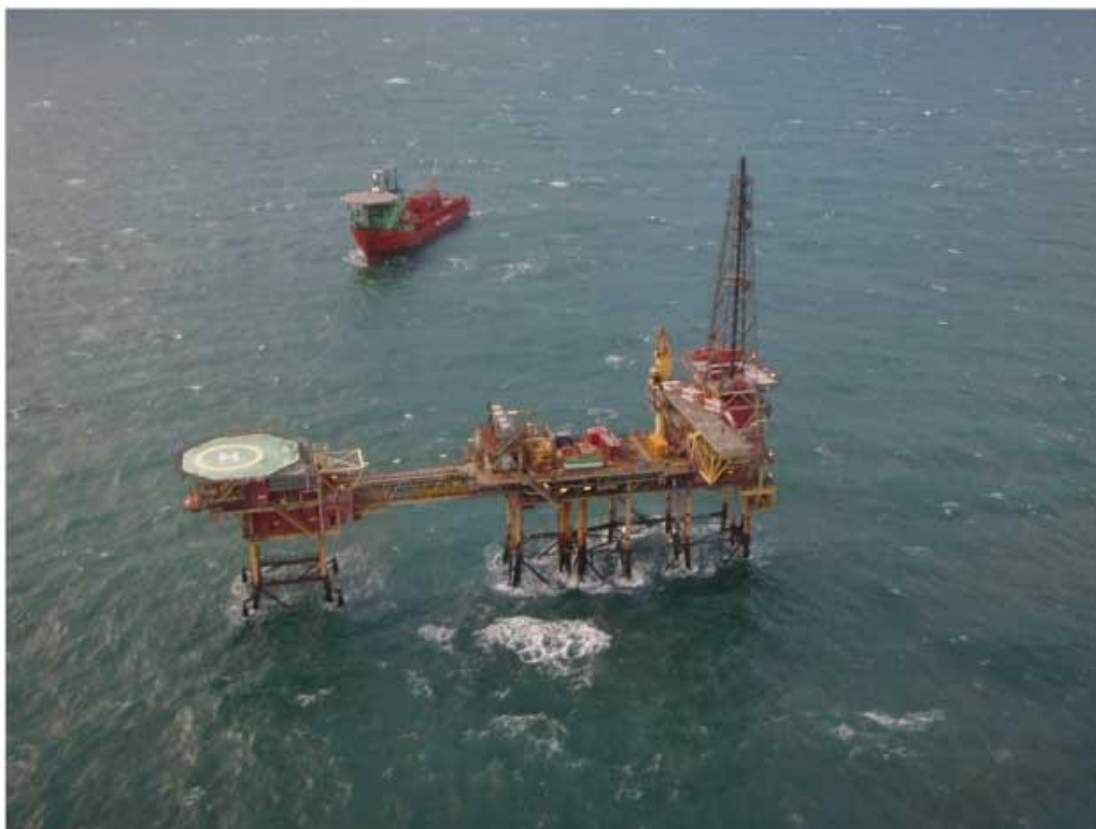
**BW Carmen at Inde Juliet**

Prior to the arrival of the Carmen, the liquids handling manifold and hose over-boarding chute were installed on the main deck on the Juliet platform. The design and management of the construction of these items was carried out by Fluor B.V. The fabrication was arranged by A-Hak BV.

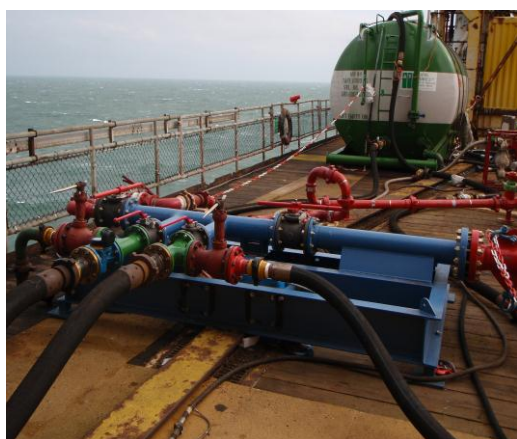
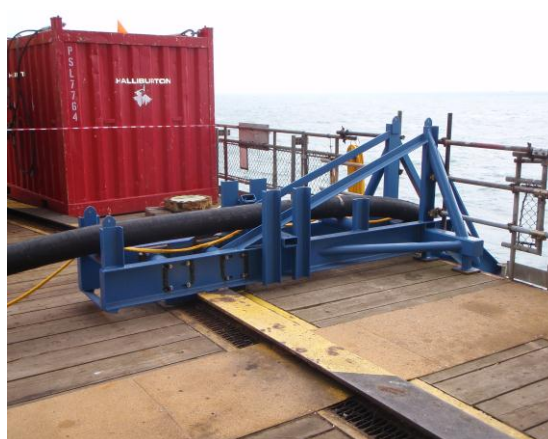
**Manifold and Hose Overboarding Chute at Juliet**

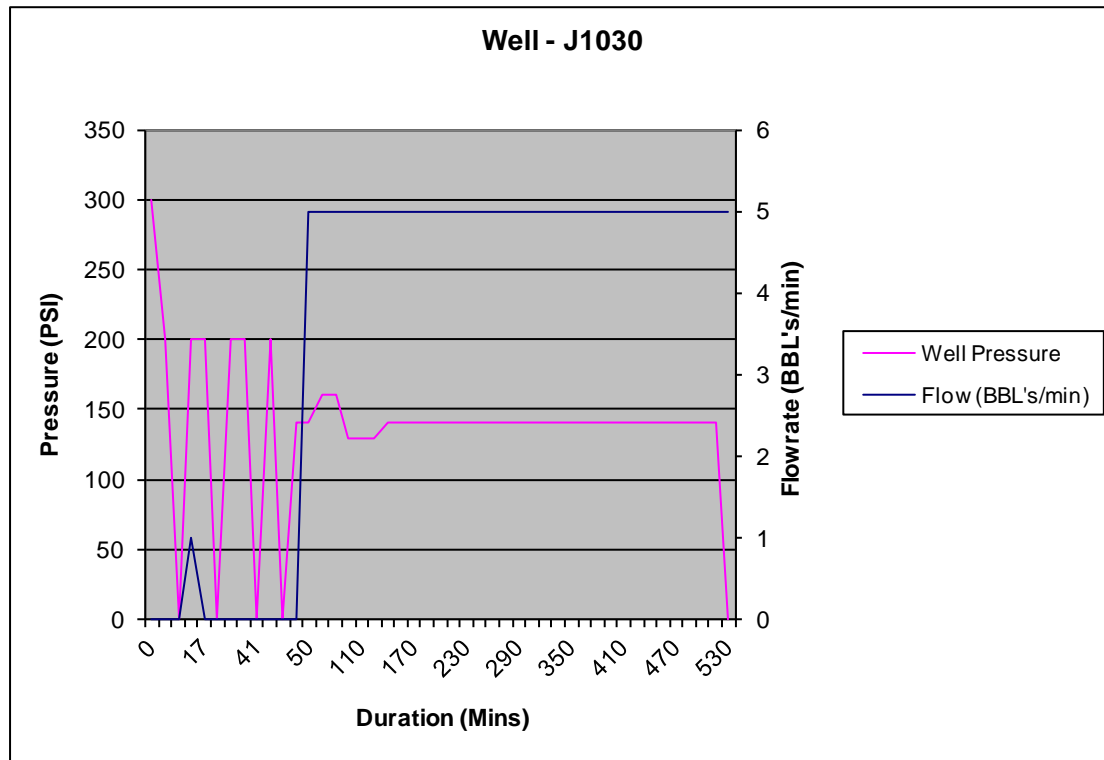
**Inde Juliet Well Injection**

After initial back pressure spikes and low flow for a period of approximately one hour, a steady flow into the well of 0.8 m<sup>3</sup>/min (5 BBL/min) was achieved for the remaining flowing period totalling nine hours. In addition to the limited pump capacity from Carmen, it was calculated that the down hole bore size of 2.7" would ultimately limit the maximum flow achievable to approximately 1.5 m<sup>3</sup>/min.

Halliburton UK were chosen to provide a hi-pressure pump capability, to carry out the re-injection down Well J1030 on the Inde Juliet platform. Three persons were mobilised to Juliet on 11 September to carry out well injection from the BW Carmen during nightshifts. The maximum potential flow rate provided by the frac pump was limited by the Carmen's offloading capacity, the resultant total volume of liquids re-injected down the well was 412 m<sup>3</sup>. This was carried out during one nightshift period on 16 September. See result graph below and Appendix F for Well Injection Layout.

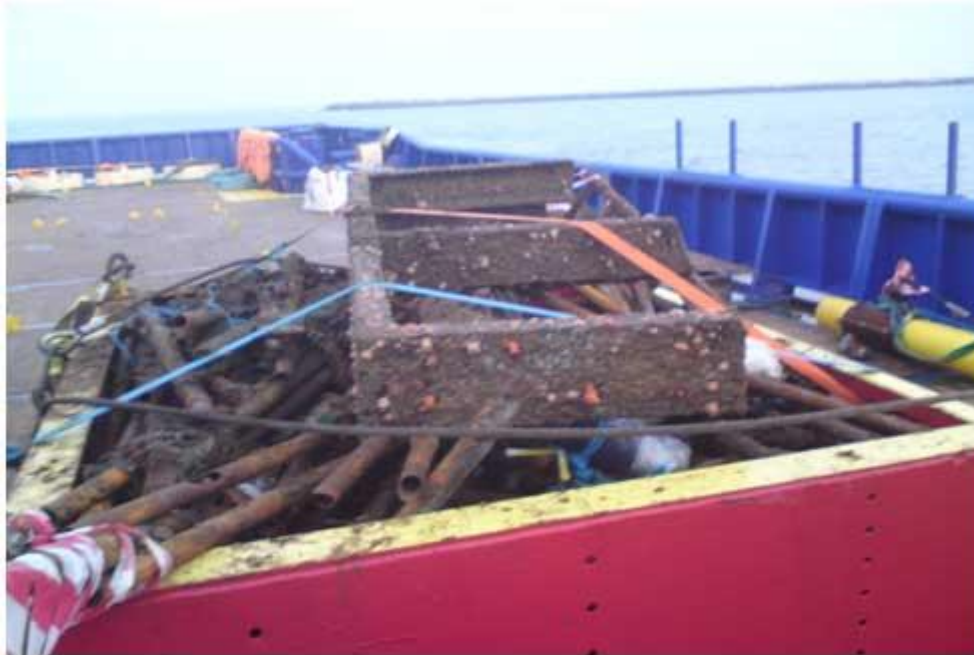
**Debris Recovered at Kilo by the DSV Bibby Topaz -2008**

The DSV Bibby Topaz conducted debris clearance during September/October 2008 at Inde Kilo and Inde Lima in preparation for the arrival of the Seafox 4. Several tons of assorted debris was recovered. Large debris was identified at Lima for later recovery.

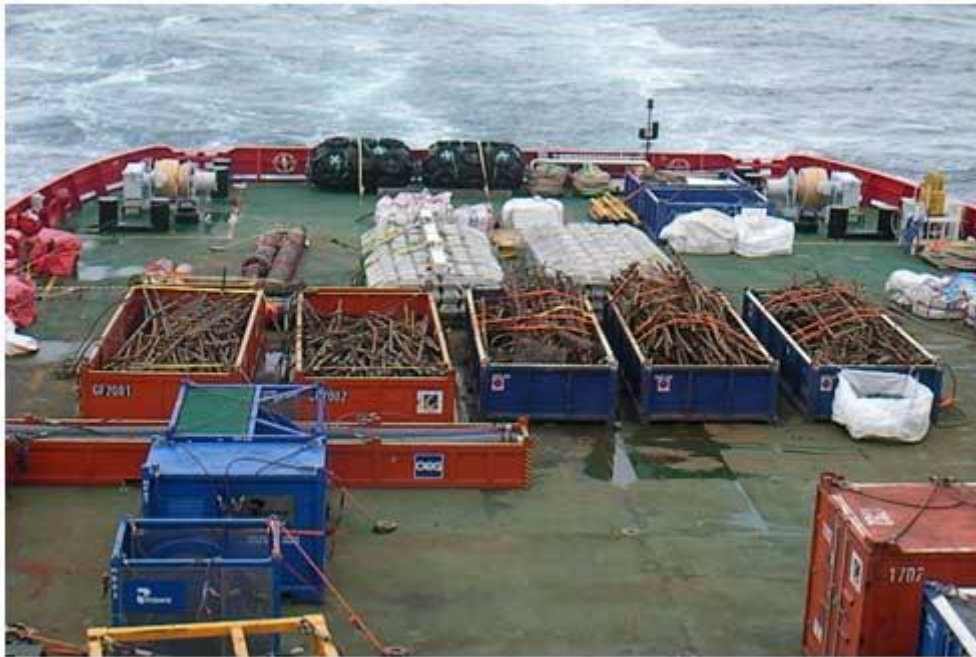
**Typical debris recovered from Inde Platform Locations – DSV Seven Atlantic**

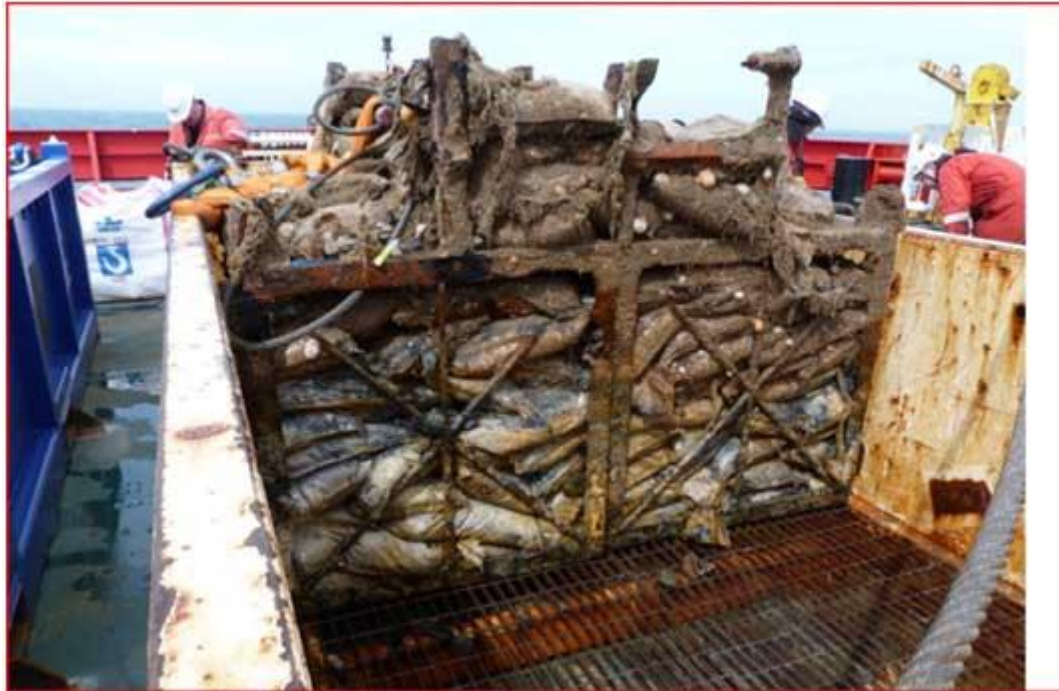
During March 2012 the ROVSV used a mass flow evacuation tool to bury the 12 inch (PL302) pipeline end. However two grout gabion containers were located below the pipeline, therefore restricting sufficient burial. During May 2012 the DSV used a diamond cutting device to remove a section of the pipeline and recover the 2 gabion containers. Measurements taken of the adjacent seabed level reported depth from top of pipe was in excess of 0.6 meter.

**Recovered grout gabion from 12 inch (PL302) at Juliet**

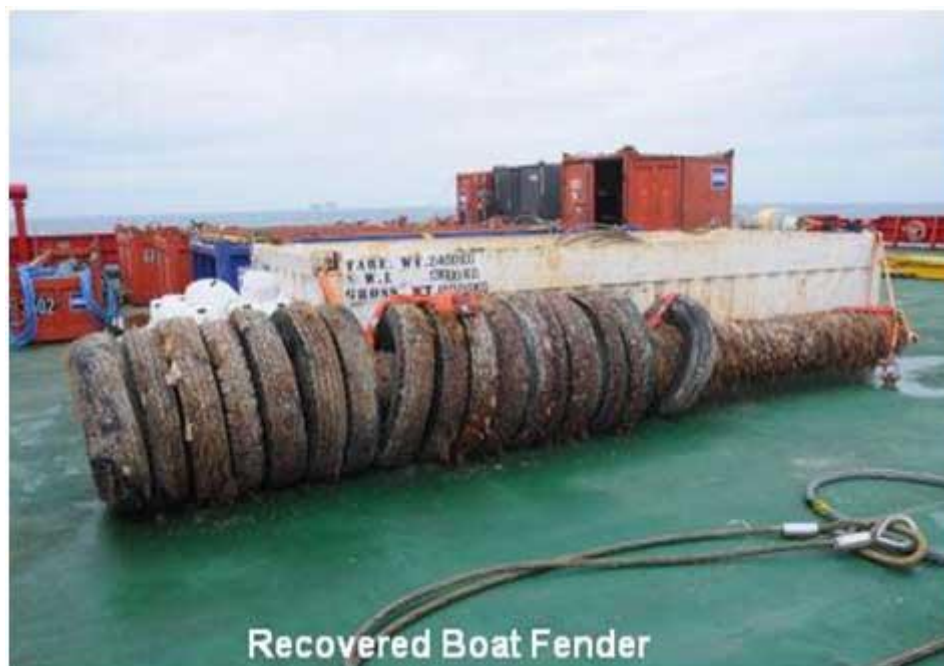
Recovered Boat Fender

A DSV intervention to Lima was conducted during March/April 2010. A diamond wire cutting device was employed to cut the 16 inch (PL82) riser at the base of the jacket. Further cuts were made after the riser turns and spools were removed. This ensured separation between the platform and the pipelines. A 32 inch conductor section was removed from inside the jacket base. A boat fender lodged between the jacket vertical legs was removed.

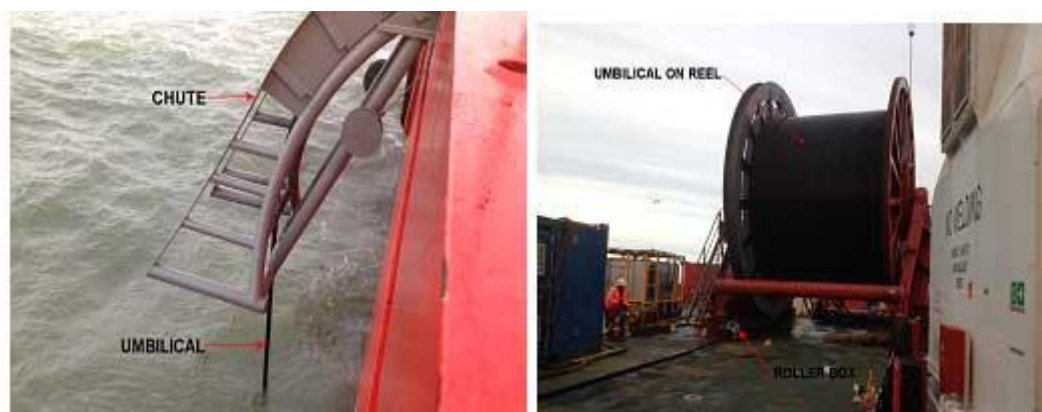
The DSV carried out the recovery of the 3 inch Kilo to November umbilical during January 2012. A temporary spool and tensioning system was fitted to the aft deck area on the DSV. Diver assisted the recovery to deck of the umbilical end at JD. The recovery operation went smoothly with no snags experienced along route. The recovery time was 6 hours and 5 minutes with a maximum tension recorded of 5.5 Tons. The 2.4 km umbilical was then transported onshore in the UK for disposal and recycling.

**Inde Kilo to November – Umbilical recovery on to DSV**

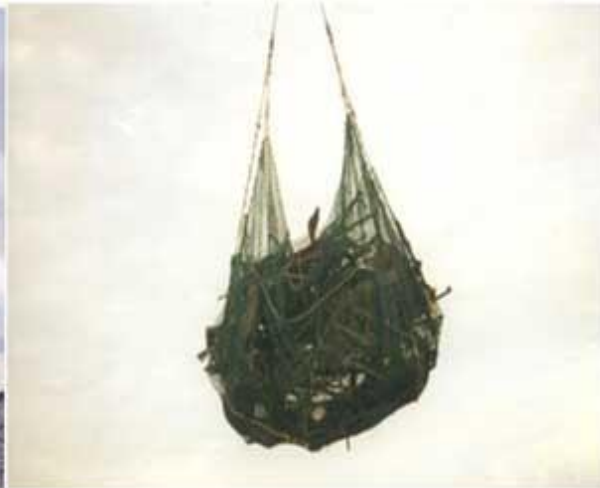
The debris recovery program commenced on 8 June 2012 by trawling through the decommissioned 500 m safety zone. Each pass through the zone concluded with the recovery of the trawl and any debris removed from the net before proceeding with the next line. The objective of this practice was to limit the amount of debris which would be gathered at any one time and thereby making gear handling a safer process for the deck crew. The debris clearance sweeps were followed by the verification trawls.
