### What happened?

While directing plant during construction activities, an operative's feet became trapped between the tracks of a 5 tonne rubber tracked excavator and kerb. This resulted in fractured bones in one foot and a fractured ankle on the other.

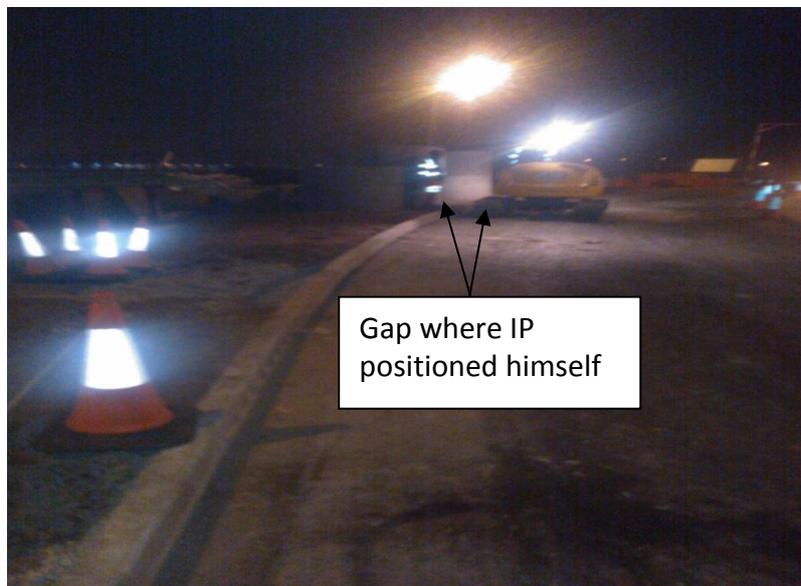
The IP had left the excavator to check on the agreed road crossing point, with the knowledge that the excavator was going to turn through 90 degrees on its tracks in preparation for crossing the road.

The plant operator assumed that the IP had left the area and did not expect the IP to be in the vicinity of the equipment so began his manoeuvre. The IP had positioned himself as per below image, the excavator turned, resulting in the above injuries being sustained.

- There needs to be clear communication between the Operator and the Banksman/Vehicle Marshaller, and both must fully understand the plan of action.
- Only trained Banksmen/Vehicle Marshalls should be used to direct plant (there is now a CPCS course (A73) available for Vehicle Marshalls).
- Banksmen/Vehicle Marshalls should be easily identifiable – the use of different colours of vests or hats is an easy way to achieve this.
- Plant Operators should always check the safety zone is clear before movement commences.
- The use of technology should be considered where there is a close man machine interface.
