# North West Hutton Decommissioning Programme Close-out Report

**Prepared by Jee for BP**

**Document No. BP261\_r01g**

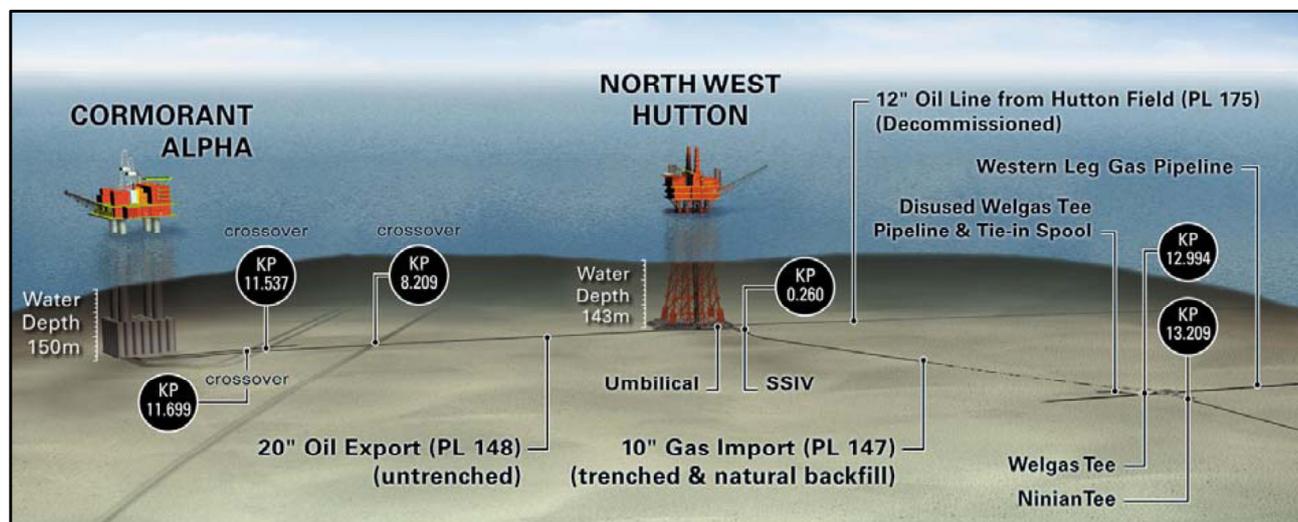
Figure 1-1 - NWH field overview

Figure 1-1 shows the NWH field prior to the commencement of the decommissioning activities:

The NWH field is located in Block 211/27a of the United Kingdom area of the NNS. The platform was operated by Amoco (U.K.) Exploration Company, on behalf of Amoco U.K. Petroleum Limited and their partners in the field (hereinafter the “NWH partners”).

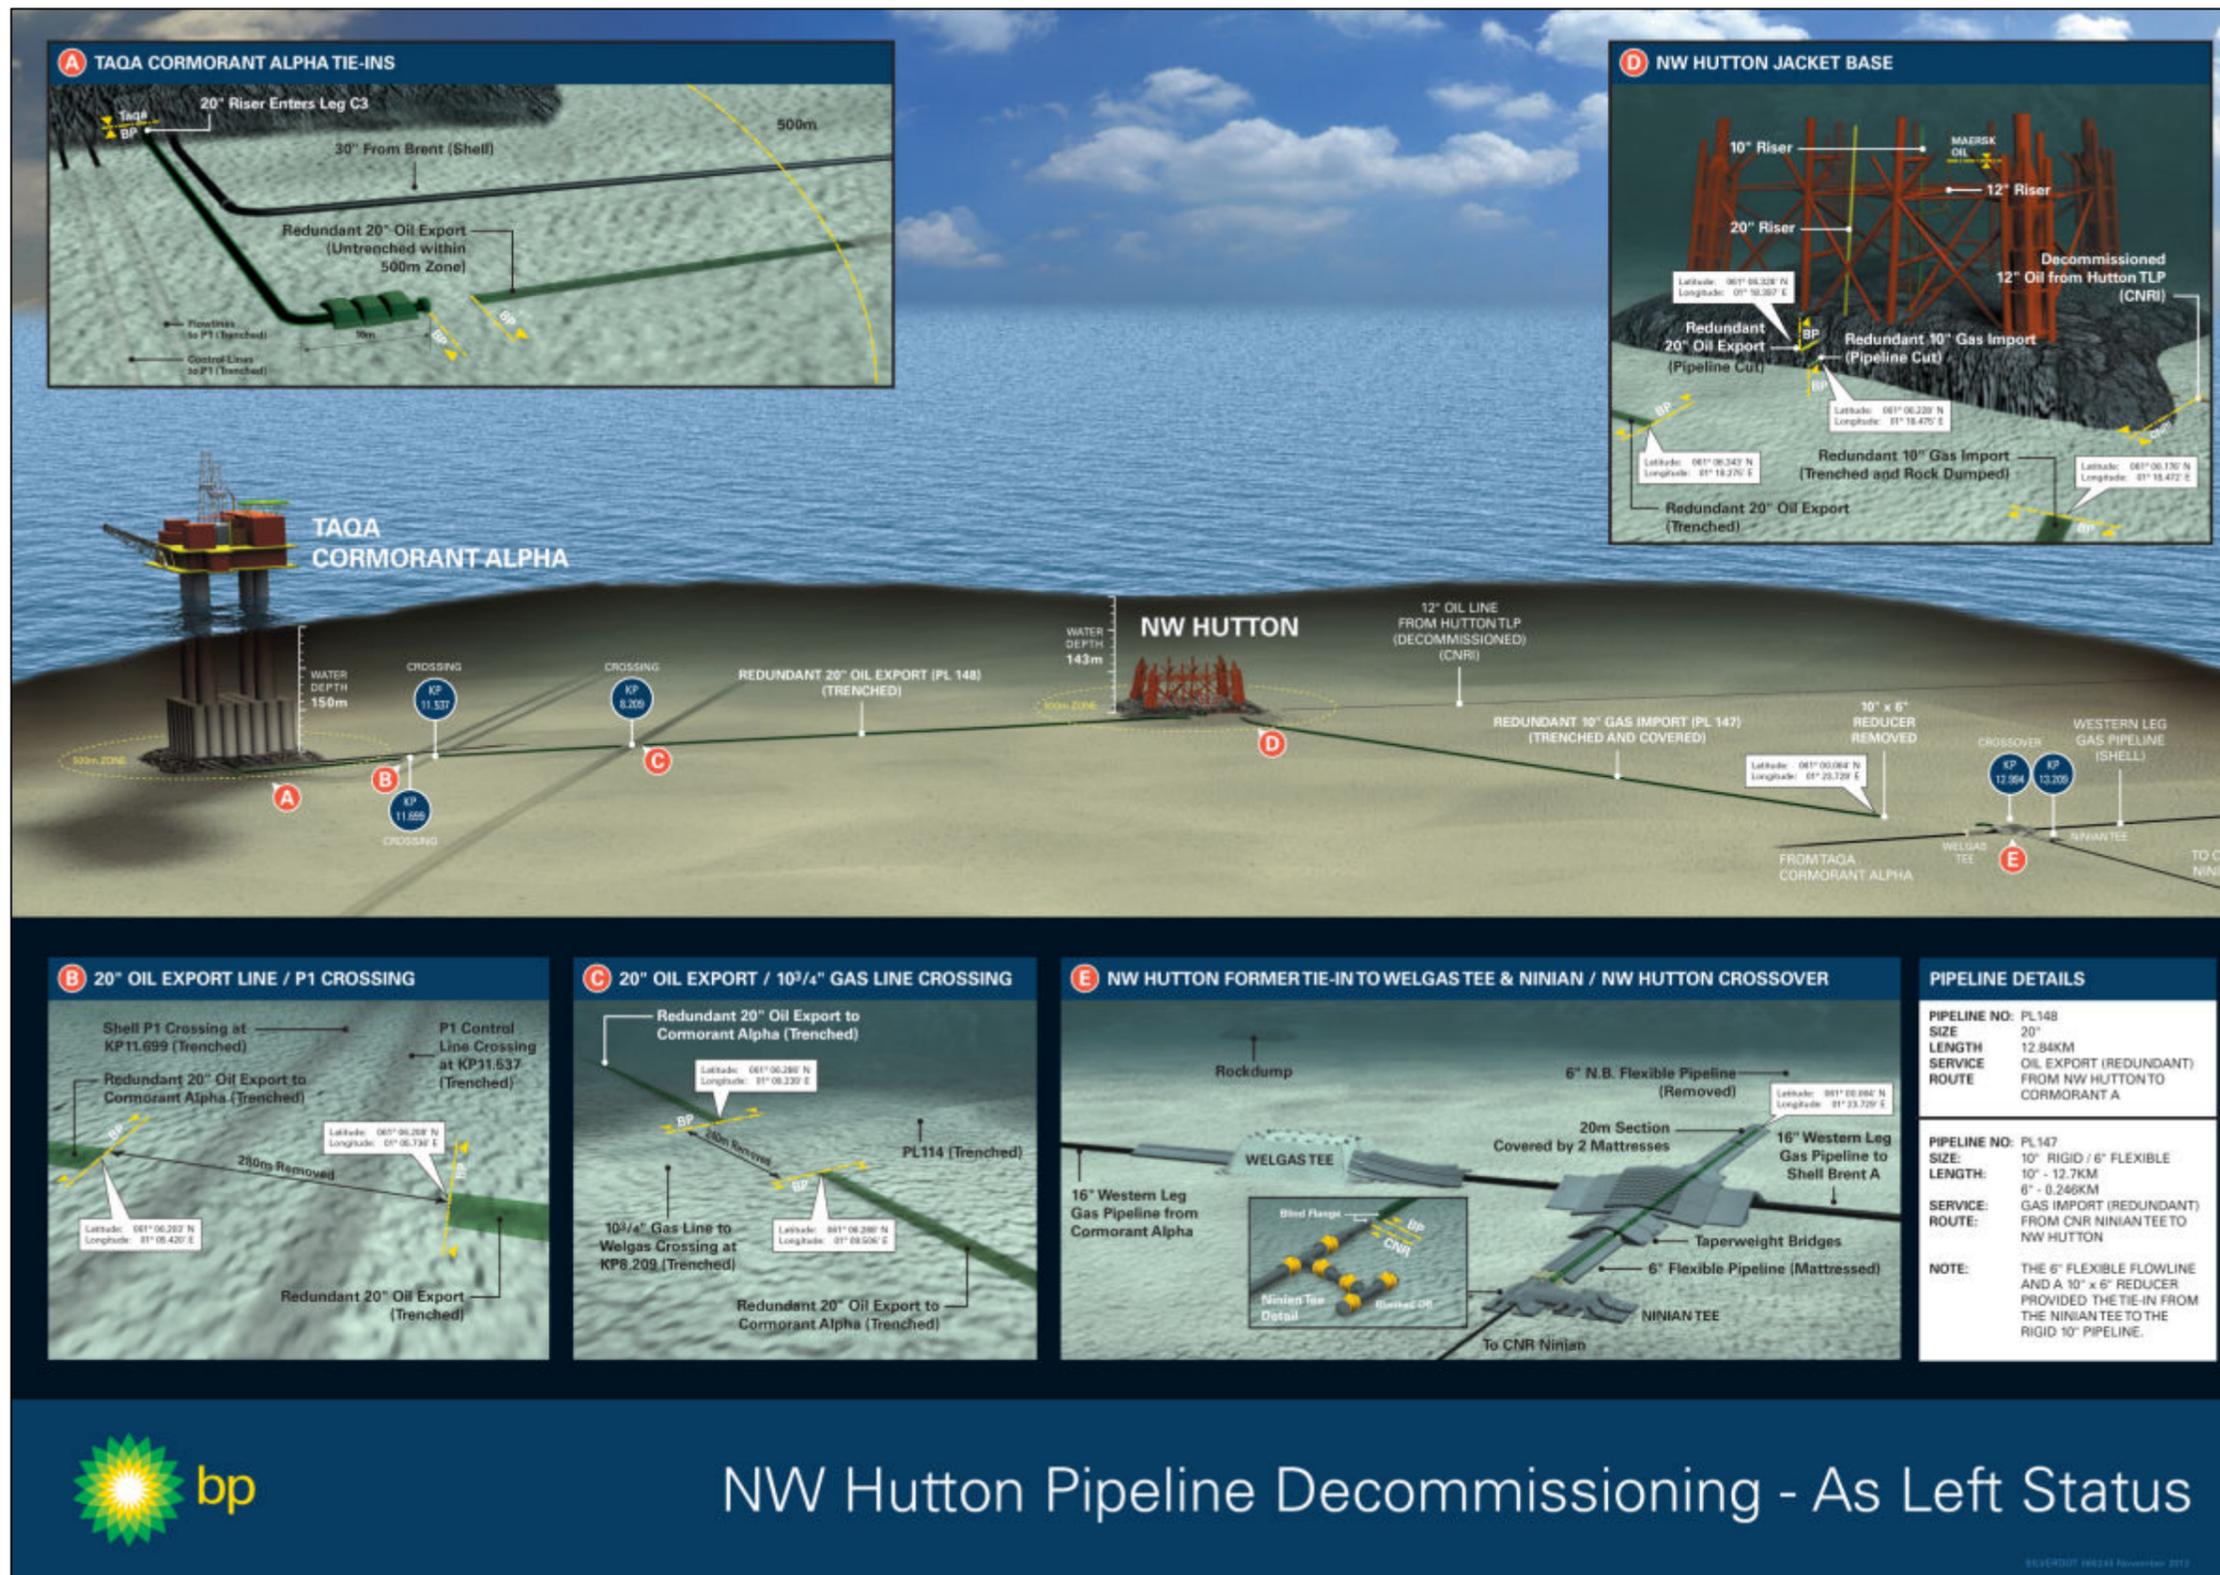
Figure 1-2 - NWH "As-left" field status

An as-left schematic of the NWH field is shown in Figure 1-2.

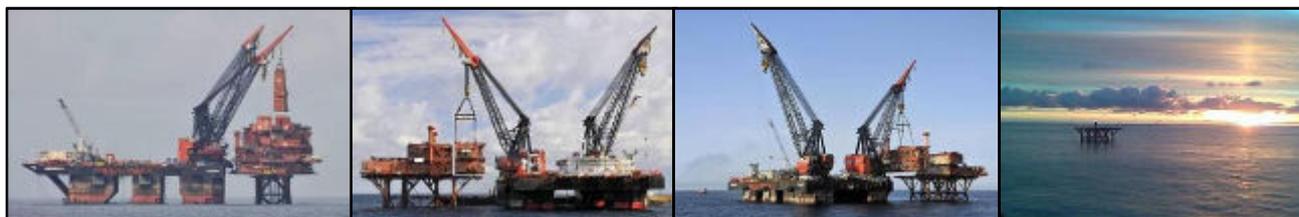
Figure 3-1 - Topsides decommissioning

The physical removal of the topsides was carried out by Heerema Marine Contractors, using the semi-submersible heavy lift vessel Hermod. Works began in May 2008 and were completed in August taking a total of 117 days (95 days + 21 WoW). Reverse installation was used to dismantle the topsides (shown in Figure 3-1 below). Five barge loads were taken to the disposal yard at Teesside in the UK. A disposal summary is shown in Table 3-1 on page 12.

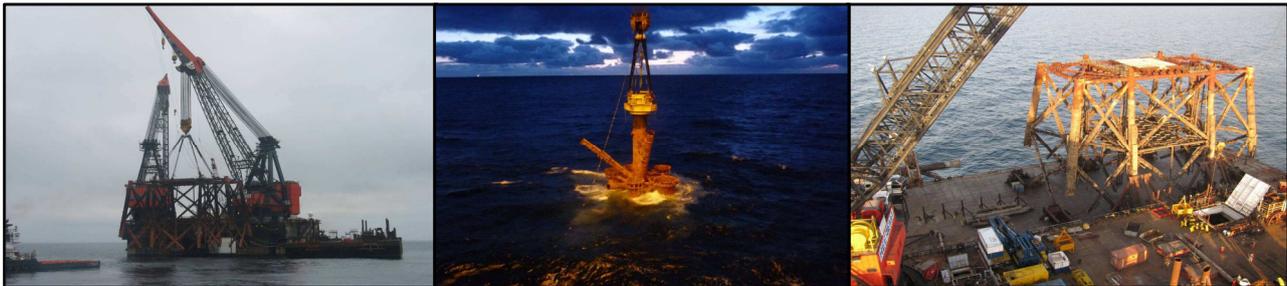
Figure 3-2 - Jacket decommissioning

The decommissioning of the jacket structure was again conducted by Heerema using the Hermod. Works took place between 8<sup>th</sup> of April 2009 and 17<sup>th</sup> of July 2009 taking a total of 100 days (86 days + 14 days WoW). The jacket was cut into sections subsea and lifted onto barges (shown in Figure 3-2 below). Four barges were used to transport the materials to the disposal yard at Teesside in the UK. A disposal summary is shown in Table 3-1 on Page 12.

Overall there were a total of 248 cuts using 3 cutting methods. These were as follows:

- ✦ 105 using hydraulic shears
- ✦ 58 using diamond wire cutters
- ✦ 85 using an abrasive water jet cutting tool

58 lifts took place to remove 9,200 tonnes of the NWH steel jacket, with the heaviest lift weighing around 2,250 tonnes.

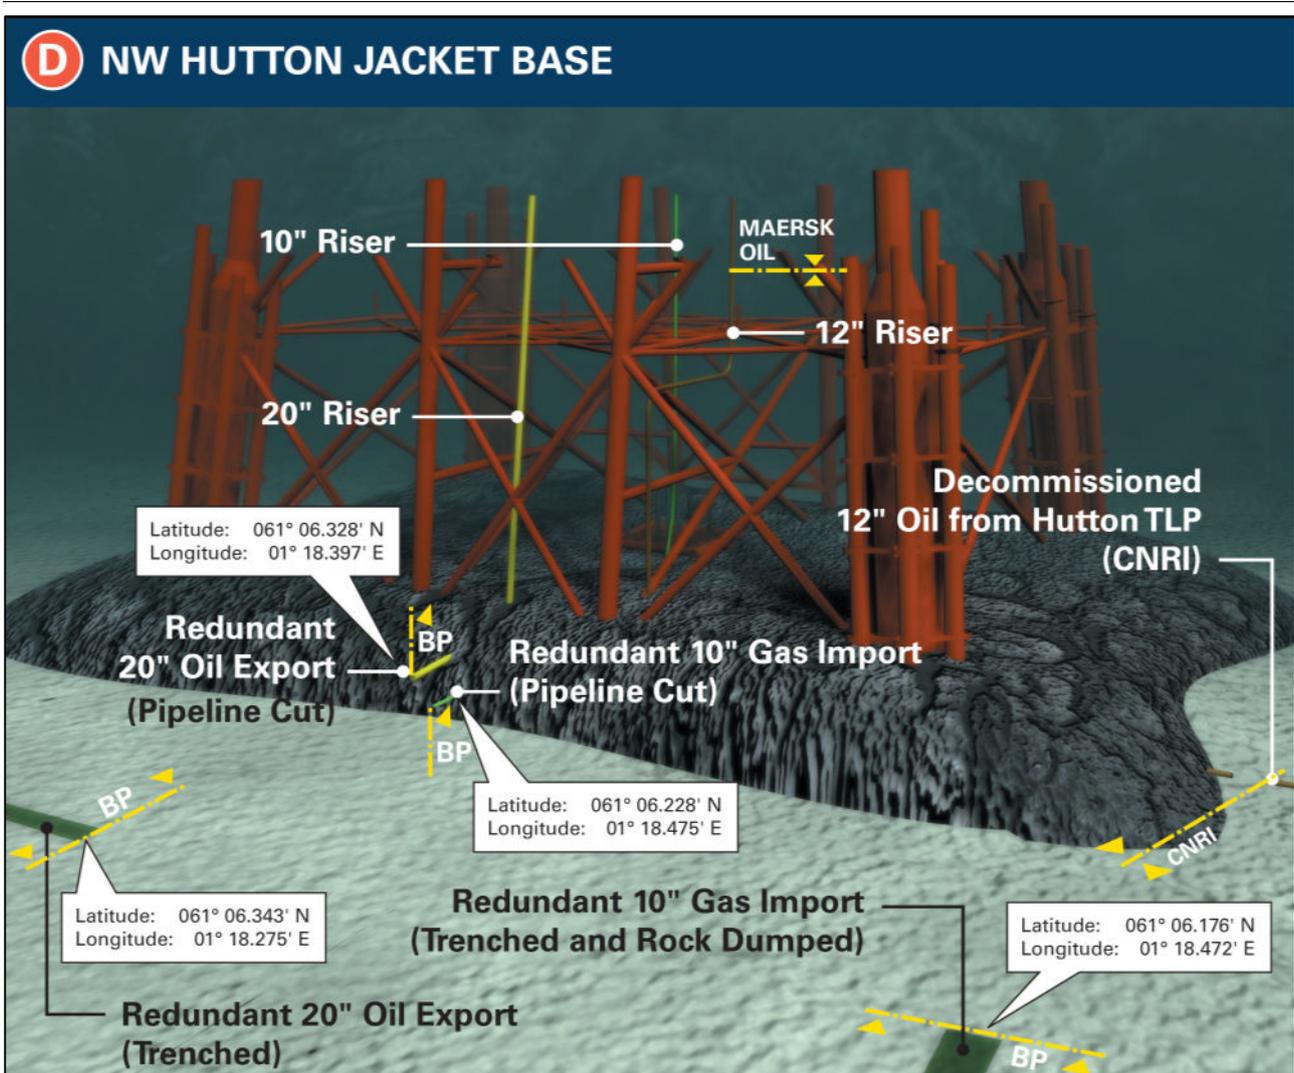
Figure 3-3 - Remaining footings

The NWH Decommissioning Programme committed to cutting the footings at approximately 100m below sea level. However, due to cutting tool access and orientation difficulties the final cut point was made at 95m below sea level. DECC in a letter to BP dated 14th January 2009, confirmed that the difference in cut height did not constitute a change to the Decommissioning Programme. This correspondence was assured as part of the Third Party Verification process undertaken by DNV. Third Party Verification is discussed in Section 12.

Incorporated within the jacket footings is a drilling template which is of tubular steel construction, 12.8m long 12.2m wide and 3.7m high. The structure weights 290 tonnes and is buried beneath the drill cuttings pile. The drilling template has been left in-situ.

A schematic of the footings which remain in-situ is shown in Figure 3-3 below:

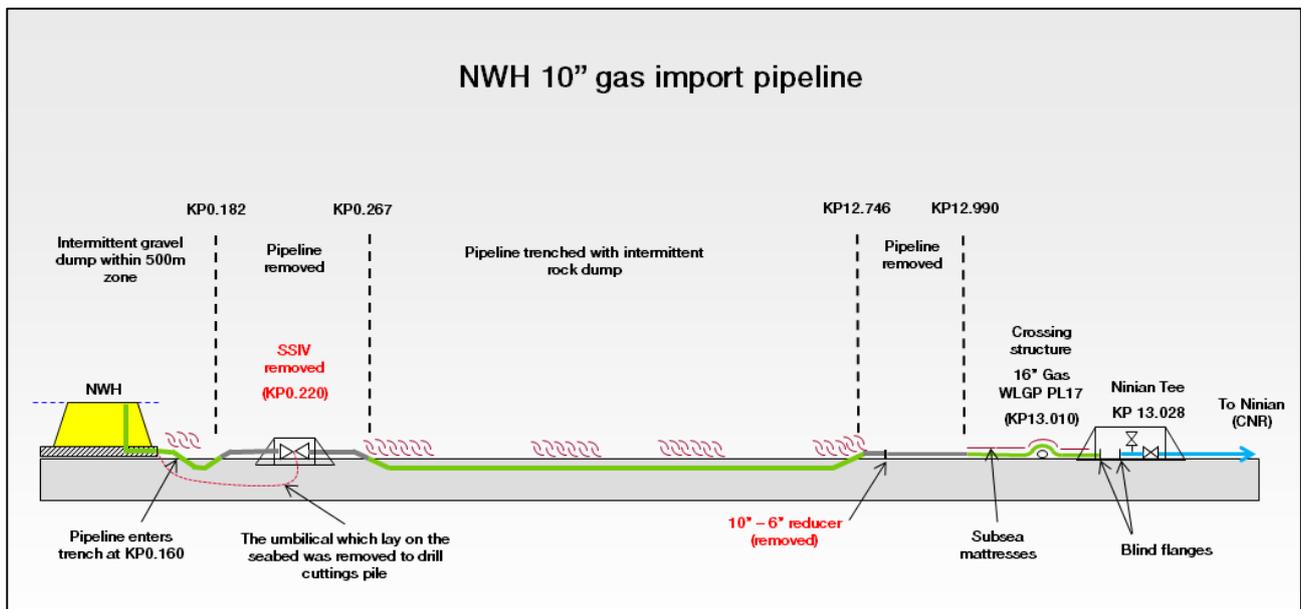
Figure 4-1 - PL147 as-left schematic

PL 147 is a 13 km, 10" concrete coated pipeline which was originally laid trenched to a depth of 0.45 m below the seabed level. As part of the Decommissioning Programme [1] PL 147, the gas import pipeline was left in-situ as it was already trenched and partially buried over the majority of its length. Approximately 73m of exposed 10" pipeline was removed along with the associated SSIV weighing 84 tonnes.

A 6" flexible pipeline was used to connect PL 147 to the Ninian Tee. During the workscope 209m of this flexible pipeline was removed in 5.5m sections. 24 protective mattresses which covered the 6" flexible pipeline were also removed.

The SSIV control umbilical connected the NWH SSIV to the NWH installation. During the decommissioning workscope this umbilical was removed to the point where it entered the drill cuttings pile. The 51 protective mattresses which covered the umbilical were also removed.

All materials were transported ashore and handed over to the waste management contractor. A schematic of the as left status can be seen in Figure 4-1 below:

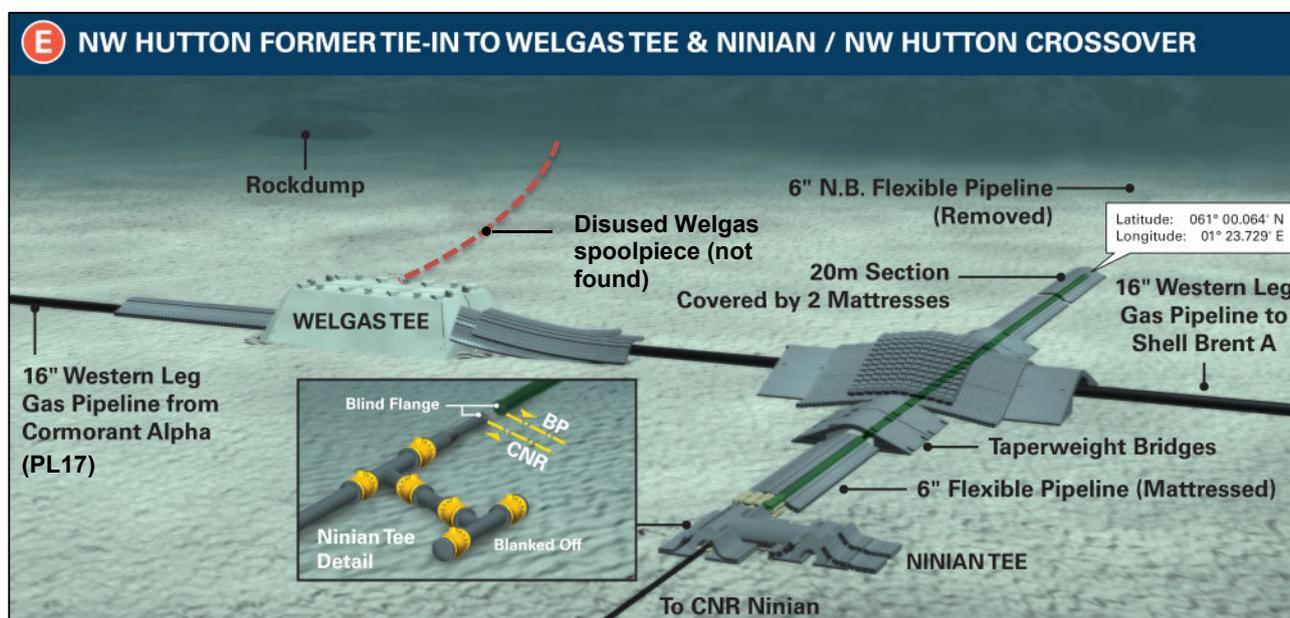
Figure 4-2 - PL 147 welgas tee area schematic

The NWH Decommissioning Programme [1] included the removal of the 120m disused Welgas spoolpiece that was originally used to connect PL147 to the Welgas Tee on PL17. However, once the mattresses were recovered there was no spoolpiece beneath. Divers probed the seabed to a depth of 0.6 meters and at various locations transversely across the pipeline route. An ROV search was conducted over a grid extending to 100m either side of the pipeline route in an attempt to find the spoolpiece. It was concluded that there was no spoolpiece present and that it had been removed during the workscope to alter PL 147 from gas export to gas import.

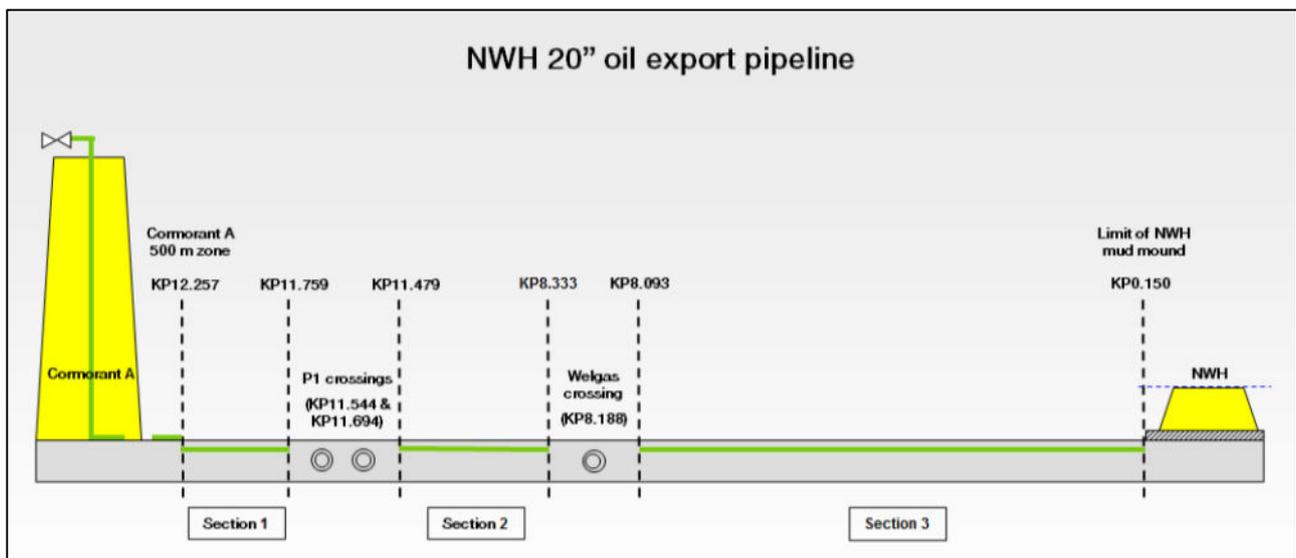
Figure 5-1 - PL 148 as-left schematic

Pipeline PL 148 is a 13 km, 20” concrete coated pipeline which was originally laid un-trenched on the seabed. As part of the approved NWH Decommissioning Programme, PL 148 was trenched. The trenching operations took place over two offshore campaigns. The first campaign took place between the 16th July 2011 and 17th August 2011 (33 days) and the second from the 8th April 2012 to the 24th April 2012 (17 days). Figure 5-1 shows a schematic of the as-left status of PL 148.

The pipeline was trenched in sections 1, 2 and 3. As discussed in a letter to DECC dated 20th November 2012, 71.5% of the pipeline length has achieved the target depth of at least 0.6m. On average the trench depth over the pipeline length is 0.7m. Table 5-1 below shows the pipeline burial status:

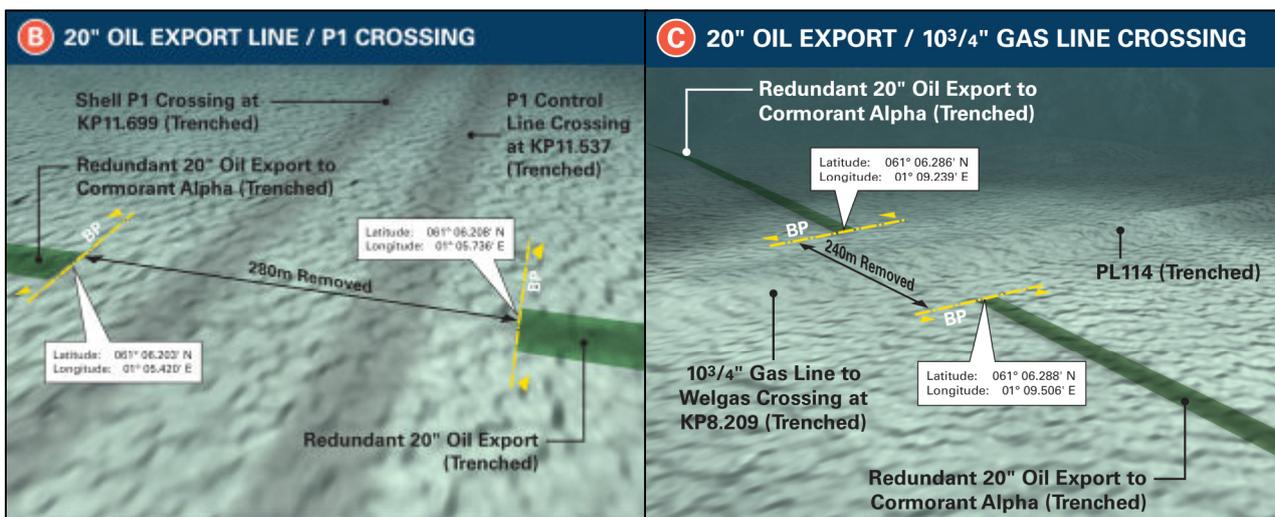
Figure 5-2 - PL148 crossing schematics

At the pipeline crossing locations and initial transition into the trench at NWH the pipeline was cut at the point where it was fully trenched. At these locations the pipeline was cut into approximately 12m lengths where possible. The lengths and weights of sections removed are shown in Table 5-2 below:

Schematics of the crossing locations can be seen in Figure 5-2 below:

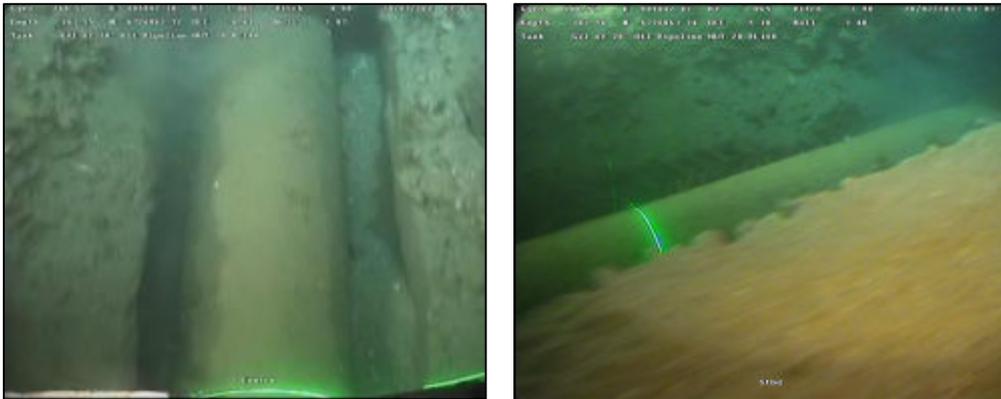
time the pipeline will naturally backfill. Future surveys will confirm this. Figure 5-3, Figure 5-4 and Figure 5-5 below show examples of the pipeline exposed, in partial cover and fully covered.

Figure 5-3 - Example visible pipeline (KP 7.065)

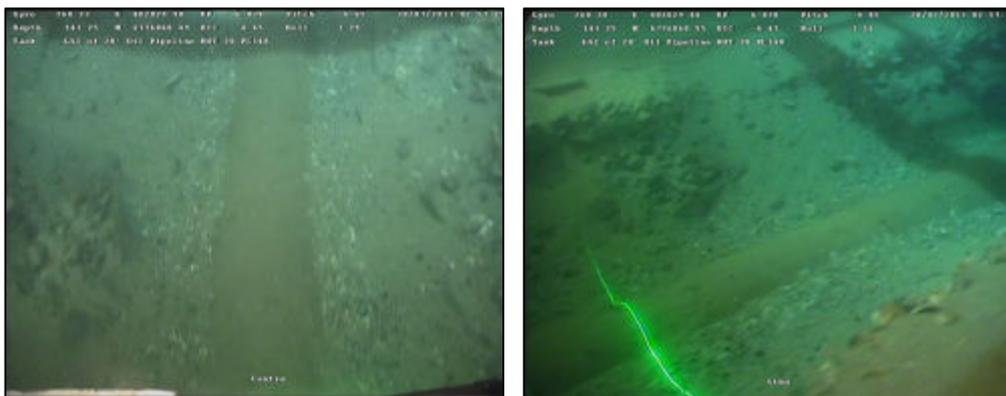
Figure 5-4 - Example partial cover (KP6.878)

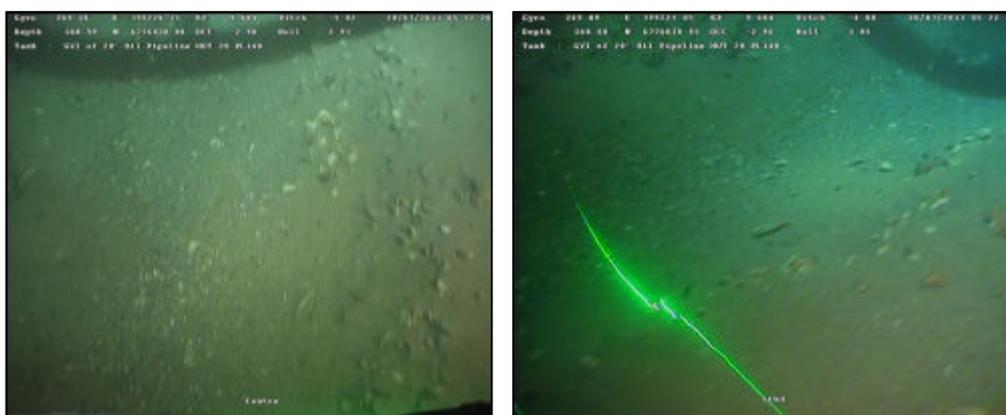
Figure 5-5 - Example full cover (KP9.684)

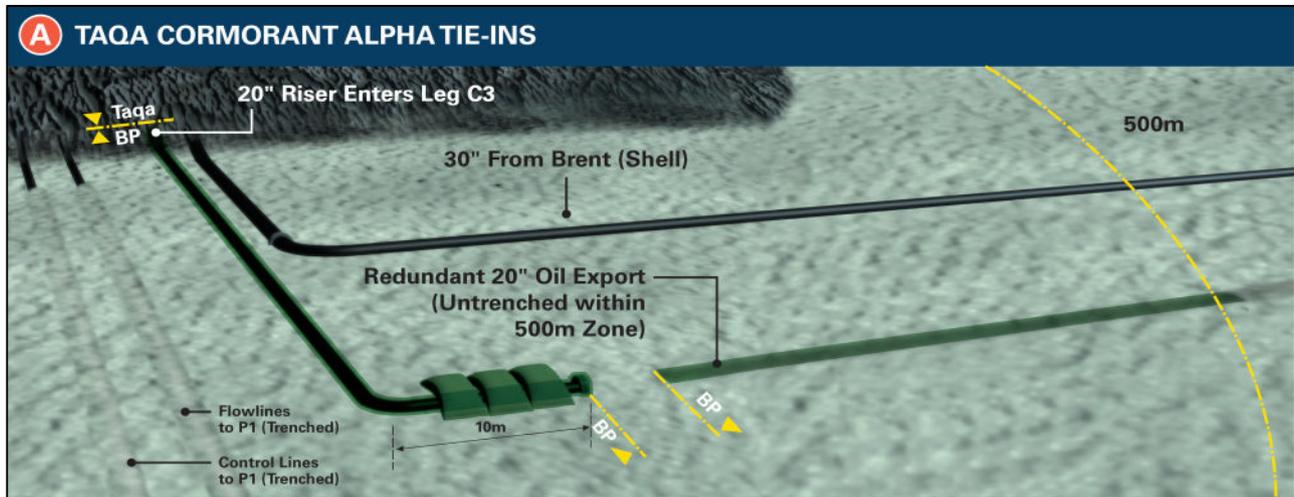
Figure 5-6 - Cormorant alpha 500m zone schematic

The section of PL 148 within the Cormorant Alpha 500m zone (shown in Figure 5-6 above) was supposed to be trenched as part of the decommissioning activities. A change to the NWH Decommissioning Programme was sought for this section to remain un-trenched on the seabed. This was due to the high consequence low probability risk of a NWH vessel colliding with the Cormorant Alpha installation. One of the controls to prevent this risk was to avoid the pipeline trenching activities within the Cormorant Alpha 500m zone. DECC accepted this change in a letter dated the 22nd of Feb 2012. This section of PL 148 will be decommissioned at the same time as the Cormorant Alpha installation.

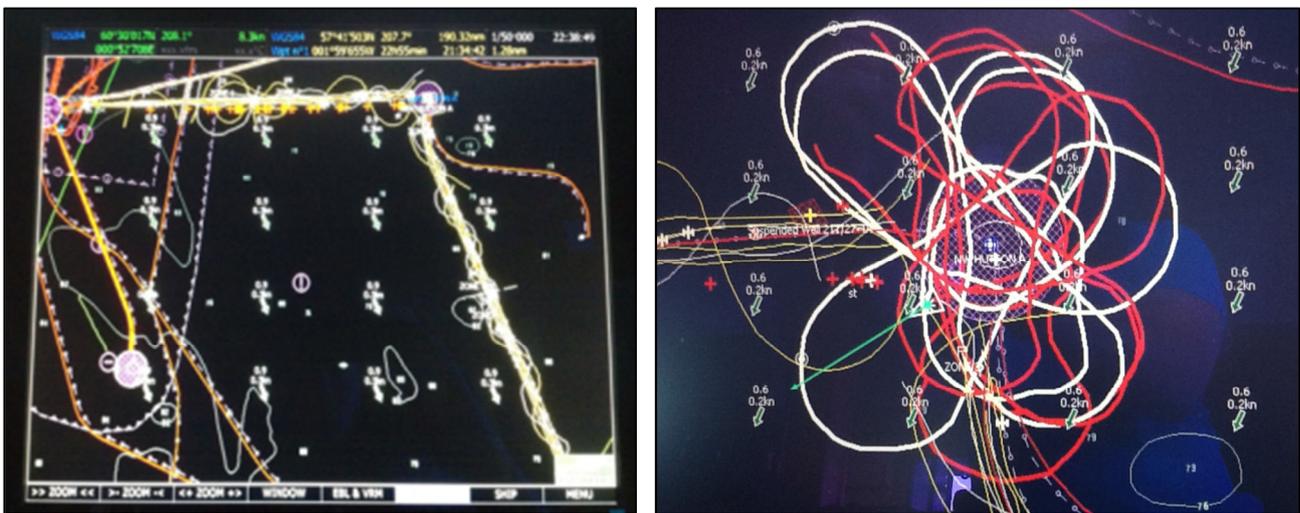
Figure 6-1 - Trawl test overview

Over-trawl tests were undertaken to demonstrate that no snagging hazards for fishermen and other third party users of the sea remain present on site. These over-trawl tests were carried out by the 'MFV Excel' over the 200m pipeline corridors (PL147 & PL148) and within the NWH 500m zone to provide assurance that debris had been cleared. The SFF issued a clearance certificate to verify these successful trawl sweeps (appendix A).

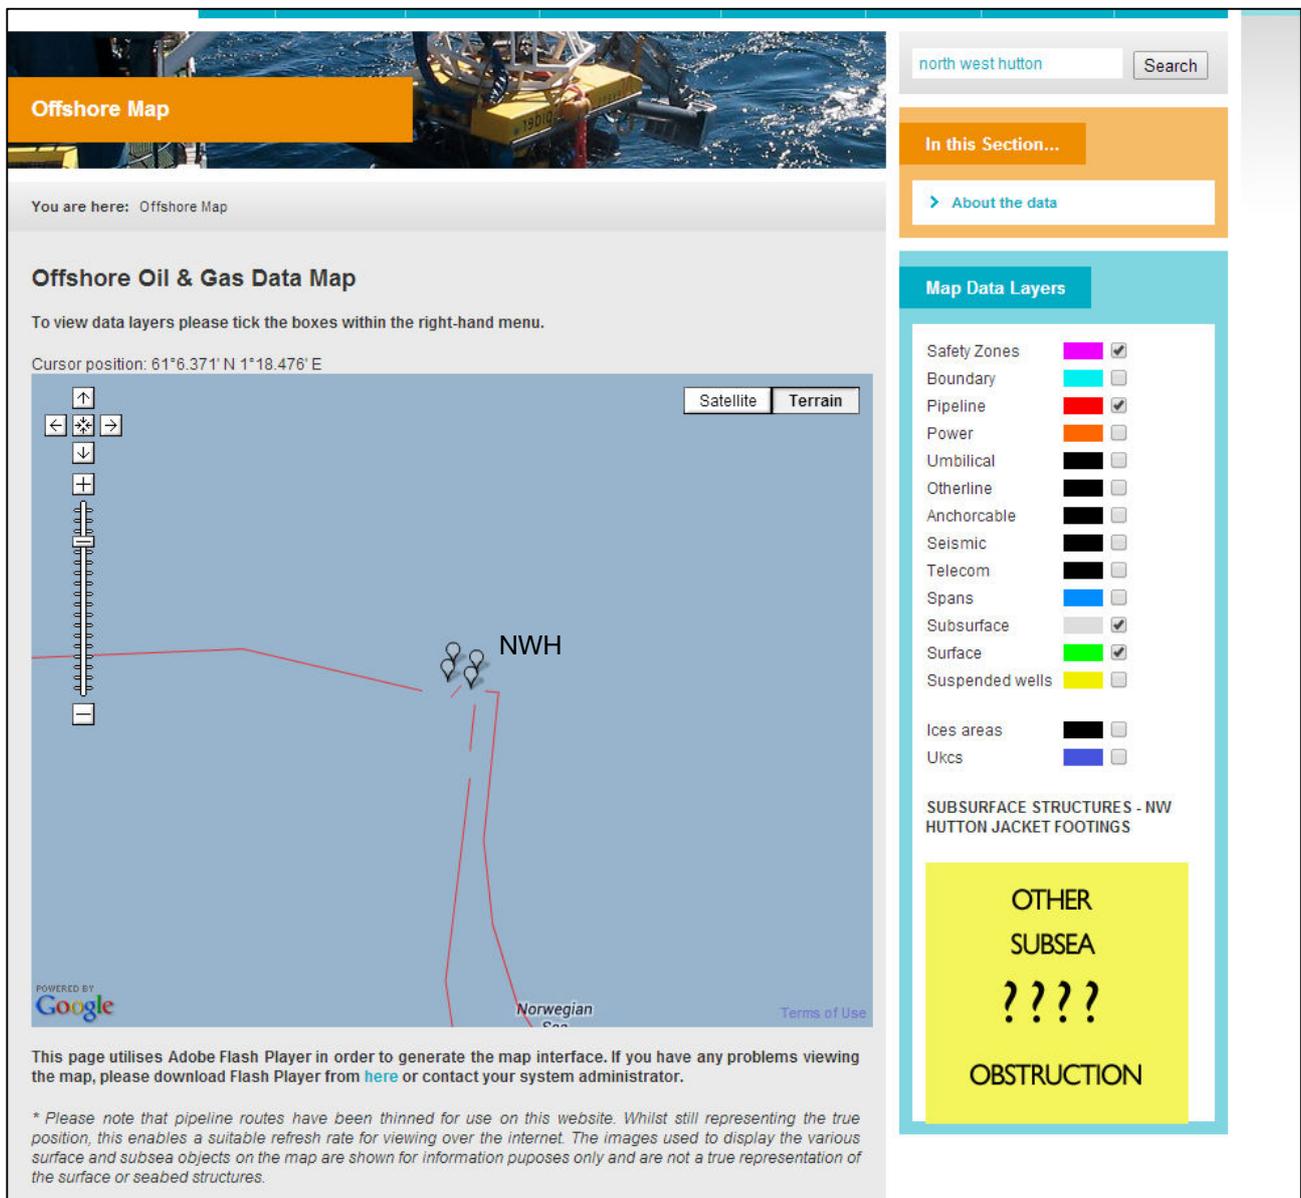
Figure 8-1 - FishSAFE screenshot

Appropriate information about the status of the NWH footings has been conveyed in accordance with guidelines the terms of the permit to dispose. The UK Hydrographic office has been informed and the NWH footings have been marked on nautical charts. The size and location of the footings has been communicated to the Fisheries Legacy Trust Company, recorded in the Kingfisher bulletin and the FishSAFE database has been updated (see Figure 8-1 below). This information was subject to Third Party Verification which concludes that the commitments made with regards to informing third party users of the area have been achieved [3].

The North West Hutton jacket footings will remain on the seabed and are marked on the relevant charts, FishSAFE, and in the Kingfisher Information Service UKCS database as an obstruction to be avoided (see Figure 8-1).
