MARINE ACCIDENT INVESTIGATION BRANCH

FISHING ACCIDENT REPORT

Loss of Beam Trawler *Flamingo*

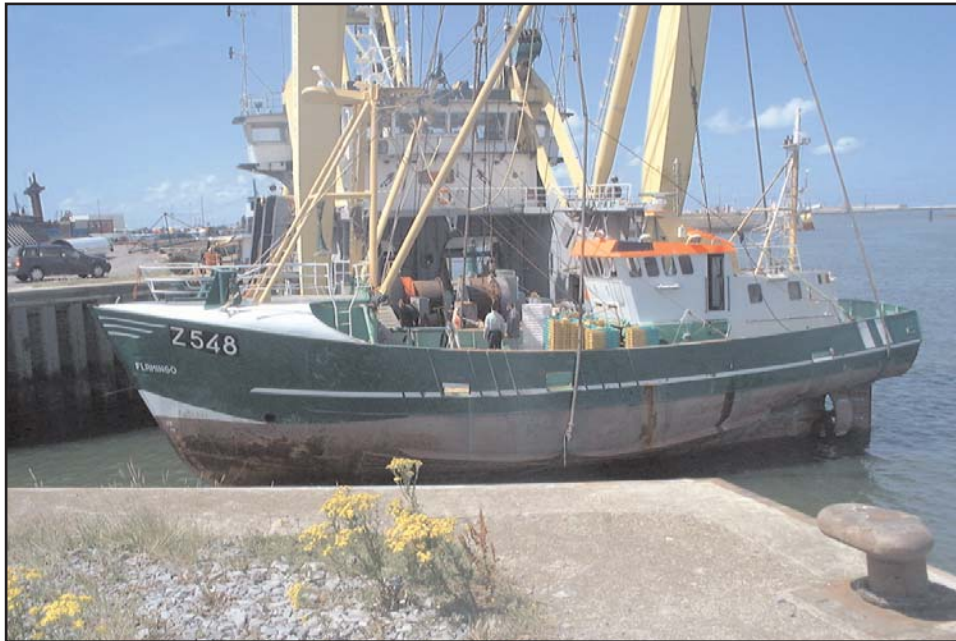
On 7 July 2002, the Belgian beam trawler *Flamingo* sank just inside UK waters to the east of Harwich. Her crew of four was lost.

Flamingo's nets were being cleaned before the catch was brought on board. However, a weight of rocks and shells in the port net caused it to break at a "weak link". This raised the vessel's centre of gravity, reduced her stability, and she capsized as a result.

1. Advise operators and skippers of beam trawlers of the inherent dangers of the design of the "weak link" connecting the cod end to the trawl net.

2. Bring to the notice of operators and skippers of fishing vessels engaged in twin beam trawling:
 - (i) Specific advice on the associated risks to stability when operating.
 - (ii) The importance of wearing lifejackets when working on the deck of fishing vessels.
