MARINE ACCIDENT INVESTIGATION BRANCH

ACCIDENT FLYER

FATAL INJURIES FROM PROPELLER

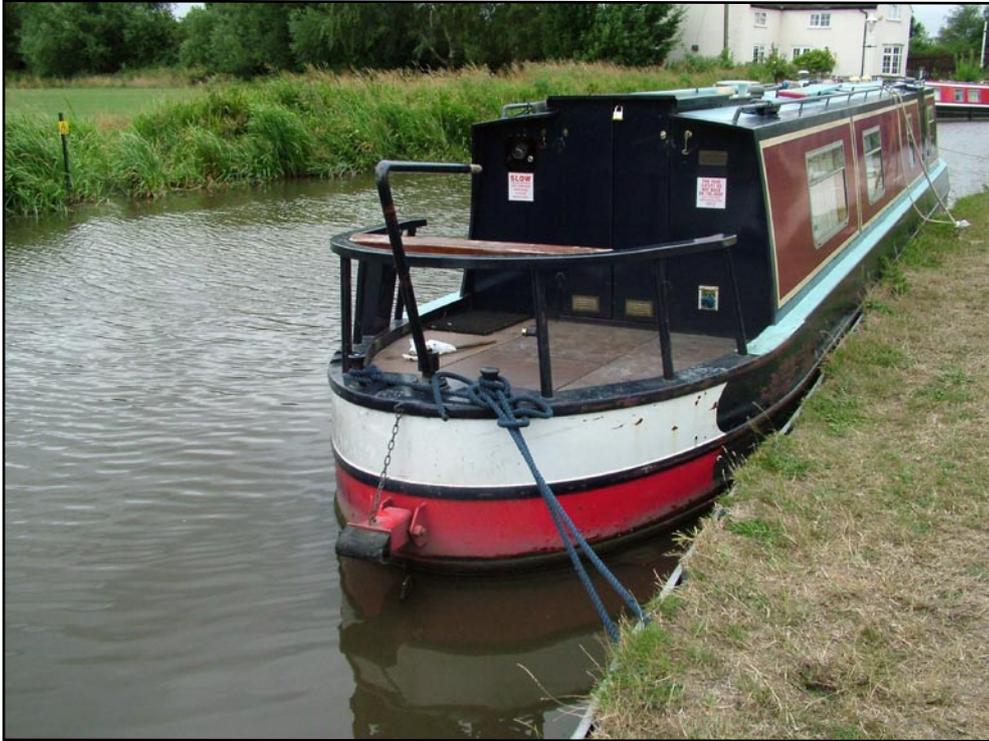
The boat then made contact with the canal bank, and the helmsman was seen to tip over the guard rail, which was at about knee height and fitted round the cruiser style stern. He managed to hold on briefly, with his legs hooked over the rail, before dropping into the water on the outboard side. The crewman with the stern line jumped back onboard and stopped the engine, but could not see the helmsman in the water. Although buoyancy aids were available on the boat, the helmsman was not wearing one. A lifebuoy was thrown into the water, but with no sign of the helmsman, the crewman jumped into the canal to assist. The crewman quickly found the helmsman's leg, but could not pull him free. Another family member and the helmsman of another boat jumped into the waist deep water to assist, but the helmsman was entangled in the propeller.

The crewman climbed back onboard and removed the weed hatch in the engine compartment to gain access to the propeller. He could see the helmsman was trapped by torn clothing, with his head and arm caught in the propeller. Using scissors, he managed to free the helmsman, and with the assistance of the emergency services who had quickly arrived at the scene, the helmsman was recovered to the canal bank. He had suffered severe injuries to the back of his shoulders and head. His left arm was very nearly severed and he was pronounced dead at the scene.

- 1. Although serious accidents are rare on the inland waterways, boaters, and particularly those new to boating, should be aware of the potential hazard posed by a rotating propeller.**
- 2. All responsible people on board should be familiar with the actions to take in an emergency and be able to stop the propeller quickly if needed.**
- 3. Boaters should check canal maps for potential obstacles such as locks and bridges, and slow down if the view ahead is obscured to avoid having to make difficult manoeuvres at short notice.**
- 4. Although guard rails are not required on narrow boats, where they are fitted, they should be of an appropriate height to prevent people from falling overboard near the propeller.**
