## FLYER TO VESSEL OPERATORS USING PROXIMITY SWITCHES ON DAVIT LAUNCHED SURVIVAL CRAFT

### **TOMBARRA - MALFUNCTION OF A DAVIT PROXIMITY SWITCH RESULTING IN THE FAILURE OF A RESCUE BOAT FALL WIRE WITH THE LOSS OF ONE LIFE**

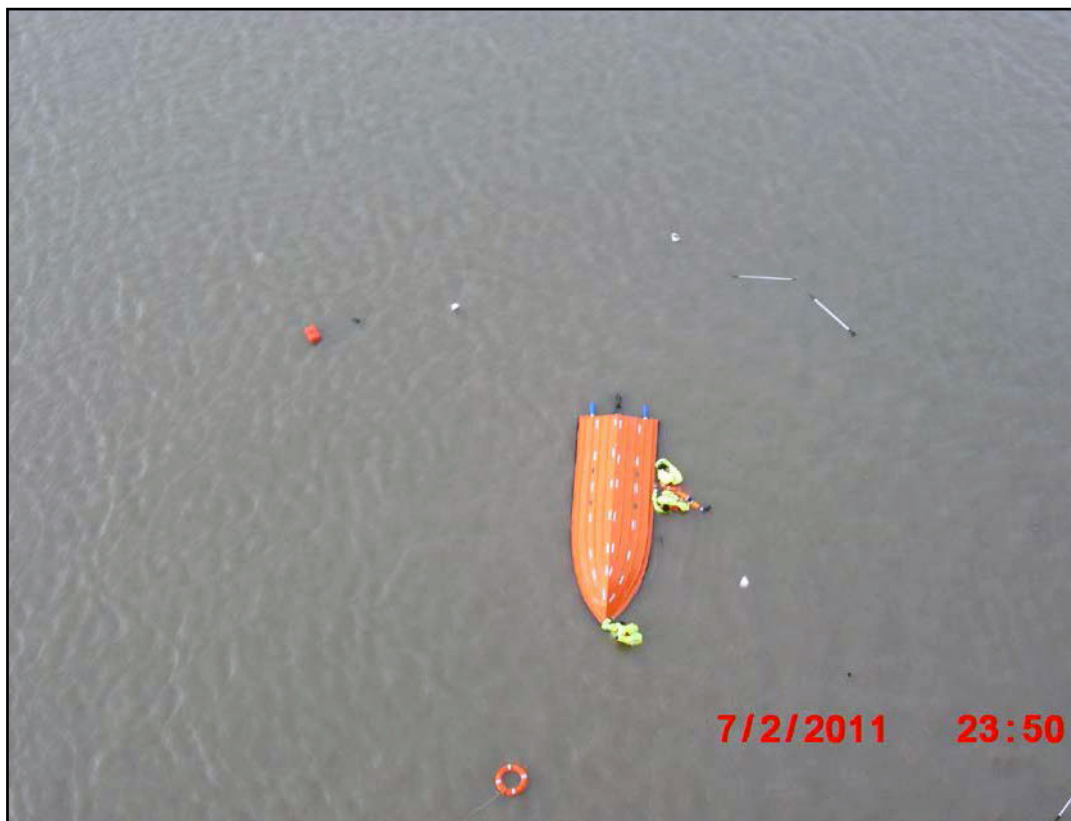
The davit proximity switch that should have cut electrical power to the winch motor before the davit arm reached its stops failed to operate. As a result, when the rescue boat reached its stowed position, the winch rapidly overloaded the fall wire. The wire parted, and the rescue boat (**Figure 1**) plummeted about 29m into the water below, killing one of its four crew.

**Figure 1:** The rescue boat and crew after the fall wire failure

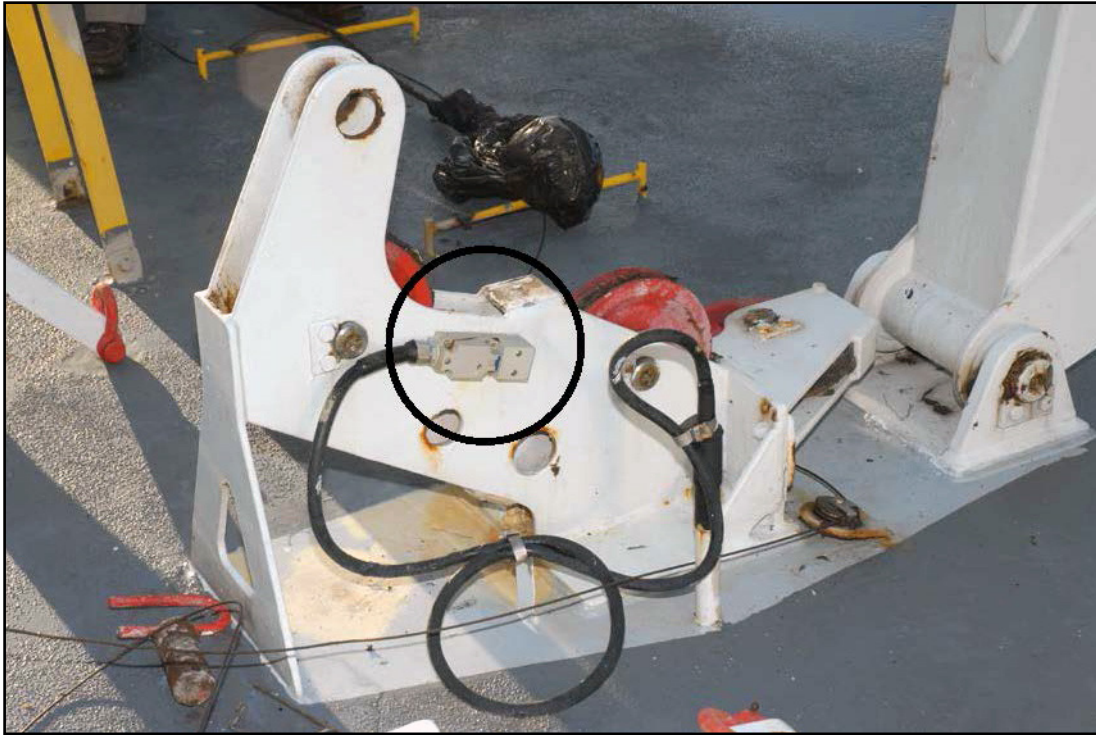
The davit proximity switch (**Figure 2**) did not operate due to a short circuit of its printed circuit board. The short circuit had been caused by either moisture ingress or by transient power surges.

Inductive proximity switches can fail in either the 'ON' or 'OFF' state, depending on the exact failure mechanisms, and therefore both the failure mode, and the time of occurrence, can be unpredictable.

**Figure 2:** Proximity switch on davit (circled)

1. Safety devices (both inductive proximity switches and mechanical limit switches), fitted to davits, are intended to prevent the over-stressing of the falls and davit structure. They are not fitted for ease of operation.
2. Davit safety devices must always be tested prior to a rescue boat being hoisted.
3. Davit safety devices should not be relied upon. The davit winch must be stopped prior to the davit safety device operating.
4. Visual aids to prompt when winch motors should be stopped could be extremely beneficial.
5. Care must be taken when cleaning and painting electrical equipment on deck. High-pressure hoses must be used with caution.
