SAFETY ALERT

Recent incident relating to the use of a mobile ground investigation drilling rig

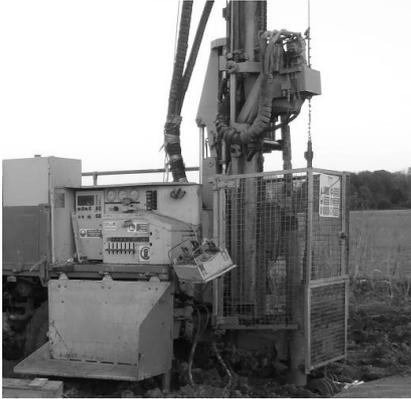
<p><u>Activity</u></p> <p>Geotechnical drilling operations using a mobile drilling rig, geobore S drill string and 200mm casing.</p> <p><u>Background</u></p> <p>In order to progress the geobore S coring it was necessary to lower the height of the top of the 200mm casing below the drilling table by using the rotary head to 'drill-in' the casing. To do this the geobore S casing had to be removed from inside of the 200mm casing requiring splitting of the joint at the drill head rod to the geobore S drive head.</p> <p>To enable the casing to be reset to the correct height above the ground using the rotary drill head it was necessary to break out the geobor S drill string thus enabling the 200mm casing drive head to be attached to the 200mm casing. During this process the geobor S drill string unscrewed inside the casing. The top section of the geobor S drill casing was withdrawn from the 200mm casing and moved to the side of the drill rig using the drill head carriage.</p> <p>To break the drill string at the required joint, a stillson wrench was attached to the geobor S drive head and braced against the drill rig mast with approximately a 70mm overlap. Having positioned the wrench, the assistant driller was in the process of leaving the area and closing the interlocking gate when the rotation lever on the control panel was accidentally activated by the lead driller when he tripped and fell against it. This action caused the drill string and wrench to rotate hitting the employee in the head.</p>

Findings:	<p>The following contributing factors have been identified:</p> <p>The ground was rough (ploughed field) and whilst walk ways had been established and boards laid, the conditions underfoot were less than ideal.</p> <p>200mm casing lengths taken to the drill site were 1.5m long, two of which had been installed. The 200mm casing when installed was unable to be advanced passed the drill table.</p> <p>Attaching the stillson wrench to the geobor S drive head with the rotary head off centre is an insecure method of break out when the stillson wrench is braced against the drill rig mast with the intention of breaking the geobor S drill string by rotating the rotary drill head.</p> <p>Activation of the control lever caused the drill string to rotate which in turn caused the unrestrained geobor S casing to “kick out” allowing the wrench to slip off the drill mast.</p> <p>During the incident investigation it was found that the drill rig and interlocking guard operated as designed however, it has been established that the automatic “slow rotation” feature (guard open) allows one rotation of the rotary head at 51rpm before slowing down to 7rpm</p> <p>Note. The current European Standard EN16228-1:2014 states reduced rotation speed range should be 30 rpm to 0 rpm.</p>

Recommendations and corrective action:	<p>Review and where necessary revise the existing drilling methodology, thus ensuring that it takes account of the findings and lessons learned.</p> <p>Implement a documented safe system of work which takes account of the findings and lessons learned. Particular attention has been paid to how a change in a routine operation is managed.</p> <p>In liaison with the equipment supplier/manufacturer ensure that the equipment complies with “in country” legislative requirement and industry best practice.</p> <p>Consideration must be given to:</p> <ul style="list-style-type: none"> • Speed of rotation in all stages of operation; • Operation of the control lever & the requirement for an isolation switch.
