Sulfate damage to concrete floors on
sulfate-bearing hardcore
Identification and remediation

Ian Longworth, MSc(Eng), CGeol, CSci,
BRE Associate, Materials and Engineering Group,
Building Research Establishment

February 2008
Department for Communities and Local Government

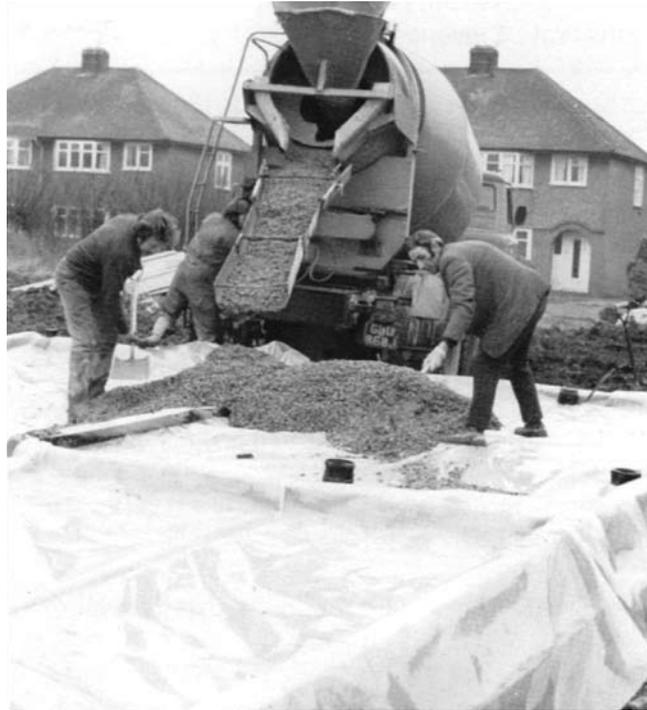
Figure 4: Laying of concrete in the mid 1970s on a 300 micron damp-proof membrane that has been placed over hardcore in the foundations of a house.

- Sulfate migration from hardcore into concrete may be prevented by the use of a separating membrane. Polythene sheets, installed primarily as a damp-proof membranes (DPM), began to serve this purpose from the mid 1960s, and became almost universal for concrete slab construction on sulfate-bearing hardcore by the early 1970s. DPMs installed in the 1960s were typically only 500 gauge (125 micron) thick, and doubts have been cast by some practitioners on their effectiveness as a barrier to sulfate migration. However, no case of deleterious sulfate attack where such a membrane was installed has been brought to the attention of BRE. Thicker membranes that are more resistant to perforation during installation were installed in later decades (eg Figure 4), the current standard being 300 micron.

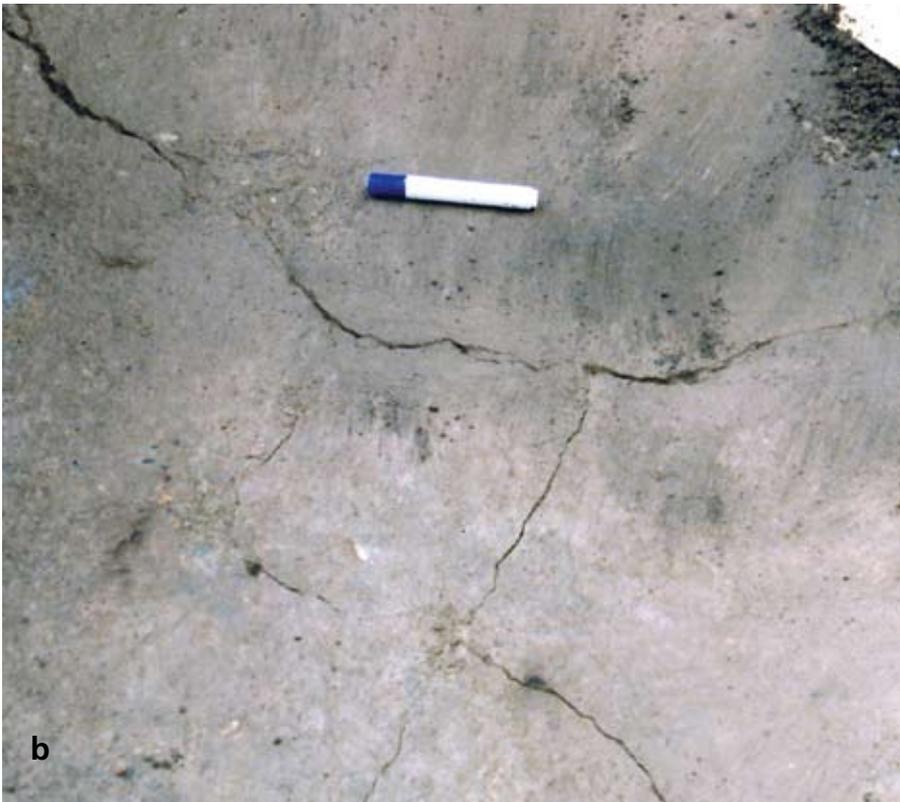
(b) Map pattern cracks in sulfate-attacked oversite concrete beneath a suspended wooden floor of an adjacent room.

Figures 7(a) to 7(c) show sulfate attacked oversite concrete that was laid over plaster contaminated brick rubble beneath a suspended wooden floor of a bungalow in the West Midlands. The concrete, much softened as result of TSA, domed upwards in several rooms lifting the sleeper walls that supported the floor. The doming was accompanied by radiating and map pattern cracks.
