Fife, Fergus, Flora and Angus Fields Decommissioning Programmes Close-Out Report

FFFA Field Layout

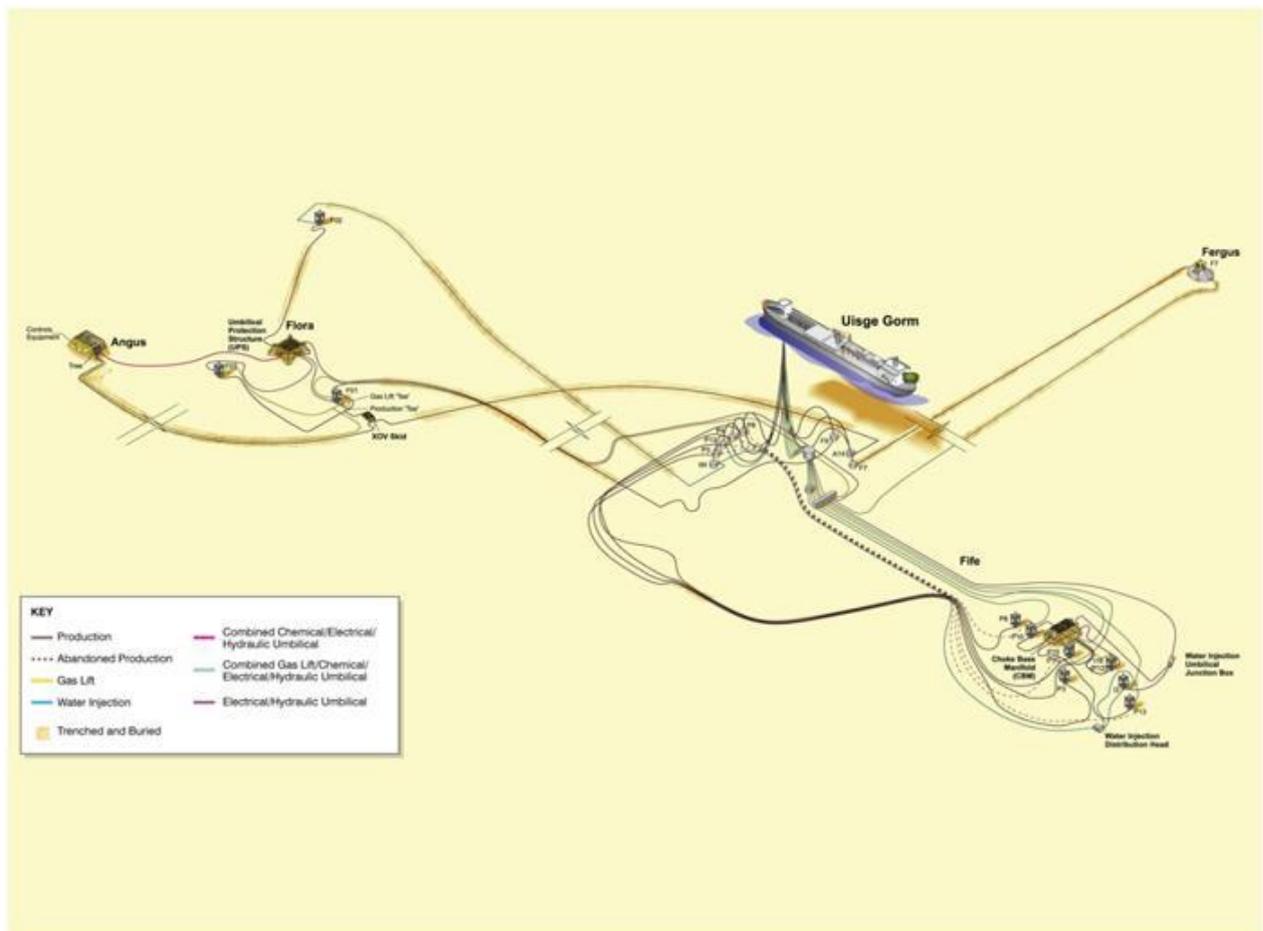
Figure 2 FFFA Fields Layout Schematic (Pre-Decommissioning)

The Fife, Fergus and Flora fields came on stream between 1995 and 1998 and were located approximately 18 km south-east of Angus, the *Uisge Gorm* was located in the central Fife area and in operation for 13 years. Table 2 provides an overview of the fields that made up the development, and Figures 1 and 2 provide a schematic overview of the location and initial layout of the fields.

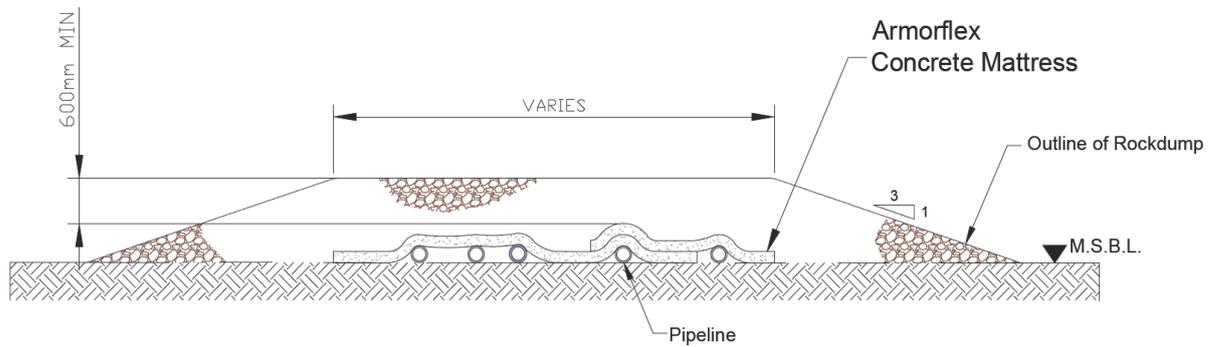
Figure 3 Profiled Rock Installation Design Parameters

1. Carry out a full as-found survey of the mattresses and adjacent seabed to be covered.
2. Rock dump over all mattresses, including any cut pipeline ends, ensuring a minimum cover of 600mm and a berm gradient of 1 in 3.
3. Rock dump is to be a smoothly contoured mound over the mattresses.
4. Carry out an as left survey of the rock dumped area.

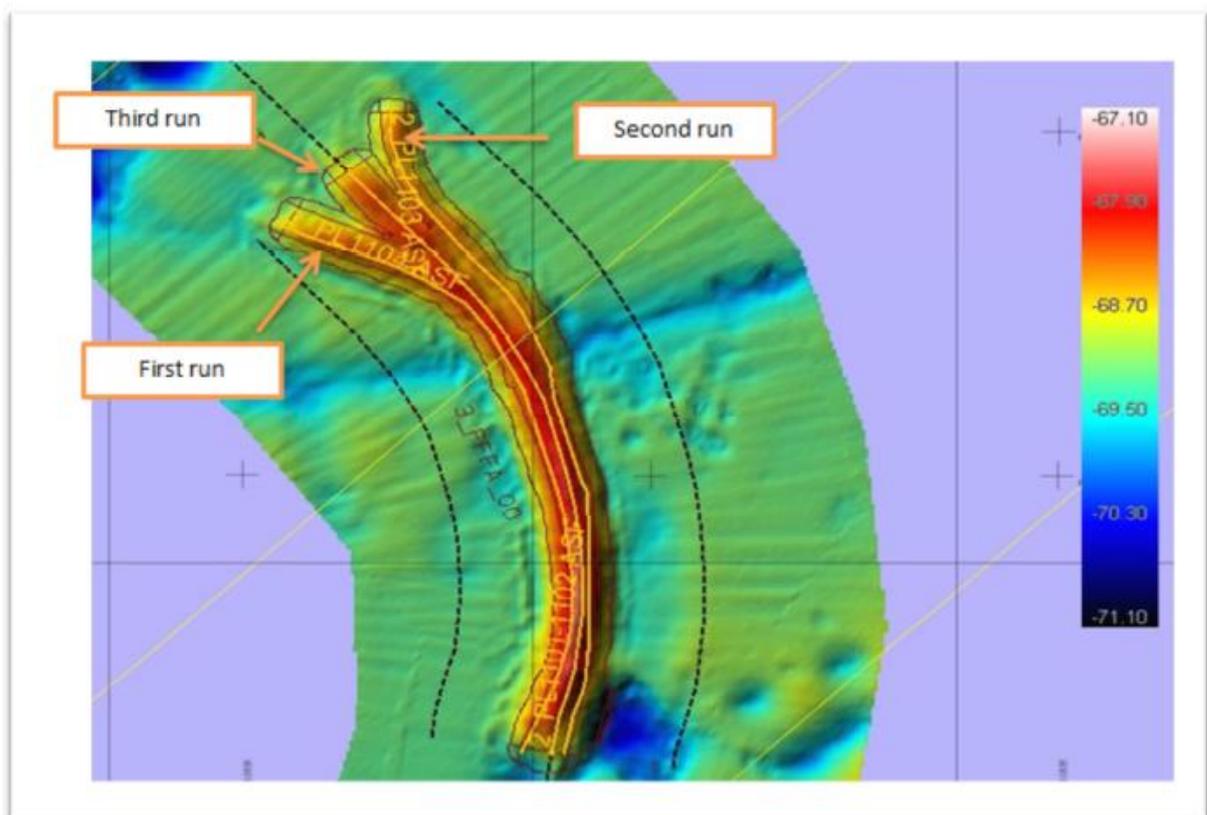
Figure 5 As-Built Survey Screen Shot, Final Profile

Due to complex SRI design at the FFFA location it was decided to work with three dumping lines. The first two runs were made with an offset of 0.7m on either side of the dumping line and a third run in middle (see Figures 5 and 6). After a visual check, the last rectifications were completed at lower rates.

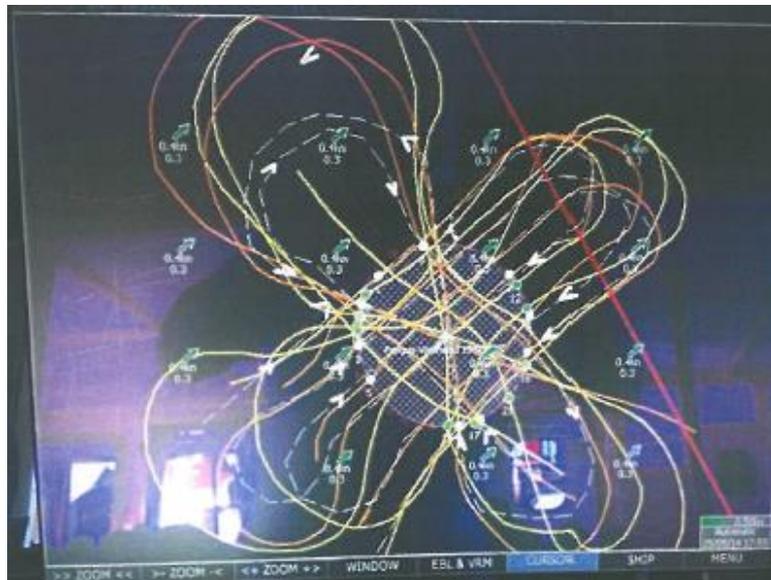
Figure 7 Typical Sweep Pattern of FFFA Well Centres

The trawl sweeps covered the 500 metre safety zone of all wellheads from a variety of compass approaches and all existing pipeline corridors in a zig-zag pattern along the length of the pipeline from both ends to provide full and effective coverage.

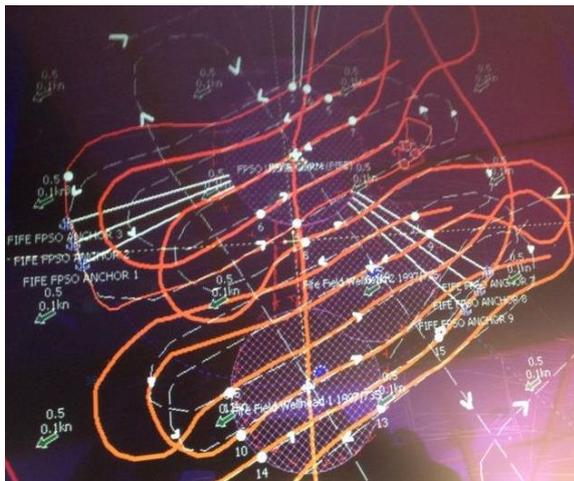
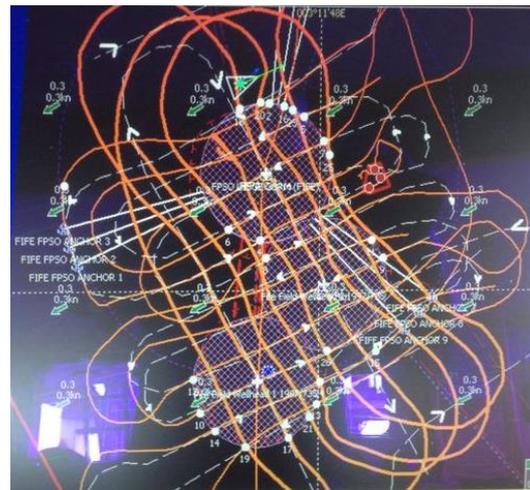
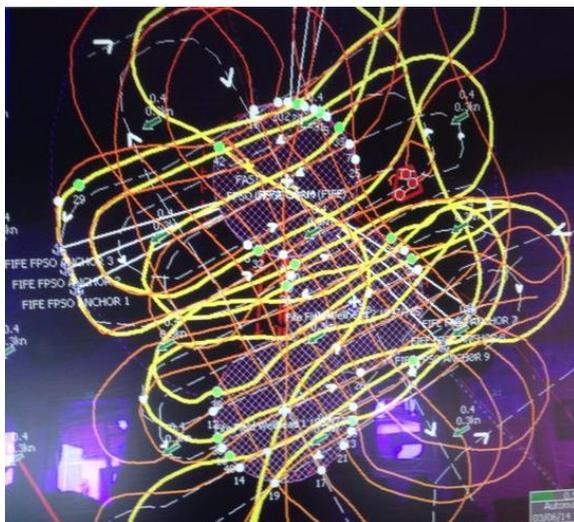
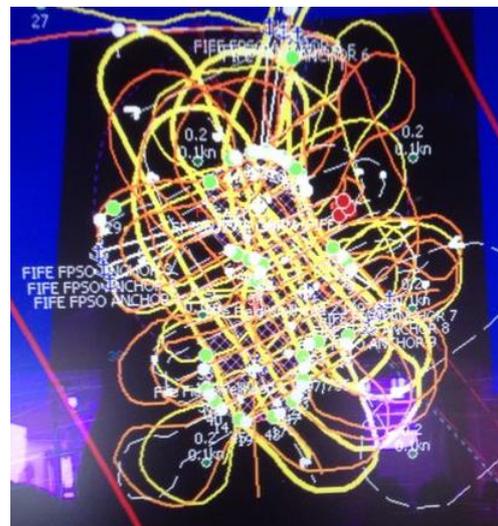
Figure 9 Fife Central Armorflex Mattress Location Sweep Patterns (FPSO 500m Zone)

The defined scope of work also included a detailed sweep pattern over the Armorflex mattress rock dump location within the original FPSO 500m zone area to ensure rock dump profile stability and over-trawlability. The vessel completed several sweeps over the area from different compass approaches as shown below in Figure 9, with no snags or hazards identified.

Accordingly the area has been deemed clear for the resumption of normal fishing vessel activities.

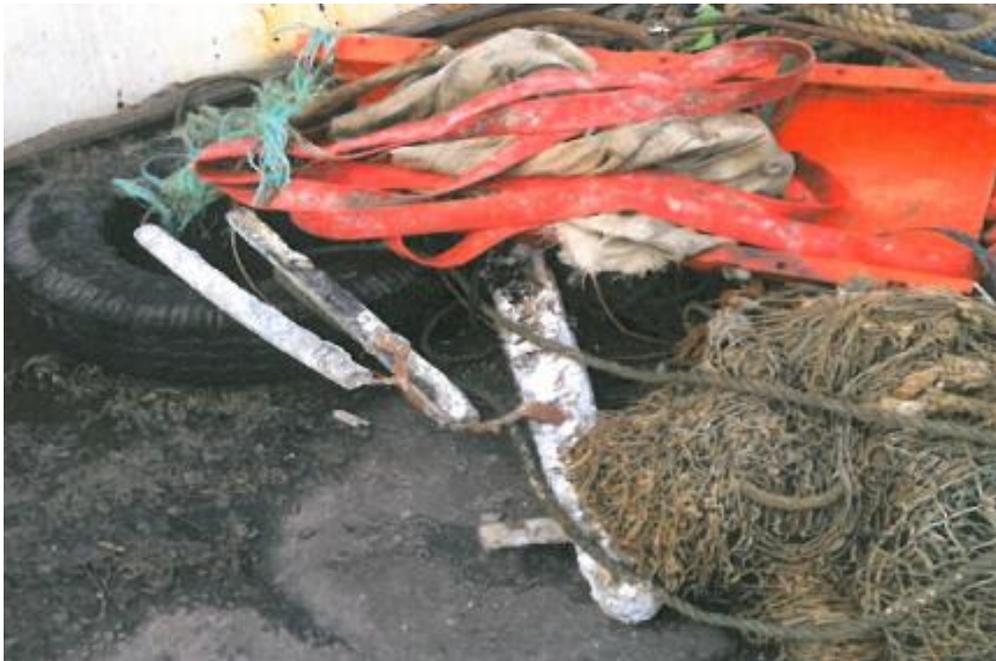
Figure 10 Typical Debris Recovery From Trawl Sweeps

During the Fife area chain mat sweeps, a snag hazard on hard debris was identified outwith the defined 500 metre safety zones whilst the vessel was executing a turn to adopt a different approach path to continue sweeping the 500 metre zone. The chain mat could not be released from the snag and was deposited in order to release the vessel and allow further investigation.

The items have not been recovered, the location is noted on the Clearance Trawl Sweep Certificate and both Fishsafe and the UK Hydrographic Office have been informed.

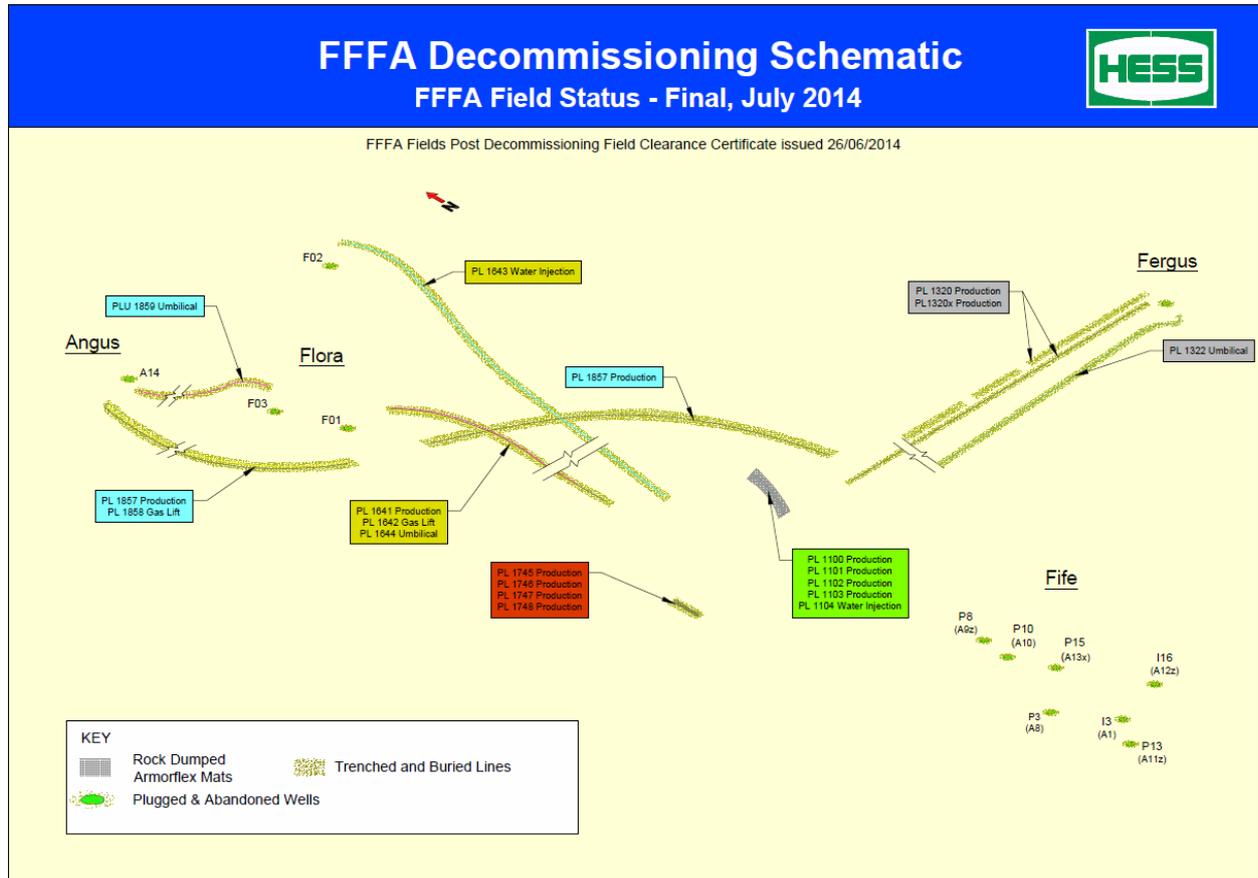
Figure 11 FFFA Fields Layout Schematic (Post-Decommissioning)

Data compiled from subsequent surveys and tests give evidence to the final condition of the seabed surface being stable and it is likely to remain so.

Hess has therefore concluded that the FFFA Decommissioning Project has met all its statutory obligations in returning the seabed back to its natural state as far as possible.
