# Recycling of **Type 22 Frigate**

HMS Cornwall

Disposal Services Authority

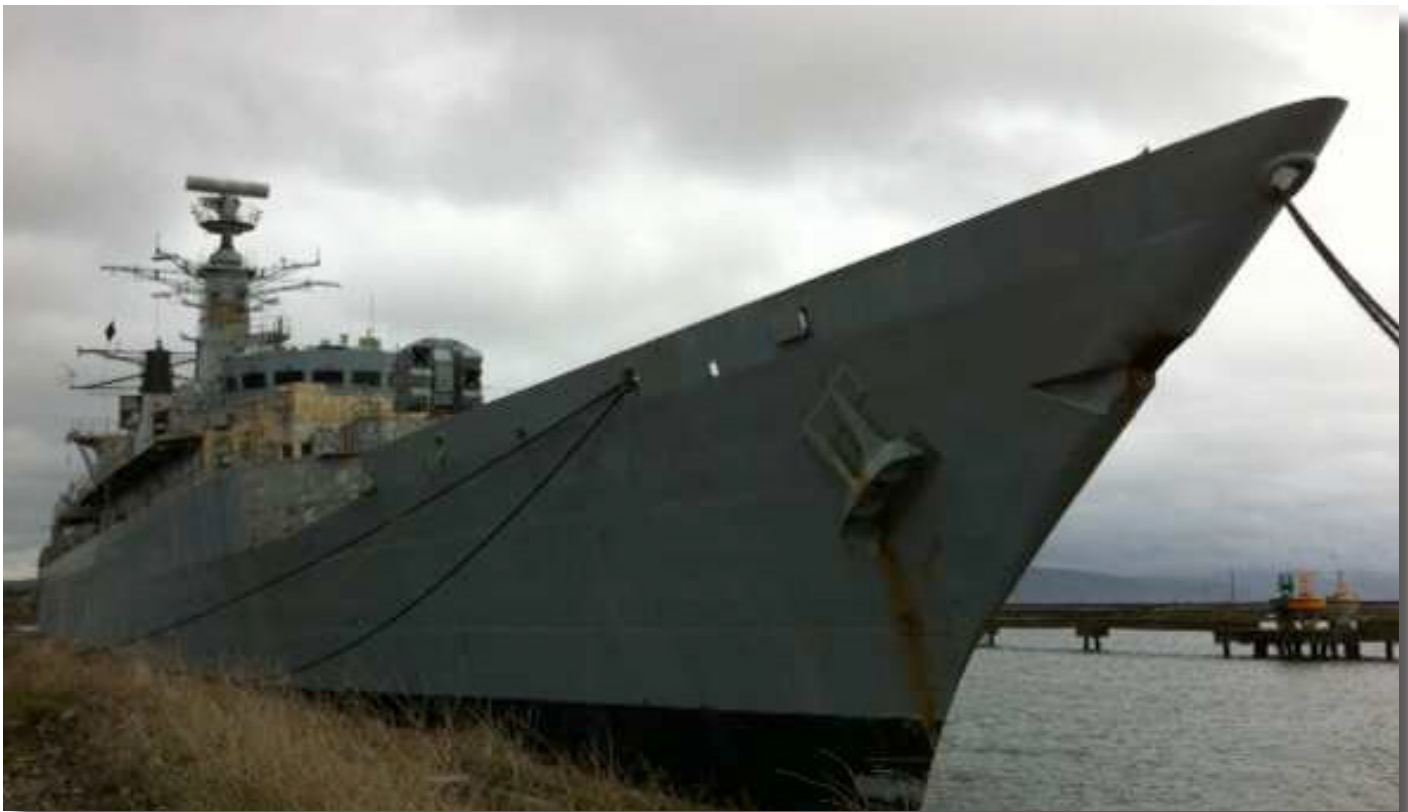
Wet Berth Mooring at Swansea Drydocks.

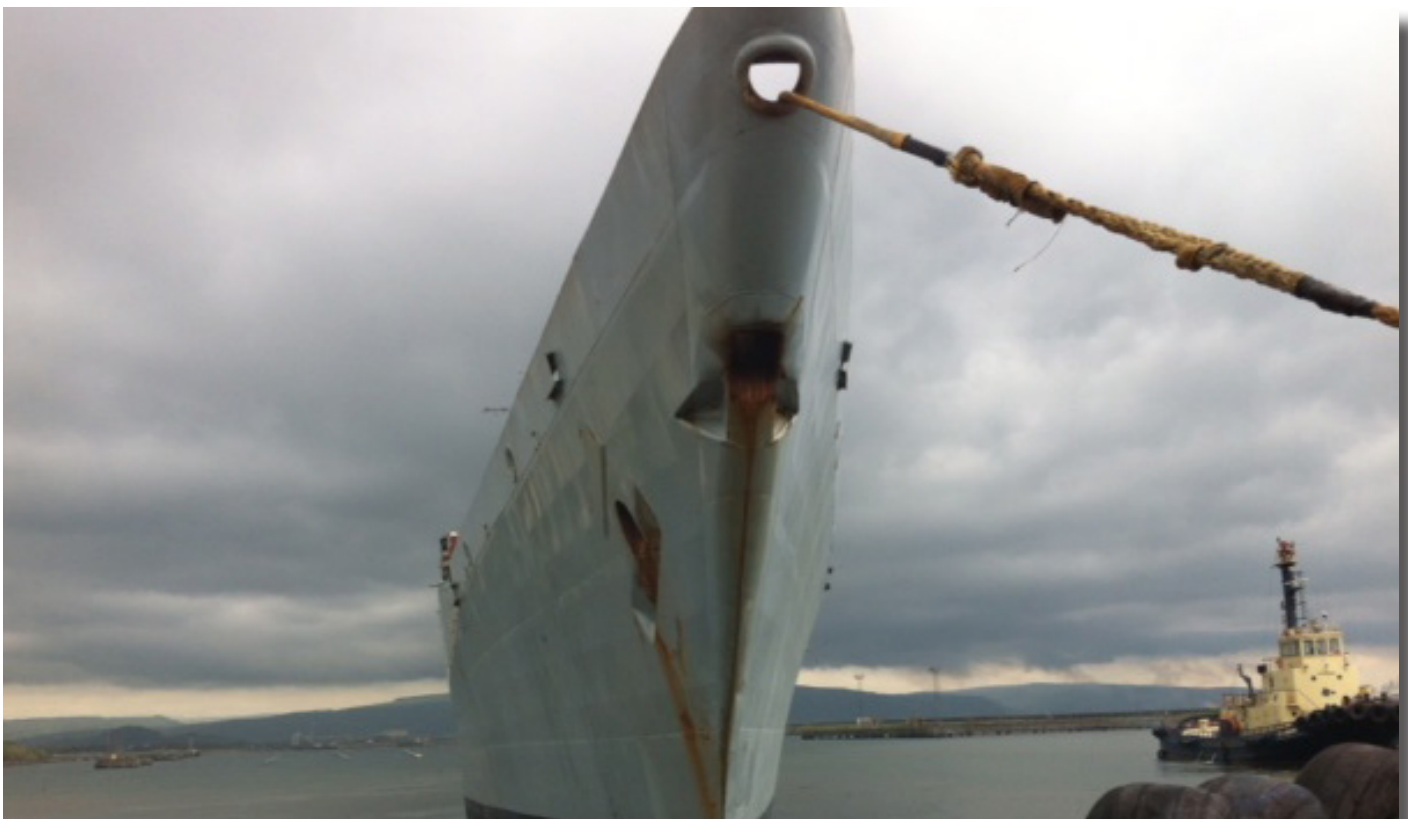
31 May 2014 - Cornwall leaving Wet Berth 1 to go to the Dry Dock.

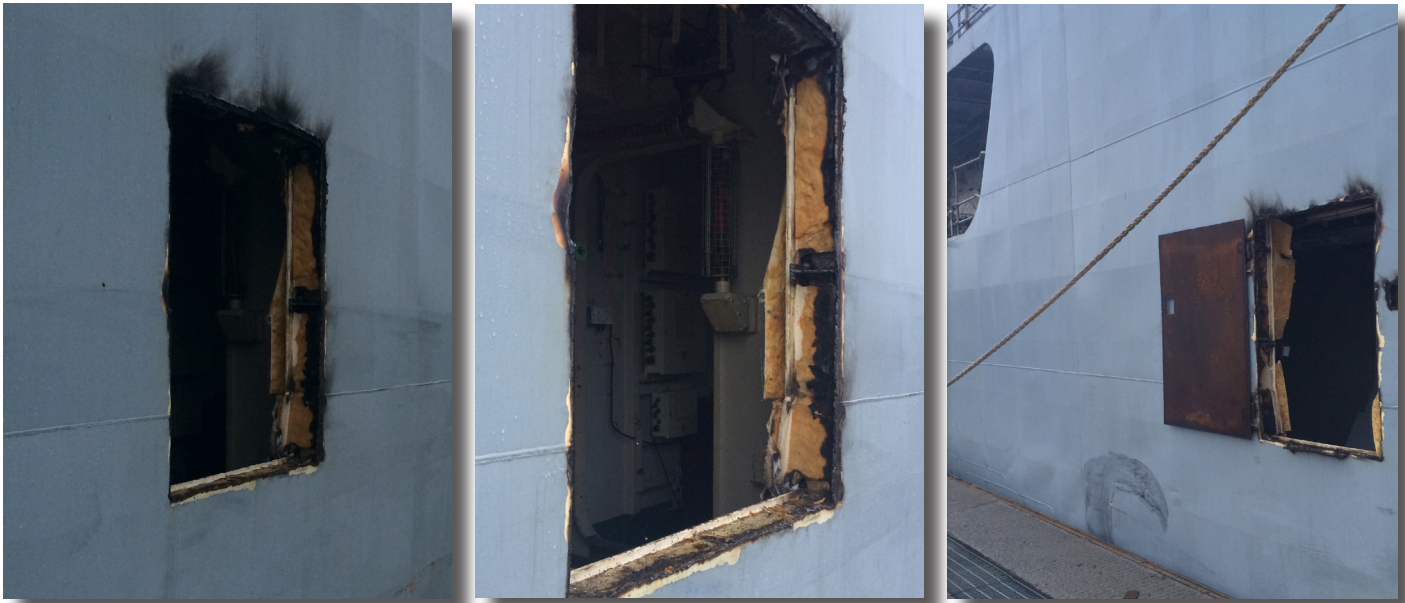
Holes were cut in side of the vessel to allow access for the removal of some non ferrous & soft strip materials, authorised and permitted by the Ballast Water and Stability management plans within the Ship Recycling Facility Plan (SRFP). The vessel remained in the wet berth repair area until 20 May 2014.

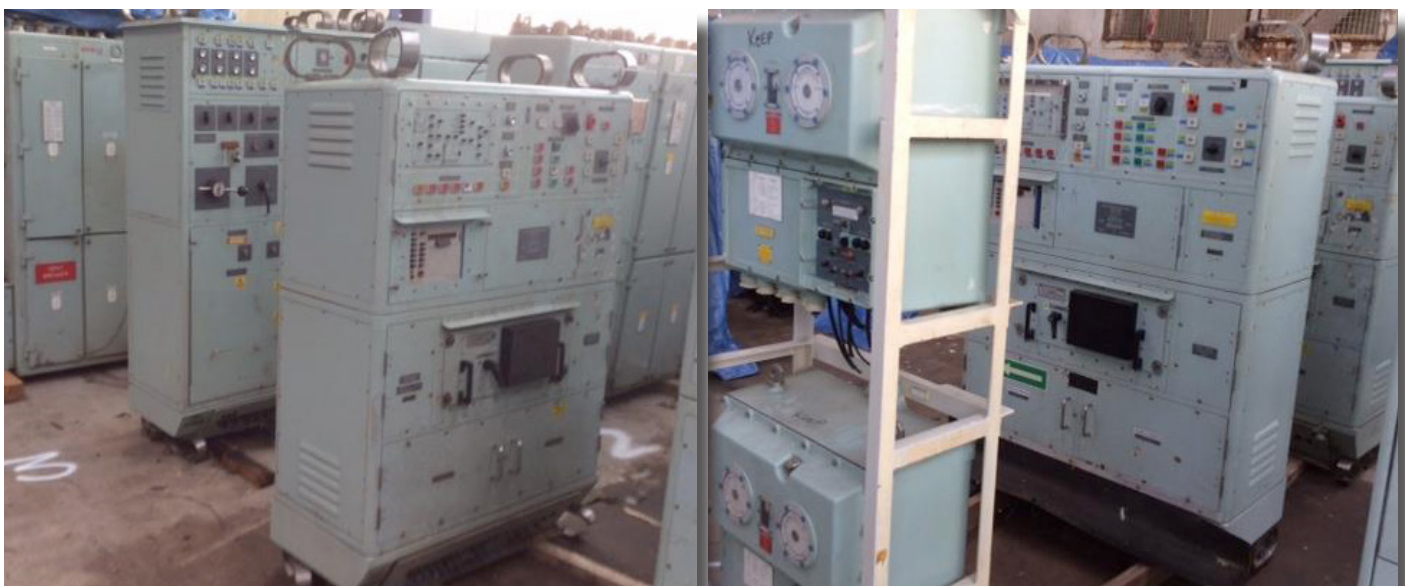
Electronics and items of interest to other Navies were catalogued, documented by NSN reference and stored.

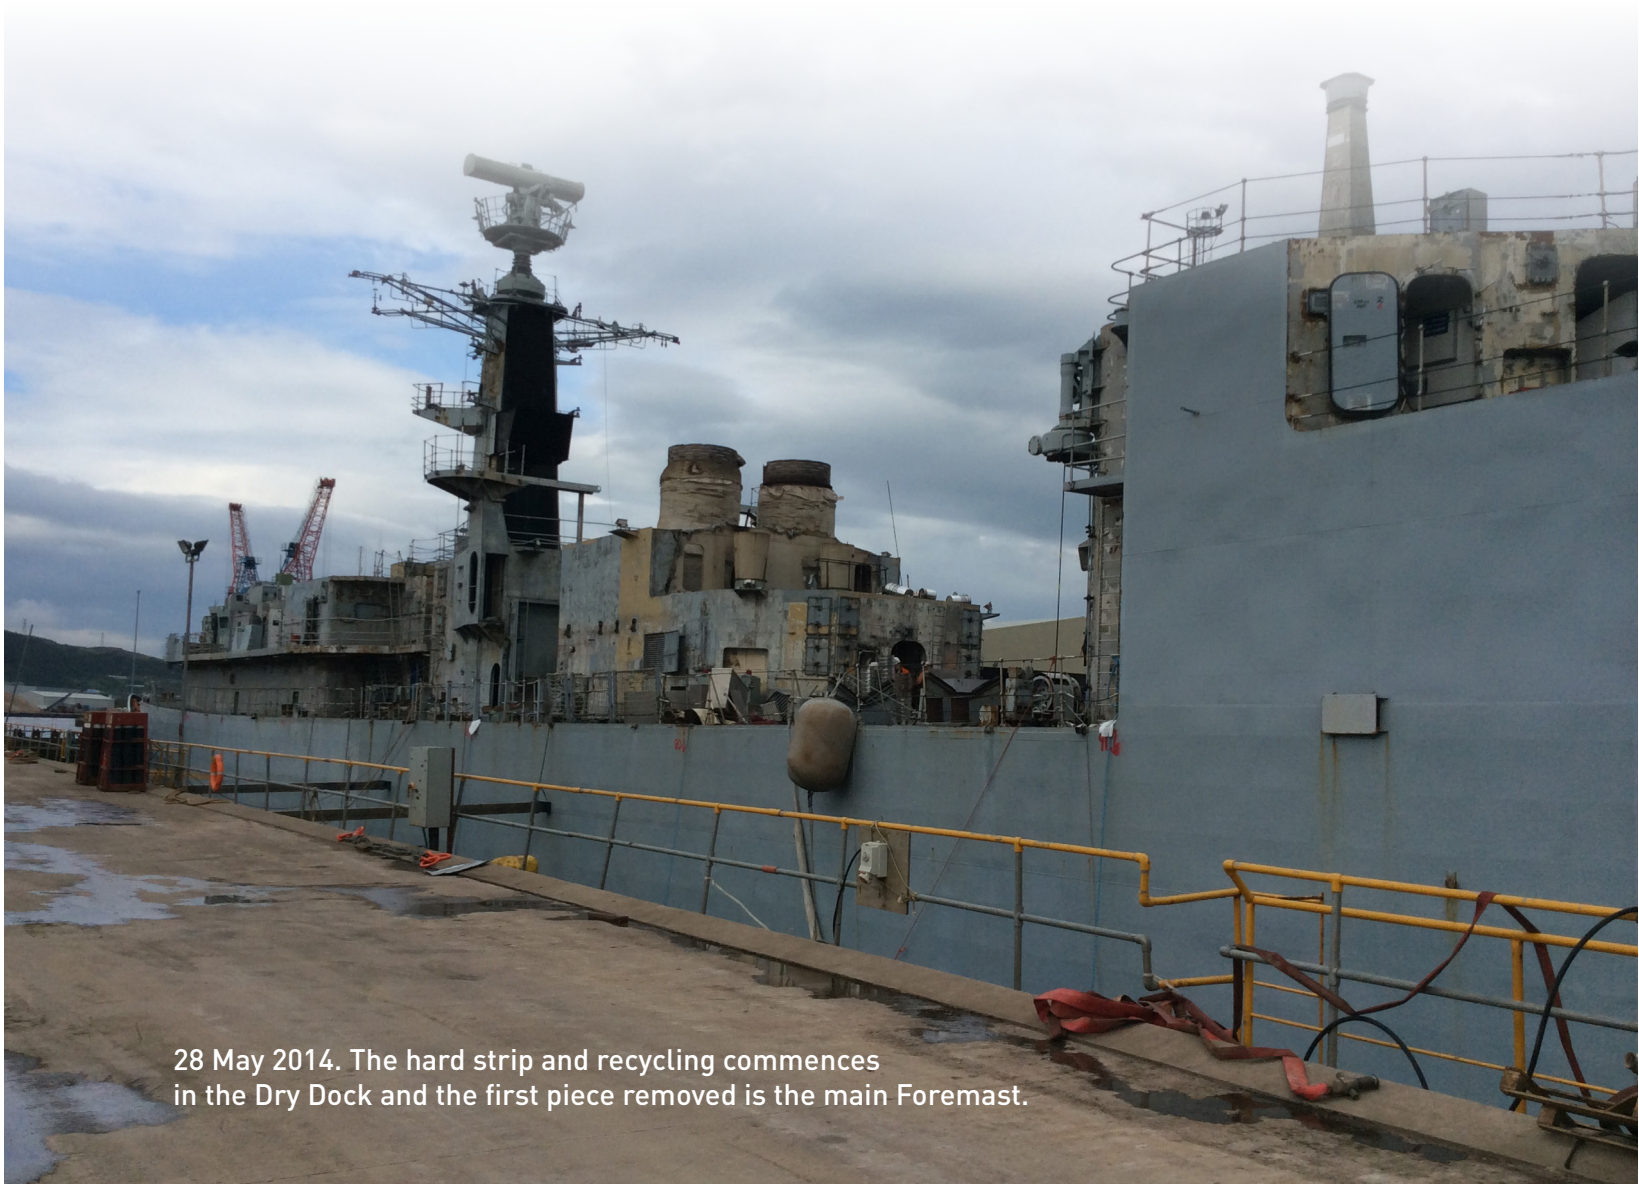
28 May 2014. The hard strip and recycling commences in the Dry Dock and the first piece removed is the main Foremast.

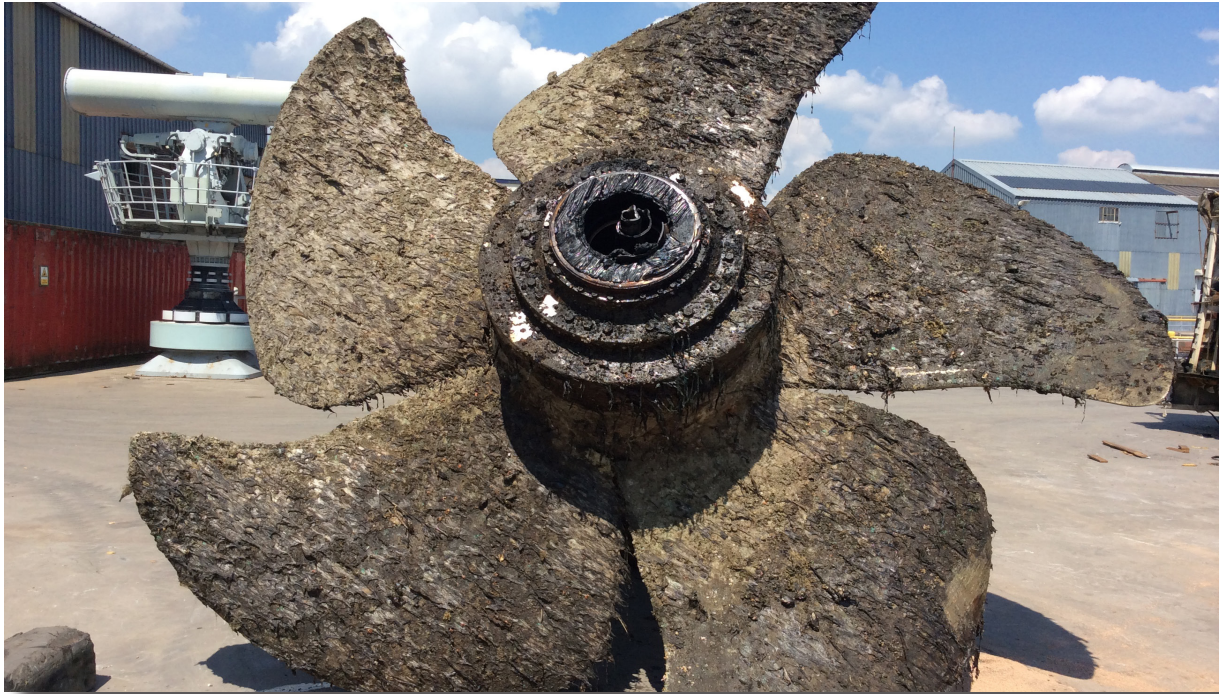
23 June 2014. The propeller once removed was completely stripped down to reveal all of the component parts. Each petal weighed approximately 800kg

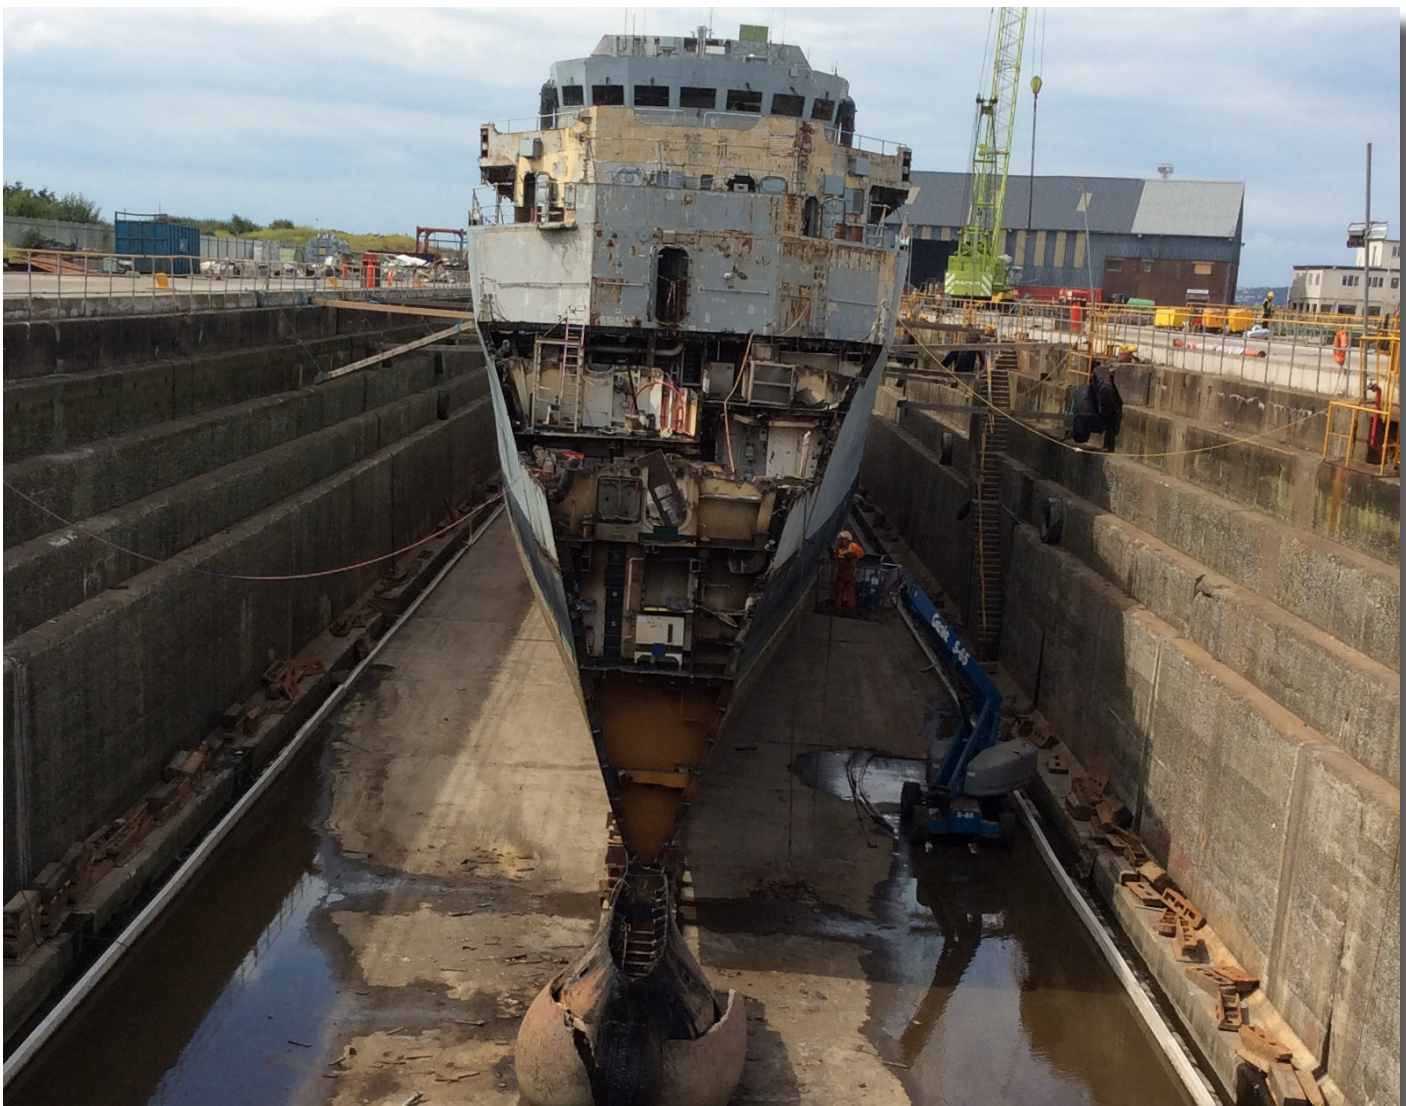
June 2014 Photograph showing the vessel in the dry dock. The vessel is set on blocks with stability bracing and shoring. This bracing and shoring was planned and controlled by the Ballast Water and Stability Management Plans as part of the SRFP. In the foreground is the Sonar Array Dome that required a special plate to split it apart and allow the vessel to be placed on the blocks safely and securely.

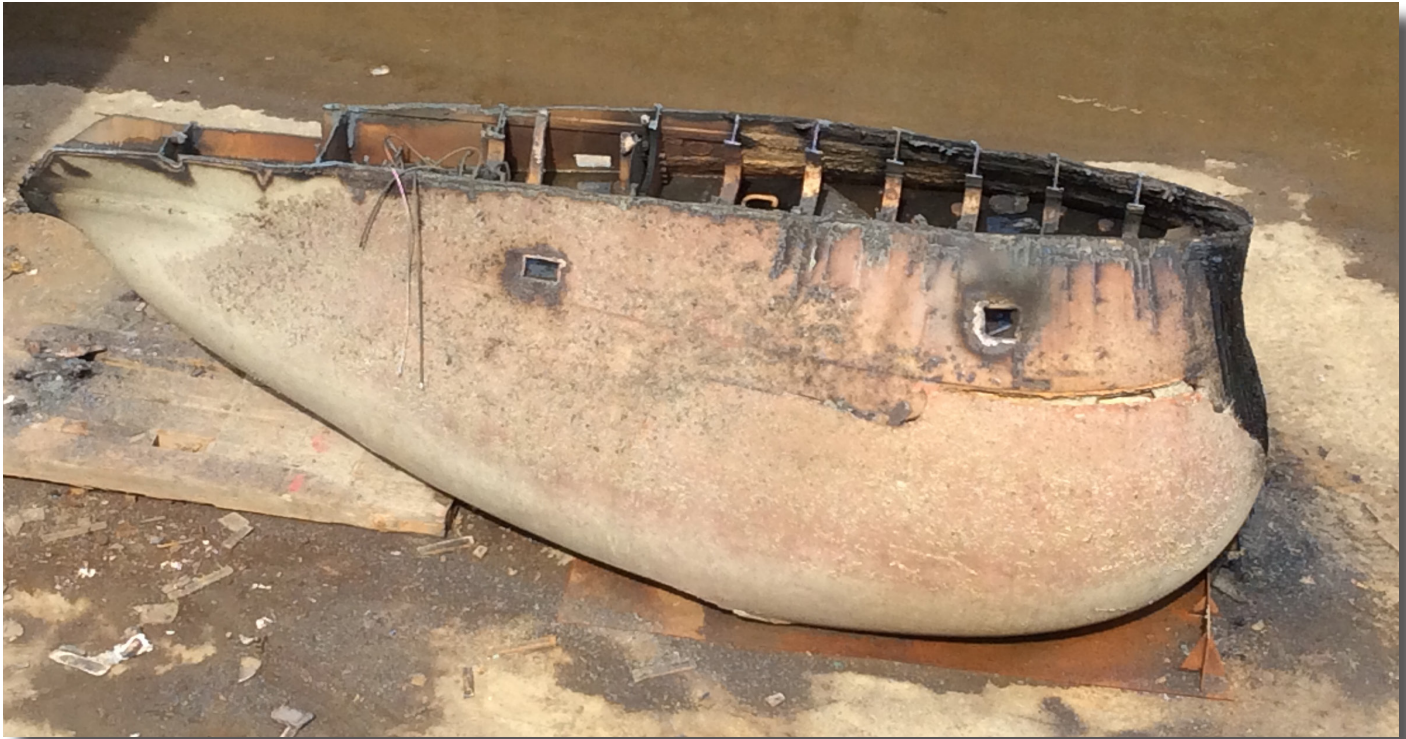
Recycling of the Sonar Dome July 2014. The Sonar Array was removed from inside the dome in one piece. It weighed 15 tonnes and consisted of 64 transducers that yielded over 7.8 tonnes of non-ferrous metal.

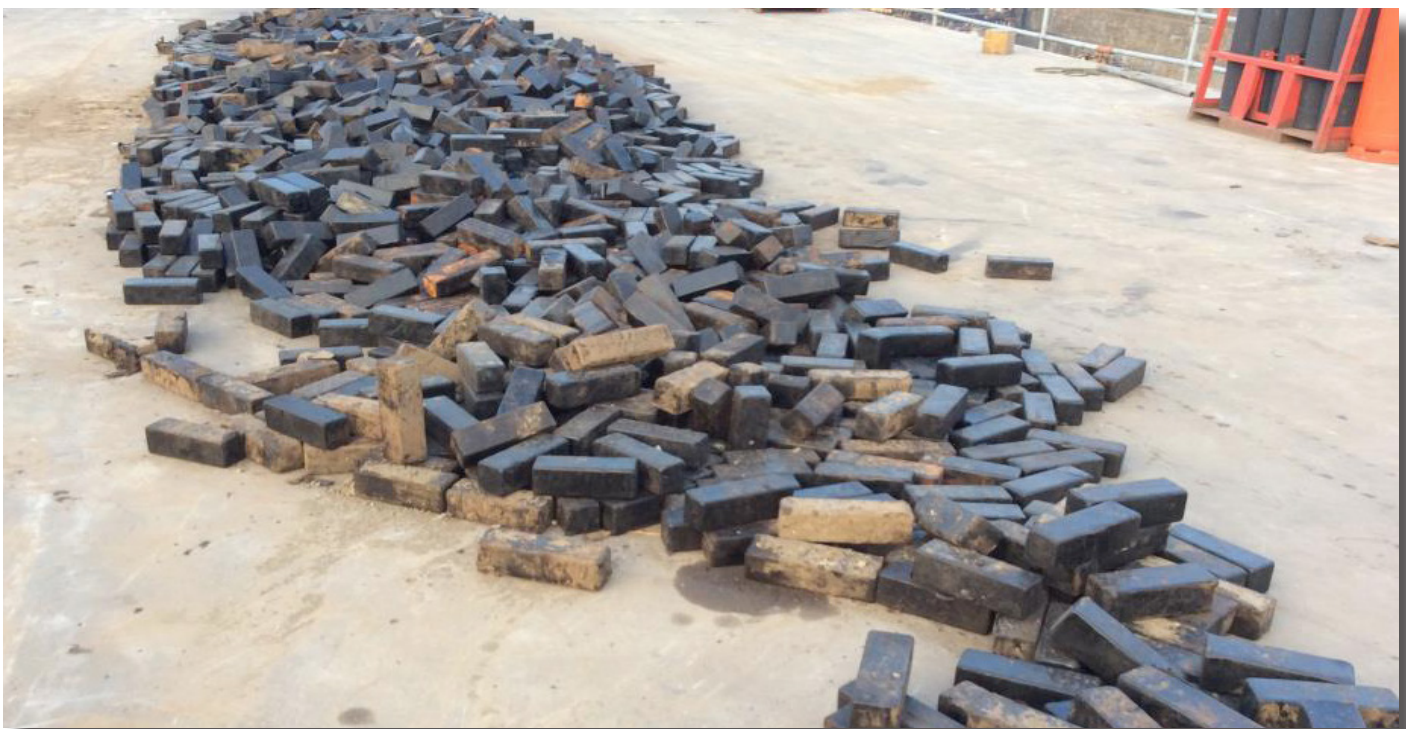
Lead Ballast Aug 2014 182 tonnes removed in total.

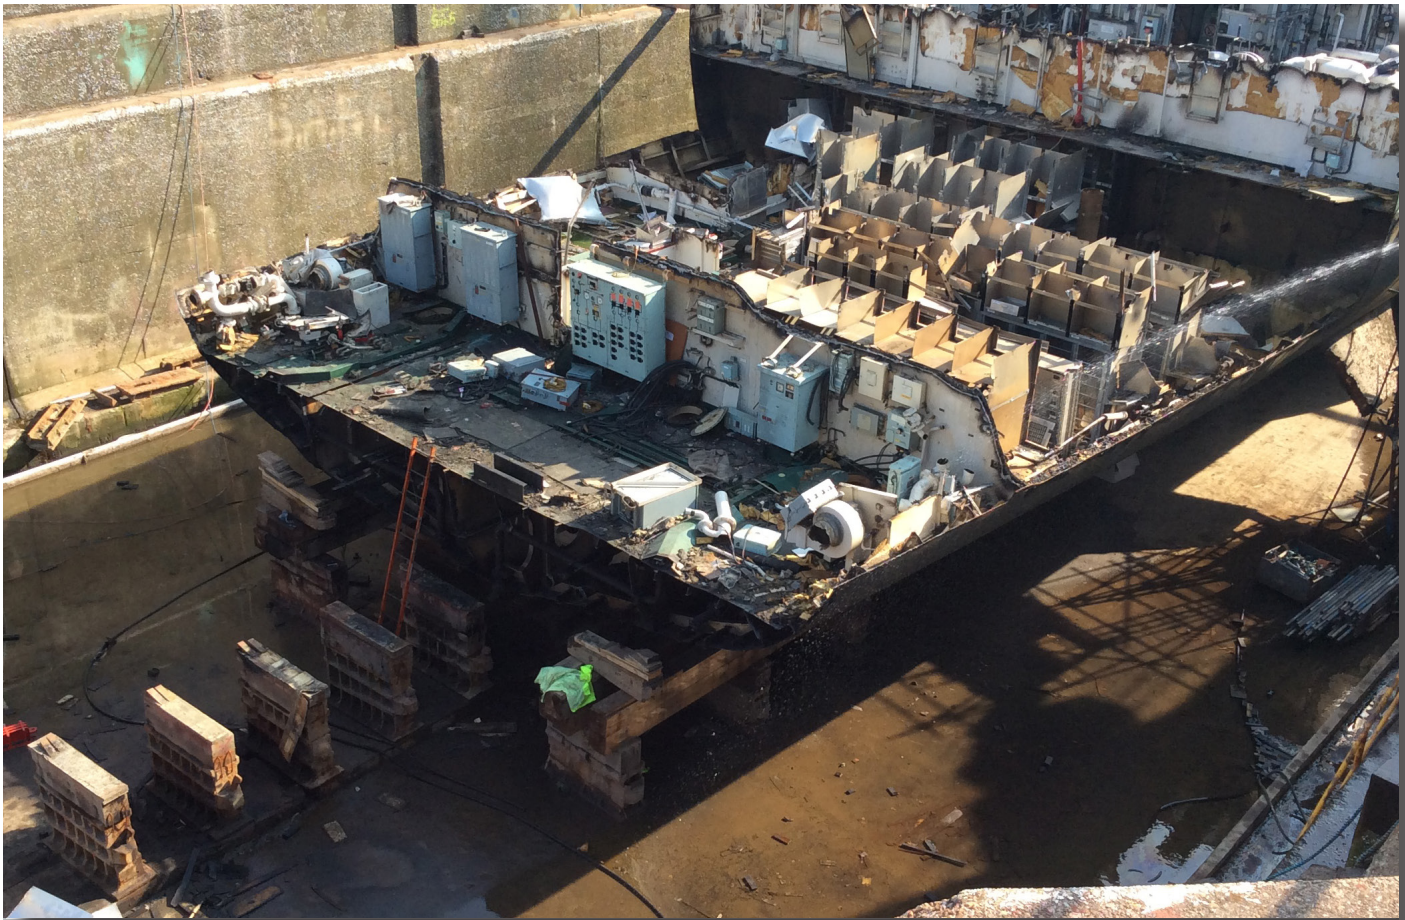
The picture above shows ballast water being collected by the retaining concrete bund within the dry dock. The collected discharge was pumped into the specially designed single site drainage system and then filtered through the interceptors and stored in holding tanks where samples were taken and sent to laboratory for analysis. All ballast water and discharge readings for HMS Cornwall, over 1000 tonnes in all, were well within the specified parameters of the discharge consent in the environmental permit. This meant that the ballast water and discharges were not deemed to be waste and were able to be released from the tanks on the outgoing tide. This procedure is controlled by the Ballast Water management plan that forms part of the SRFP.

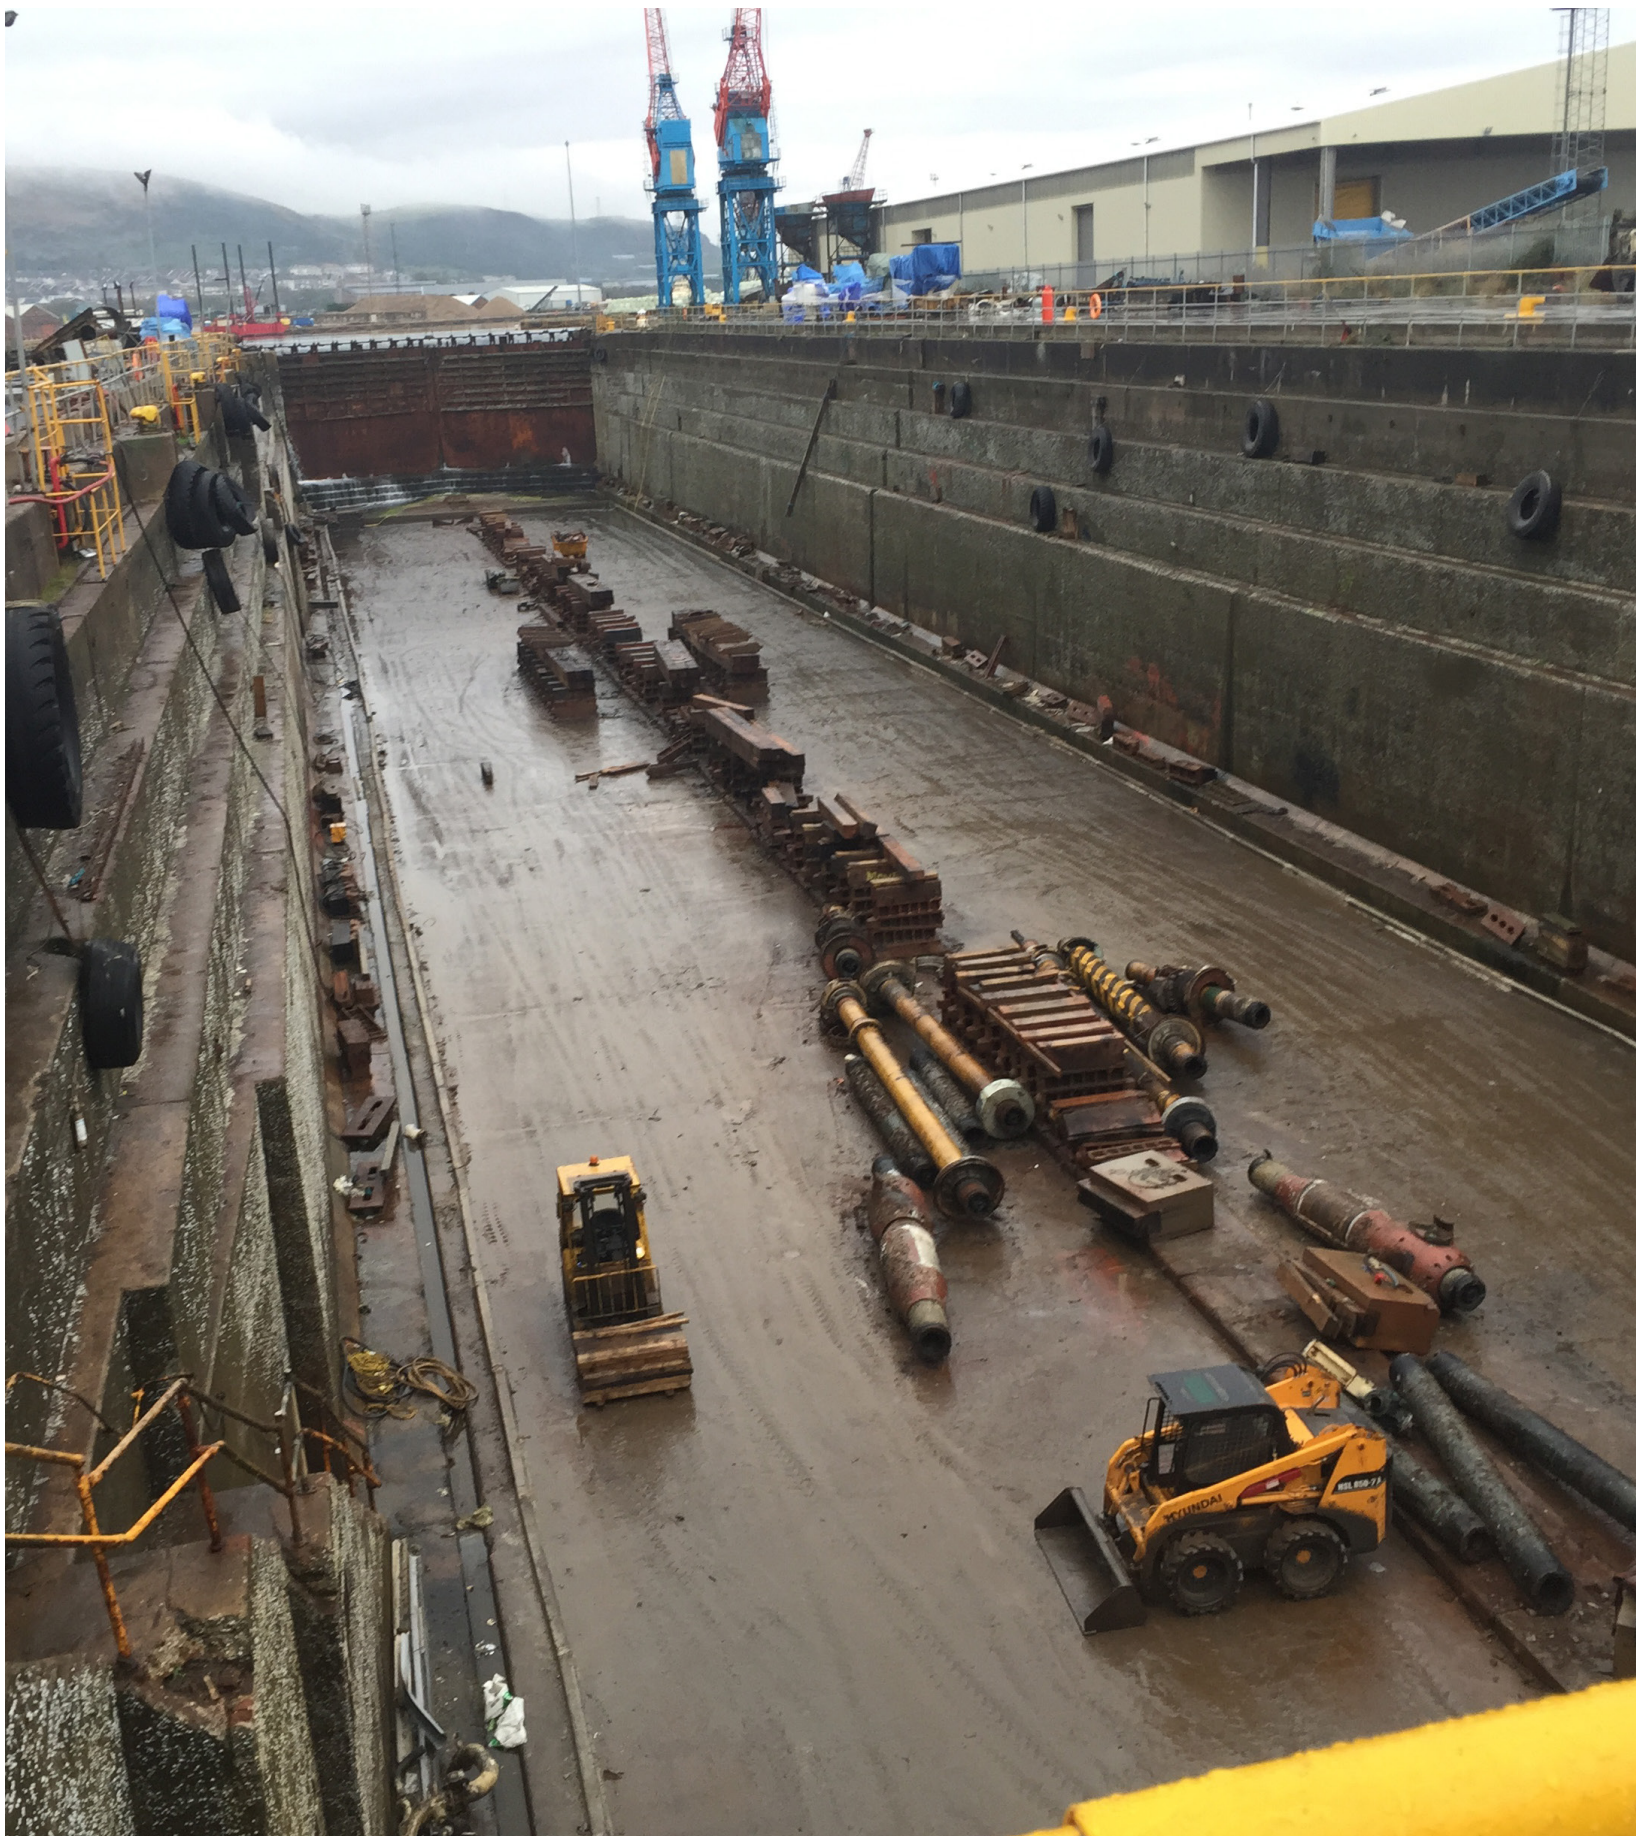
The final Pictures of the dry dock where the Former HMS Cornwall was dismantled. The final pieces were removed from dry dock no.2 on the 30th October 2014 twelve months to the day of her arrival. Thorough cleaning of the dock is undertaken prior to re-flooding in preparation for the next ship arrival.
