Missing manhole cover - Injury to member of the public

SafetyAlert

January 2016

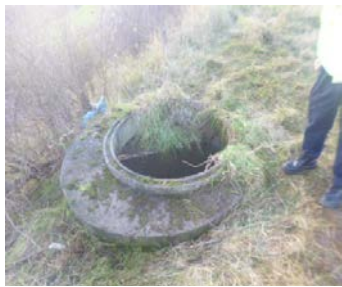
A vehicle broke down on the network and whilst awaiting recovery the occupants moved to an adjacent embankment for their safety. A member of the public stood on a raised manhole ring on the top of the embankment which was covered by timber boarding. The boarding gave way and the individual fell approximately 8 metres to the bottom of the chamber suffering serious potentially life changing injuries including multiple fractures.

(Post Incident)

- Service providers to be aware of 3rd party assets on the strategic road network
- Where undertaking maintenance work including grass cutting, litter picking etc. on verges and embankments ensure risk assessments and method statements (RAMS) include reference to any 3rd party assets and specific hazards
- Walk the site prior to commencing work activity to ensure all hazards have been identified in the RAMS
- Report any hazards immediately and make safe
- Brief all relevant staff on this incident

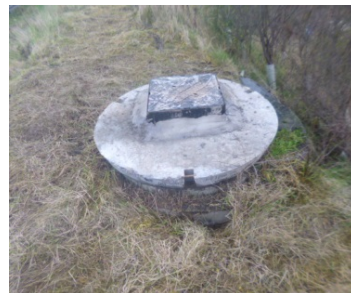
(Made Safe)
