# Sewage-related contaminants in Isles of Scilly groundwater: concentrations, spatial distribution, sources and risk

Project ENVRESW001361

September 2016

Part 3 of 4

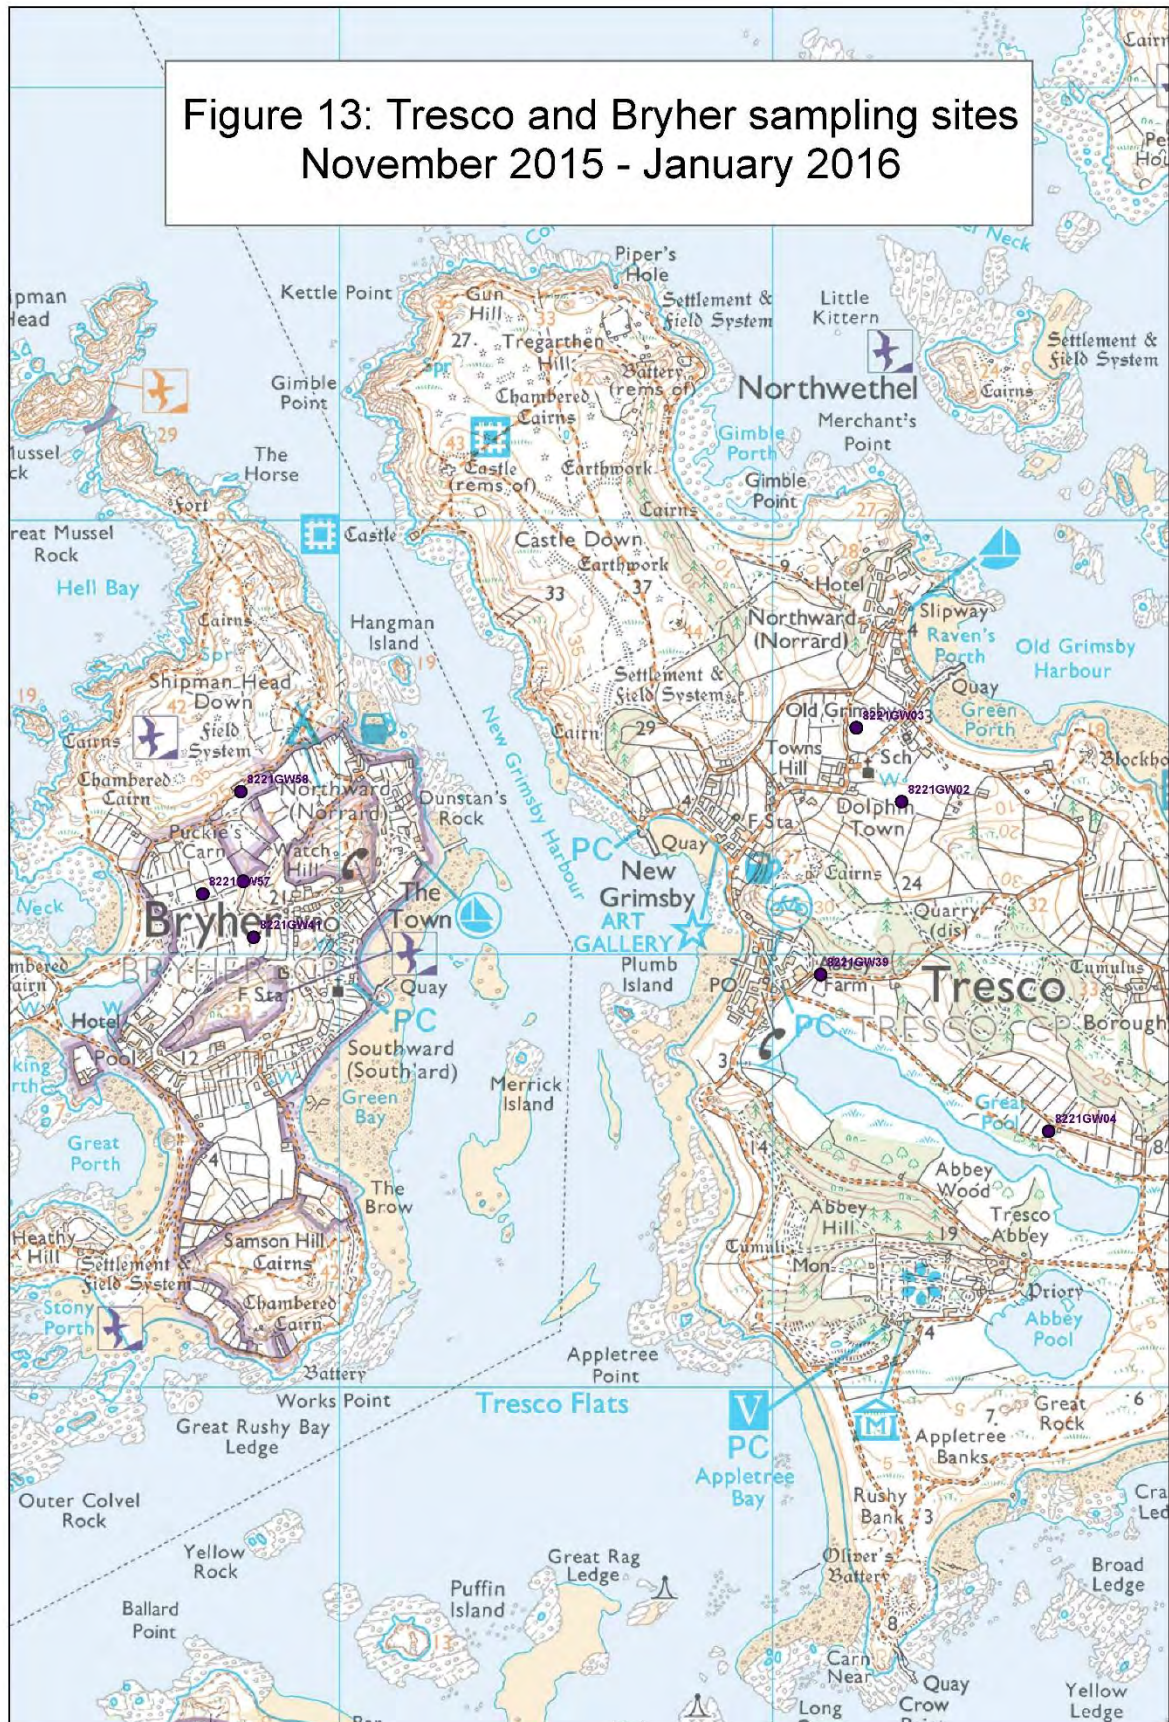
Figure 14: Isles of Scilly Council nitrate data, December 2015

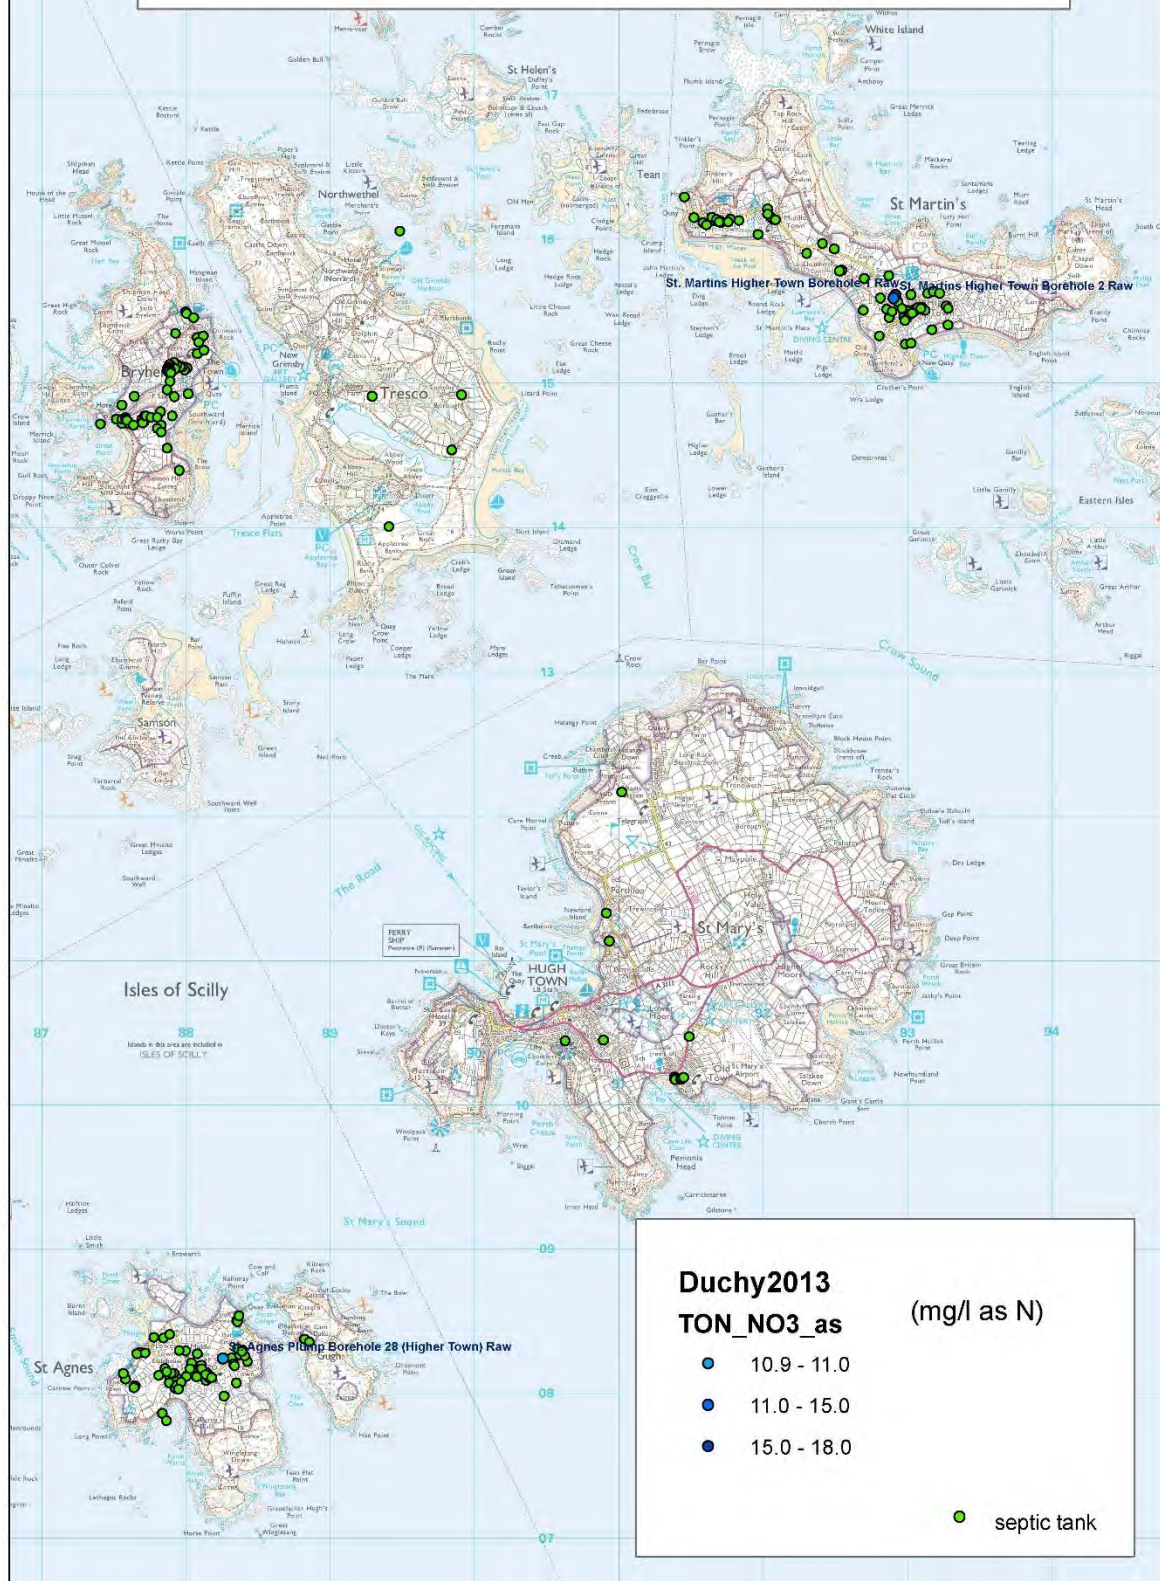
Figure 19: Carrs Well, St Mary's nitrate and ammonium concentrations

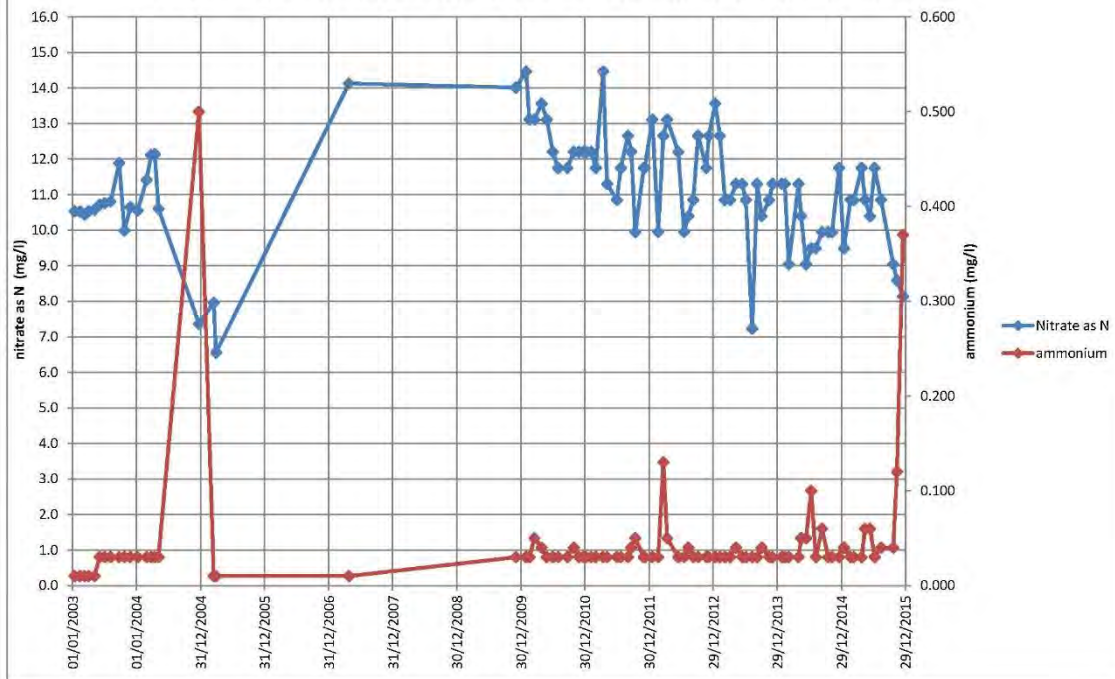
Figure 20: Hales, St Mary's nitrate and ammonium concentrations

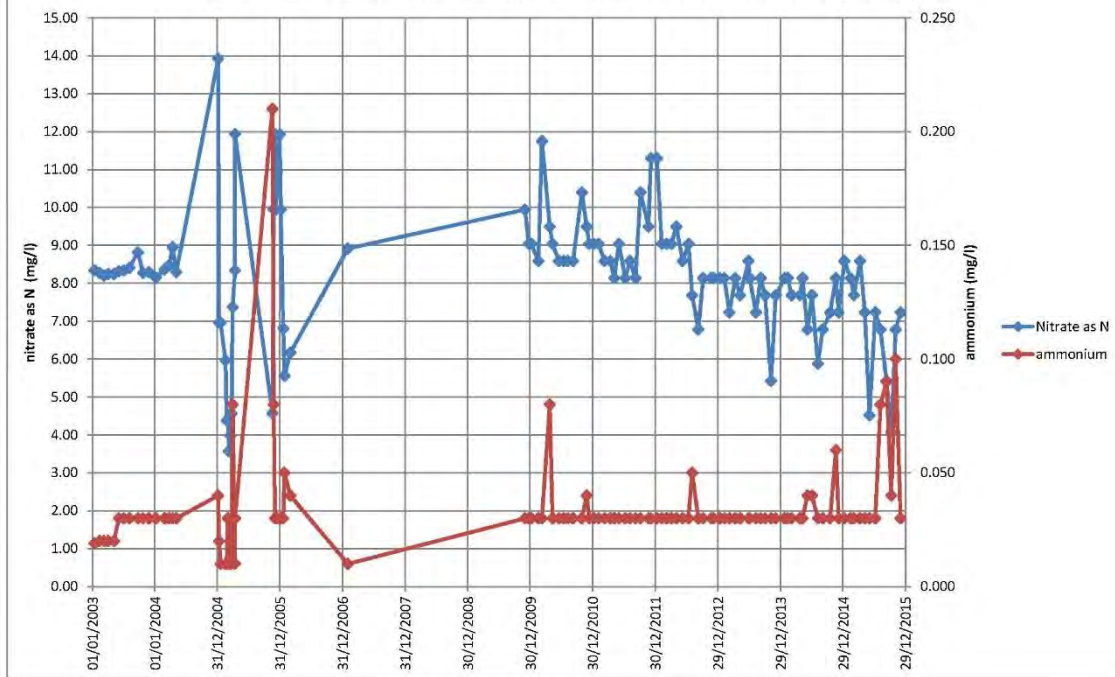
Figure 21: Joaney's Well, St Mary's nitrate and ammonium concentrations

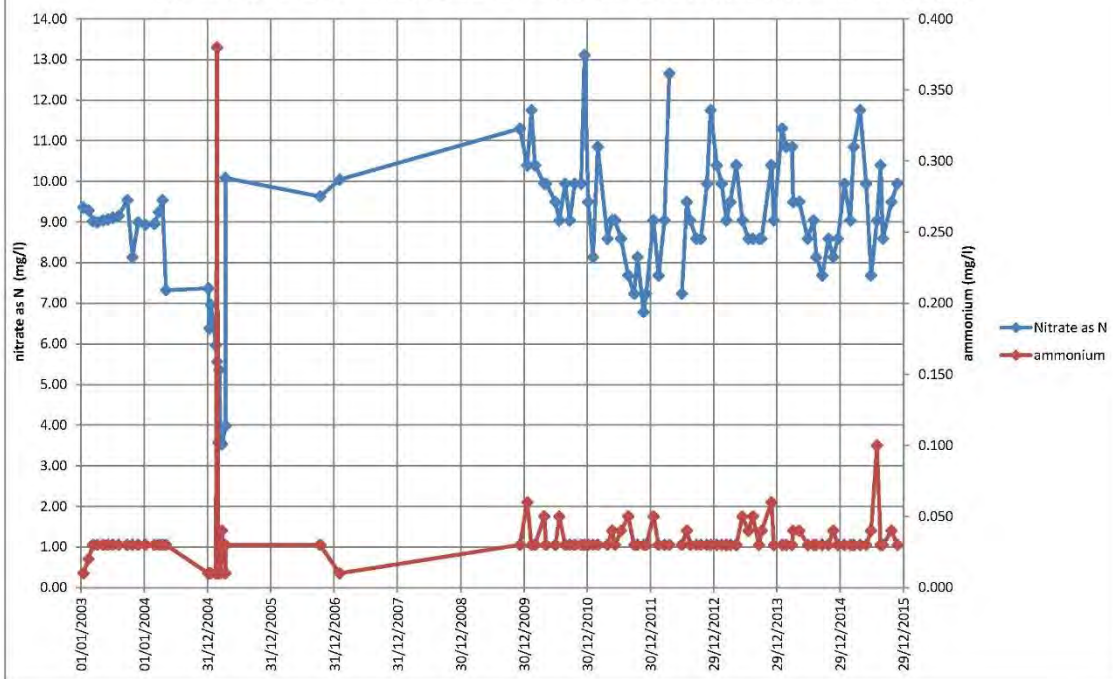
Figure 22: Rocky Hill, St Mary's nitrate and ammonium concentrations

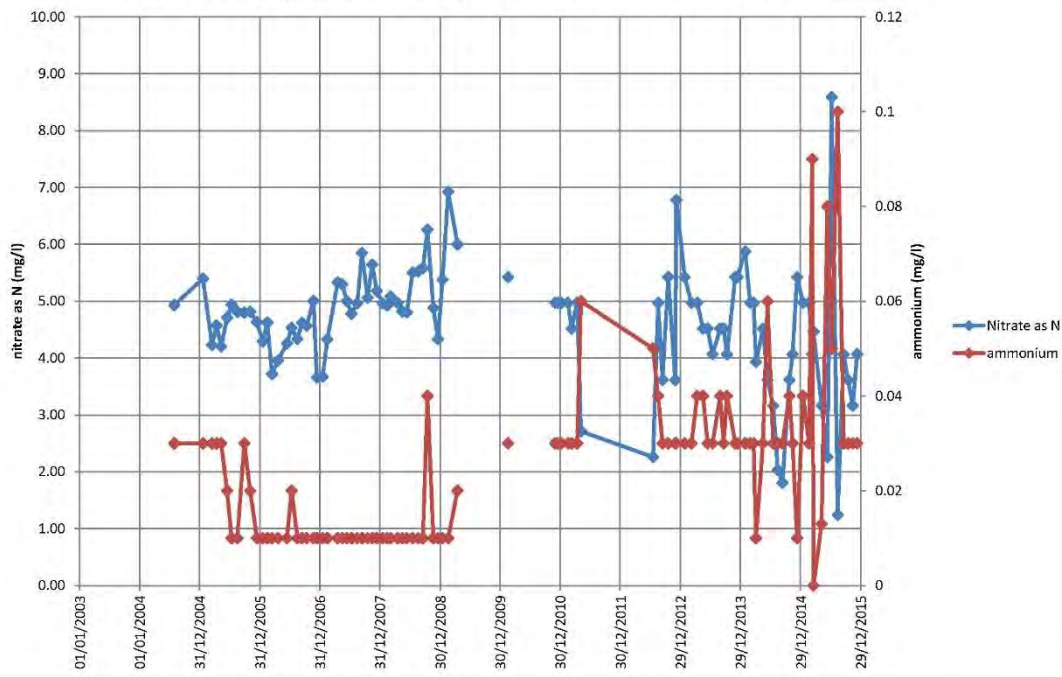
**Figure 26: Bryher Well nitrate and ammonium concentrations**

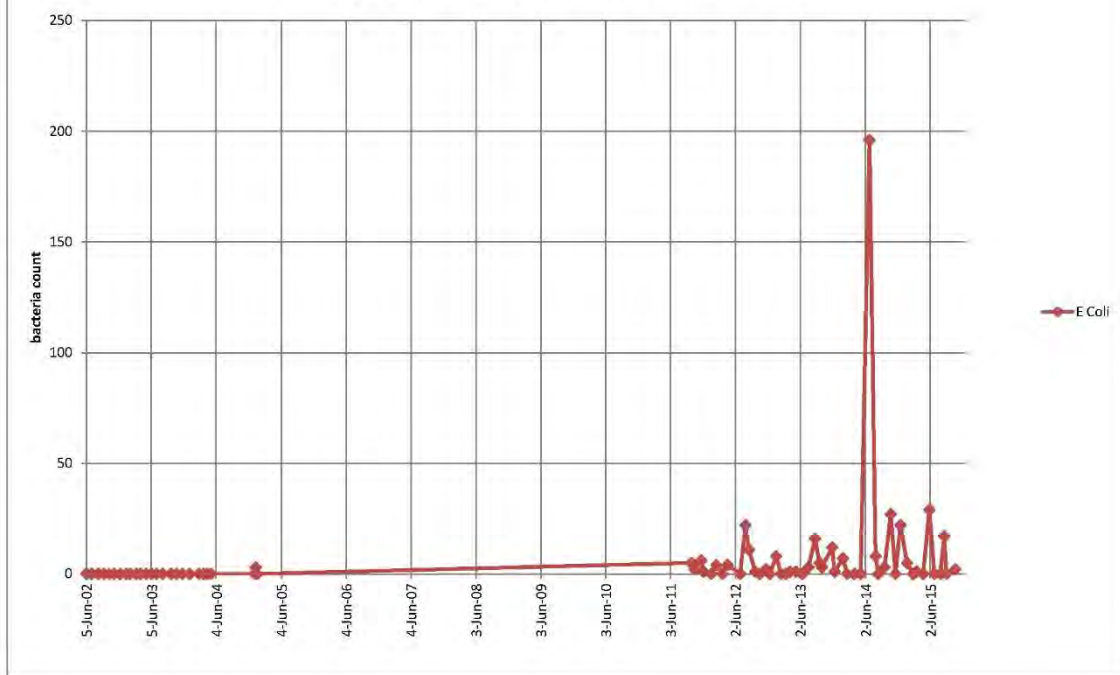
Figure 30: Rocky Hill, St Mary's e-coli count

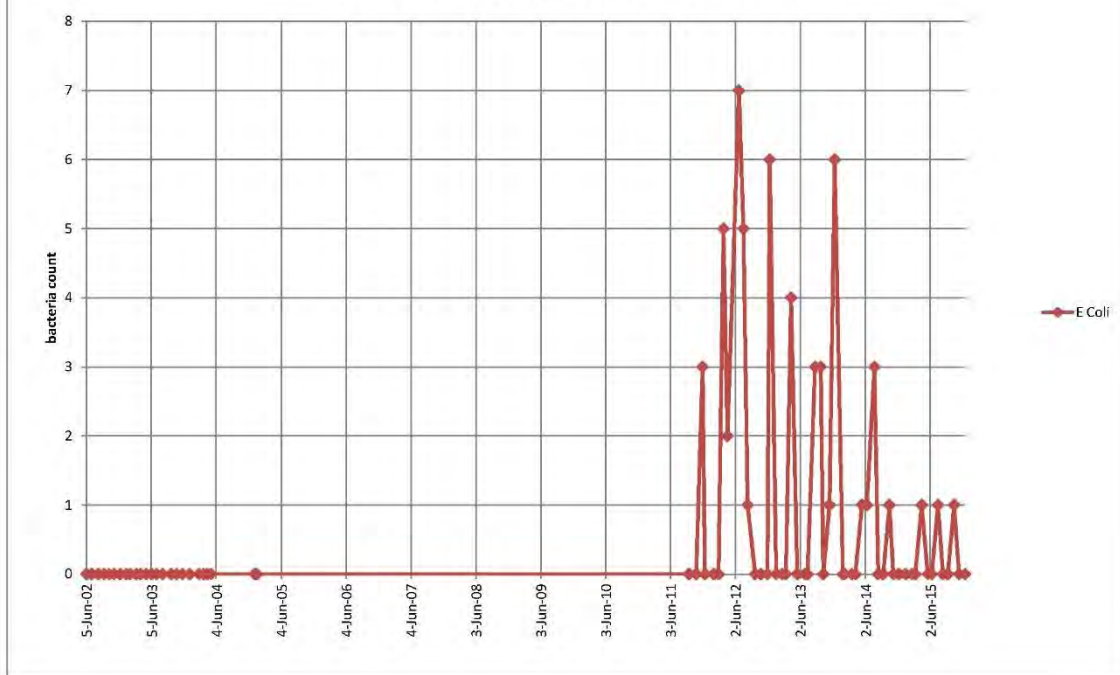
Figure 33: Bryher Borehole 2 e-coli count

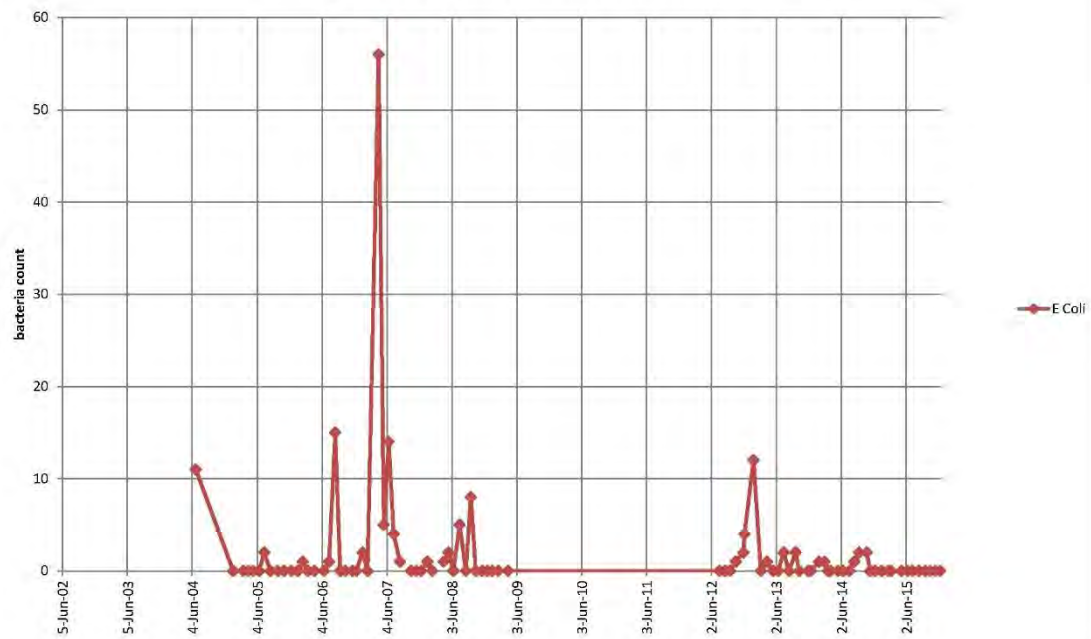
Figure 34: Bryher Well e-coli count
