# UCL ENERGY INSTITUTE

ANALYSIS OF DATA FROM HEAT PUMPS INSTALLED VIA THE  
RENEWABLE HEAT PREMIUM PAYMENT (RHPP) SCHEME

## Case Studies Report from the RHPP Heat Pump Monitoring Campaign

Issued: March 2017

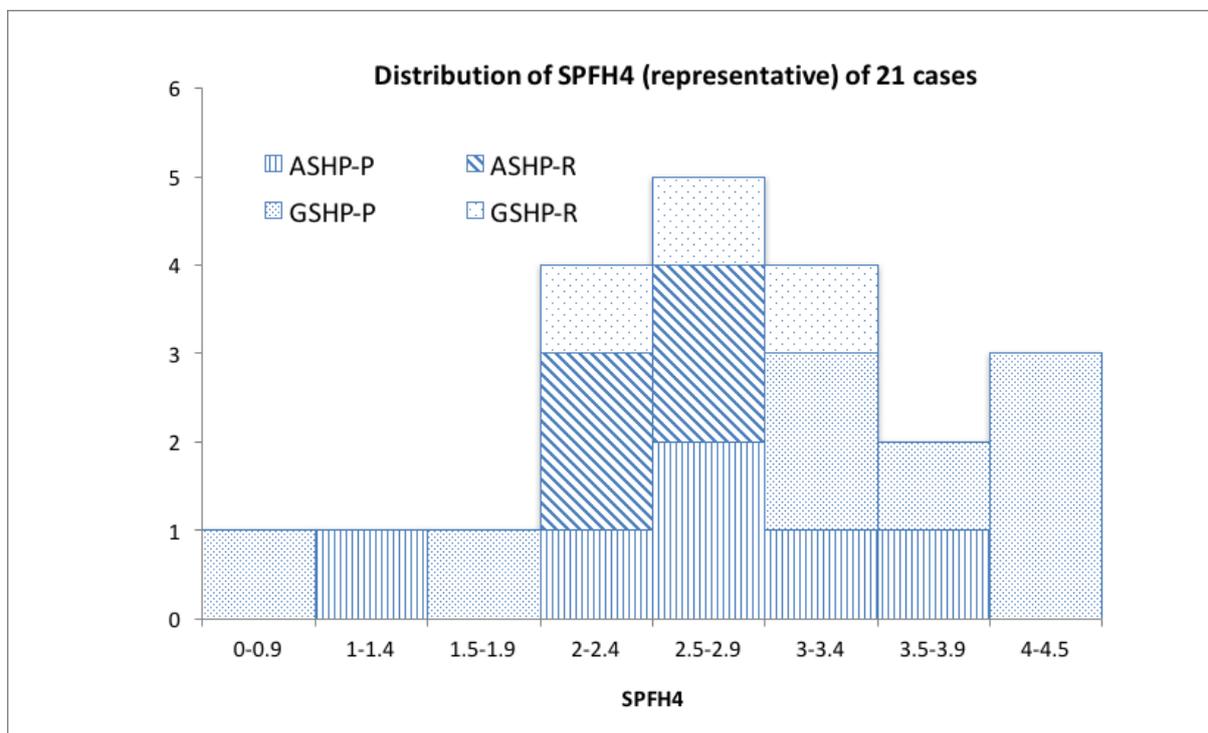
The distribution of SPFH4 in the 21 case study sites is shown in Figure 0.1 and shows a large range of performance. All seven heat pumps installed at RSL sites (ASHP and GSHP) had representative SPFH4s of 2.3 or above. Four of six ASHPs in the private sector had a representative SPFH4 of 2.5 or above. Two of the sites with GSHPs had an estimated SPFH4 of less than 2; both were in the private sector. The remaining five of the GSHPs had representative SPFH4s between 3 and 4.6.

**Figure 0-2. Distribution of representative SPFH4 by heat pump type and tenure.**

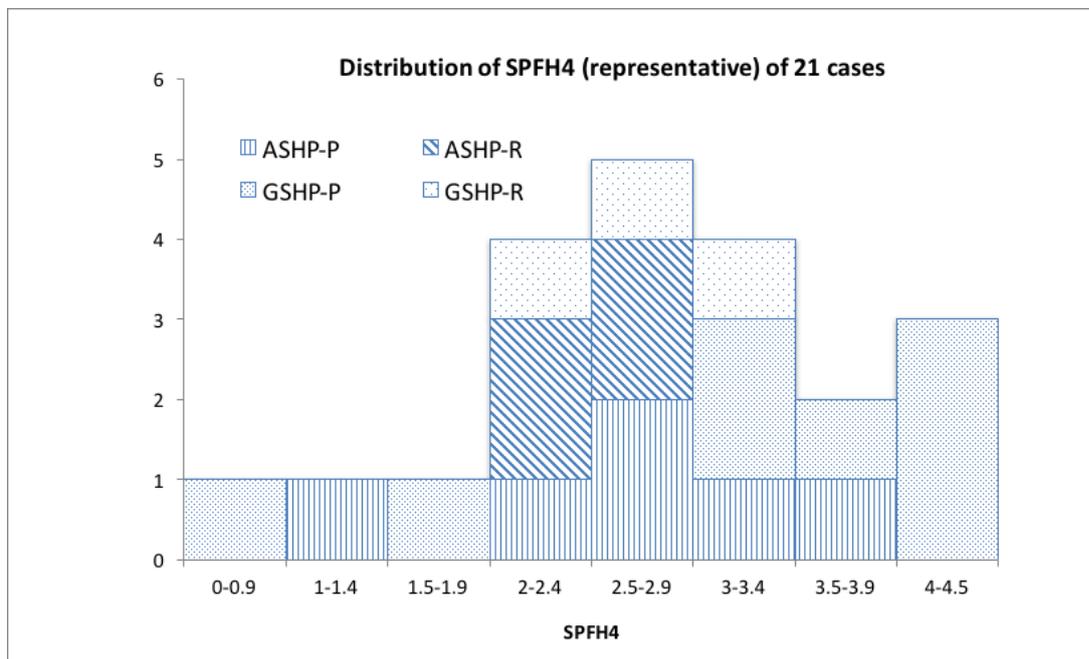
The distribution of SPFH4 in the 21 case study sites is shown in Figure 0.1. All seven heat pumps installed at RSL sites (ASHP and GSHP) had representative SPFH4s of 2.3 or above and four were above 2.5. Four of six ASHPs in the private sector had a representative SPFH4 of 2.5 or above. Two of the sites with GSHPs (CS12 & CS16) had an estimated SPFH4 < 2; both were in the private sector. The remaining five of the GSHPs had representative SPFH4s between 3 and 4.6.

**Figure 0-1. Distribution of representative SPFH4 by heat pump type and tenure.**

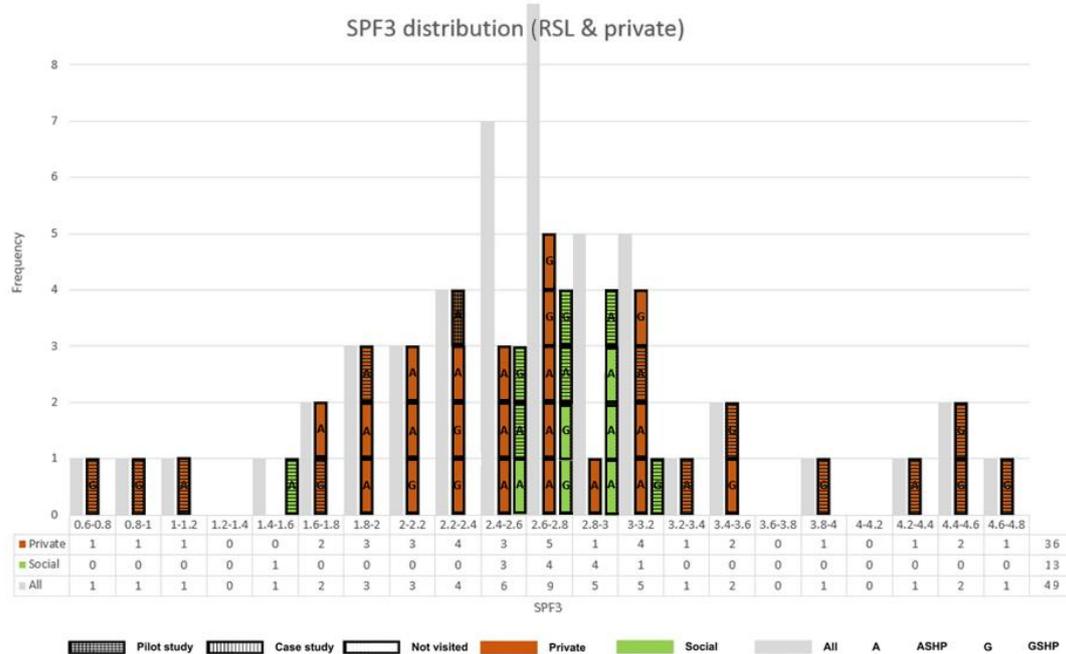
**Figure 3-2. Histogram of the SPF3s for the 48 sites that volunteered to participate in the case study investigation (based on preliminary and unpublished SPF estimates)**

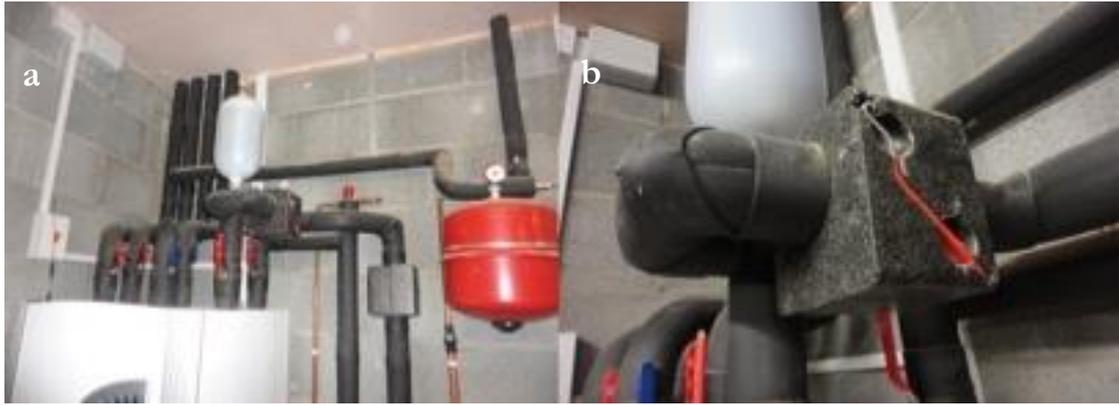
**Figure 4-2. (a) Example of high quality insulation (CS15) and (b) detail of high quality valve insulation (CS15)**

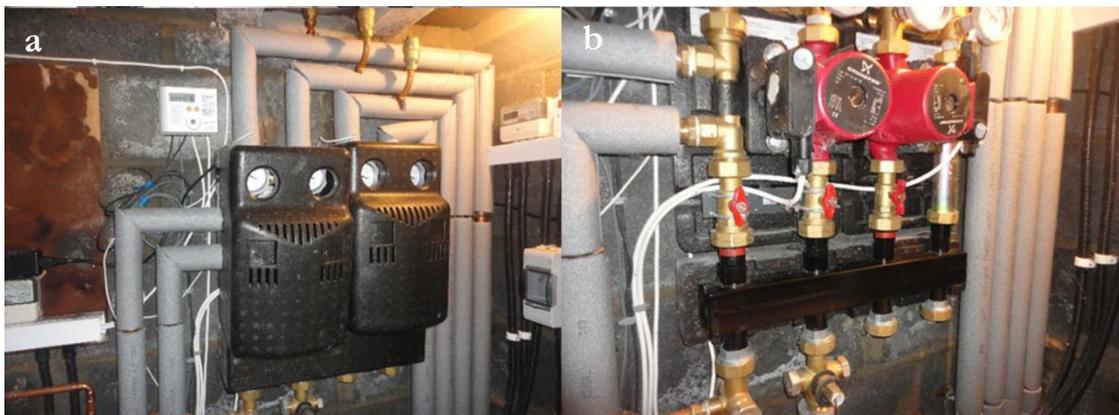
**Figure 4-3. (a) High quality insulation of pipework in outdoor, unheated shed with and (b) with insulated pump and manifold covers removed (CS13)**

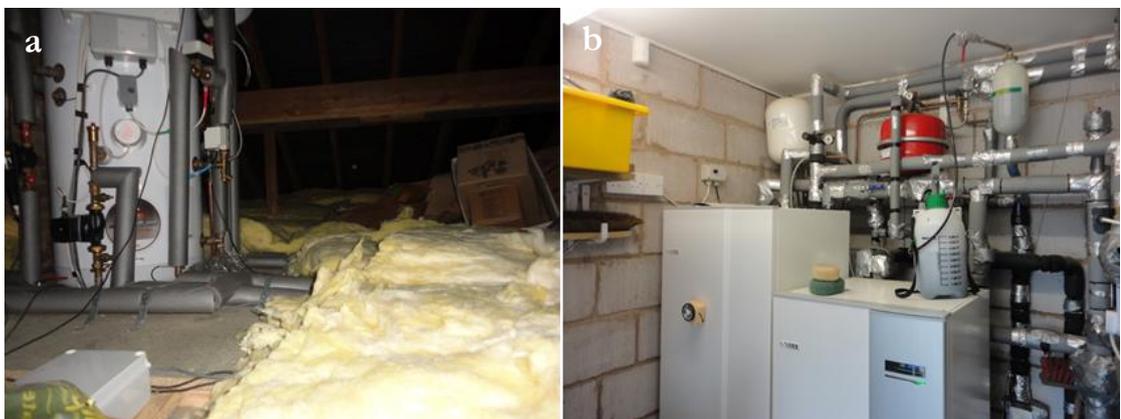
**Figure 4-7. (a) DHW cylinder located in ventilated roof space (CS07), (b) HP units located in unheated garage (CS14)**

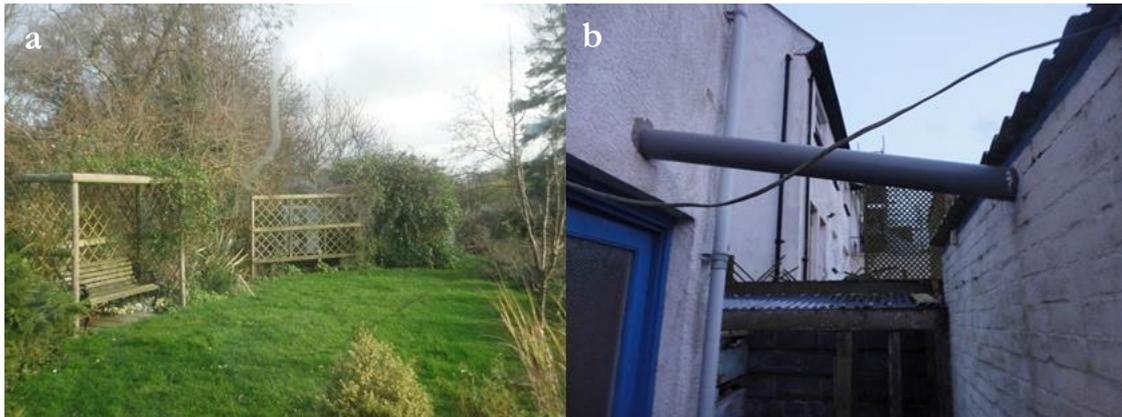
- **External pipework not kept to a minimum** – As shown in Figure 4-8 (a,b) in cases CS09, CS20 and CS10 (not pictured), the external units of the ASHPs were located many metres away from the house, with insulated but long pipe runs connecting the two, thus incurring some heat losses. Some shorter but also externally insulated pipes were observed running vertically up the outside wall of cases CS07 and CS08 before entry into the attic.

**Figure 4-8. (a) Outdoor unit behind trellis (CS09), (b) Insulated external pipework (CS20)**

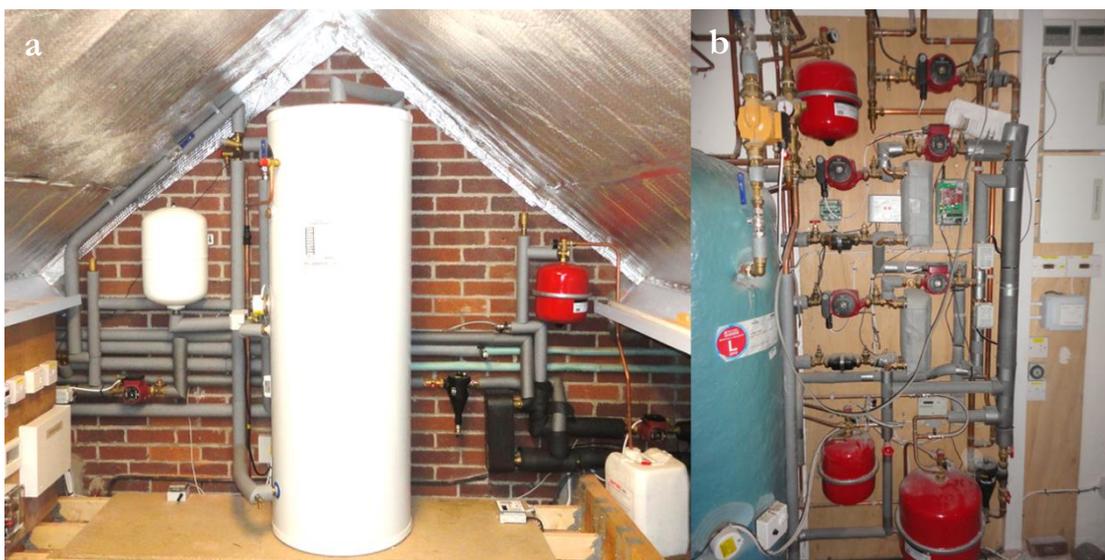
- **Installation quality and system complexity** – Notably, some very complicated installations were observed during the team's site investigation, including sites with more than one HPs (CS10), long pipework, plate heat exchangers and many more circulation pumps than originally assumed (e.g. in CS10, CS11, CS12, CS5 and CS19). Figure 4-9 (a,b) show some of these cases while Figure 4-10 (a,b) show the evolving technical practice in heat pump installation, i.e. the introduction of variable speed circulation pumps.

**Figure 4-9. (a) Neat installation with plate heat exchanger (CS11), (b) Plate heat exchangers by the same installer (CS10)**

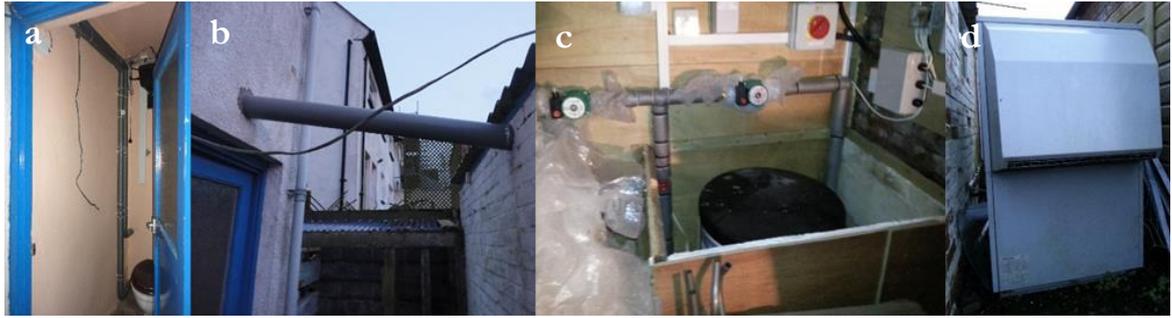
**Figure 4-12. (a) pipes running through the externally accessed, unheated outdoor toilet, (b) between the house and the external shed, (c) circulating pumps, buffer vessel and heat meters within the shed, (d) external HP unit, located next to the shed (CS20)**

<sup>29</sup> The SPF of the heat pump is not affected by heat losses from long pipe runs, but both from the wider energy policy perspective and from the perspective of the householder, this is potentially significant. Moreover the phenomenon of remote siting is unlikely to be co-incidental to the physical characteristics (size, visual intrusion, fan noise etc.) of heat pumps, and therefore represents a legitimate whole-system issue.

From the EPC data, CS20 appears to be a reasonably insulated dwelling, with an EPC rating of C. On visiting the dwelling, it was observed that the HP was sited roughly 5 metres from the house, between a brick-built out-house and a timber garden shed. The buffer vessel, circulation pump and metering were installed inside the out-house (see Figure 5-18a,b and Figure 5-19a,b). Pipework, but not pumps and valves in the out-house were insulated with split foam insulation. The buffer vessel is in a DIY insulated plywood box packed with bubble wrap, which would tend to reduce heat loss from connections and fittings to the buffer vessel (the vessel itself would be insulated).

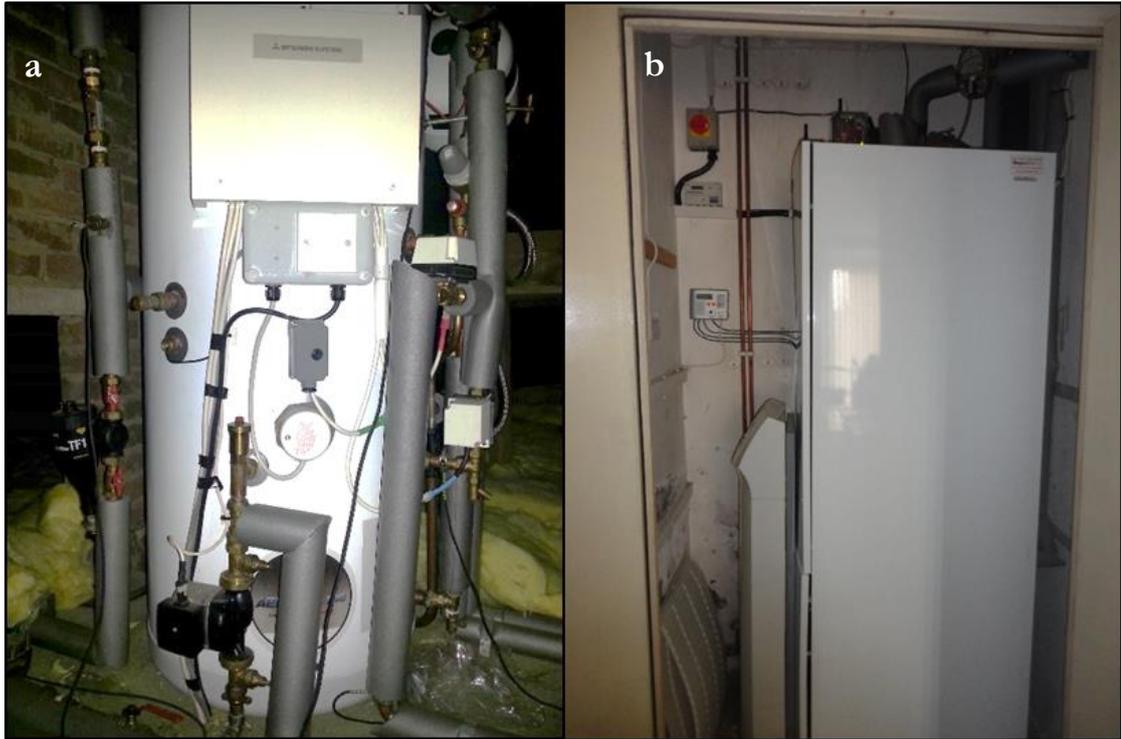
None of the social occupants had access to the flow temperature settings. These were hidden from the user, either by physically placing the controller in a hard to reach area (e.g. narrow cupboard or loft), as shown in Figure 4-13, or by verbally advising them not to interfere with the system.

**Figure 4-13. (a) Controller and hot water vessel in hard-to-reach attic space (CS07), (b) controller and hot water cylinder located in a narrow cupboard with controller facing the wall and thus unreadable (CS04)**

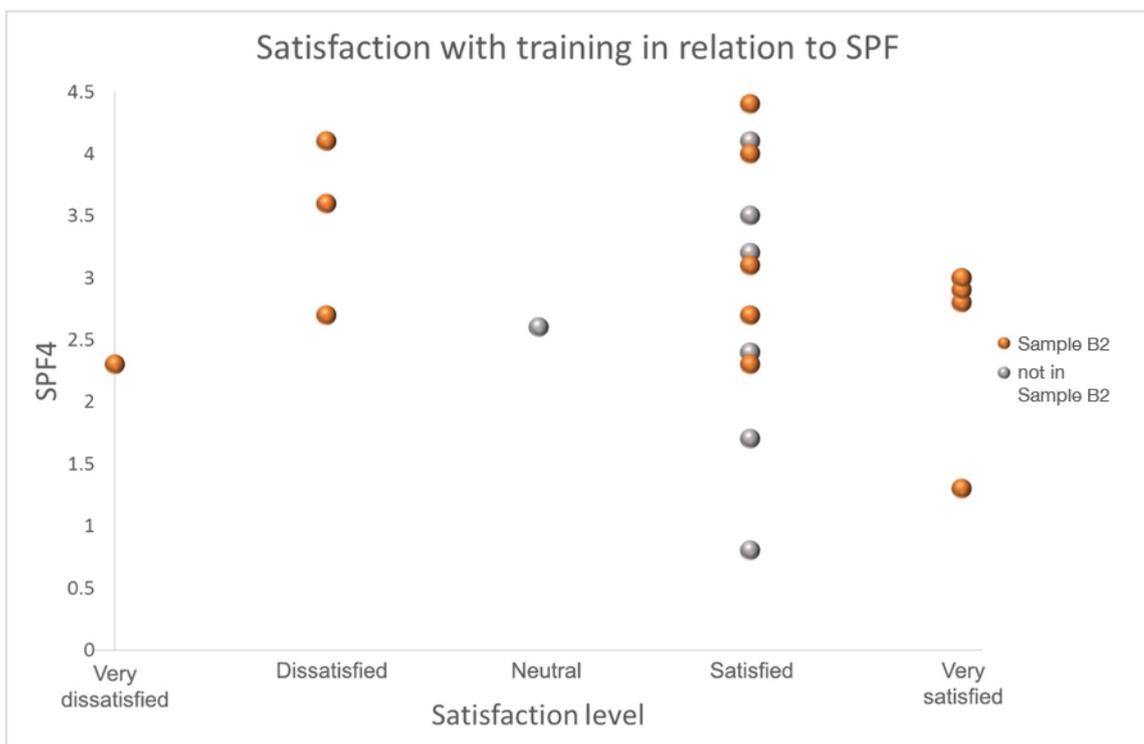
Those satisfied or very satisfied with the training given were all content with the performance of their HP. Thus, even though they found the training and material given too technical and difficult to understand, they never had to use it to solve a major problem. A few, especially those with a technical background, thought it looked complicated at first but they then found their way and learnt to use certain features. Finally, some occupants suggested that a number of post installation visits would be very useful, i.e. once they had familiarised themselves with the system.

**Figure 4-19. Occupants' satisfaction with training presented in relation to SPF4 (representative estimate), based on the reference period SPF's as in Table 4-1.**

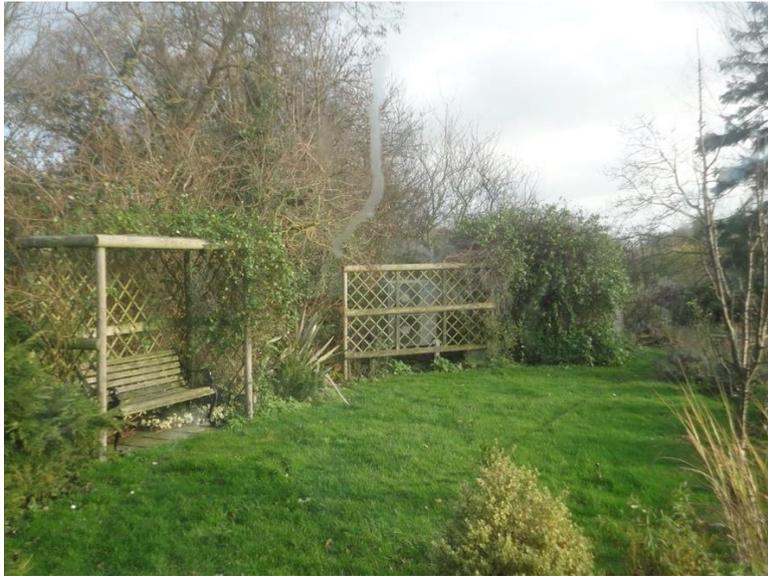
In the case of CS09 the occupant had asked, for aesthetic reasons, that the outdoor unit of their split ASHP system, be moved from the position originally suggested by installer, immediately adjacent to the dwelling, to a new position about 10 metres away (Figure 5-1). This would have increased the heat losses from the pipework that ran from the outdoor unit<sup>39</sup> to the house, and affected system efficiency through two possible mechanisms:

**Figure 5-1. CS09 – External unit behind trellis in corner of garden**

<sup>40</sup> Calculations undertaken shortly before the end of the project indicate that 10m of uninsulated external pipe-runs may reduce SPFs by up to 10% (for example, from 3.0 to 2.7), and potentially more for HPs that cycle frequently.

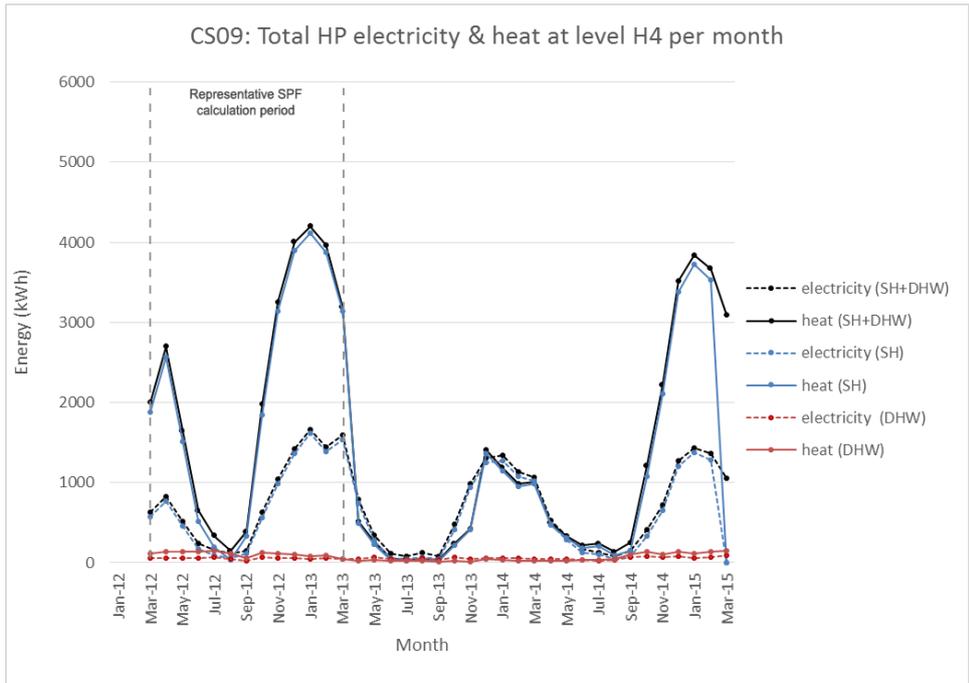
**Figure 5-2. CS09 - Total monthly amount of electricity consumed and heat produced by the HP at level H4, for SH, DHW and both from raw data. Note period between 1/11/2013 and 31/10/2014 has low output compared with other periods.**

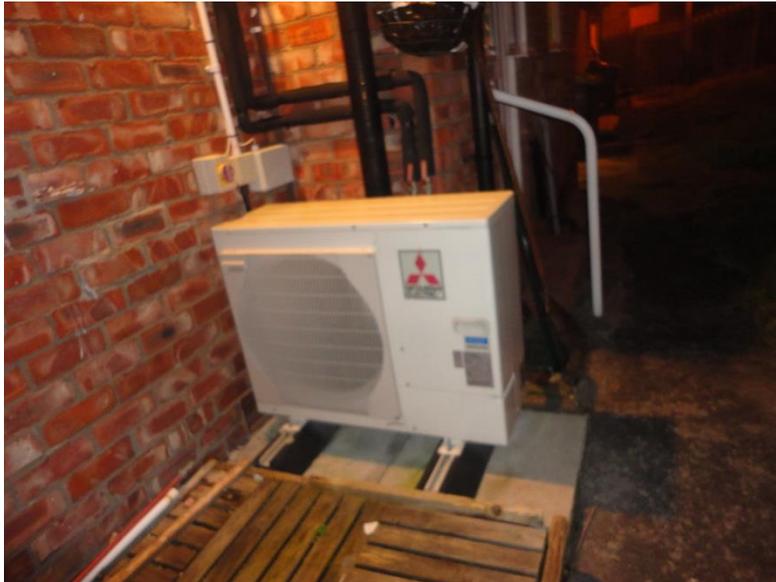
**Figure 5-3. CS07 – External fan unit and installation**

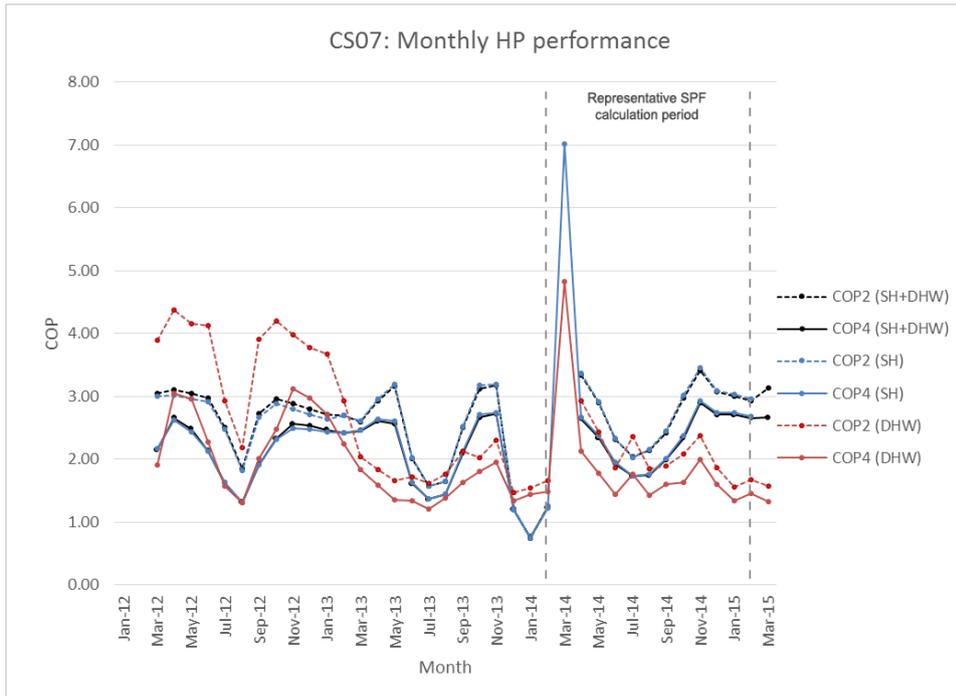
**Figure 5-4. CS07 - Monthly COPs for SH, DHW and combined at levels H2 and H4, showing anomaly in February/March 2013 when the heat pump broke down and was replaced.**

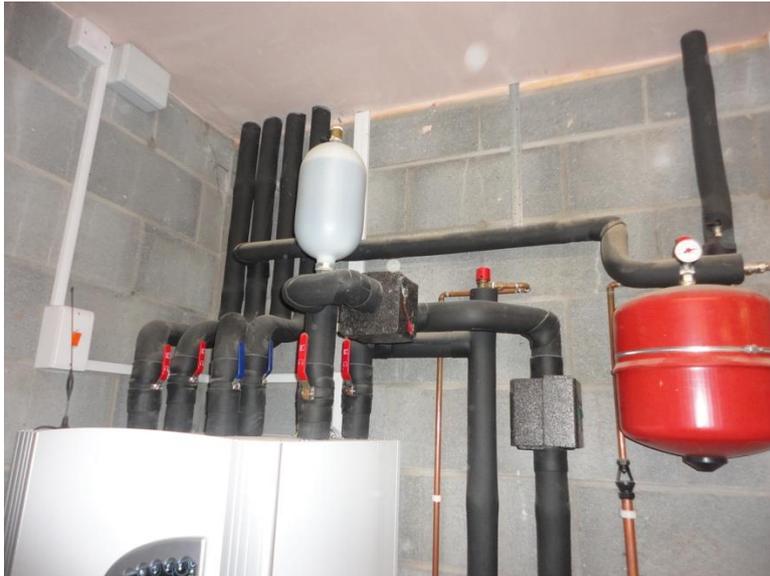
The initial estimate of the SPF for **CS15** (0.6) appeared to challenge the hypothesised connection between pipework insulation and layout and performance. Figure 5-5 shows the system pipework within the unheated attached garage was very competently laid out and insulated.

**Figure 5-5. CS15 – High quality insulation and layout of pipework**

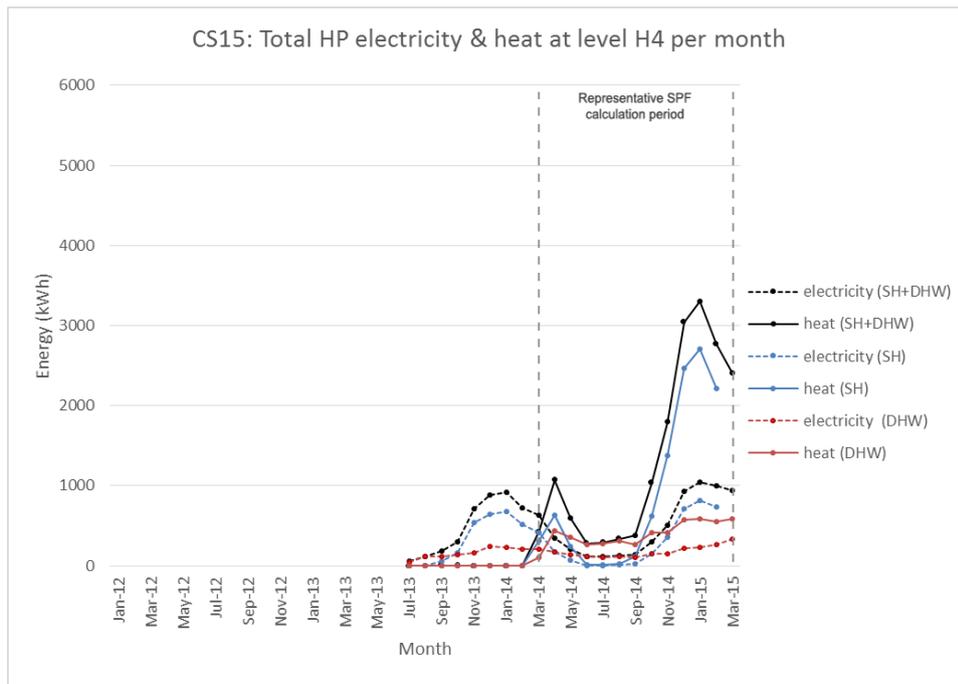
**Figure 5-6. CS15 - Total monthly amount of electricity consumed and heat produced by the HP at level H4, for SH, DHW and both: the effect of incorrectly installed heat meter temperature sensors can be seen in the period between July 2014 and May 2015.**

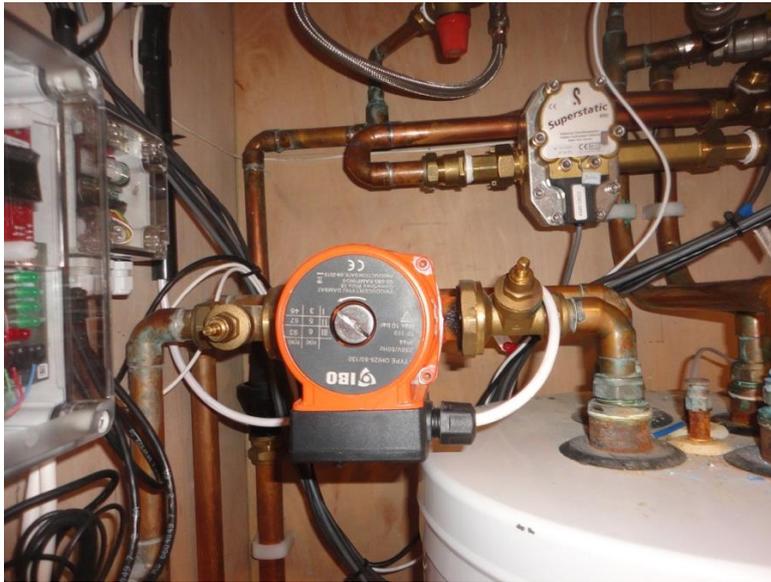
**Figure 5-7. CS12 – Uninsulated pipework associated with the HP**

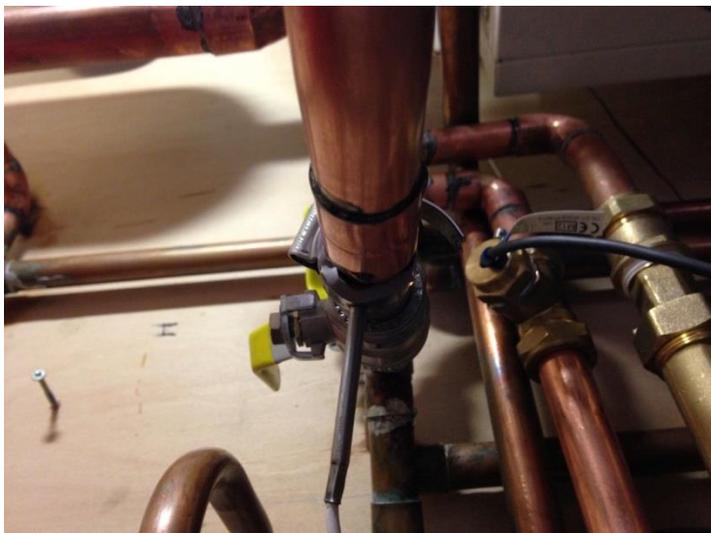
**Figure 5-9. CS12 - Close up of pipework showing insulation between temperature sensor and pipe (centre of image). The external temperature sensor for the heat meter can also be seen, just right of centre, in a pocket**

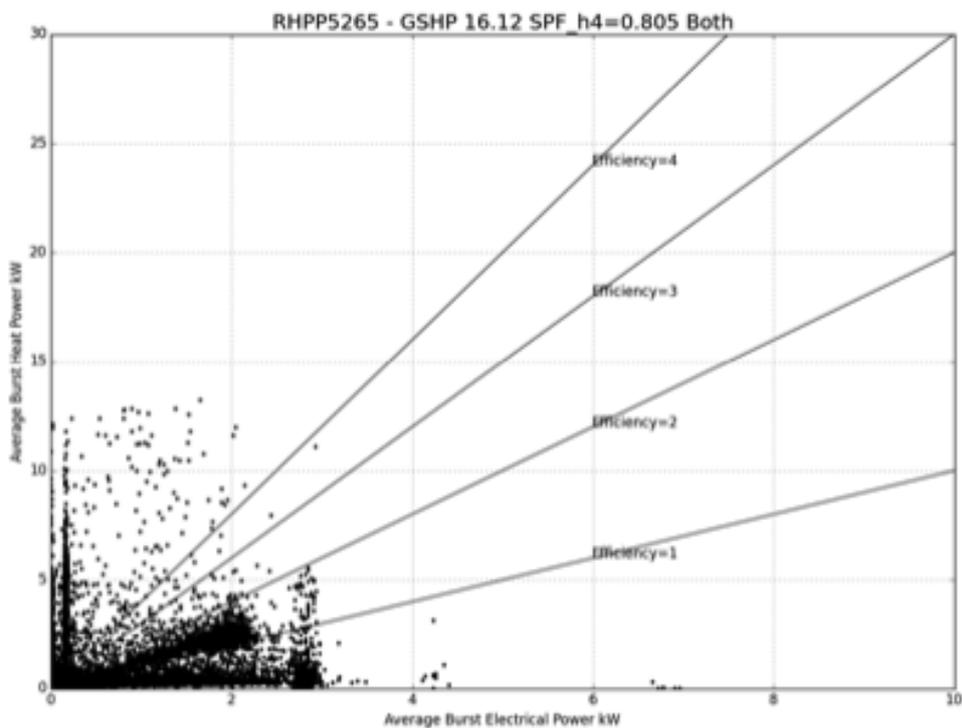
**Figure 5-10. CS12 – Average burst electricity power and average heat power**

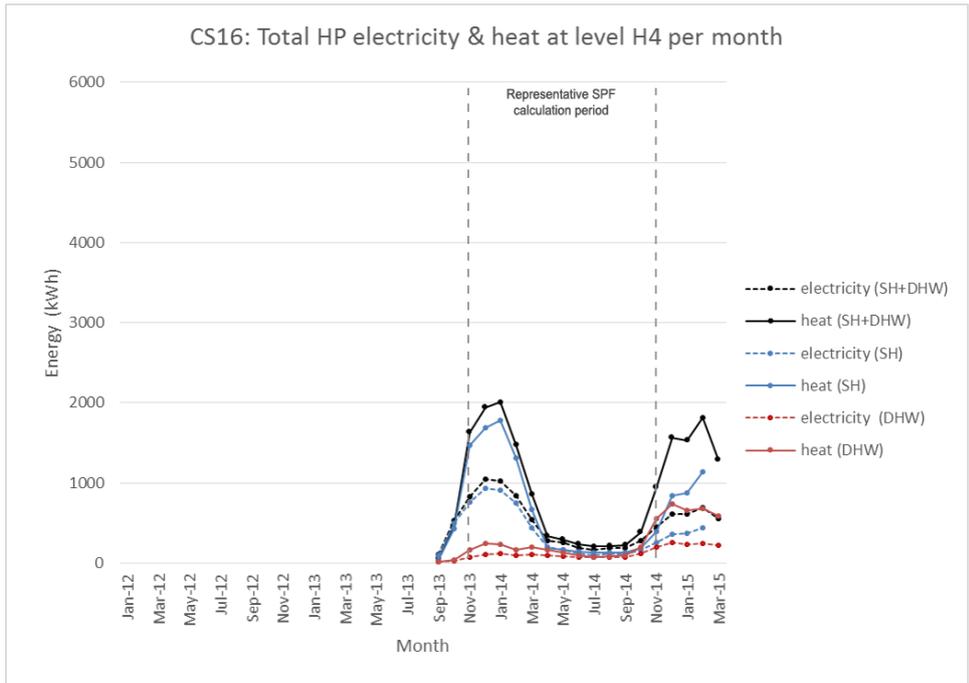
**Figure 5-11. CS16 - Total monthly amount of electricity consumed and heat produced by the HP at level H4, for SH, DHW and both**

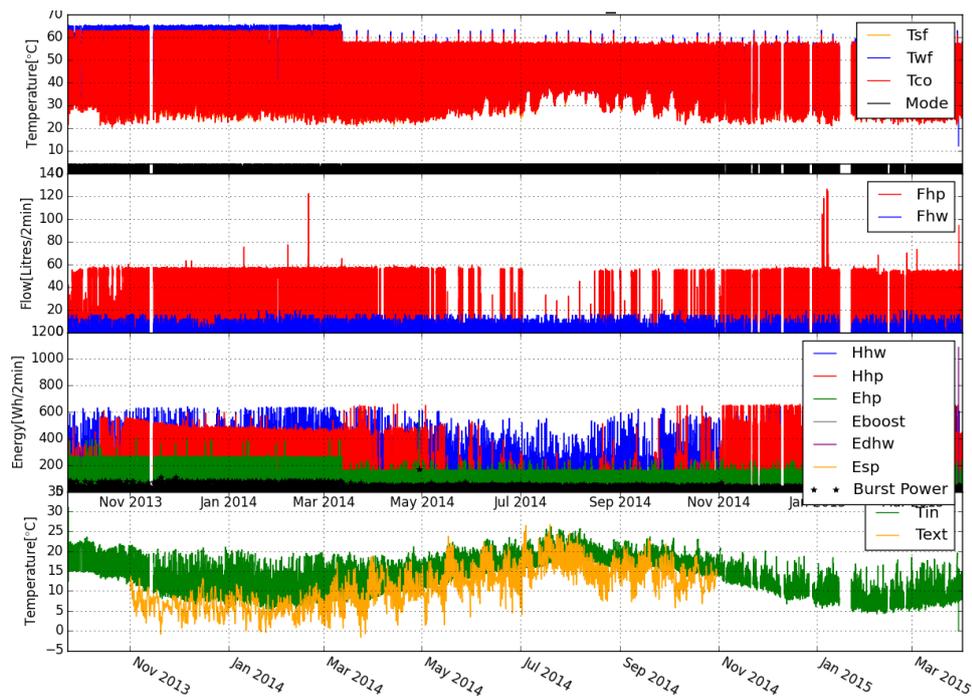
**Figure 5-12. CS16 - Intermediate frequency plots of monitoring data**

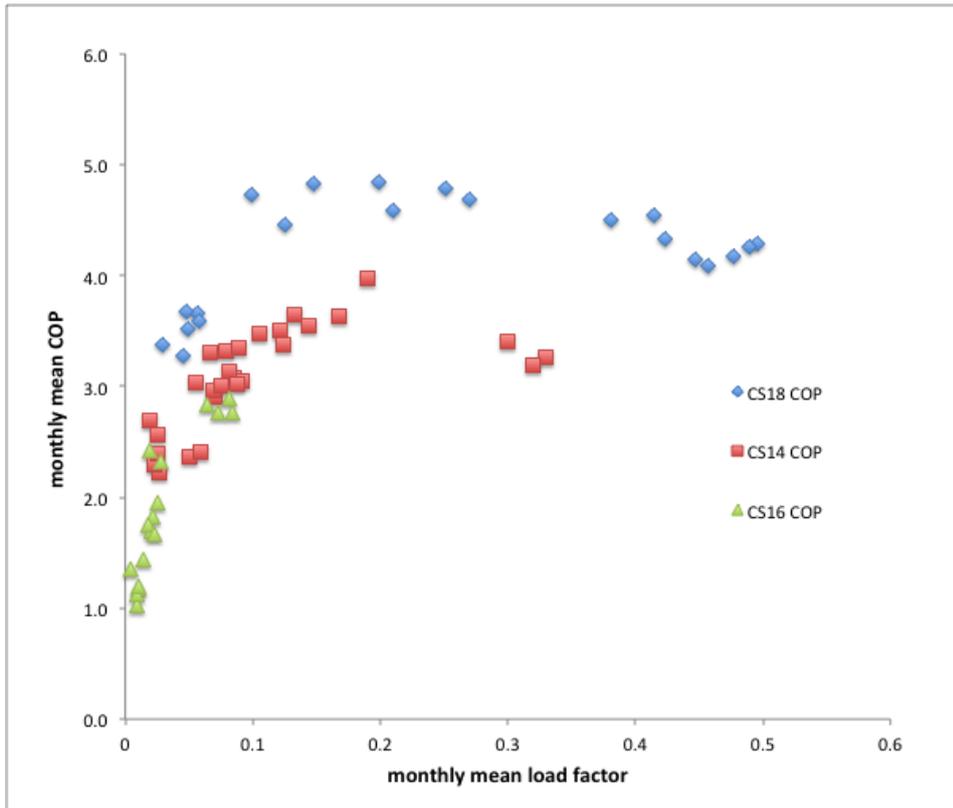
**Figure 5-13. CS14, CS16 and CS18 - Monthly mean COP versus monthly mean heat load factor. Graphic indicates that at low mean monthly load factor, monthly mean COP is correspondingly low. Data for CS14 and CS18 appear to show a reduction in monthly mean COP at high load factors. This is possibly associated with the onset of resistance heating.**

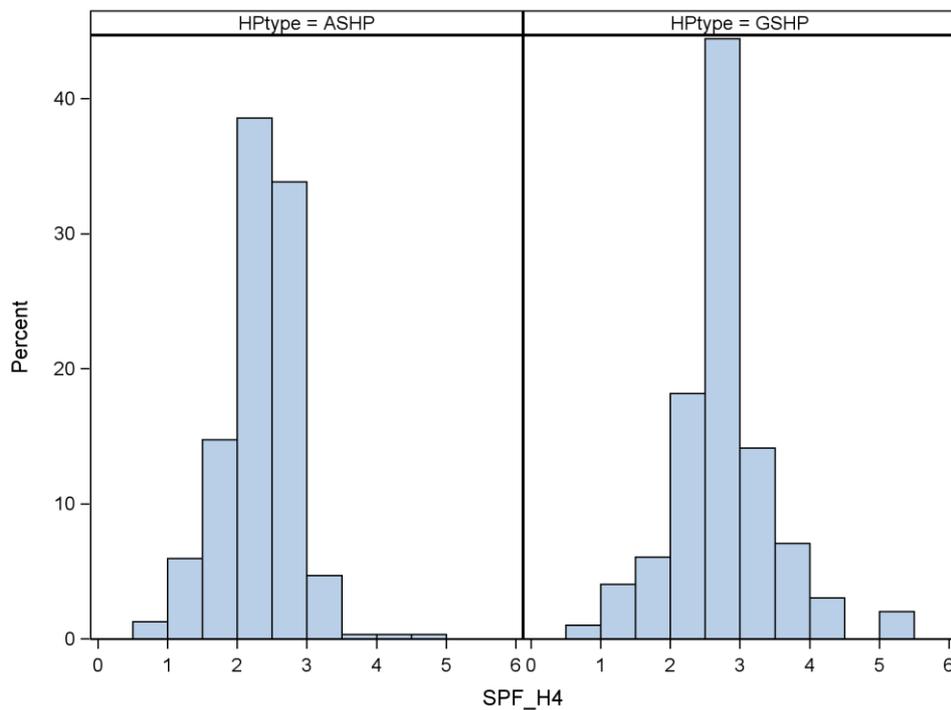
**Figure 5-14. Histogram of SPF4 for ASHPs and GSHPs in Sample B2, as defined in the *RHPP Performance Variations Report*.**

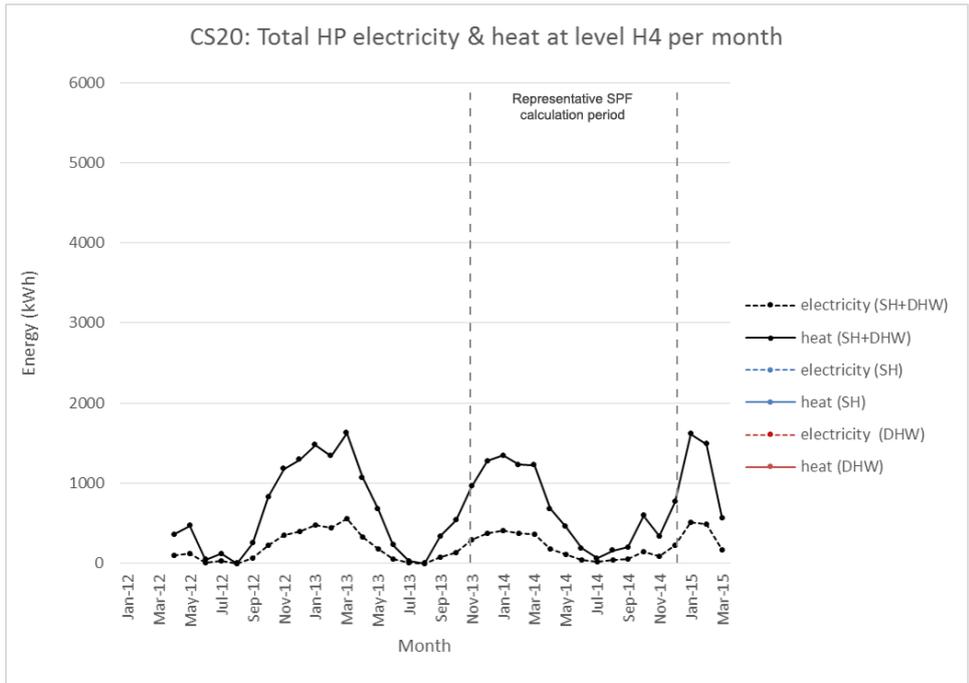
**Figure 5-17. CS20 - Total monthly amount of electricity consumed and heat produced by the HP at level H4, for SH, DHW and both. Note the absence of data for water heating**

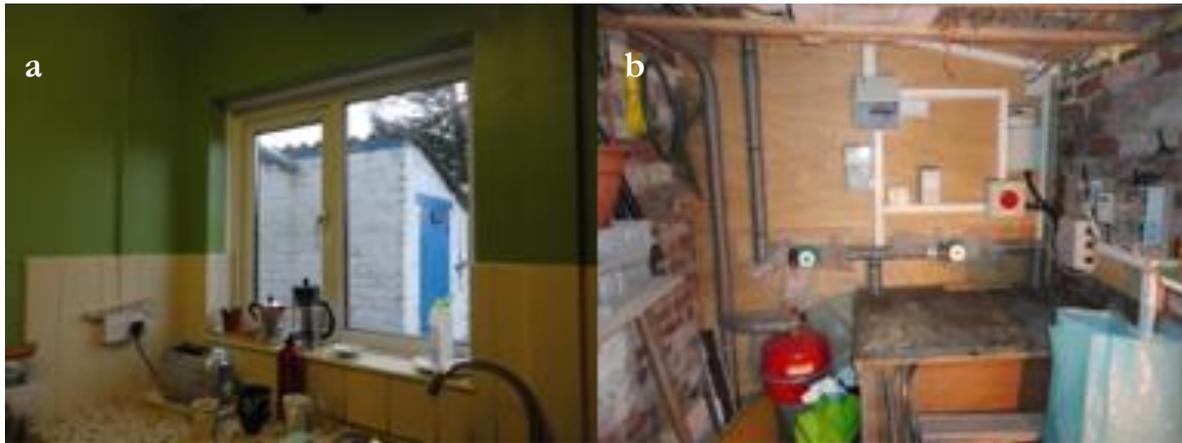
**Figure 5-18. CS20 - (a) View from the kitchen to out-house and (b) installation of buffer vessels and pipework in out-house**

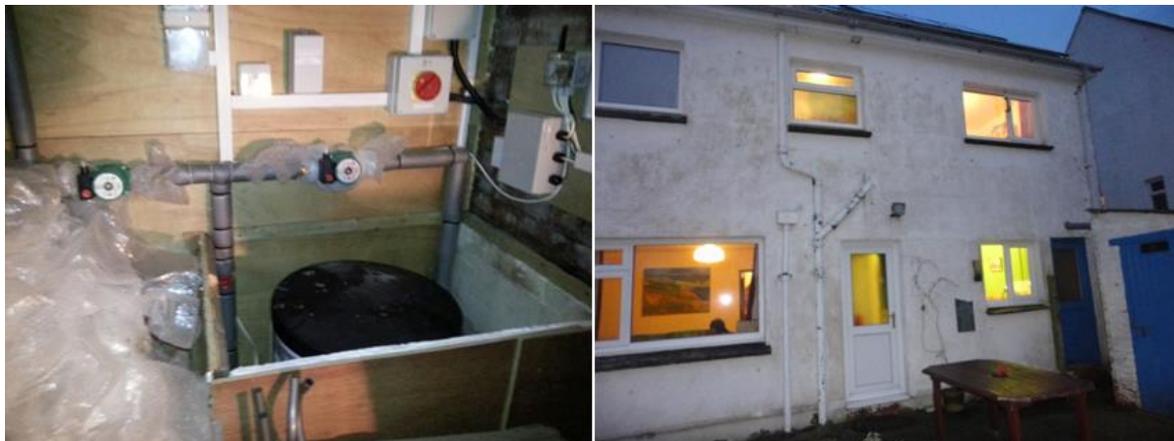
**Figure 5-19. CS20 - (a) Buffer tank (with additional bubblewrap to act as insulation) and circulation pumps in unheated shed and (b) location of the shed, to the right of blue door**

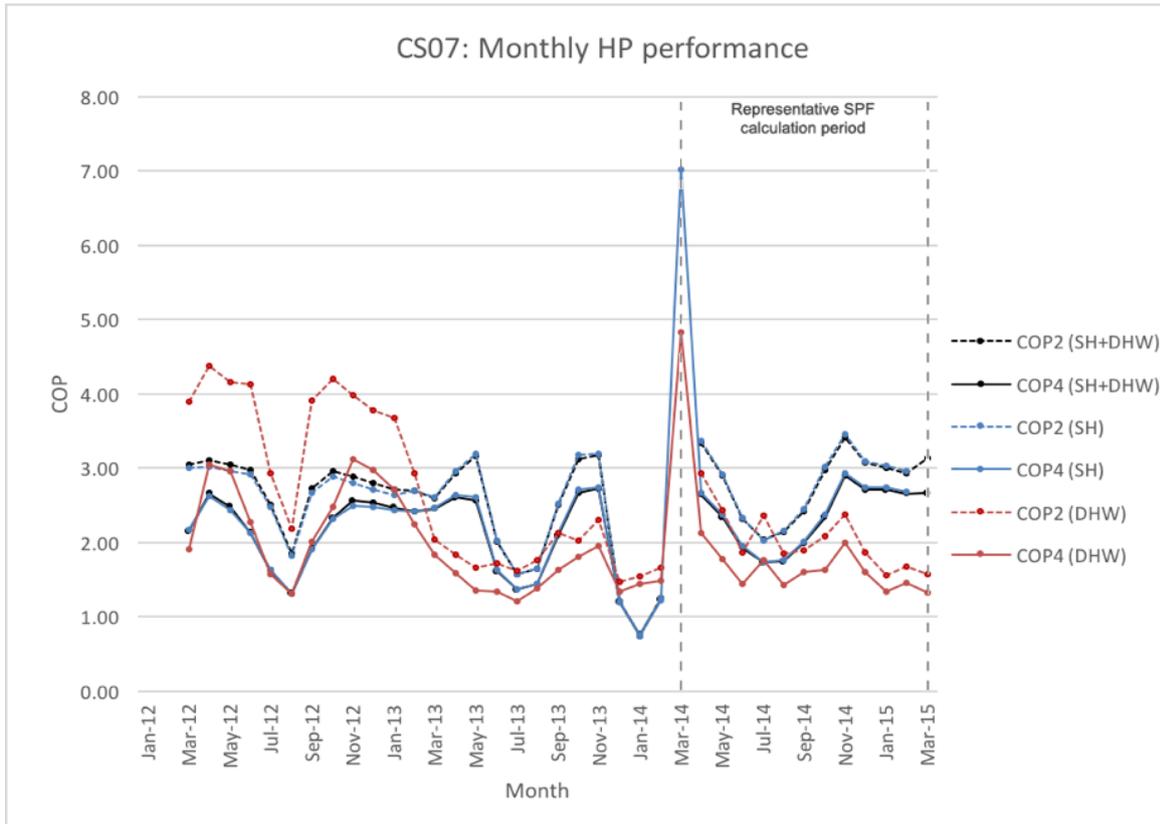
Figure D 13. Monthly COPs for SH, DHW and combined at levels H2 and H4 (CS07)
