## FISHING ACCIDENT REPORT

### CREW FALL INTO FISH HOLD

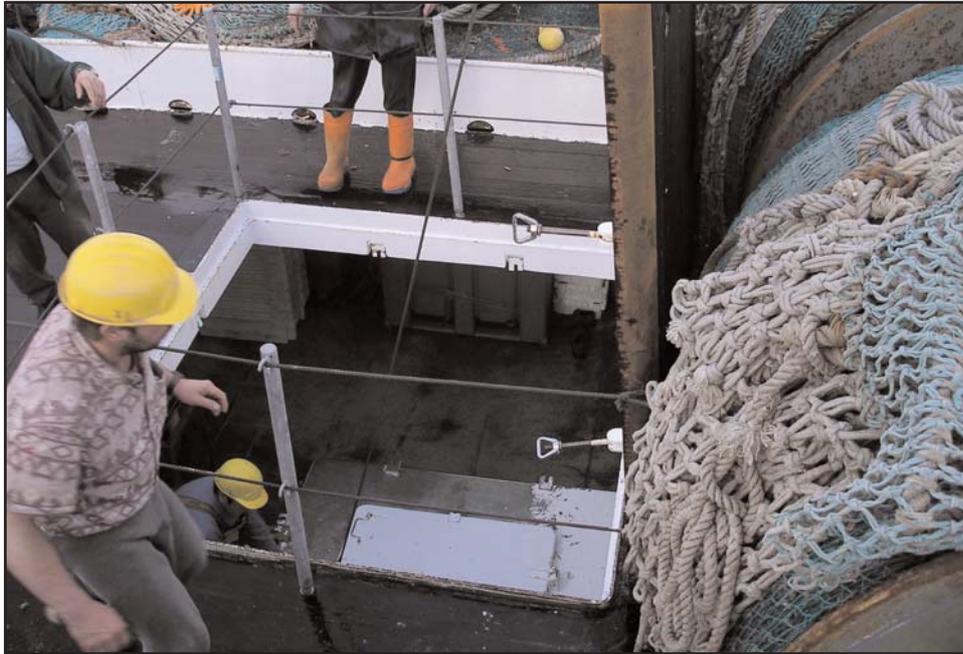
Using jury-rigged lifting gear on board a 35m trawler, two deckhands were being lifted out of the fish hold when they slipped and fell back down a distance of more than 4m. Both of the deckhands were taken to hospital with serious injuries.

The trawler had just finished landing her catch when the accident happened. Although the vessel had a hydraulic crane, with which to land the catch, the crew thought it was too slow. To speed up landing operations, the crew made up their own rigging, arrangement for lowering and lifting the catch in and out of the hold.

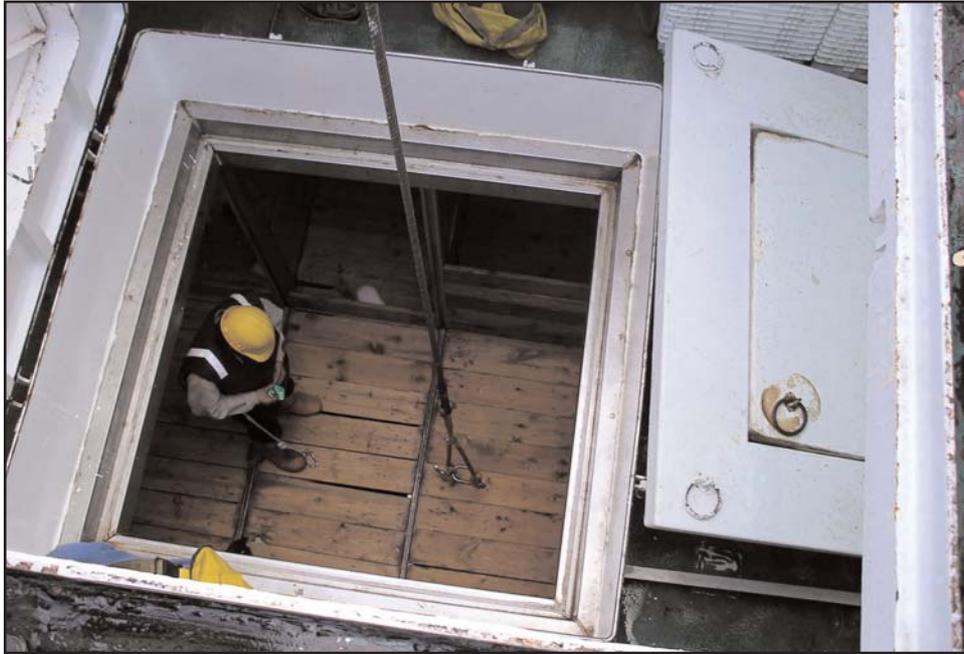
Access to the fish hold was by means of a portable ladder, but the crew rarely used it, as it was heavy and cumbersome and stowed some distance away from the fish hold hatch. Normally, the crew climbed in and out of the hold, but on this occasion, the last two deckhands chose to use the lifting gear. They clipped the fish box lifting hooks together to make a stirrup into which they each placed a foot. They then shouted up to the main deck to hoist. The winchman heard the shouts to lift and began lifting. When the two deckhands were level with the main deck, their feet slipped from the stirrup and they fell back into the fish hold. One of the deckhand's fall was broken on the way down and he was able to get out of the fish hold by himself. The other deckhand fell straight to the bottom of the fish hold and, when the other crew reached him, he was found unconscious. The deckhands were taken to hospital where they were kept for 4 days.

The obvious cause of this accident was the misuse of the lifting gear. Dangerous misuse of various equipment on fishing vessels is not uncommon and in many cases can be attributed to a macho image some fishermen wish to portray. Skippers of fishing vessels should ensure that their crew use the correct equipment provided for any task onboard. If the equipment proves impractical bring it to the skipper's/ owner's attention so that something can be done about it.

Designing a fish hold with only one means of access on a vessel of this size must be questioned. While loading or unloading a catch, access in or out of the hold is restricted. To ventilate such a space quickly, or exit it in an emergency, two means of access are necessary, as detailed in the guidance proposed for vessels over 25 metres.

In 2005, the Merchant Shipping and Fishing Vessel (Lifting Operations and Lifting Equipment) Regulations, known as LOLER, will come into force. The regulations will require the lifting gear to be marked with its safe working load and will ban the use of lifting gear to hoist crew members, the consequences of which have been shown in this case.

- The skipper had not intervened to stop the unsafe practice of hoisting deckhands out of the hold by the lifting gear.
- The portable ladder, which provided access to the fish hold was heavy and difficult to deploy. It could have been replaced with a lighter one.
- The fish hold hatch was not roped off, which would have prevented anyone from accidentally falling into it.
