## SAFETY FLYER TO THE FISHING INDUSTRY

Creel boat, *Varuna* (BRD 684), fatal man overboard, 20 November 2017

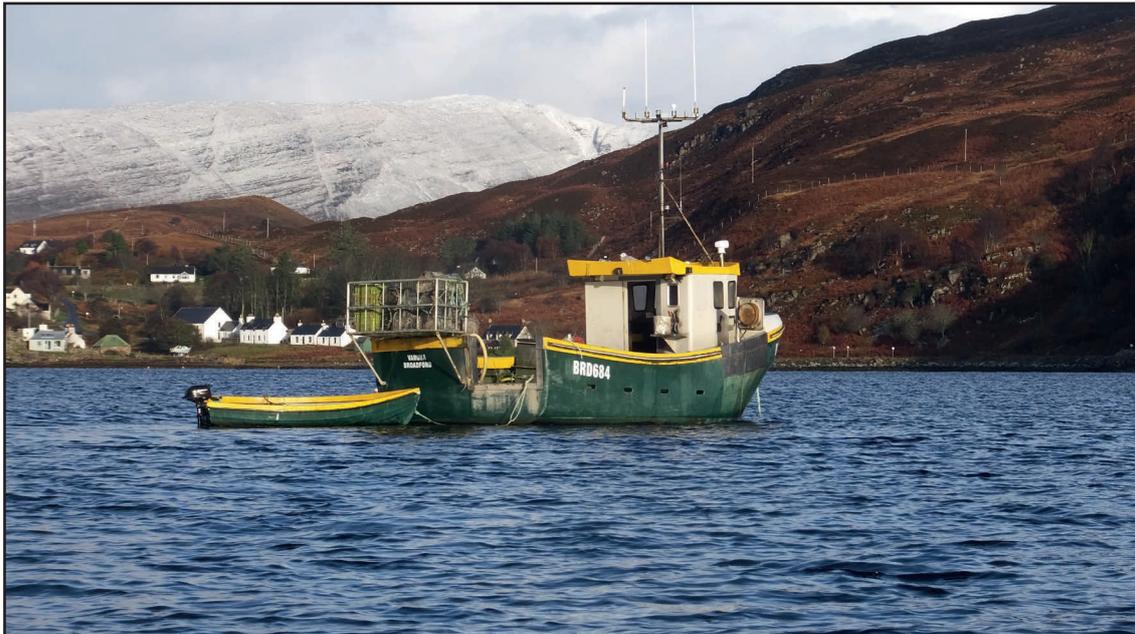
At about 1415 UTC<sup>1</sup> on 20 November 2017, the single-handed creel boat *Varuna* was found aground and unmanned on Eilean nan Naomh, a small island to the west of Camusterrach on the north-west coast of Scotland.

The vessel's engine was running and continuing to drive the boat on to the shore, and the shooting gate in the transom was open.

1. The water temperature was 9°C, and as *Varuna's* owner/skipper was not wearing a PFD his chances of survival after entering the water were slim. The first effect of falling into water of that temperature would have been massively debilitating cold shock. Thereafter, the owner/skipper would have quickly lost the ability to swim and tread water as cold incapacitation impaired his strength and coordination. Given the speed with which a search was commenced, had he been wearing a PFD when he entered the water it is very possible that he would have survived this accident.

2. The risks involved in single-handed fishing are inherently greater than on boats with more crew as the lone fisher has to rely entirely on their own resources to resolve any situation. Even a simple slip or fall can have tragic consequences when there is no-one else nearby to lend a hand. When *Varuna's* skipper went over the side, no-one was around to raise the alarm or turn the vessel back to rescue him. As recommended in the Fishermen's Safety Guide, *a risk assessment here is essential because once all the risks have been identified, solutions can be applied*. In most cases, risk control measures are easy to adopt and are relatively inexpensive. In this instance, closing-off the shooting gate when not in use might have prevented the accident and, as above, wearing a PFD while working on deck but also carrying a Personal Locator Beacon would have substantially increased the owner/skipper's chances of survival once he did enter the water.
