Rose Decommissioning Close-Out Report

Document ID:		CEU-PRJ-SNS0057-REP-0030	
Document Classification:		PUBLIC	
Document Ownership:		Decommissioning	
Date of Document:	20/07/16	Signature	Date
Prepared by:	R. Taylor	 	25/7/18
Reviewed by:	S. Axon

This document contains the close-out report for the two Rose Decommissioning Programmes (DP) approved by the Secretary of State on the 29 May 2015, one for each set of notices under section 29 of the Petroleum Act 1998:

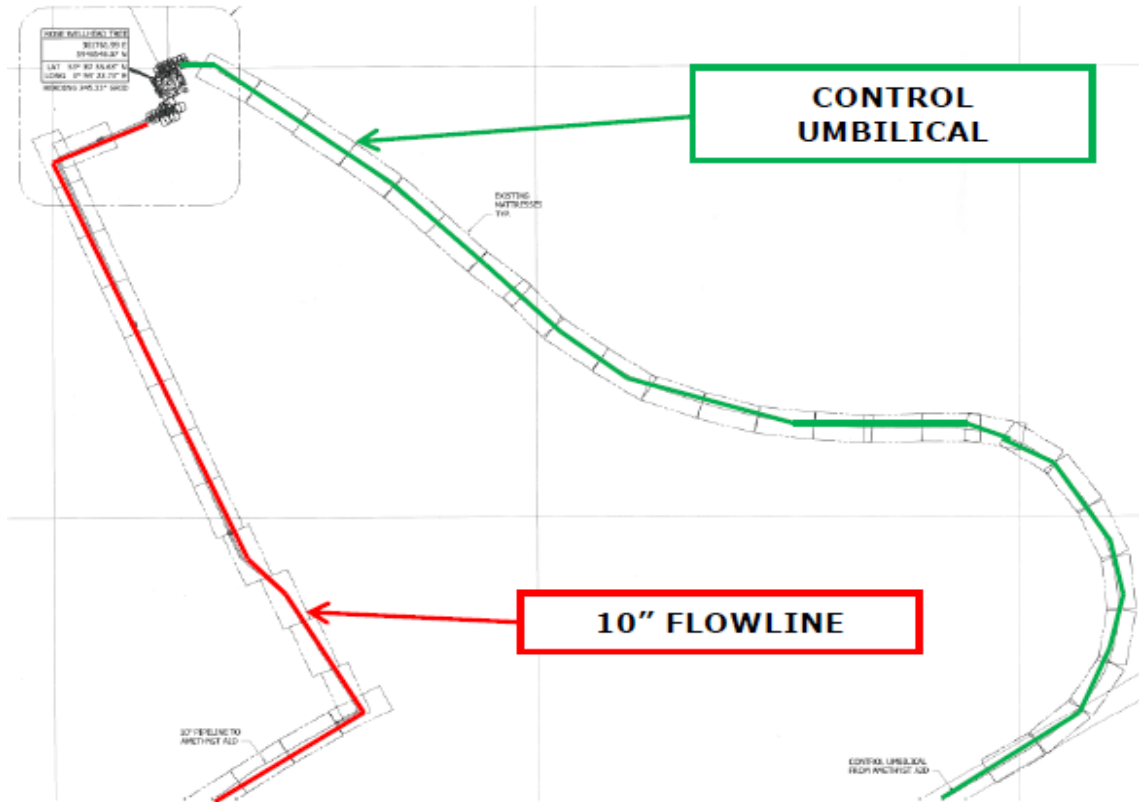
Figure 4.4.1: Mattress locations on Rose well approaches

Prior to the removal of mattresses by the Seven Pacific, an ROV survey was carried out to confirm the condition and number of mattresses to be removed at the former Rose well site and the Amethyst A2D Platform.

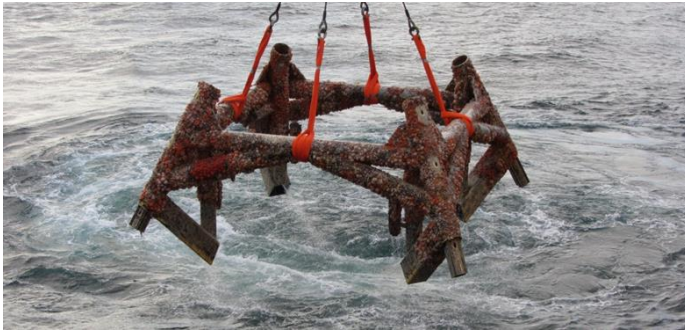
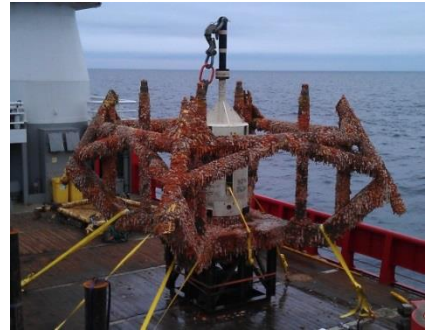
Figure 9.1.1: Rose WHPS - recovery & on deck

The WHPS (Figure 9.1.1) and top canopy (Figure 9.1.2) were recovered using the DSV. The following pictures show the WHPS and WHPS canopy lying on the deck of the Seven Pelican DSV.

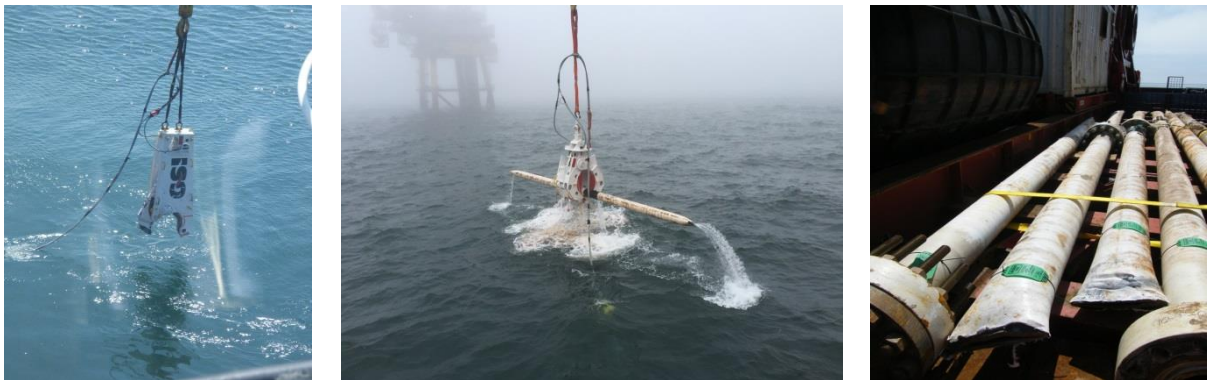
Figure 9.3.1: Pipeline section cut, recovered using grab, and stored on deck

The pipespools were recovered to the deck of the Seven Pacific ROVSV using the hydraulic grab and then secured Figure 9.3.1.

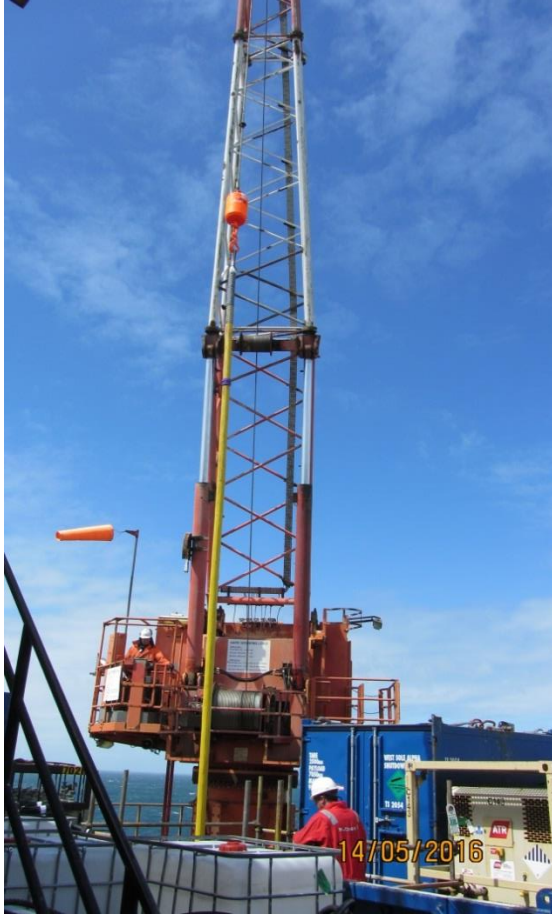
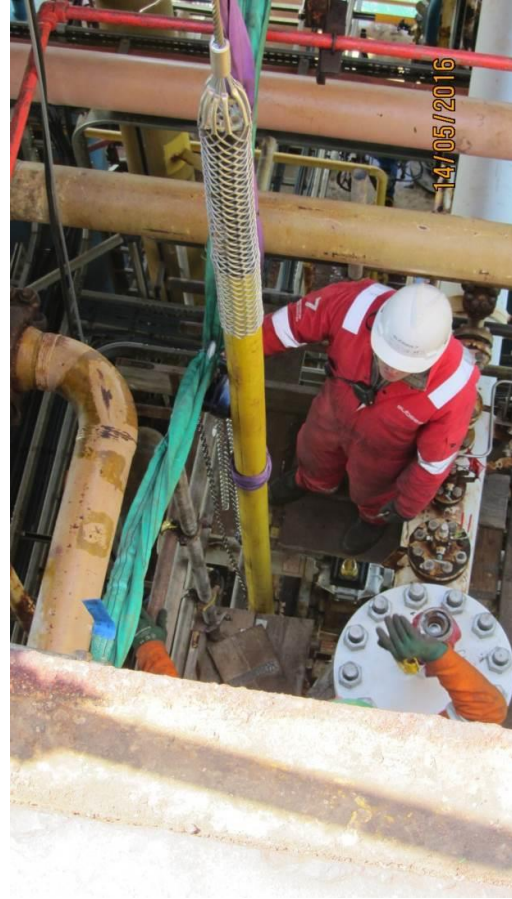
Figure 9.4.1: Umbilical lifted through J-tube using A2D platform crane

The umbilical was cut at the bottom of the J-tube by divers deployed by the Seven Pelican DSV before the severed section was lifted out through the top of the J-tube using the platform crane (Figure 9.4.1).

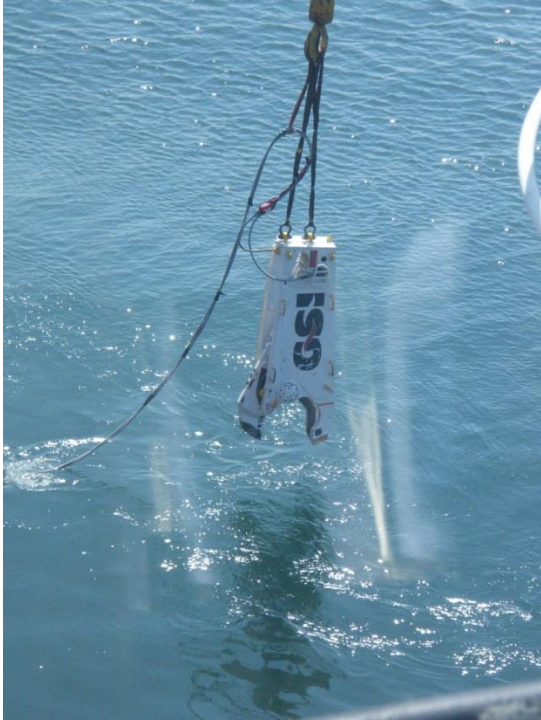
Figure 9.4.2: Shear cutter

- Pipeline and umbilical cutting: We found it effective to use hydraulic shears for cutting the pipeline, pipespools and umbilical rather than using diamond wire cutters;

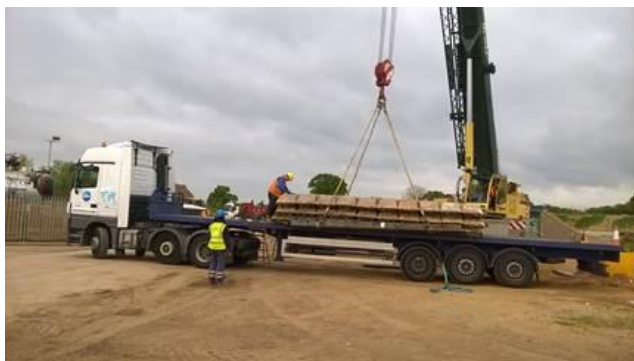
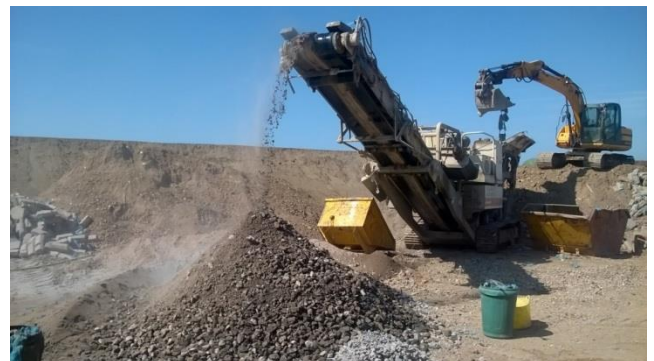
Figure 9.5.1: Concrete mattresses finally crushed and recycled

The concrete mattresses were finally crushed and recycled (Figure 9.5.1).

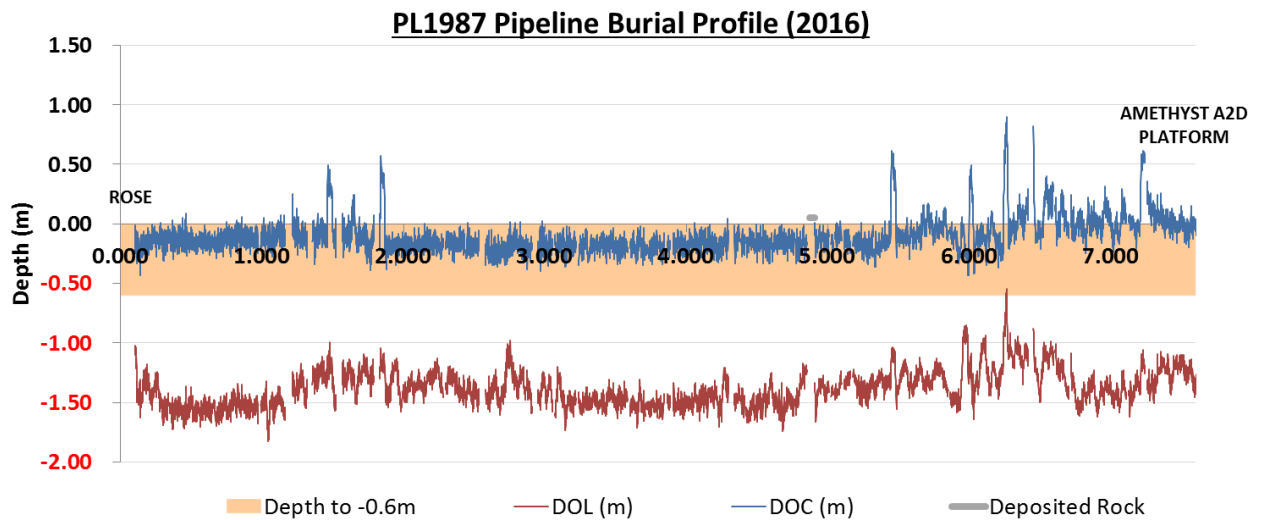
Figure B.1.1: PL1987 Burial Profile (2016)²

² Gaps in a burial profile graph can arise in cases where the pipe-tracker is unable to track the umbilical or pipeline reliably. Typically, a pipe-tracker will move along just above the seabed, and its ability to track can be hampered usually if the pipeline or umbilical is too deep or if there's not enough material (steel) within the umbilical to allow a signal to be reflected-back to the tracker. Given the general profile of the umbilical we believe that they remain stable in those areas where no tracking data were recorded.
