# Crashworthiness

Railway Accident Investigation Seminar 2018

Dominique Louis, Inspector RAIB

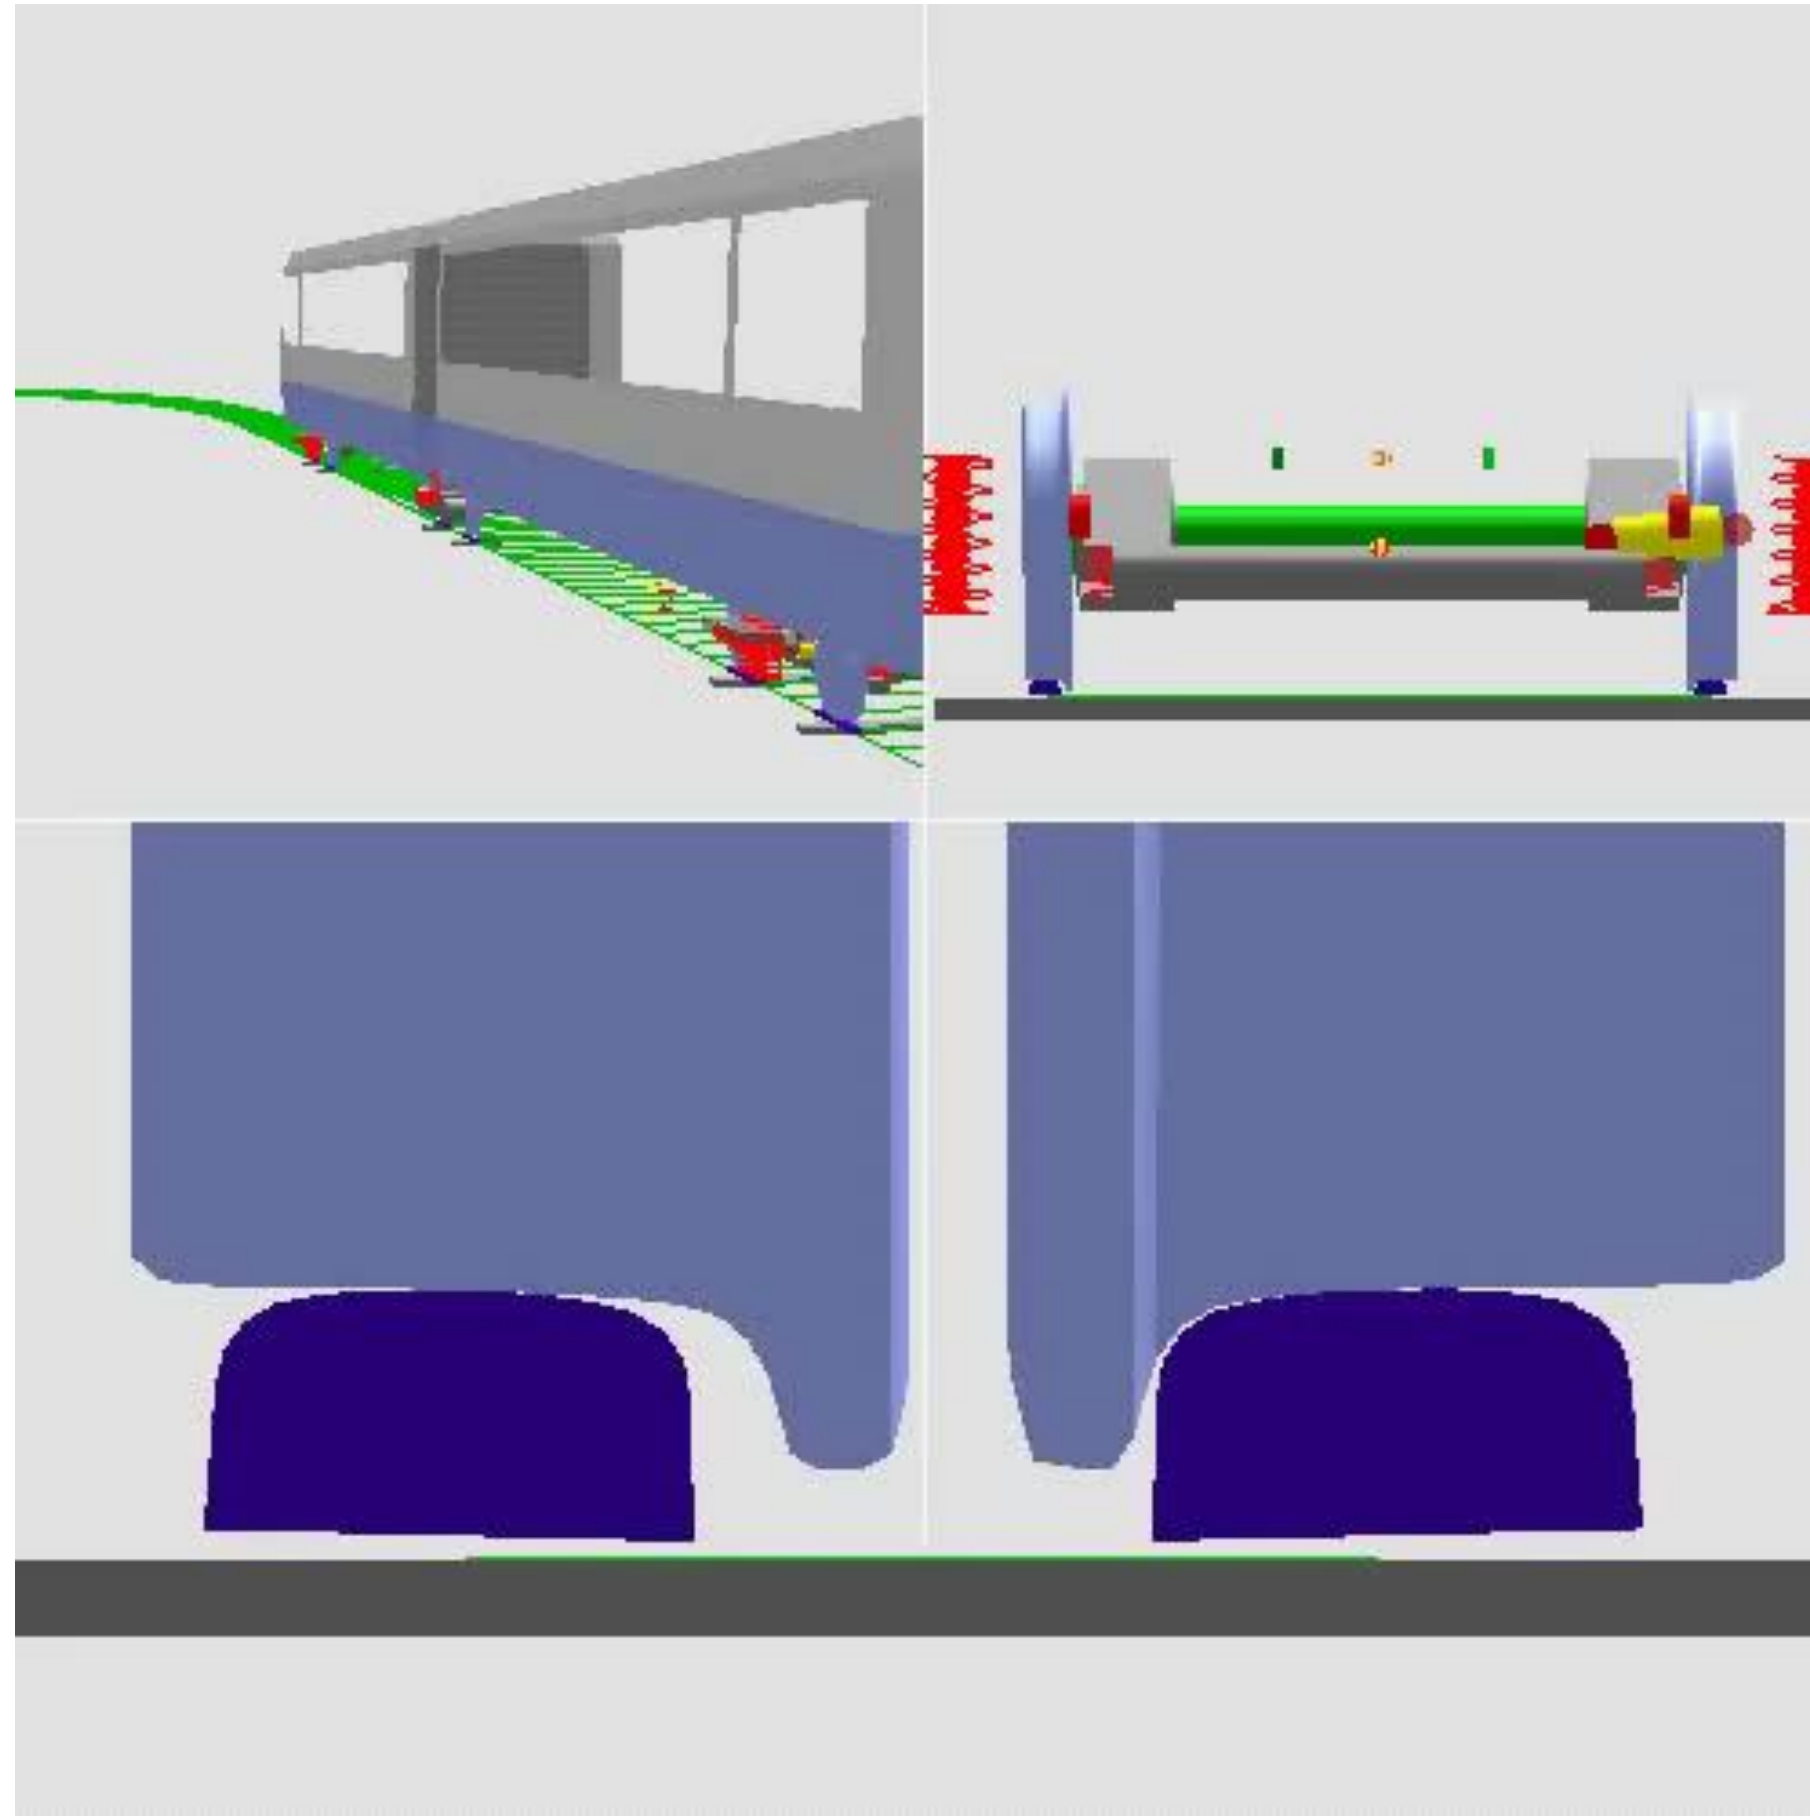
# Derailment simulation

- ▶ To understand severity, one needs to understand the sequence of events
- ▶ At Sandilands, the sequence of events was divided into two phases
  - ▶ Up to point of derailment: Bombardier Transportation simulation
  - ▶ Beyond point of derailment: visual representation using computer model
    - ▶ Bombardier's derailment simulation
    - ▶ External examination of tram identifying contact marks
    - ▶ Site evidence (eg: POD, OLE dropper contact, location cabinet, marker lights, paint marks, etc)
    - ▶ Physical model to test hypothesis
    - ▶ Computer model to represent the output

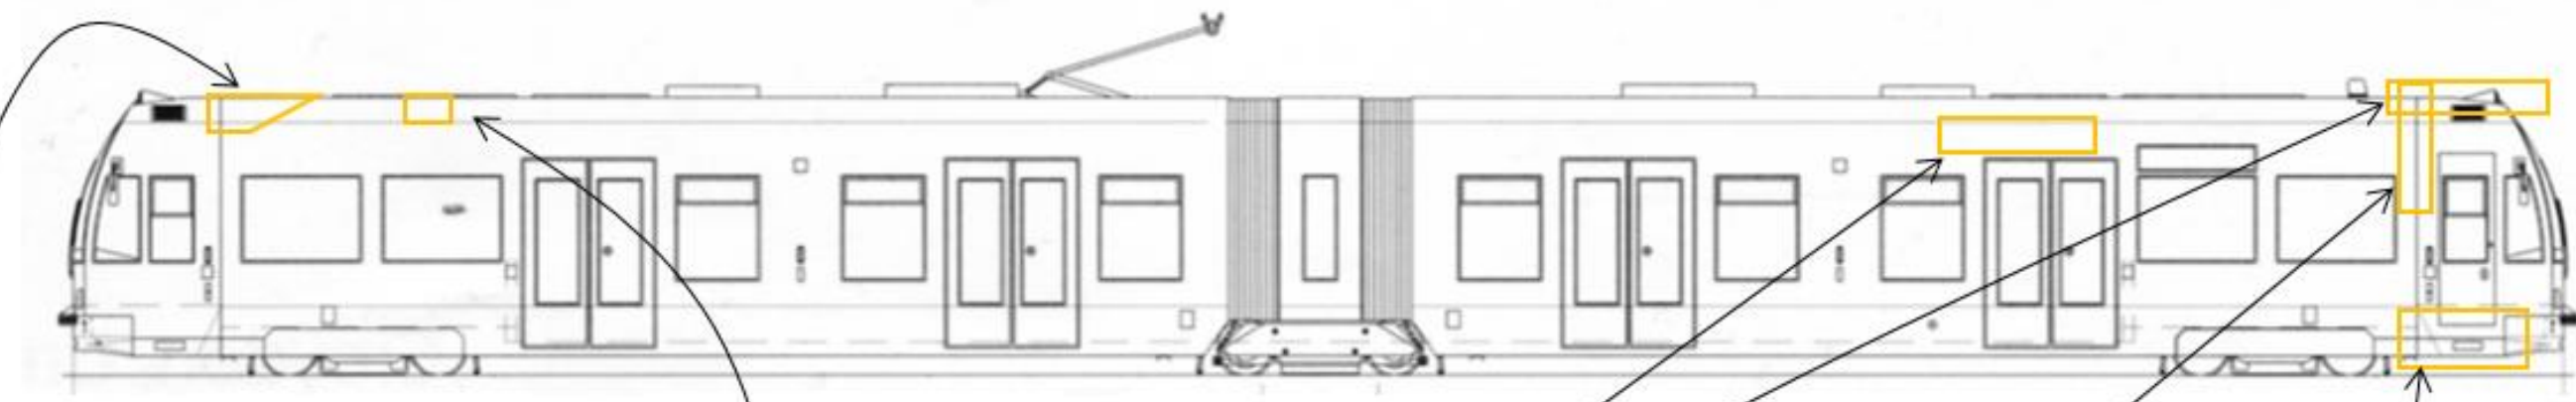
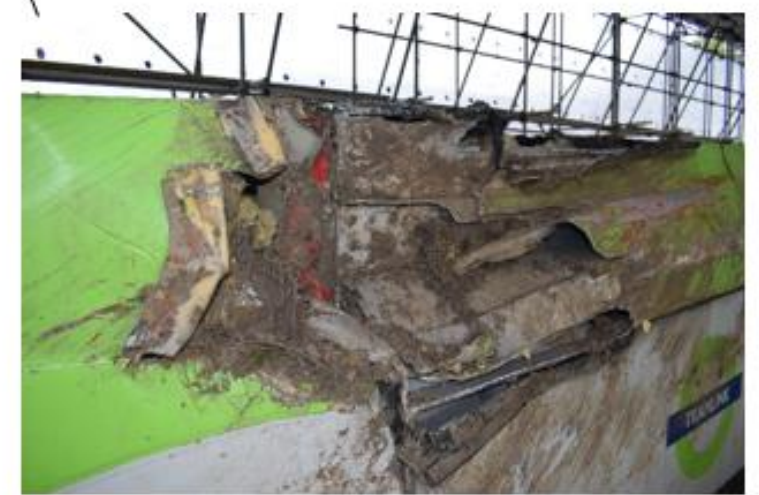
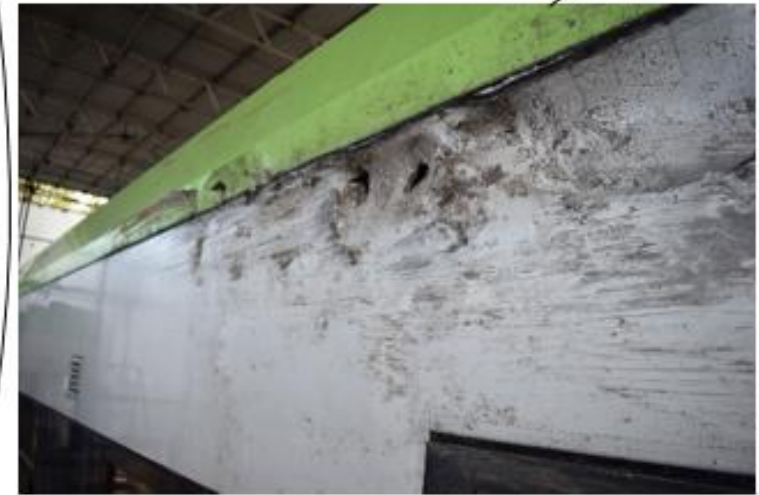
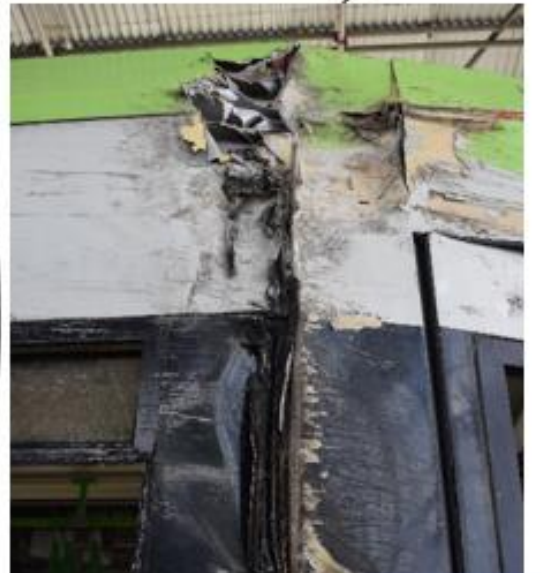
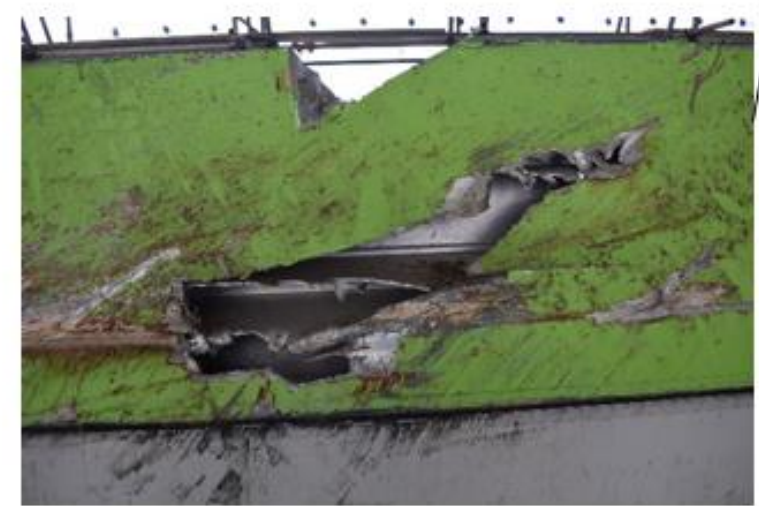
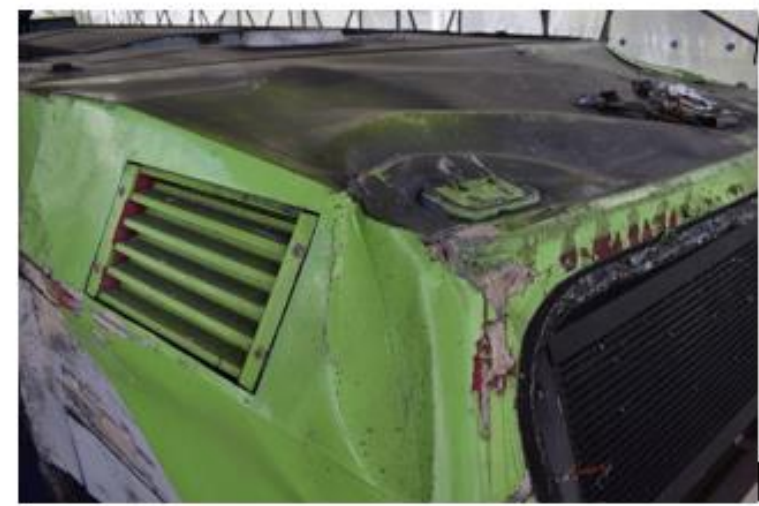
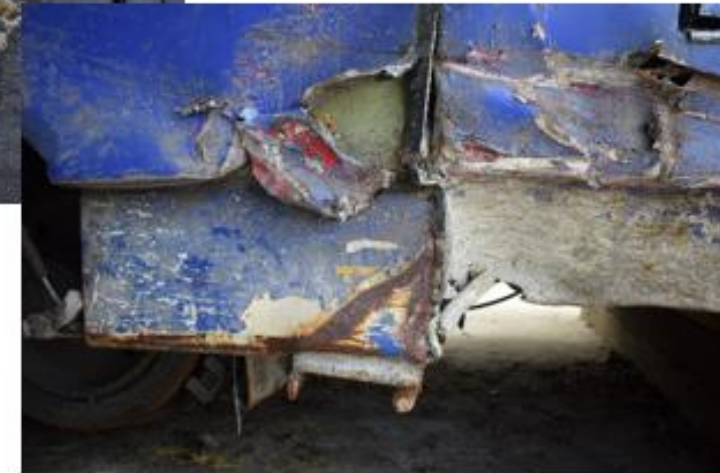
# Exterior examination - Example

**Damage to body structure (not glazing or doors and not scrape marks)**

Outer skin pierced/noteworthy damage

Tram examination shows no gross deformation of bodyshell

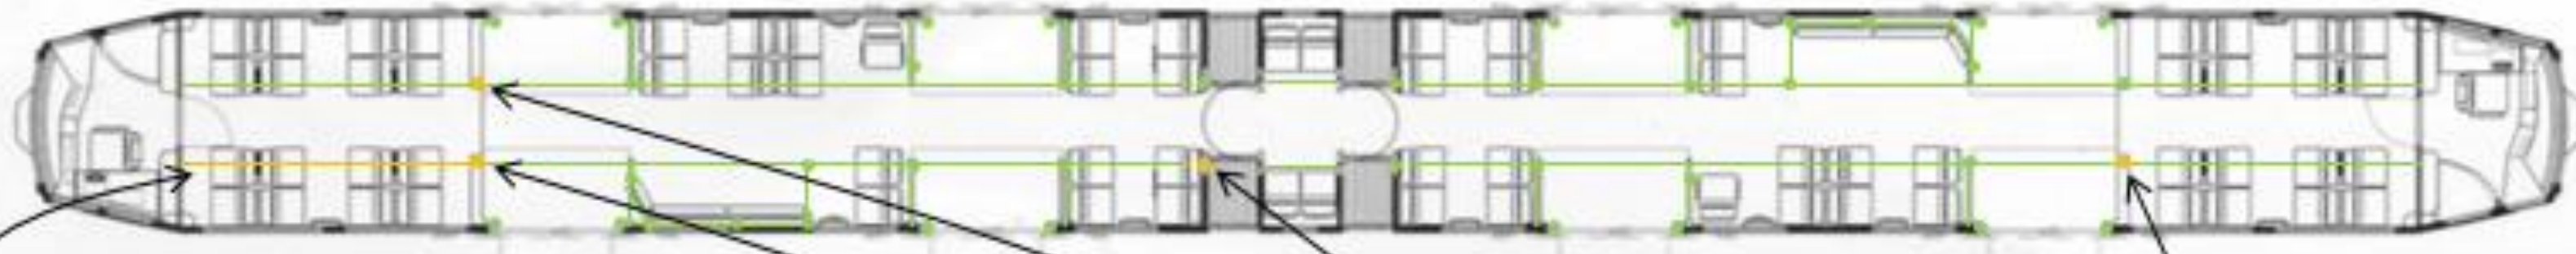
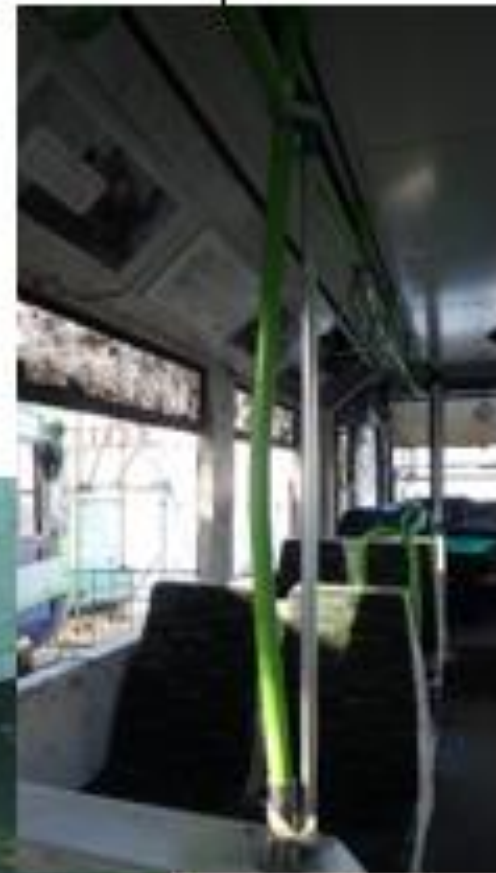
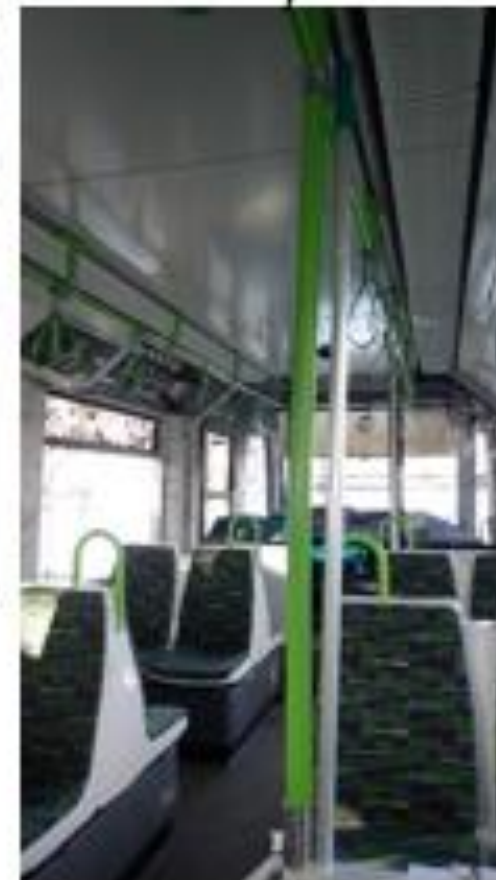
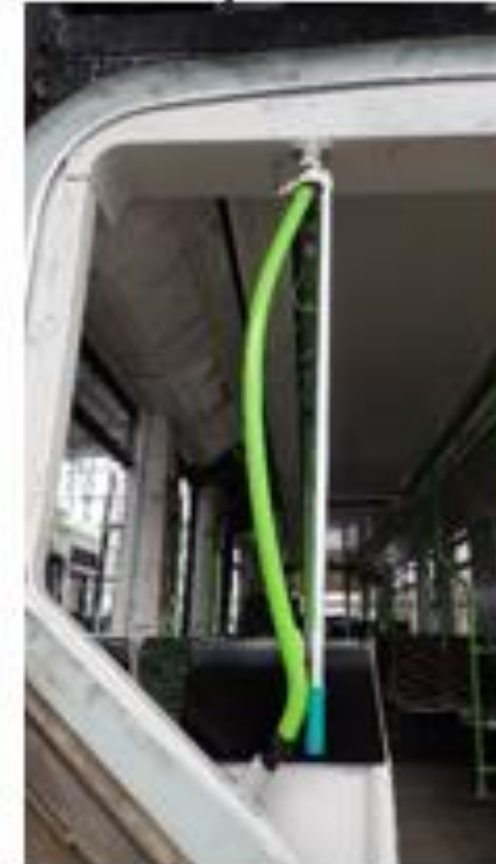
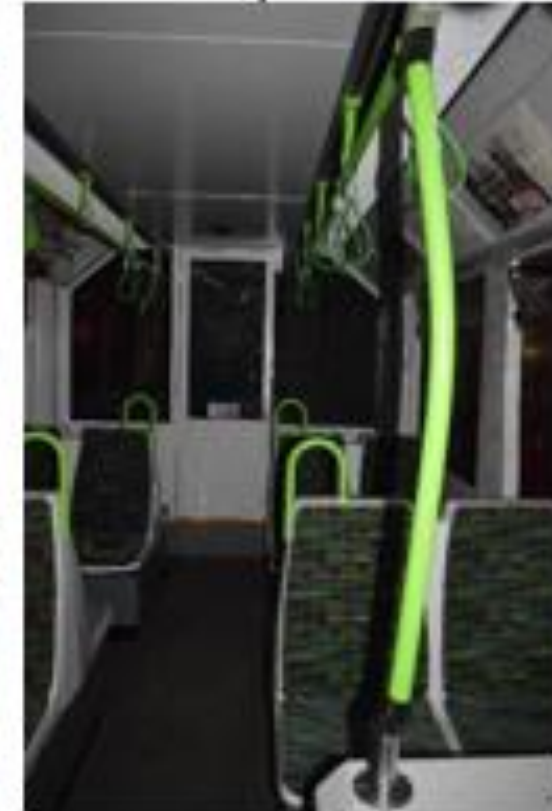
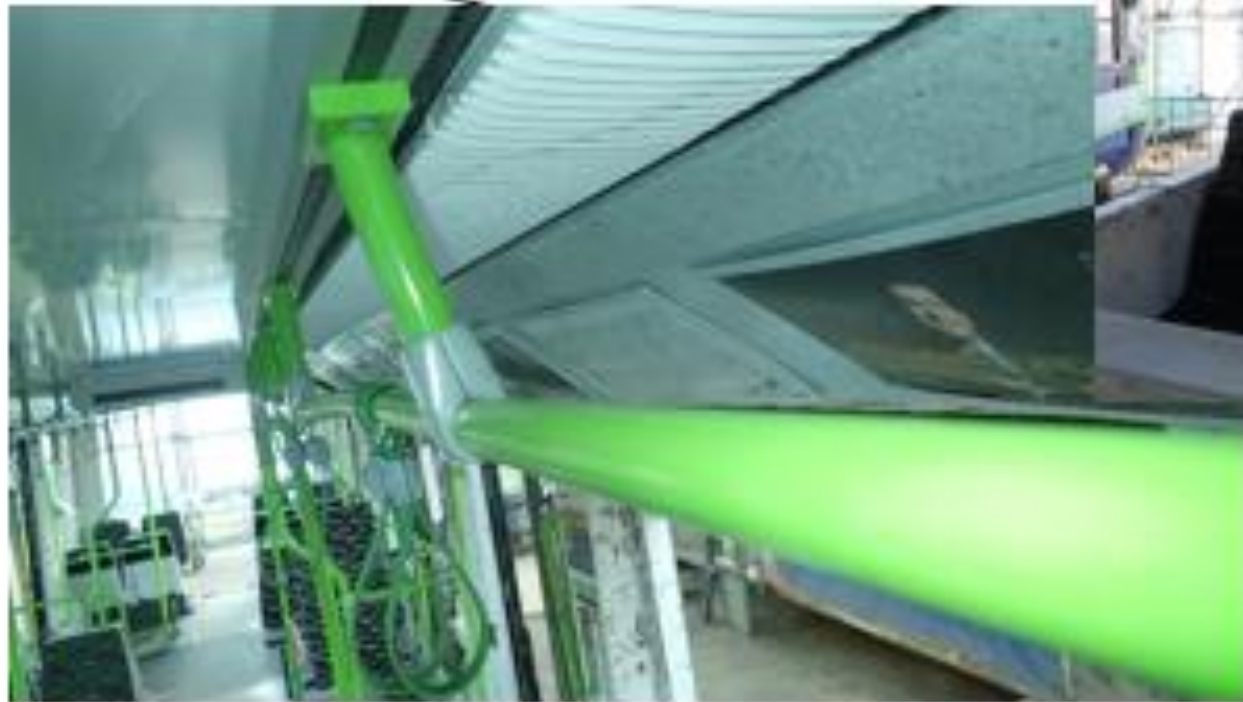
# Interior Examination - Example

- Legend:
- Grabpole detached during accident (none)
  - Grabpole deformed during accident
  - Grabpole intact

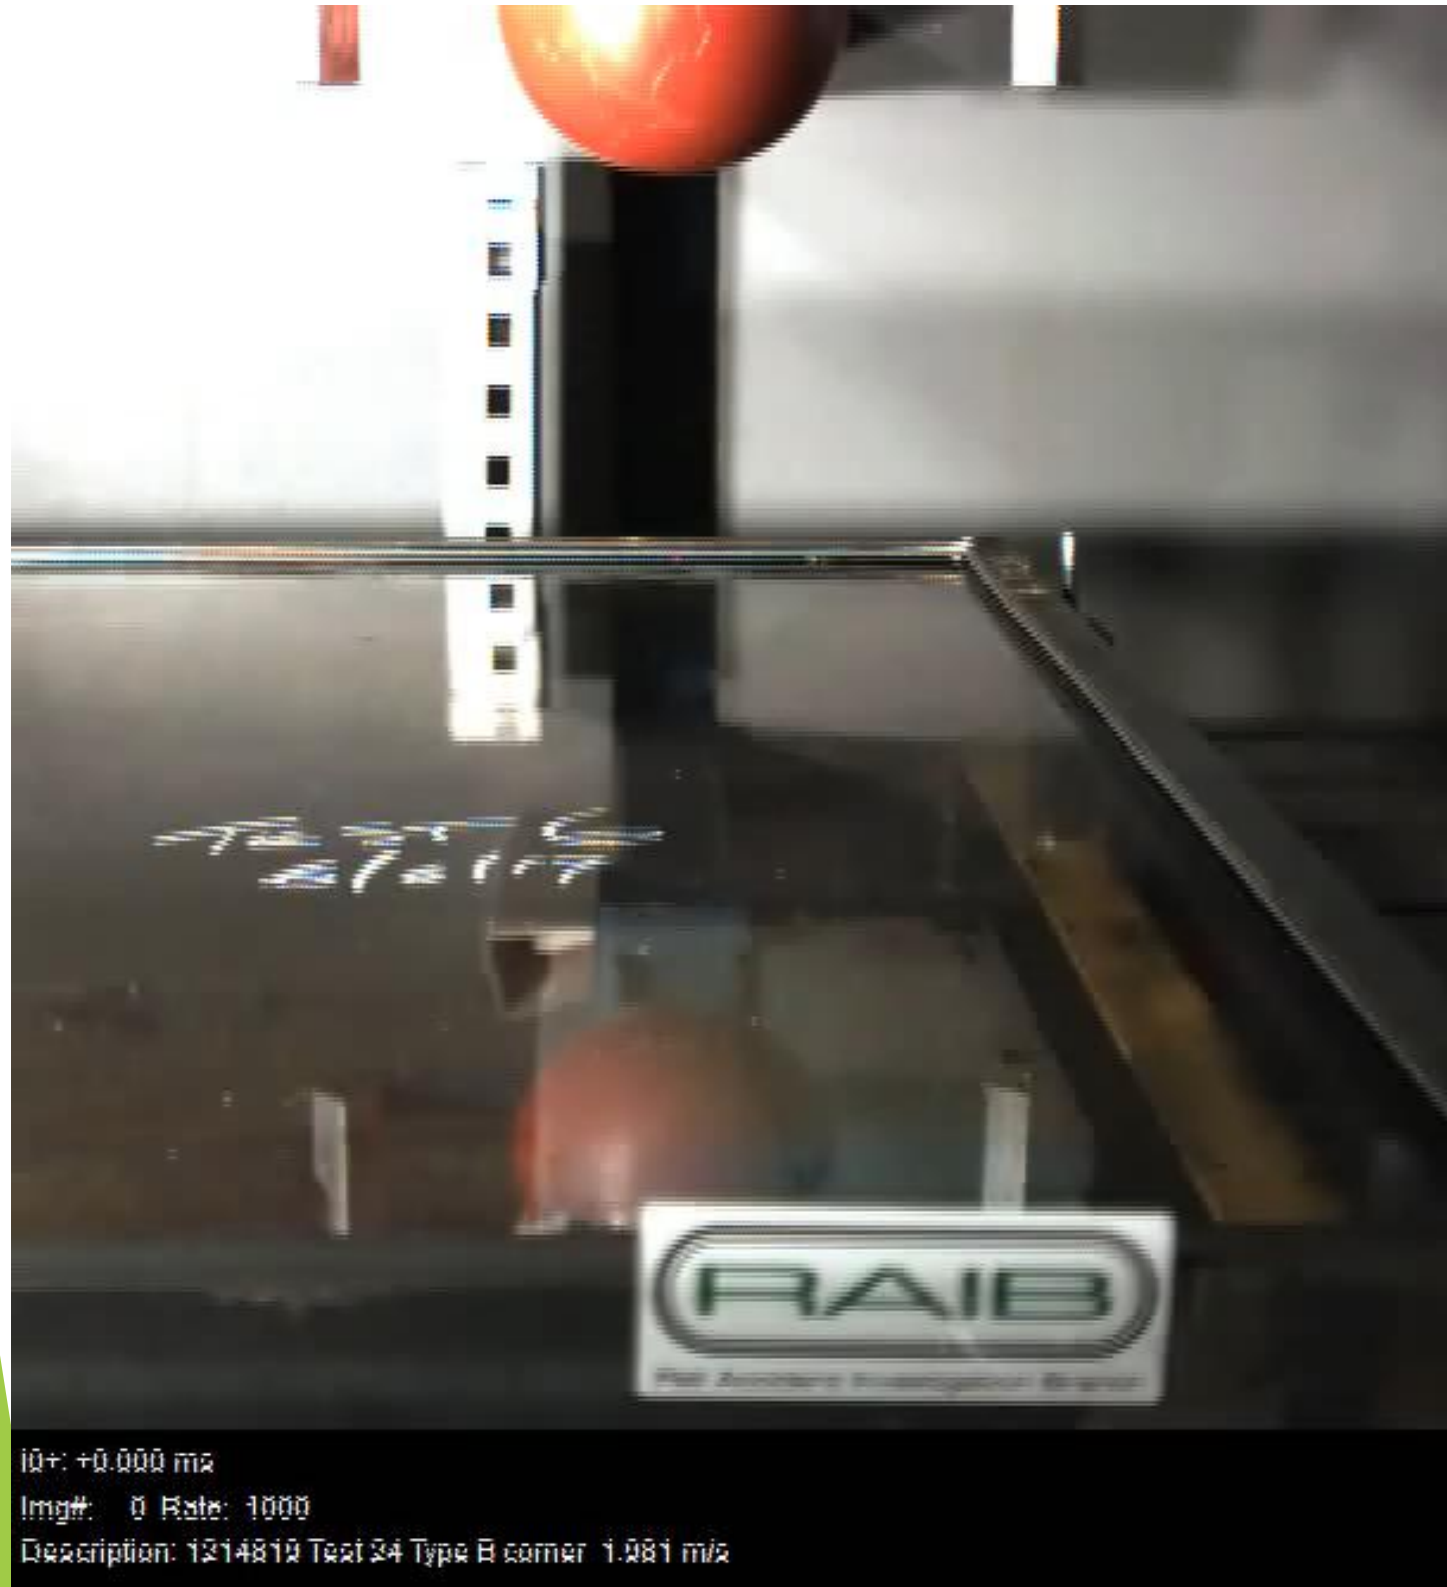
Headform test - 210mm above window (corner)

- ▶ All 7 people who were fatally injured were either fully or partially ejected
- ▶ In total, 34 out of 69 passengers ended up partially or even fully ejected through windows and doors
- ▶ Questions we were trying to answer:
  - ▶ How strong were the windows?
    - ▶ Did any window break before the tram hit the ground?
    - ▶ Would the windows break when the tram hit the ground?
  - ▶ How much residual strength is there in a shattered window?

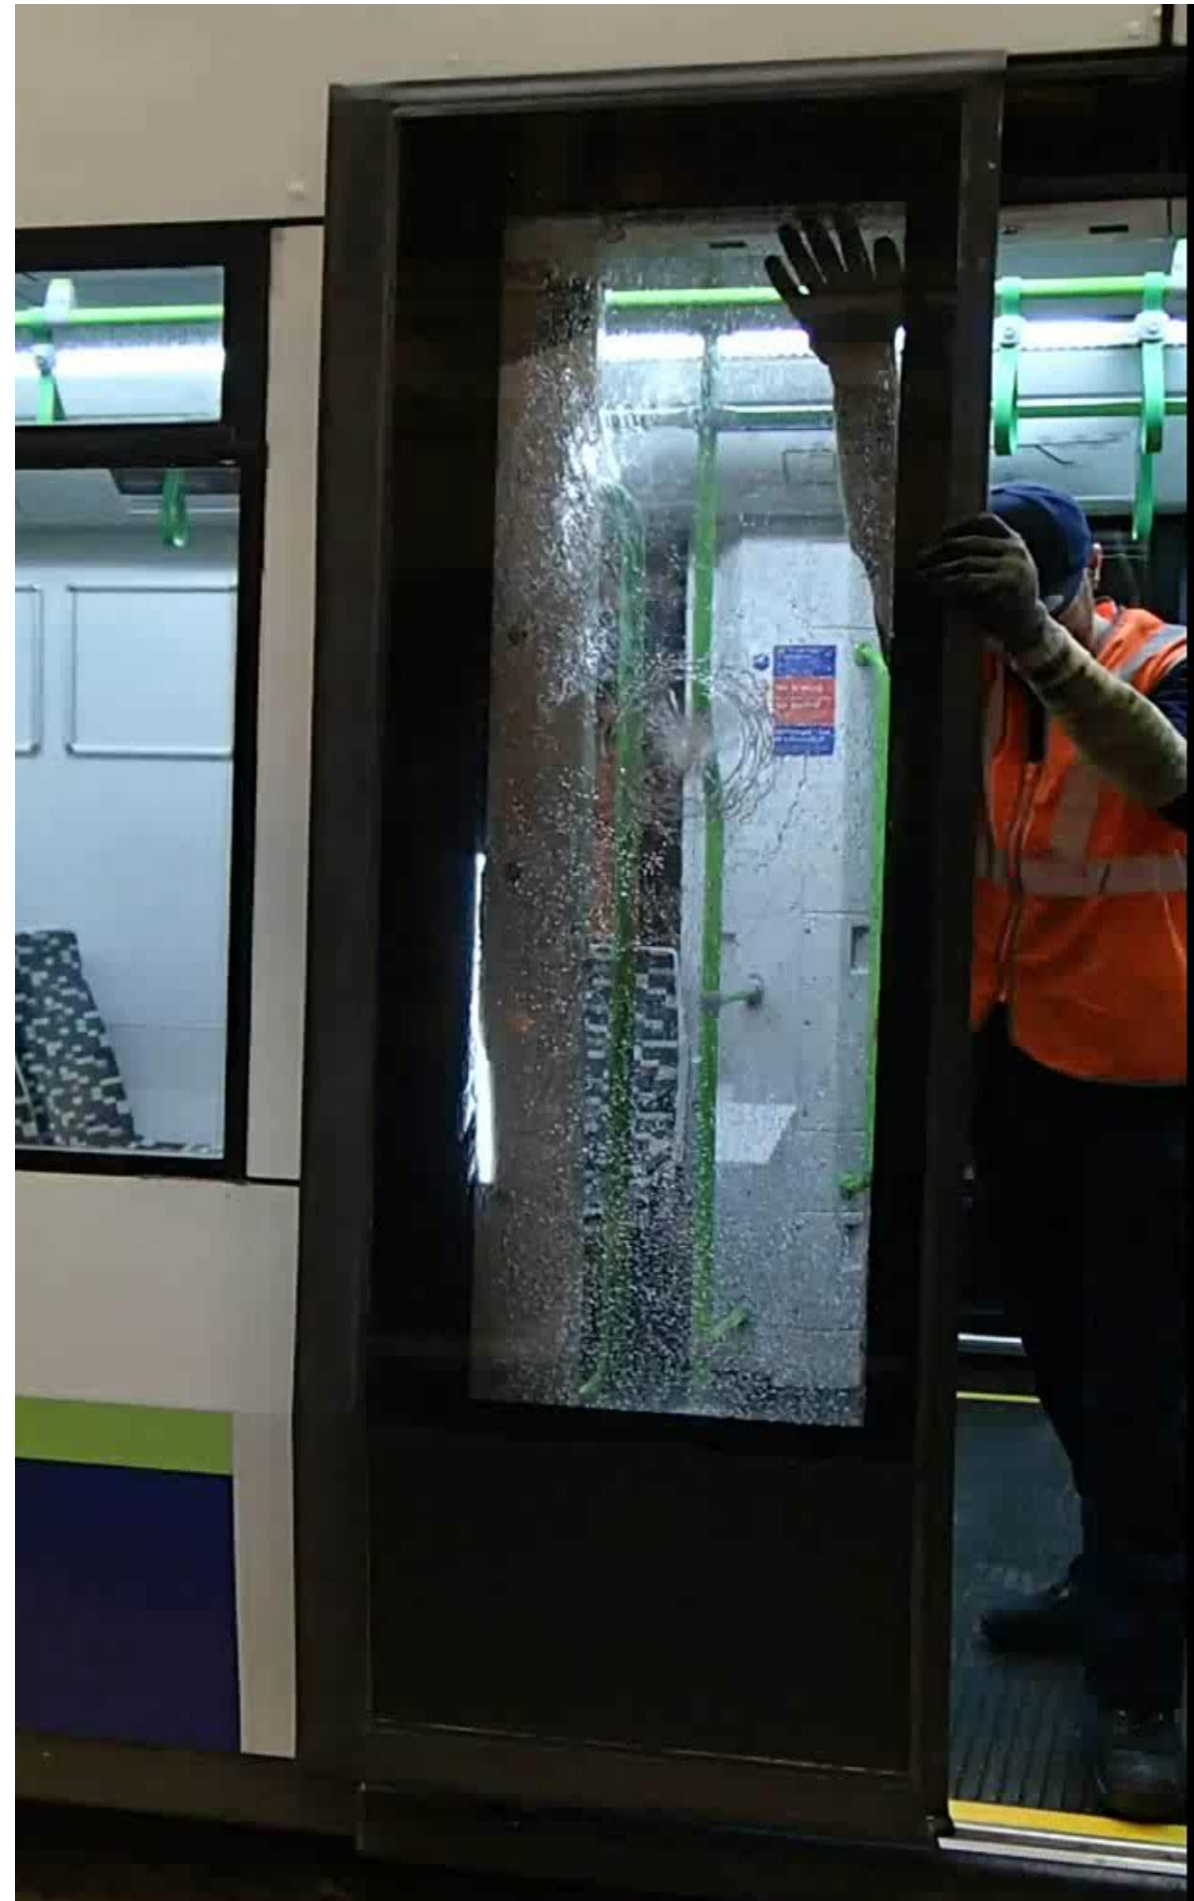
Residual strength once shattered
