Solid wall heat losses and the potential for energy saving

The nature of solid walls in situ

Prepared for: Dr Elizabeth Milsom, BEIS

Date: 15 November 2016

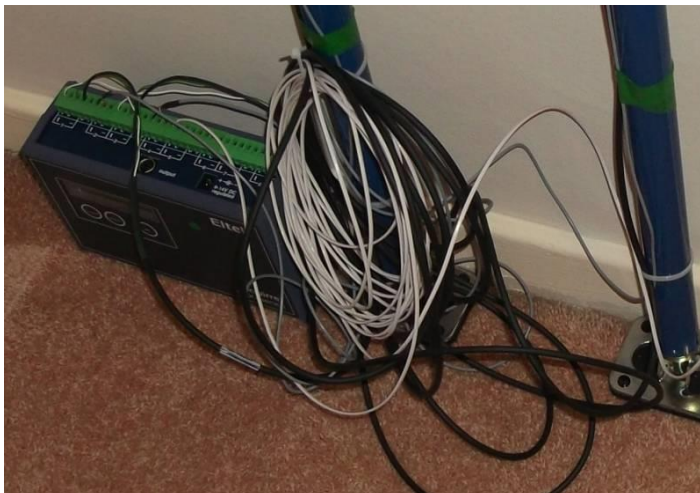
Figure 3: An Eltek 851L datalogger, recording EMF and thermistor readings from the sensing equipment

Data from the HFPs and the thermistors were recorded using an 8-channel Eltek 851L logger. This is shown in Figure 3.

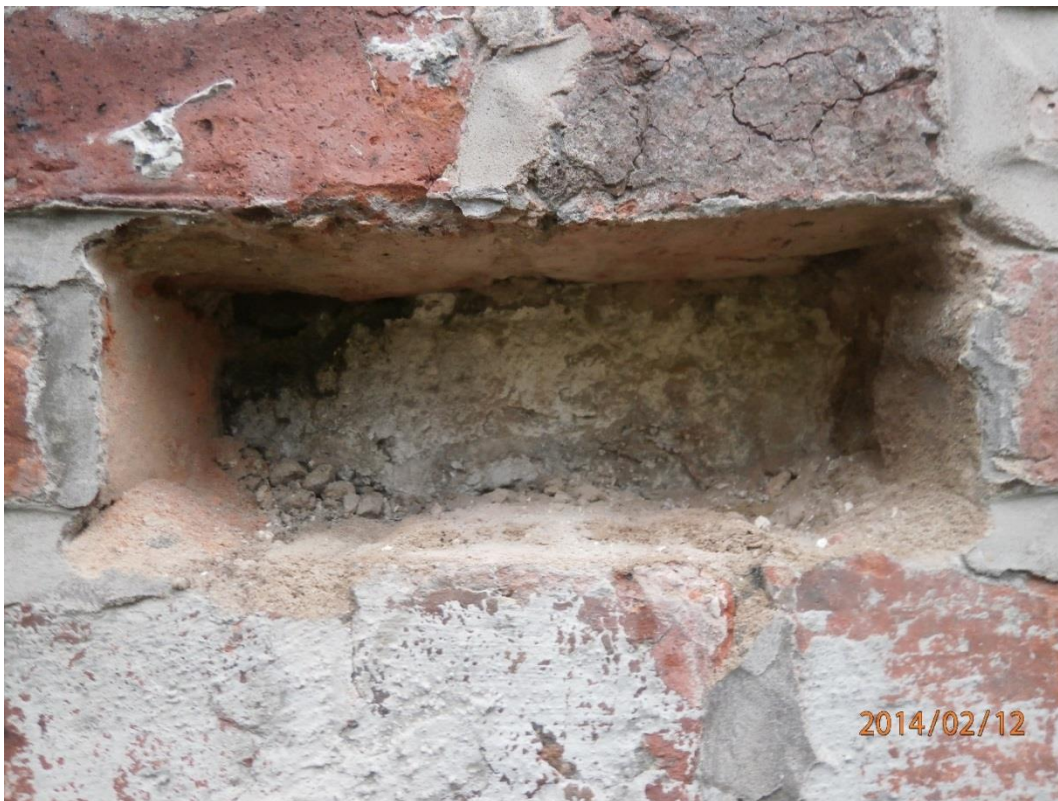
Figure 4: Opening revealed following removal of brick. The amount of mortar present, the presence and position of any frogs and other internal features were examined.

- a) The proportion of the joint between stretchers, known as the collar joint, filled by mortar.
- b) The width of the collar joint.
- c) The proportion of the vertical joints (perpend joints) filled by mortar.
- d) The presence of any frogs or drillings in the bricks, and whether laid frog-up or frog-down.
- e) The dimensions of any frog within the brick and the proportion of the frog filled with mortar.
- f) The presence of any snapped headers or broken bricks within the inner leaf of the wall.
- g) Any other observations.

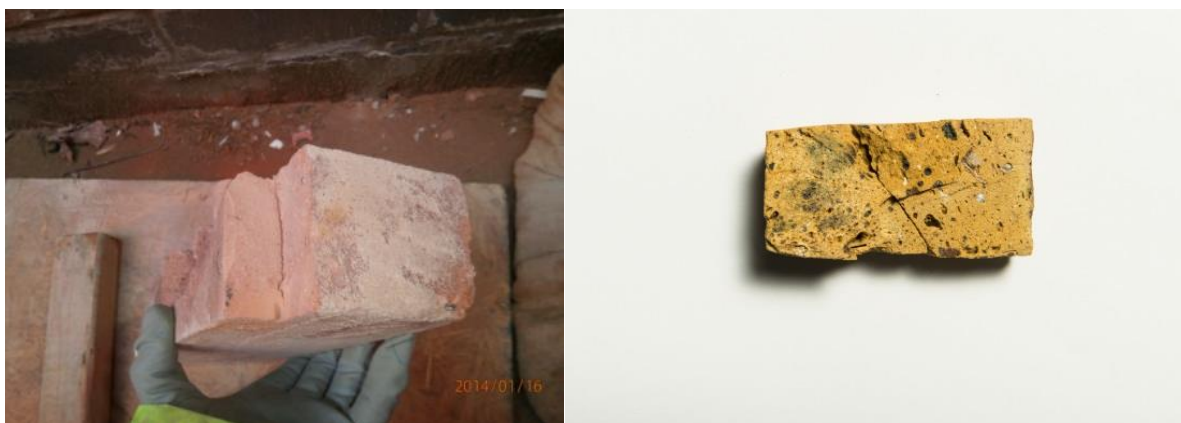
Figures 5 and 6: A brick where a sample has been cut off, and a sample of brick from the back of a removed brick (dimensions of this sample are approximately 30mm x 30mm x 60mm. Larger samples were taken in the second fieldwork period to allow for direct testing of thermal conductivity as described in Section 4).

To obtain a sample suitable for the measurement of density and moisture content of the brick, a small cuboid was cut from one of the back corners of the brick which had been removed for inspection (an example of a removed portion of brick is shown in Figure 5 and 6). Samples of mortar were also removed from the inter-stretcher area for analysis of moisture content.

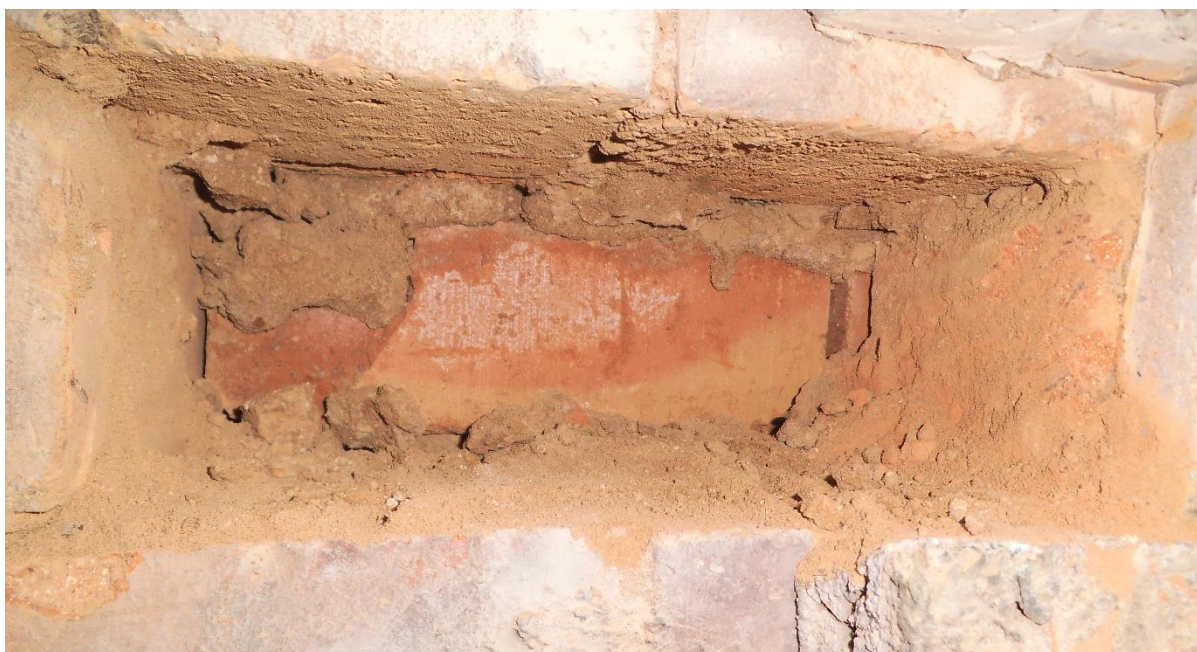
Figure 8: Exposed collar joint showing area of missing mortar. Some mortar remains attached (e.g. in the top left of the exposed inner leaf), with other regions showing staining (e.g. bottom right of the exposed inner leaf). The central portion of the inner leaf shows no staining, suggesting little or no mortar was present.

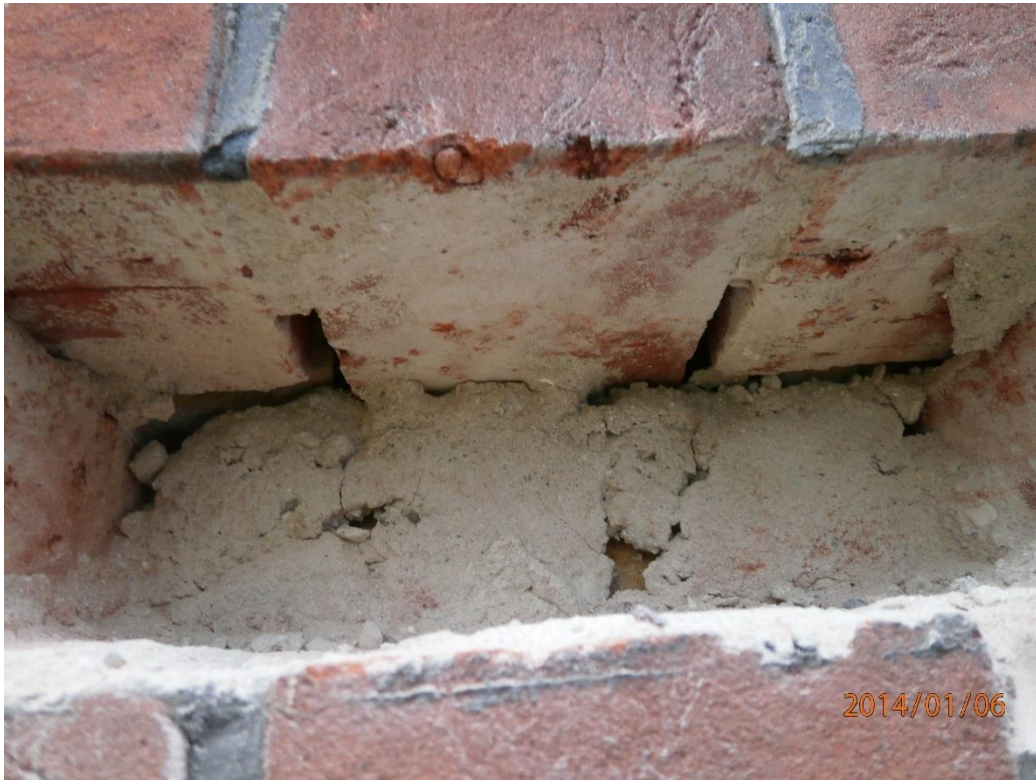
Figure 10: Example of missing mortar in perpend joints. Looking upwards at exposed bricks in the upper course at the top of the void, the extent of mortar in the perpend joints can be seen. In this example, the perpends can be estimated to be approximately 50% filled.

When the brick was removed, the vertical joints, known as perpend were also examined for the proportion of the exposed surface area filled with mortar. This assessment was made through the on-site examination by the field technician who examined the perpend area exposed when the brick was removed, as well as the adjacent surface on the removed brick itself. The extent of fill at the perpend was often easiest to ascertain by looking at the roof of the void created by the removal of the brick, where the perpend of the upper course were visible (see Figure 10 below). The technician also took photographs of the perpend joints, and these were used to validate the original on-site observations by a second member of the BRE team at the analysis stage. The on-site technician was also encouraged to factor into the assessment any observations from their experience of removing bricks by the stitch-drilling technique. For example, the depth at which the drill bit ceases to encounter resistance when drilling may indicate where the mortar ends and a cavity begins.

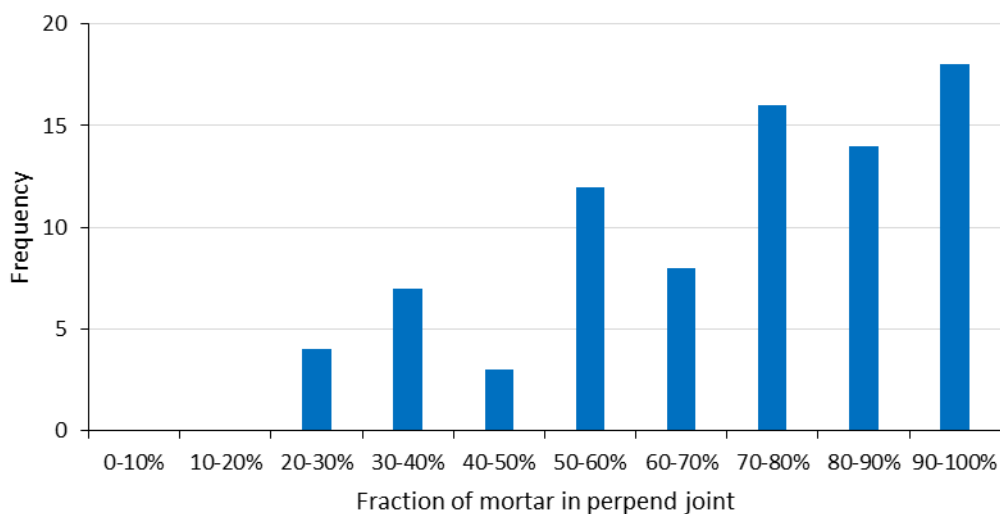
Figure 11: Percentage of mortar in perpend joints, as observed from fieldwork

As with the collar joint gap, perpends were also seldom fully filled with mortar. The median percentage of the exposed perpend area estimated to be filled with mortar was 70% based on results from 82 cases. The interquartile range was 32% between 50% (at the 25th percentile) and 82% (at the 75th percentile). This is shown in Figure 11 below.

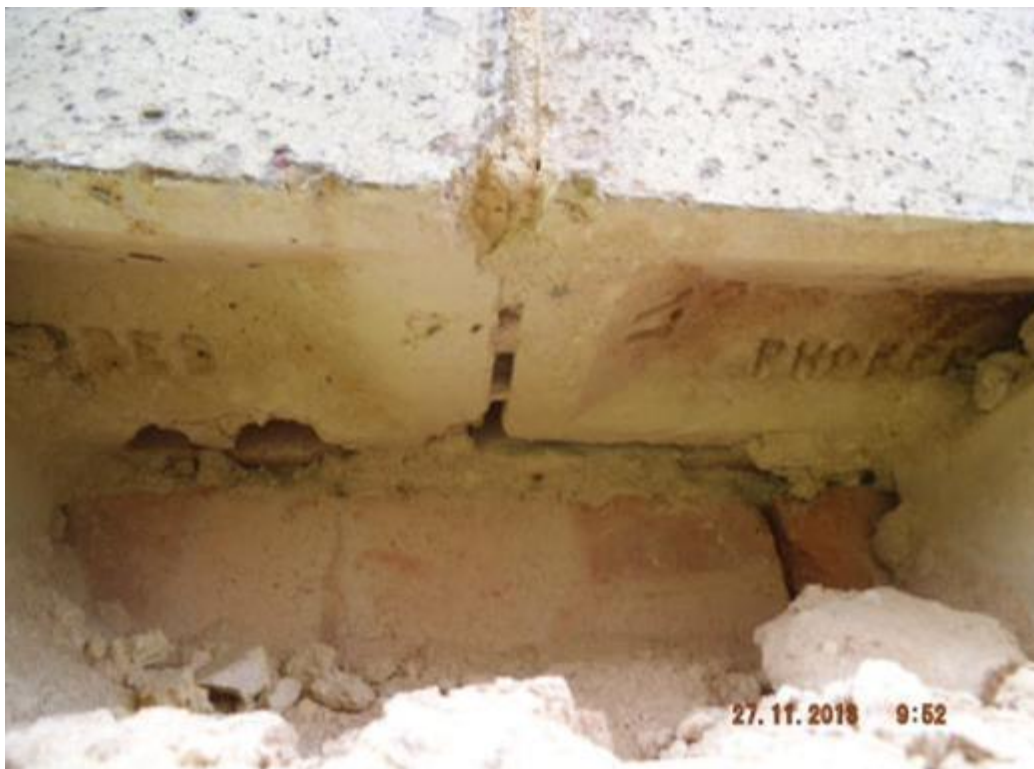
Figure 12: Frog-down bricks. The cavity created by the frog in the brick is clearly visible. The on-site technicians were able to ascertain that any cavity was genuine (and not simply created by falling mortar following the brick removal) by looking along the course. This example also shows evidence of an imperfect brick being used (the back face of the upper left brick in the in the upper course is broken) – see below.

A photograph of a wall built with 'frog-down' bricks is shown below in Figure 12.

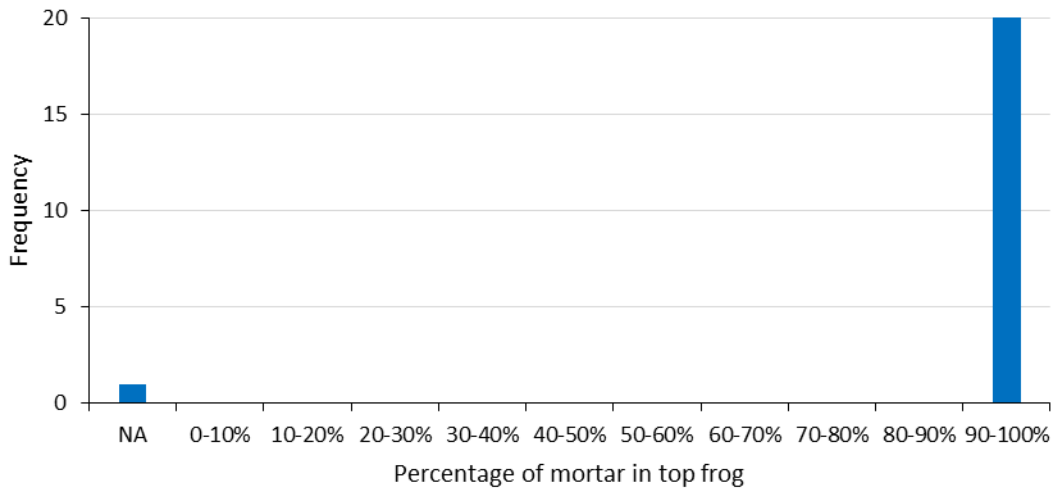
Figure 13: Percentage of mortar in frogs found on the top face of bricks, from fieldwork

was removed it is not possible to tell if the wall was built with a mixture of frog-up and frog-down bricks). Frog-up bricks were almost always fully filled with mortar whereas frog-down were very seldom fully filled with mortar. The distributions of mortar fill for frog-up and frog-down bricks are shown in the Figures 13 and 14 below.

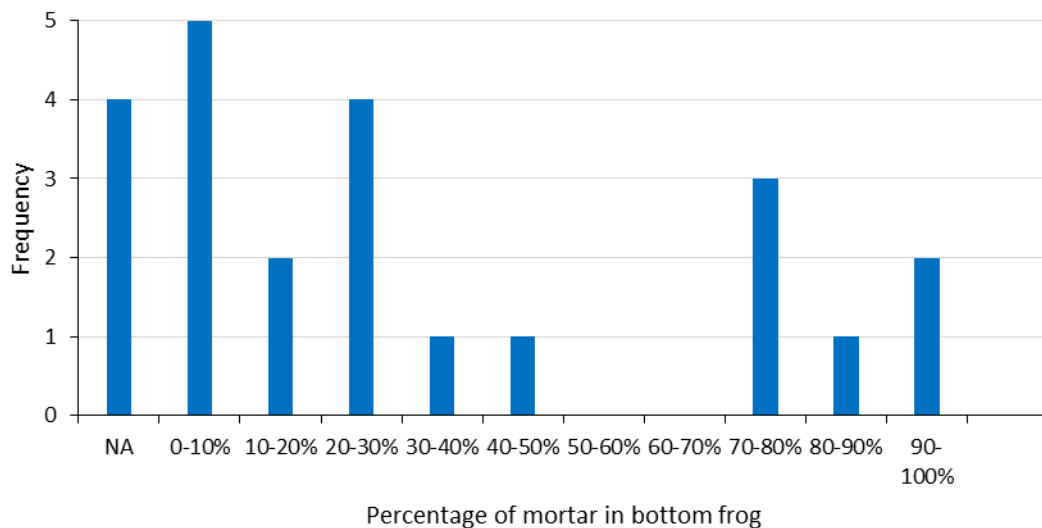
Figure 14: Percentage of mortar in frogs found on the bottom face of bricks, from fieldwork

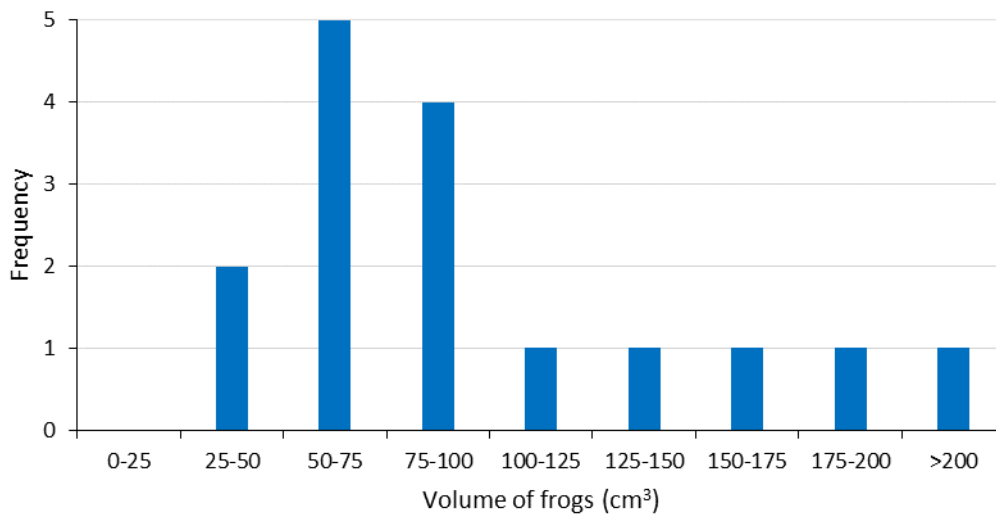
Figure 15: Volume of frogs for those where measurement was possible in the field

The dimensions of frogs also varied, for those cases where measurement was possible (mortar or other practical reasons sometimes prevented this). The median volume of the frogs where measurements were taken was 76 cm³. The distribution of frog volumes is shown in Figure 15 below.

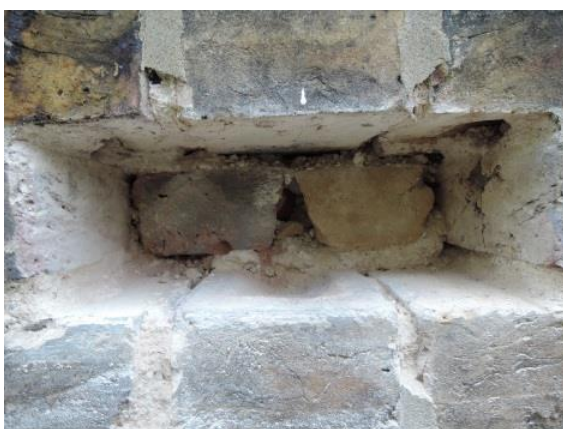
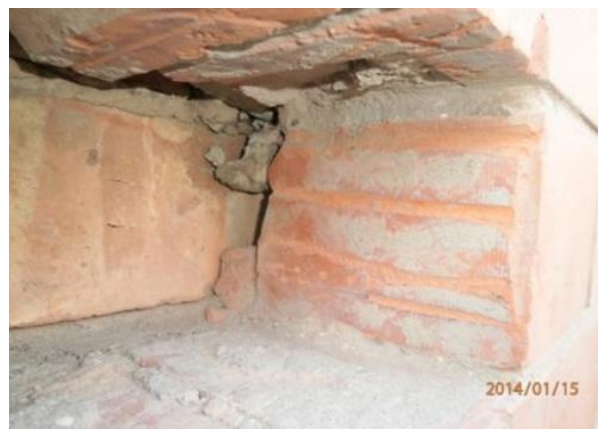
Figures 16 and 17: The use of broken bricks / brick bats on the inner leaf (*left*) and in place of a full header brick (*right*) introduce air cavities into the wall structure. These types of features were found in ~9% of walls examined.

Photographs of brickbats used in the walls are shown in Figures 16 and 17 below to illustrate the type of observations seen in this aspect of the fieldwork.

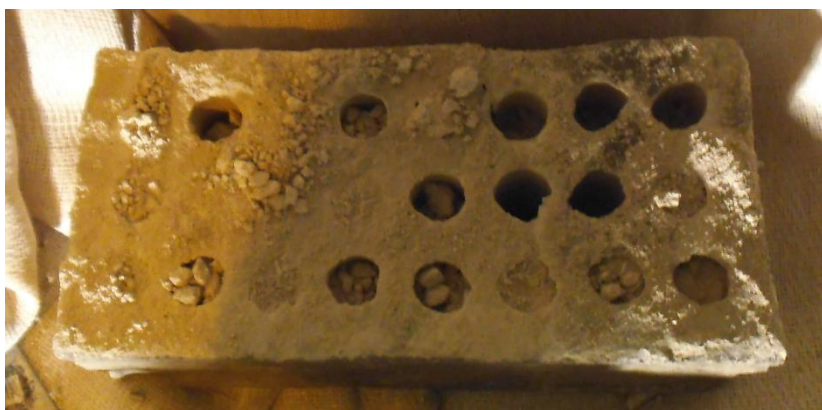
Figure 18: A perforated brick found in one of the walls examined

Only one example of a perforated brick was found, indicating that these are likely to be rare across all solid wall dwellings. Evidence from the hot-box experiments, described in section 3 of this report, suggest that perforations in a brick can act to reduce the U-value of the wall. A photograph of the perforated brick is shown in Figure 18 below.

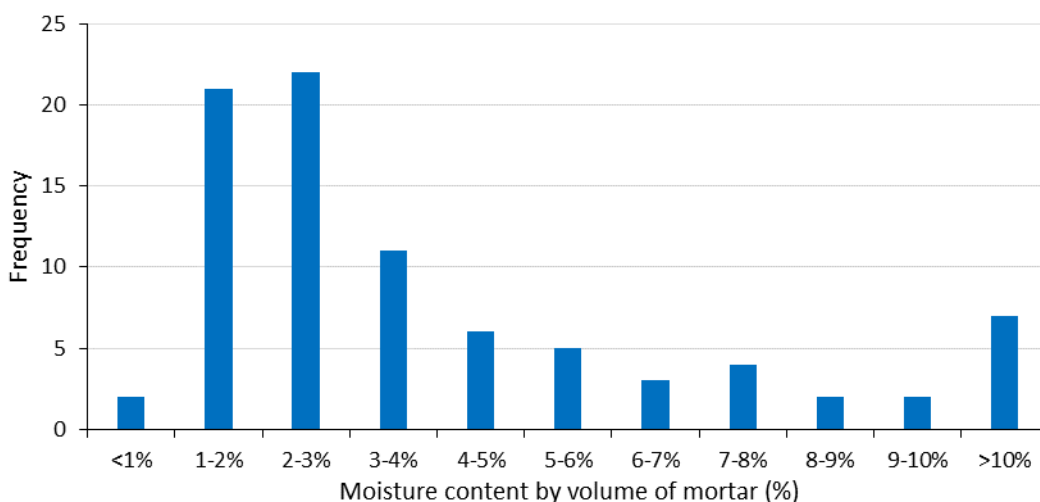
Figure 20: Distribution of moisture content by volume of mortar samples

Mortar dust drillings were also taken by the field technicians on site, which were placed in airtight containers ready for testing. Overall, mortar was generally dry, although slightly wetter than the brick samples. The median moisture content of mortar was 2.8% by volume. Around two thirds of the measured mortar samples ranged in moisture content from 2% to 15%, yet 5 cases showed very wet mortar samples, with moisture contents reaching 31% in one (the same case with the high brick moisture content). The distribution of mortar moisture content by volume is shown in Figure 20 below.

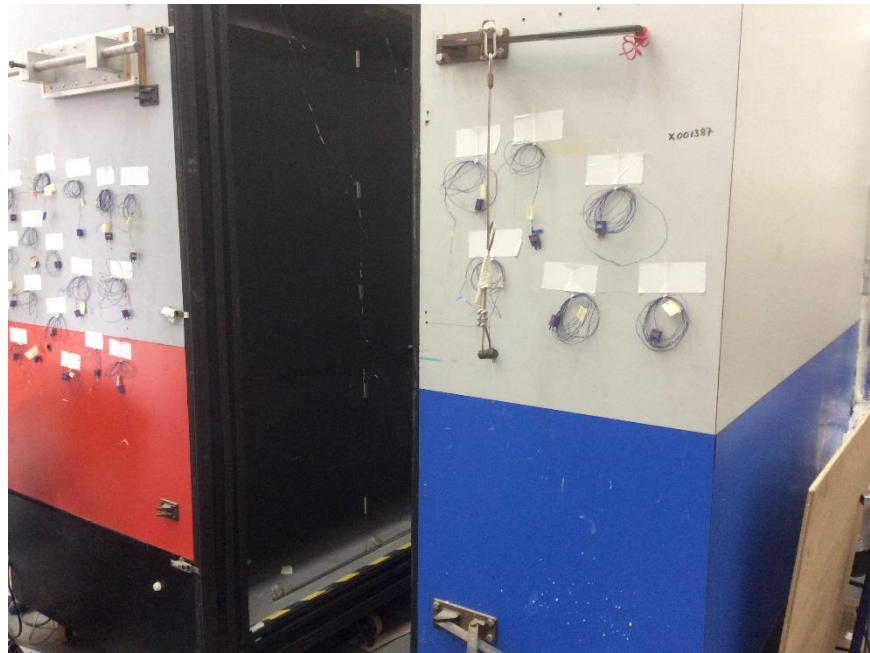
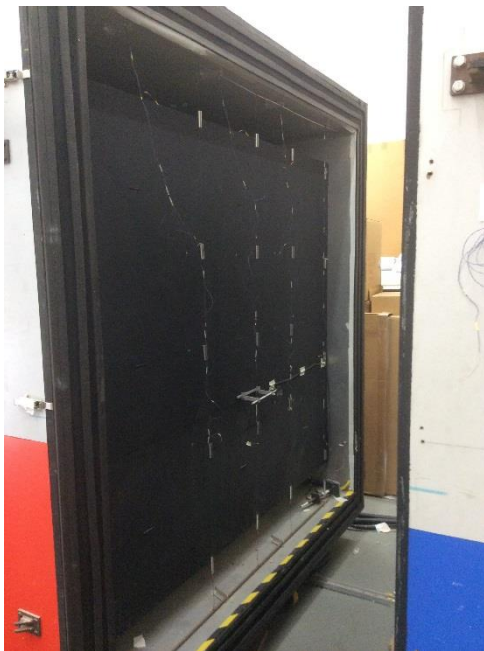
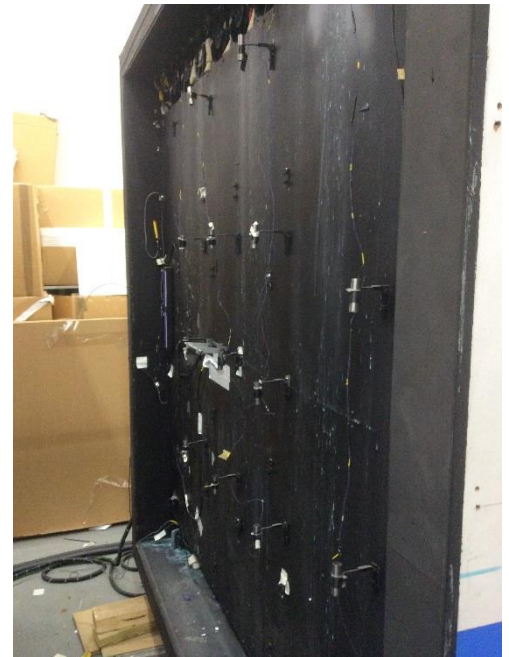
Figure 28, 29 and 30: Photographs of the NPL Wall Hot-Box Apparatus. The hot side of the box, marked in red is on the left hand side of the photographs. The cold side, marked in blue, is on the right hand side.

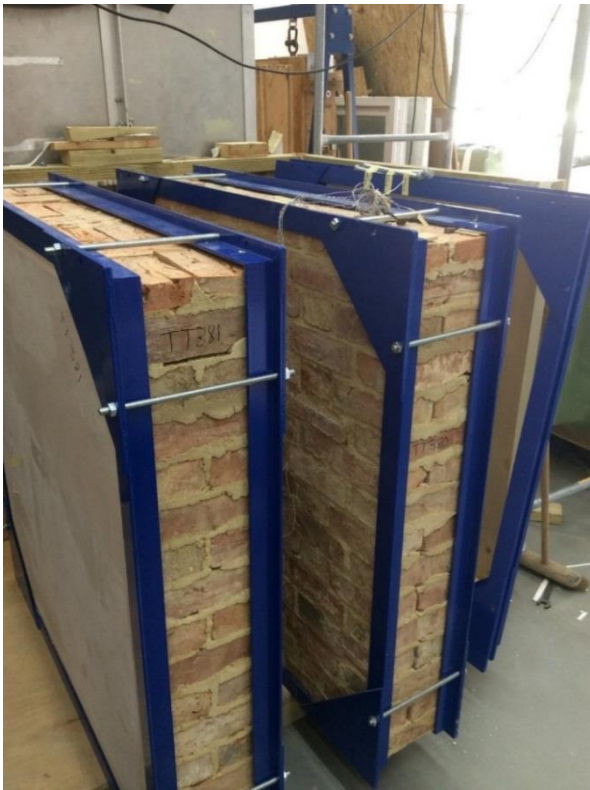
Figure 31: Two of the BRE built walls which are held in place within the specifically designed blue 'moving frames' to allow them to be lifted into the hot-box.

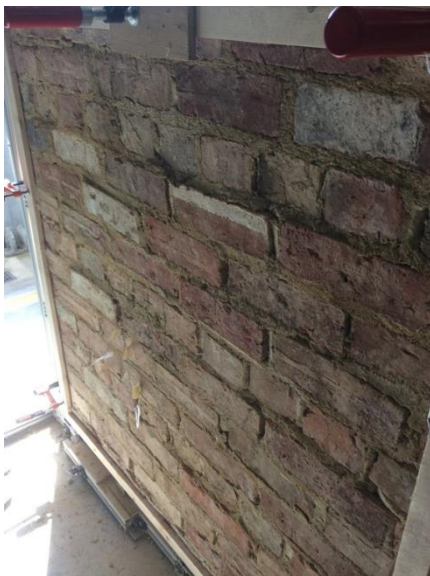
Figure 33: At the construction stage, each wall was built within a wooden frame which could be removed allowing the moving frame to be attached. The wooden frame can be seen surrounding this wall (Wall 4, built with an English Garden Wall Bond).

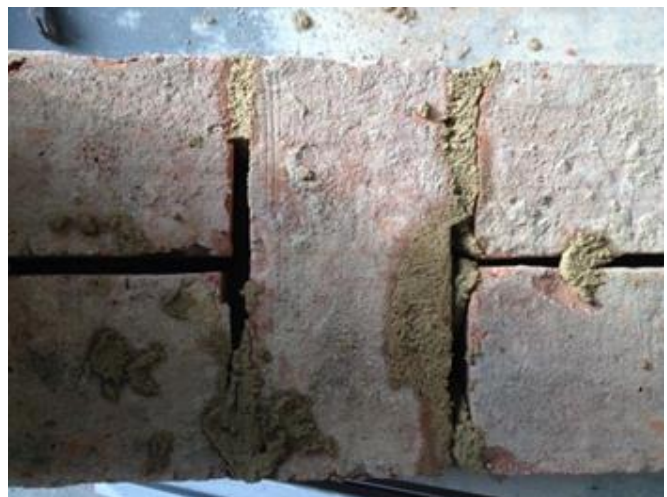
Figure 34: Walls 3 to 6 all incorporated the types of small cavities which we had observed in the field. Shown are the partial filling of joints with mortar in Wall 3, particularly in the collar joints and perpend, which matches observations from the fieldwork

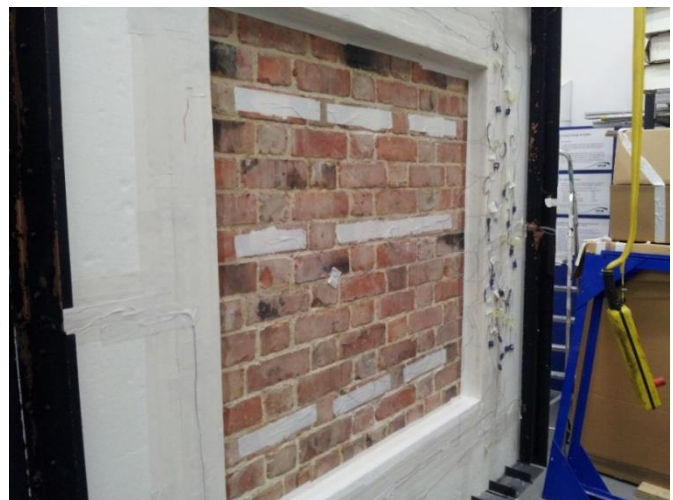
Figure 42: A completed wall, within the EPS guarding, ready to be placed into the hot-box. Once in this position the wall could be rolled into place on castors.

The steel frame, however, could not simply be clamped to the newly built wall as this would have resulted in damage to the plaster. This problem was anticipated, and to ensure the plaster was not damaged during the moving process a 47 mm wide strip of 12 mm thick plywood was fixed around the perimeter of the warm face of the wall prior to plastering. The plywood was fixed with normal wood screws and rawl plugs. When it was time for the wall to be moved the plywood was removed, and the steel moving frame was fastened against the brick surfaces. In this way the wall was ready to be lifted into position. Additional modifications needed to be made to the hot box panel itself in order to accommodate the heavy masonry wall panels. This took the form of a special collar guard system and surround panel which were designed and built with a removable top section. This allowed the wall panels to be lifted in from above using a two tonne gantry crane. This is shown in Figure 41 and Figure 42. During the process of installing the wall into the hot-box surround panel, aluminium beams were clamped into position to ensure the wall was stable prior to being finally fixed into the surround panel. Once in the hot-box surround panel the wall could be wheeled into position on castors.

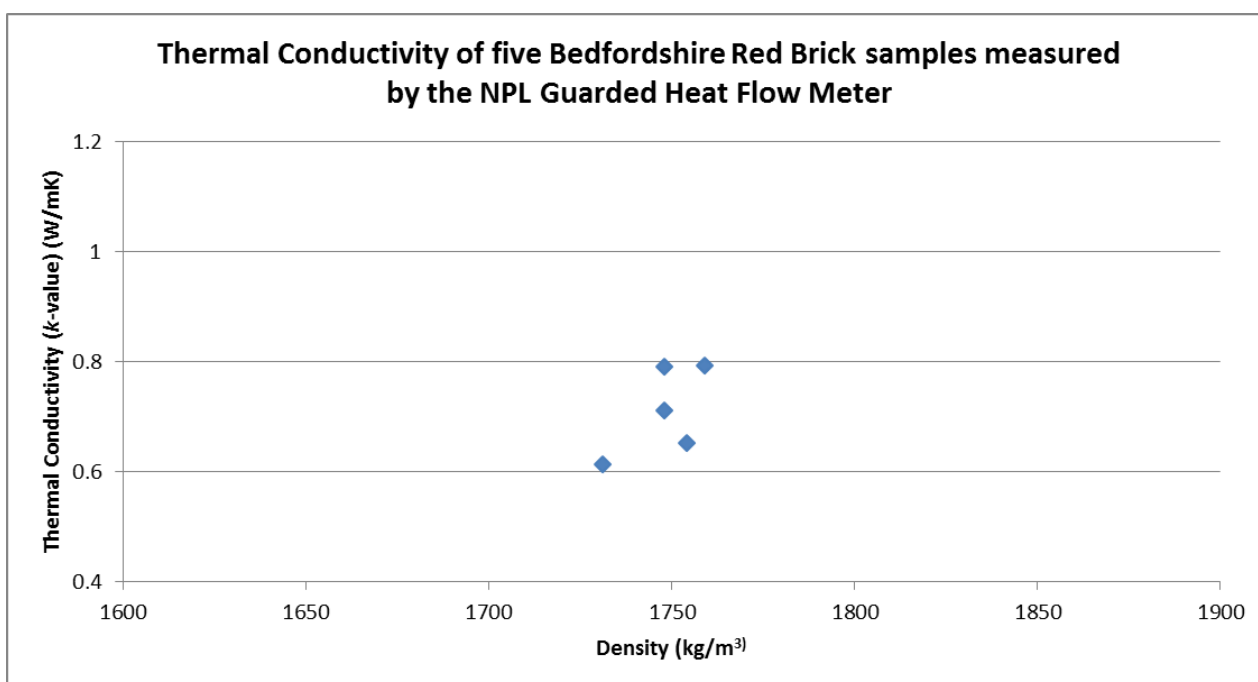
Figure 44: Variation in thermal conductivity within Bedfordshire Red Bricks, as measured by the NPL guarded hot plate apparatus.

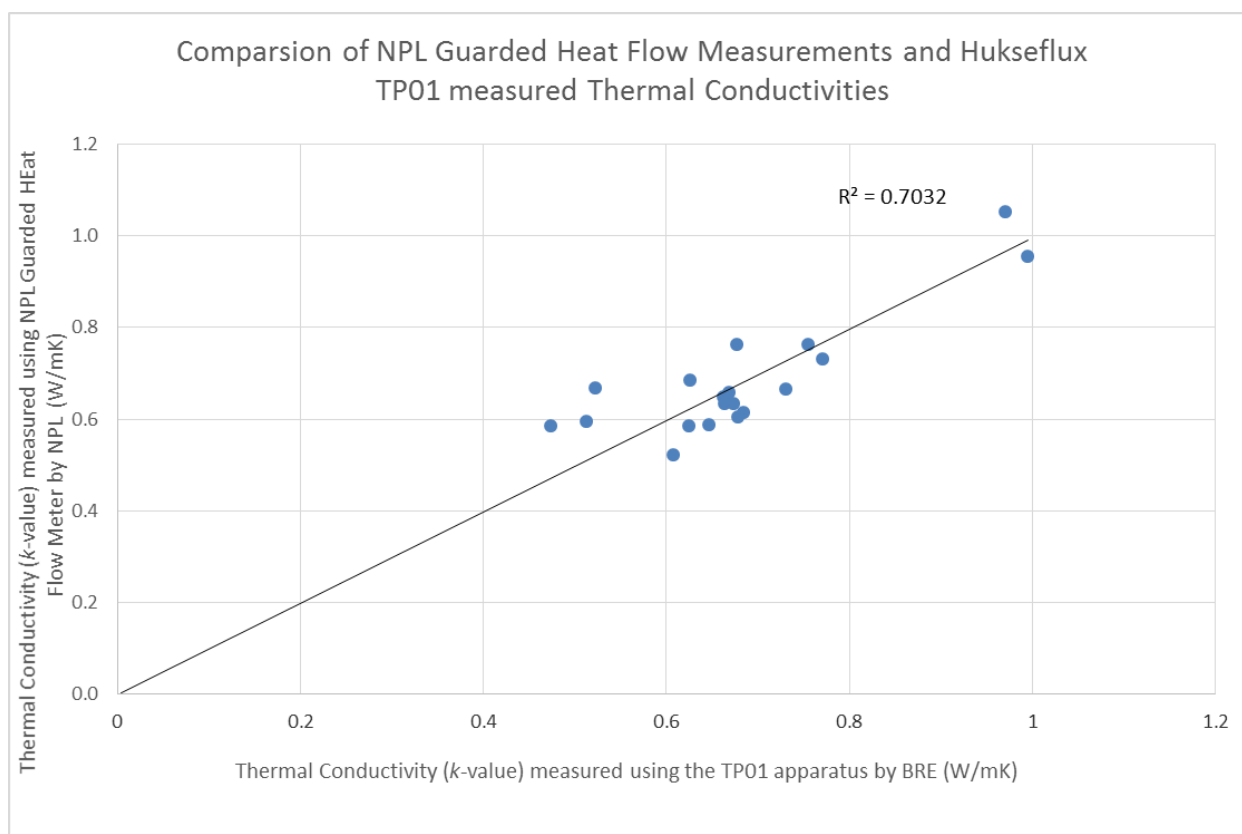
Figure 47: Comparison between the NPL guarded heat flow meter measurements and the TP01 apparatus measurements for sample Group A. A good correlation can be seen.

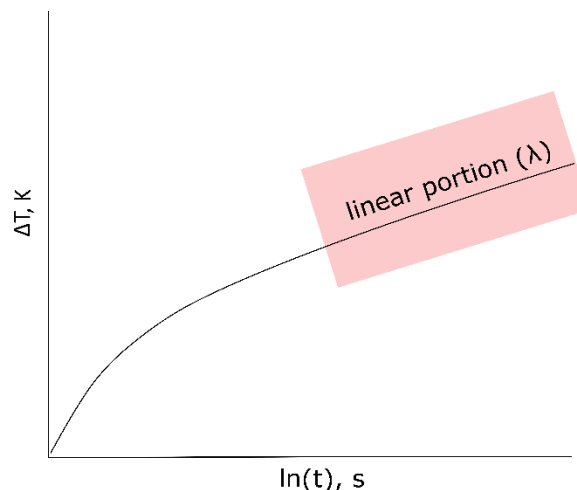
Figure 51 – Relationship between the change in temperature and time.

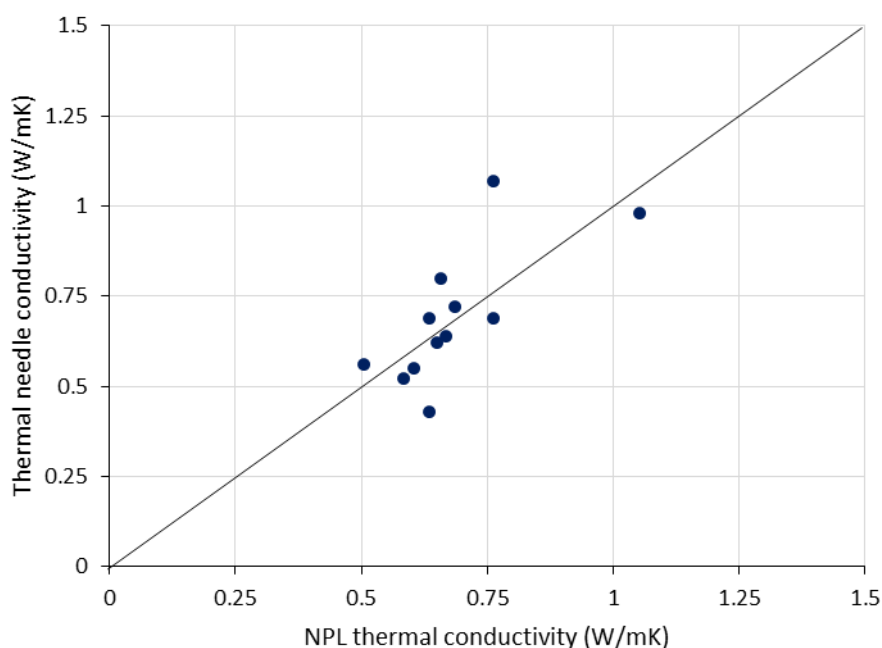
Figure 53 - Thermal conductivity values from NPL and thermal needle measurements.

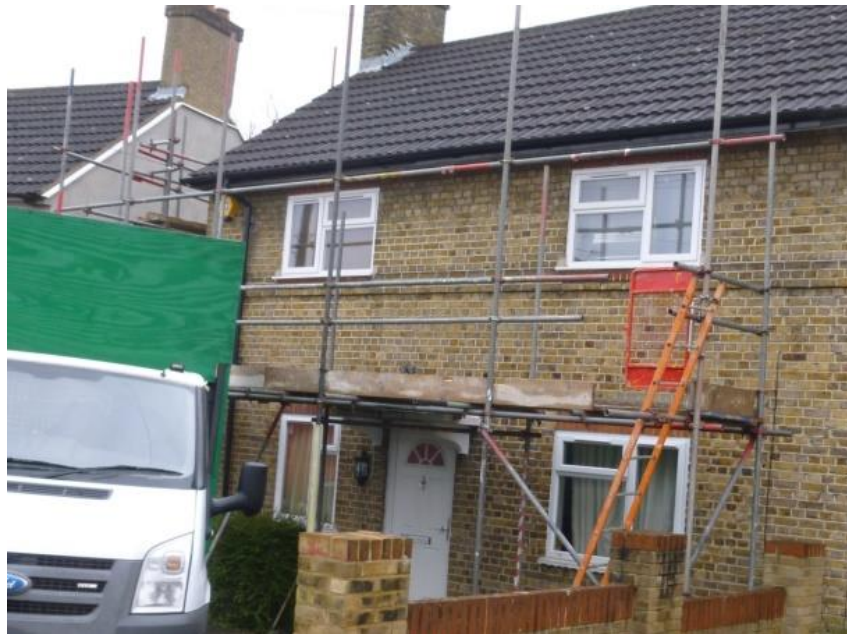
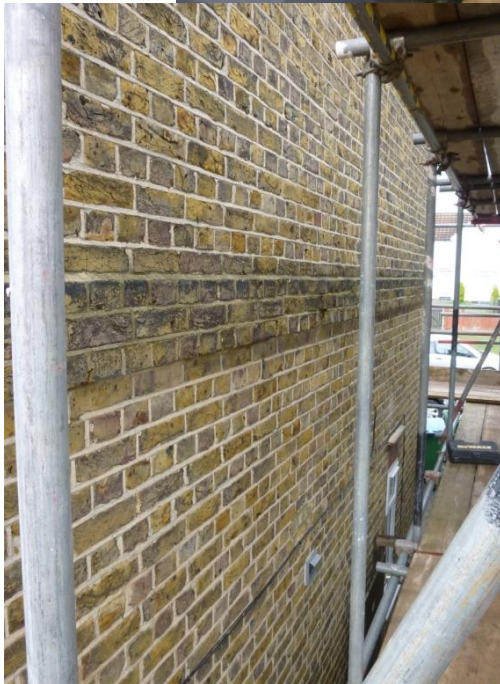
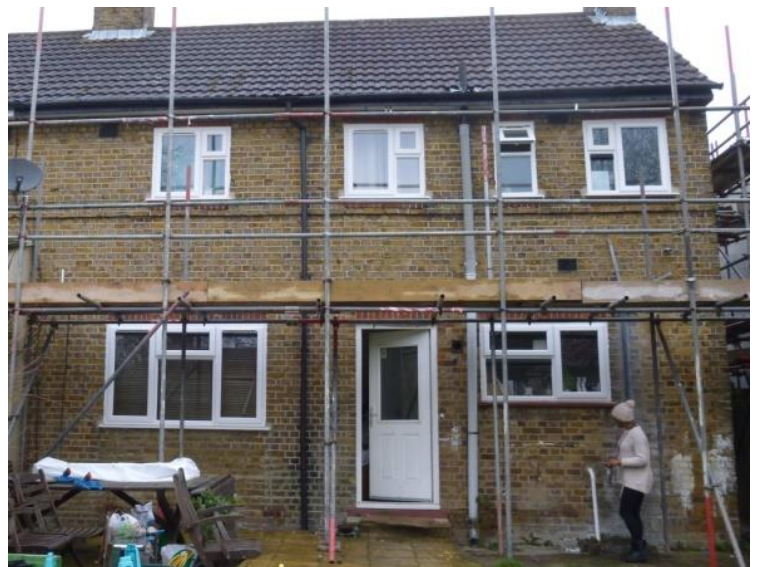
Figure 55, 56 and 57: Dwelling 1 visited for first moisture drilling tests

The first dwelling visited was an unrendered, semi-detached solid wall dwelling in the East of England. The dwelling was in a relatively sheltered, suburban location. Dust drillings were taken in multiple locations across all facades, as shown in the diagram below, in line with the methodology outlined in Good Repair Guide 33 [11]. Photographs of the front, rear and side walls of the dwelling are shown below in Figure 55, 56 and 57. Scaffold was used to provide access to various heights to allow the collection of the dust drillings.

The samples were oven dried at 105 °C until they achieved a constant mass.

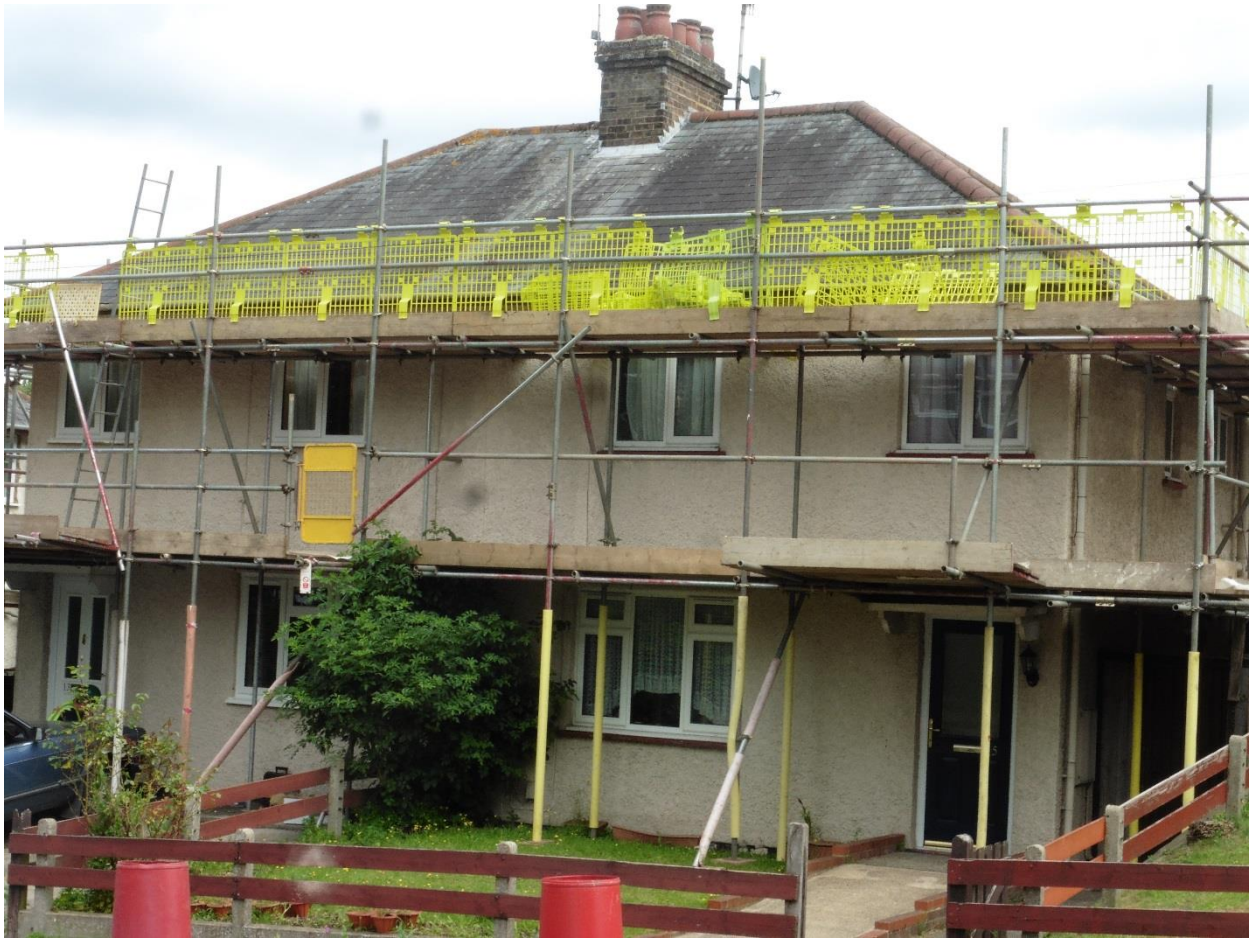
Figure 62: Dwellings 2 and 3 visited for moisture dust drillings.

These dwellings were a pair of semi-detached houses, shown in Figure 62 below, situated on the east side of the street on the north face of a steep chalk hill. The narrow front gardens extend down to the pavement and on to the road. The front plot of the left hand house of the pair has been concreted to create a hard standing for vehicles. Each house is built of brickwork which had been rendered and painted.

The dust drilling was recovered using rotary percussive drill using a 9 mm bit. The dust samples were stored in glass vials.

The samples were oven dried at 105 °C until they achieved a constant mass.

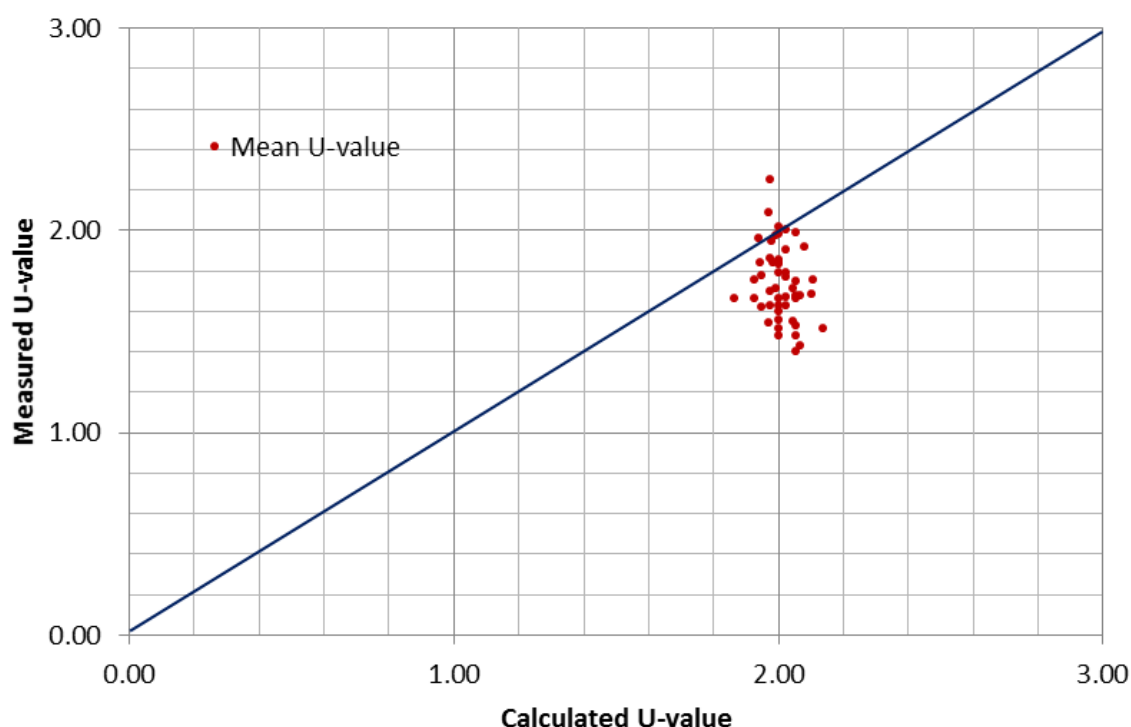
Figure 70 Measured and calculated values for the 50 cases used for comparison using the default calculation assumptions.

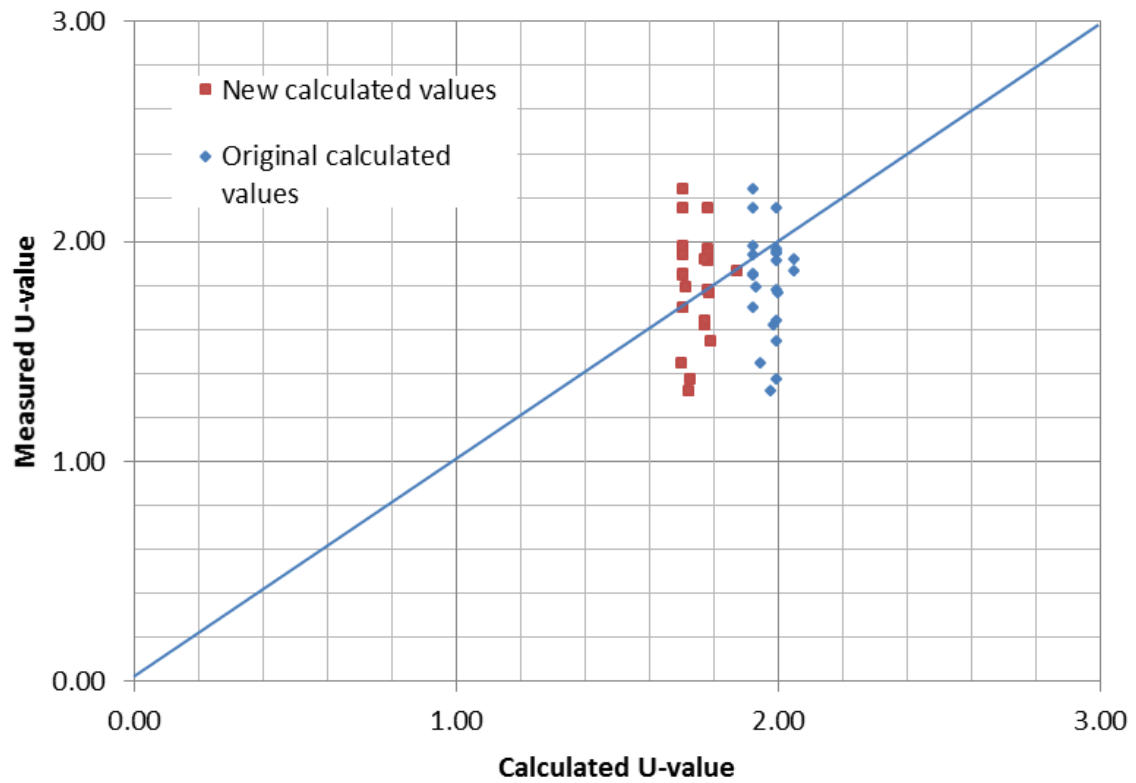
Figure 72: Comparison of measured and calculated values for the 23 cases which did not have additional observations under the original and revised calculations
