High Speed Two Phase 2a (West Midlands - Crewe)

Cultural heritage survey data used in the
Supplementary Environmental Statement 2 and
Additional Provision 2 Environmental Statement
(BID-CH-004-000)

A report prepared for High Speed Two (HS2) Limited:

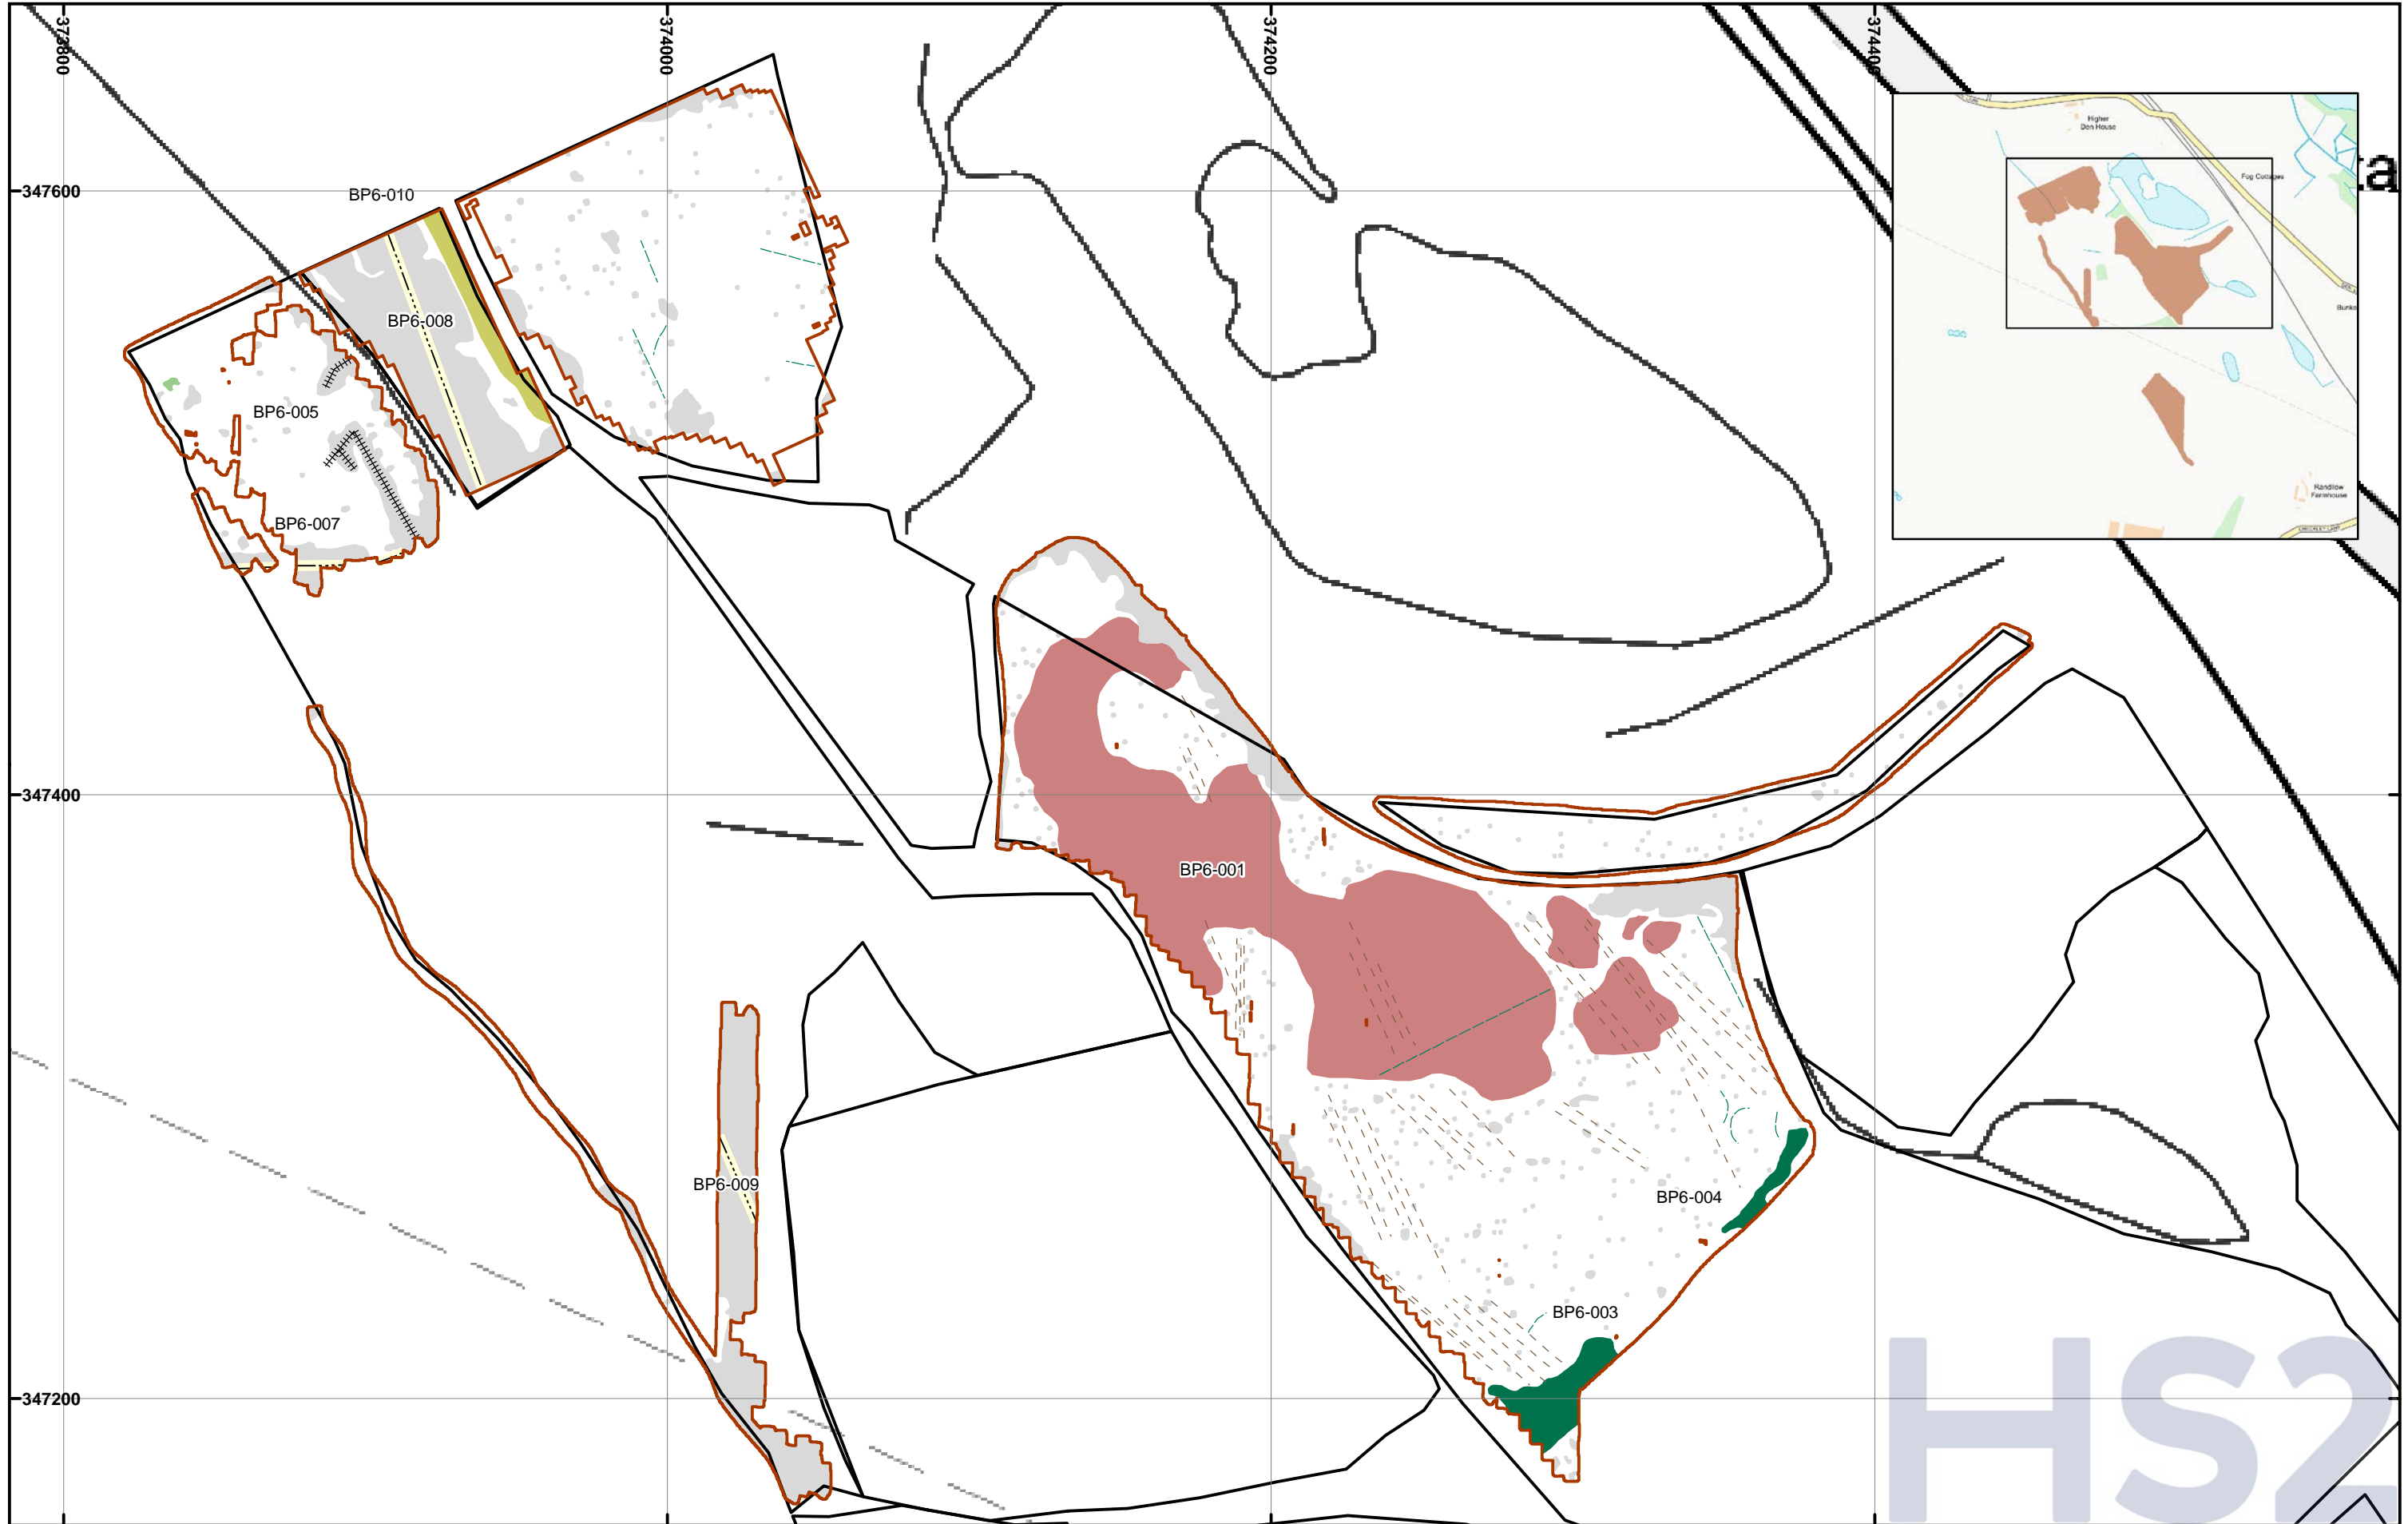
Map Number: **Figure 60**

Map Name: **Survey Area 14:
Borrow Pit 6 (North)
(Interpretation)**
