# Stamford Decommissioning Close-Out Report

Document ID:		CEU-DCM-GMA0042-REP-0027	
Document Classification:		PUBLIC	
Document Ownership:		Decommissioning	
Date of Document:	15/09/17	Signature	Date
Prepared by:	S. Axon	<i>S. Axon</i>	14/12/18
Reviewed by:	S. Mackenzie	<i>S. Mackenzie</i>	14/12/18
Approved by:	G. Kabra	<i>S. Axon</i> <i>pp G. Kabra</i>	14/12/18

This document contains the close-out report for the two Stamford Decommissioning Programmes (DP) approved by the Secretary of State on the 30th April 2015, one for each set of notices under section 29 of the Petroleum Act 1998:

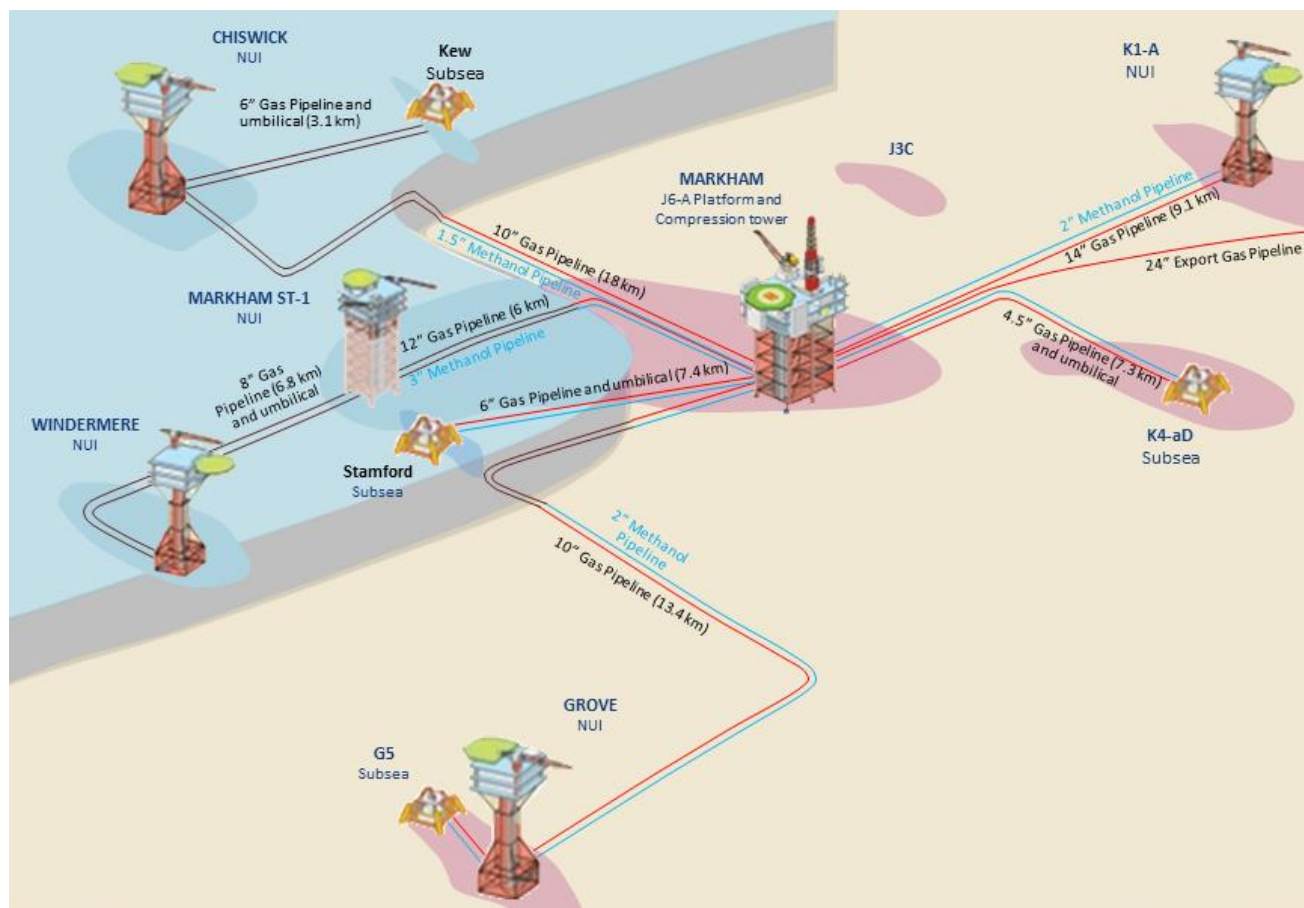
Figure 1.2.1: Stamford Field layout prior to decommissioning

The field was developed by tying back a single Stamford appraisal/development well (49/10b-3) to the Markham J6A platform located in the Dutch sector 7.5km from the Stamford well location. The Stamford pipeline and umbilical crosses the median line into the Dutch sector.

First gas was achieved in December 2008 with the gas transported via a 6" pipeline back to the Markham J6A Compression Tower platform. A 5" control umbilical providing power, chemicals and hydraulics to the wellhead. The pipeline was connected to the J6A CT via a 6" flexible riser routed up through the platform J-tube.

The remaining subsea infrastructure included the Stamford wellhead, wellhead protection structure, Xmas tree and stabilisation features for protection which included concrete mattresses, grout bags and rock deposits.

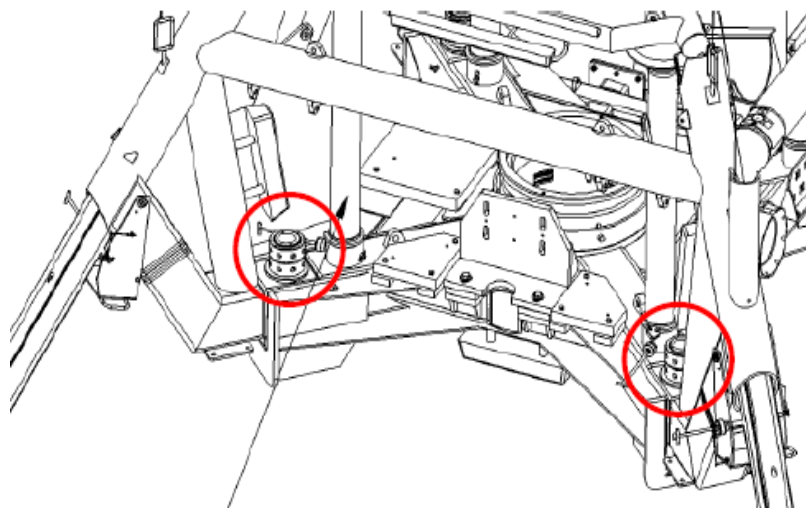
Figure 4.2.1: Side Panel Locking Nuts on WHPS

Figure 4.2.1 shows the side panel locking nuts which were removed, Figure 4.2.2 shows a trawl deflection leg in the 'up' position with retention bucket engaged and Figure 4.2.3 shows the tie bars that were removed. Onshore trials were carried out on a similar Xmas tree prior to mobilising and this provided confidence in the method and tools to be used; the tools for the side panel nuts had been fabricated for the purpose.

Finally, the four nuts holding the two side panels in place were removed; the side sections were then rigged and recovered to deck.

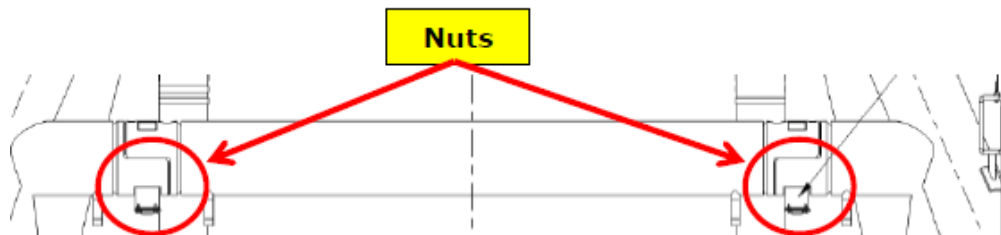
Figure 4.2.3: Tie-bars to be released

The two tie bars were located on the north-west and south-west faces, these had to be removed to allow complete removal of the side sections. These were fully unbolted and recovered with choked slings due to the unknown integrity of the existing lifting points.

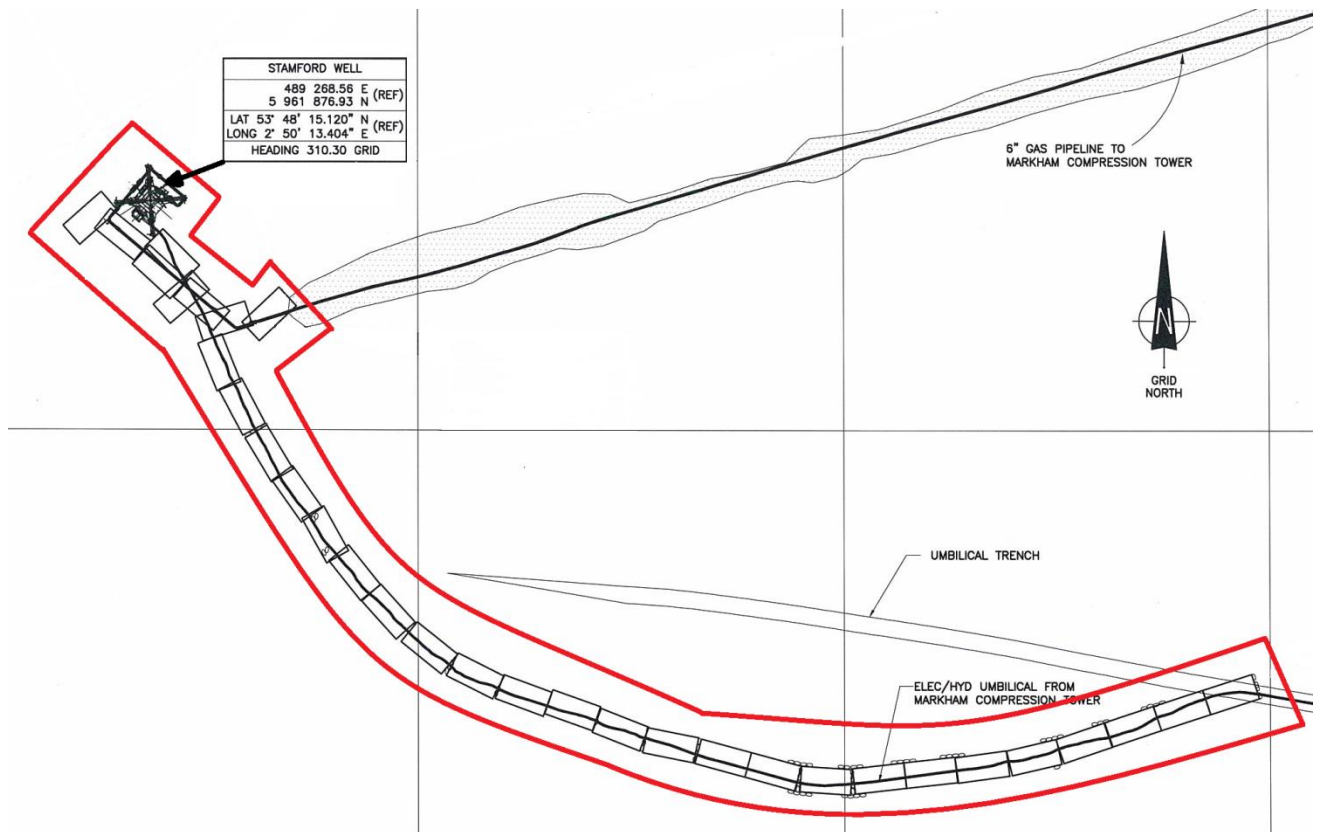
**Figure 4.4.1: Mattress locations on Stamford well approaches**

Prior to the removal of mattresses by the Seven Pacific an ROV survey was first carried out to confirm condition and number of mattresses to be removed at the former Stamford well site as outlined in Figure 4.4.1.

All concrete mats at Stamford were found to be in good condition and were lifted successfully using this method. There was some minor degradation of mats but this did not impede the method used. A trial lift of a mattress was carried out during the DSV phase 1 campaign to provide confidence of the method to be used and condition of the mats. Mattresses within the Markham J6A 500m zone will remain *in situ* until full decommissioning of the Markham J6A platform and associated infrastructure.

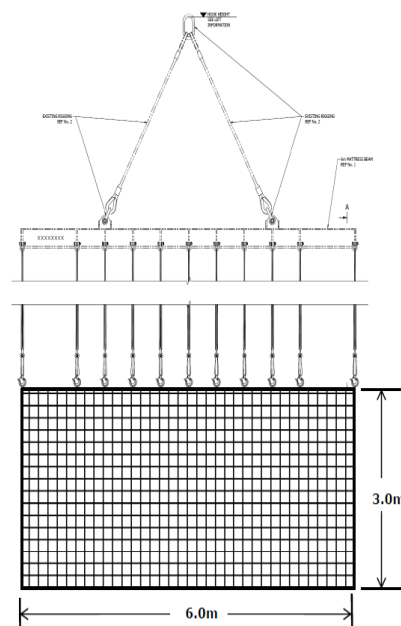
**Figure 4.4.2: Mattress Rigging**

Lifting loops were checked for condition prior to each lift. An ROV operable mattress spreader beam was then deployed via the ROVSV crane (Figure 4.4.2). The lifting beam was positioned over the concrete mattress and snap hooks were connected by ROV along one edge. The crane hook was lifted gently all-the-while with the ROV monitoring the activity. The mattresses were brought back to deck and stored in speed loaders for ease of back load.

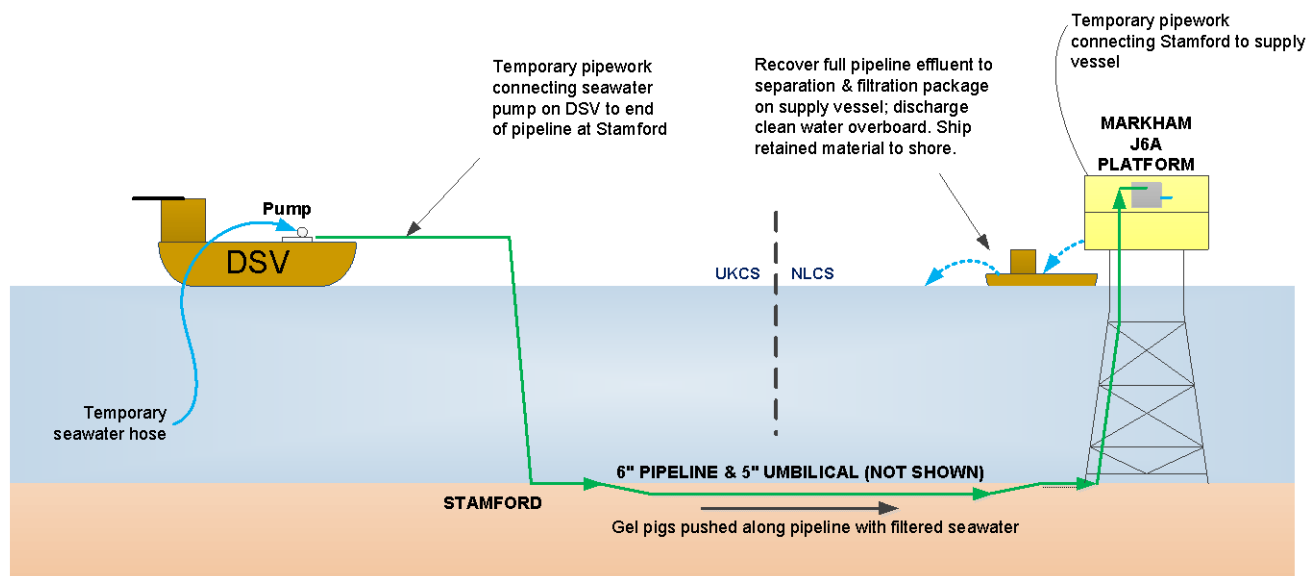
Figure 5.1.1: Stamford Pipeline Flushing Schematic

During Phase 2 pipeline flushing operations were completed between the Seven Pelican and Olympic Taurus (Figure 5.1.1). The Olympic Taurus was located at the former Stamford well location. The DSV located at the Stamford well location removed the blind flange, and installed a flooding flange that was to be used to allow the pipeline to free flood with seawater back to J6A, displacing gas which was to be vented at J6A. The divers also attached a crossover flange assembly to the flushing hose routed to the Olympic Taurus. The DSV then moved to the J6A platform to connect the flushing hose between the DSV and platform. A gel pig train was loaded into the pipeline at the platform and DSV started pumping operations using raw seawater.

During the phase 1 campaign two out of three tie-in spools were removed after they were locally flushed to remove any hydrocarbons remaining. With the necessary barriers and isolations in place, divers disconnected the spools to be recovered to deck. Blind flanges were fitted to the Xmas tree and pipeline ends and leak tests carried out. The pipeline was now disconnected from the well. The spool pieces were found to contain low levels of NORM contamination. Once on deck the pipespools were bagged and tagged and quarantined ready for back load and processing onshore.

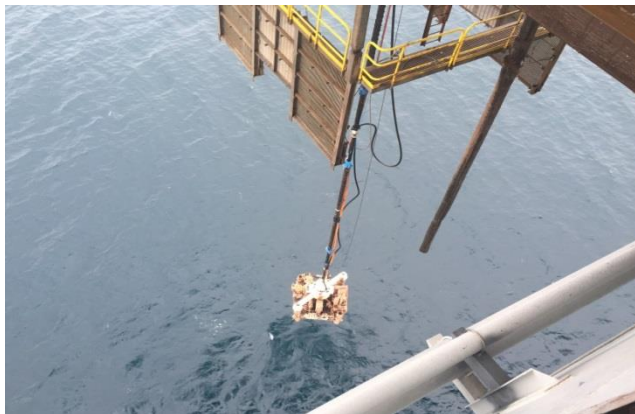
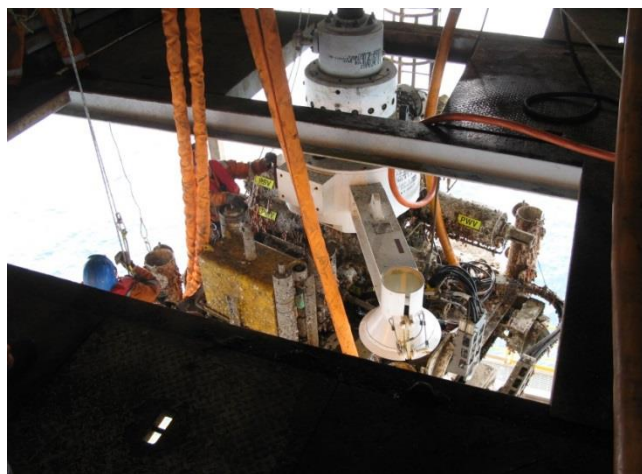
Figure 9.1.1: Recovery of the Xmas Tree

The Xmas tree was recovered using the drill rig during well abandonment operations (Figure 9.1.1) and then transferred to a supply vessel.

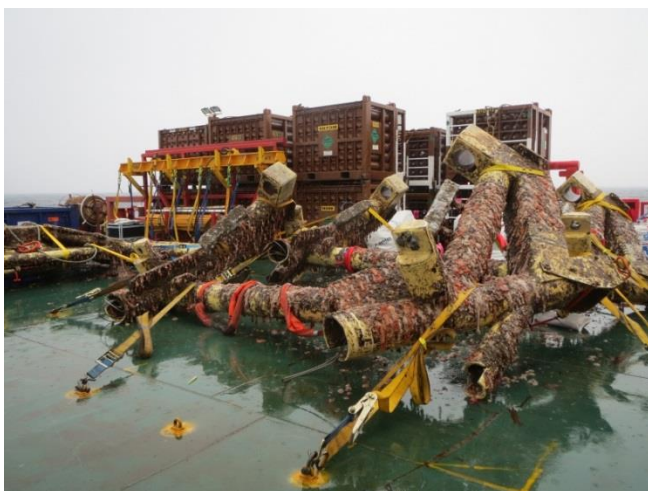
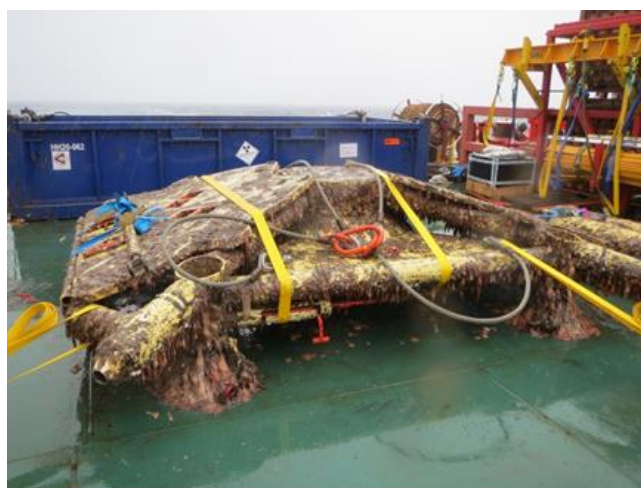
Figure 9.2.1: WHPS & Canopy

The WHPS and top canopy were recovered using the DSV (Figure 9.2.1). The following pictures show the WHPS and top canopy lying on the deck of the Seven Pelican DSV.

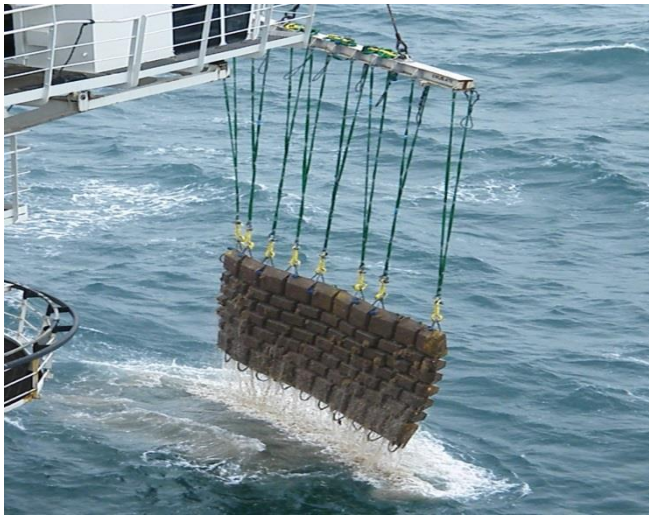
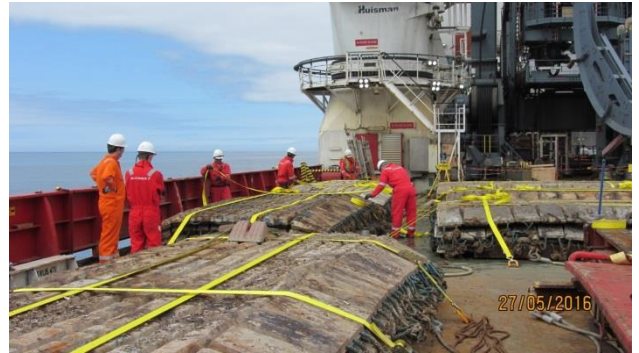
Figure 9.3.1: Mattresses Recovered and Secured on-deck

The concrete mattresses were recovered to the Seven Pelican DSV and secured on deck (Figure 9.3.1).

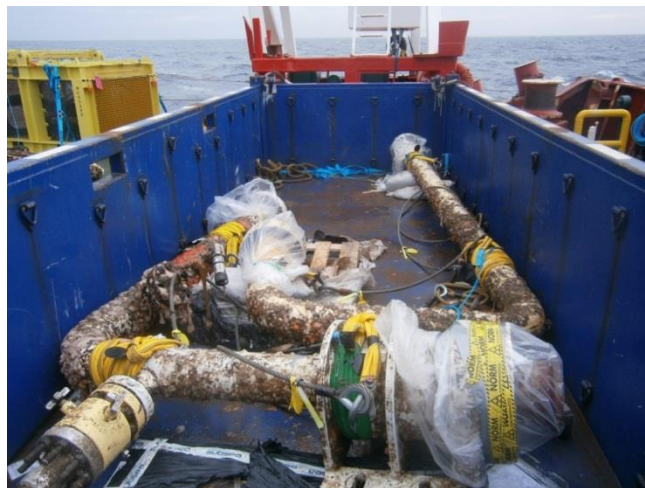
Figure 9.4.1: Pipe spools stored inside container

The pipespools were recovered to the deck of the Seven Pelican DSV. It was established that they were contaminated with NORM and they were dealt with in accordance with standard procedures and protocols (Figure 9.4.1).

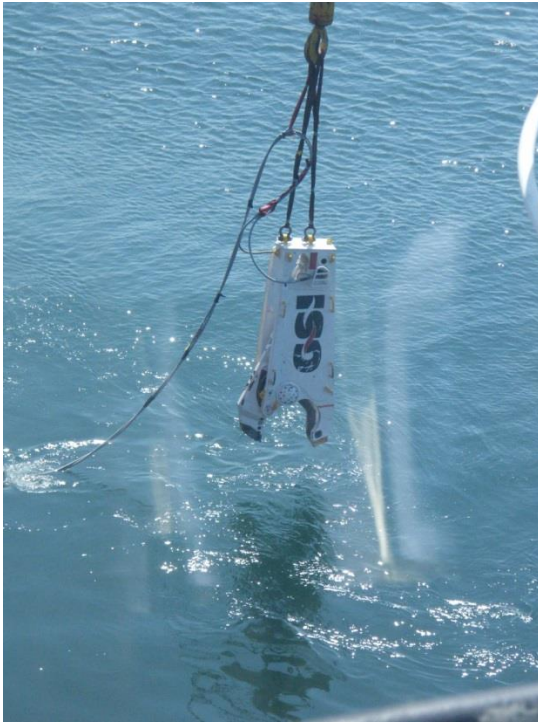
Figure 9.5.1: Hydraulic Shear Cutter

The umbilical pipeline was cut using a shear cutter (Figure 9.5.1) before being recovered to the deck of the Seven Pelican DSV (Figure 9.5.2).

- Pipeline and umbilical cutting: We found it effective to use hydraulic shears for cutting the pipeline, pipespools and umbilical rather than using diamond wire cutters;

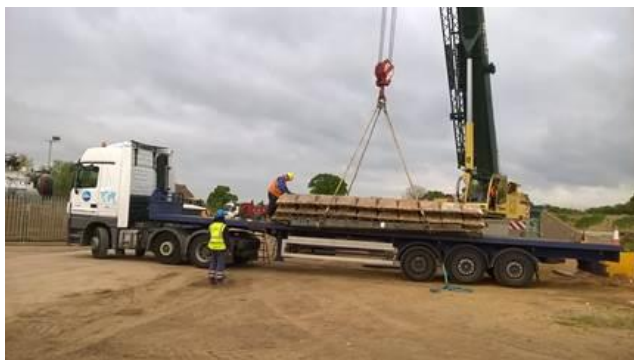
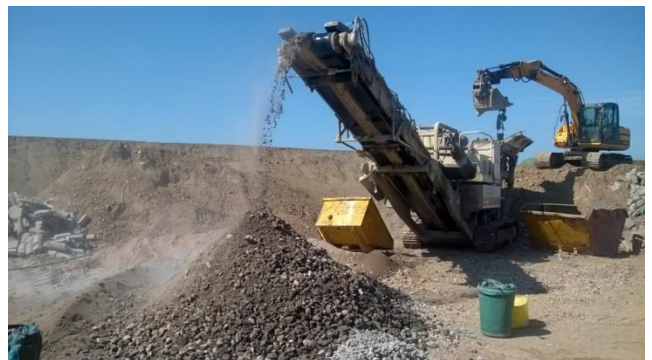
Figure 9.6.1: Concrete mattresses finally crushed and recycled

All items were recycled including the concrete mattresses which were finally crushed and recycled (Figure 9.6.1).

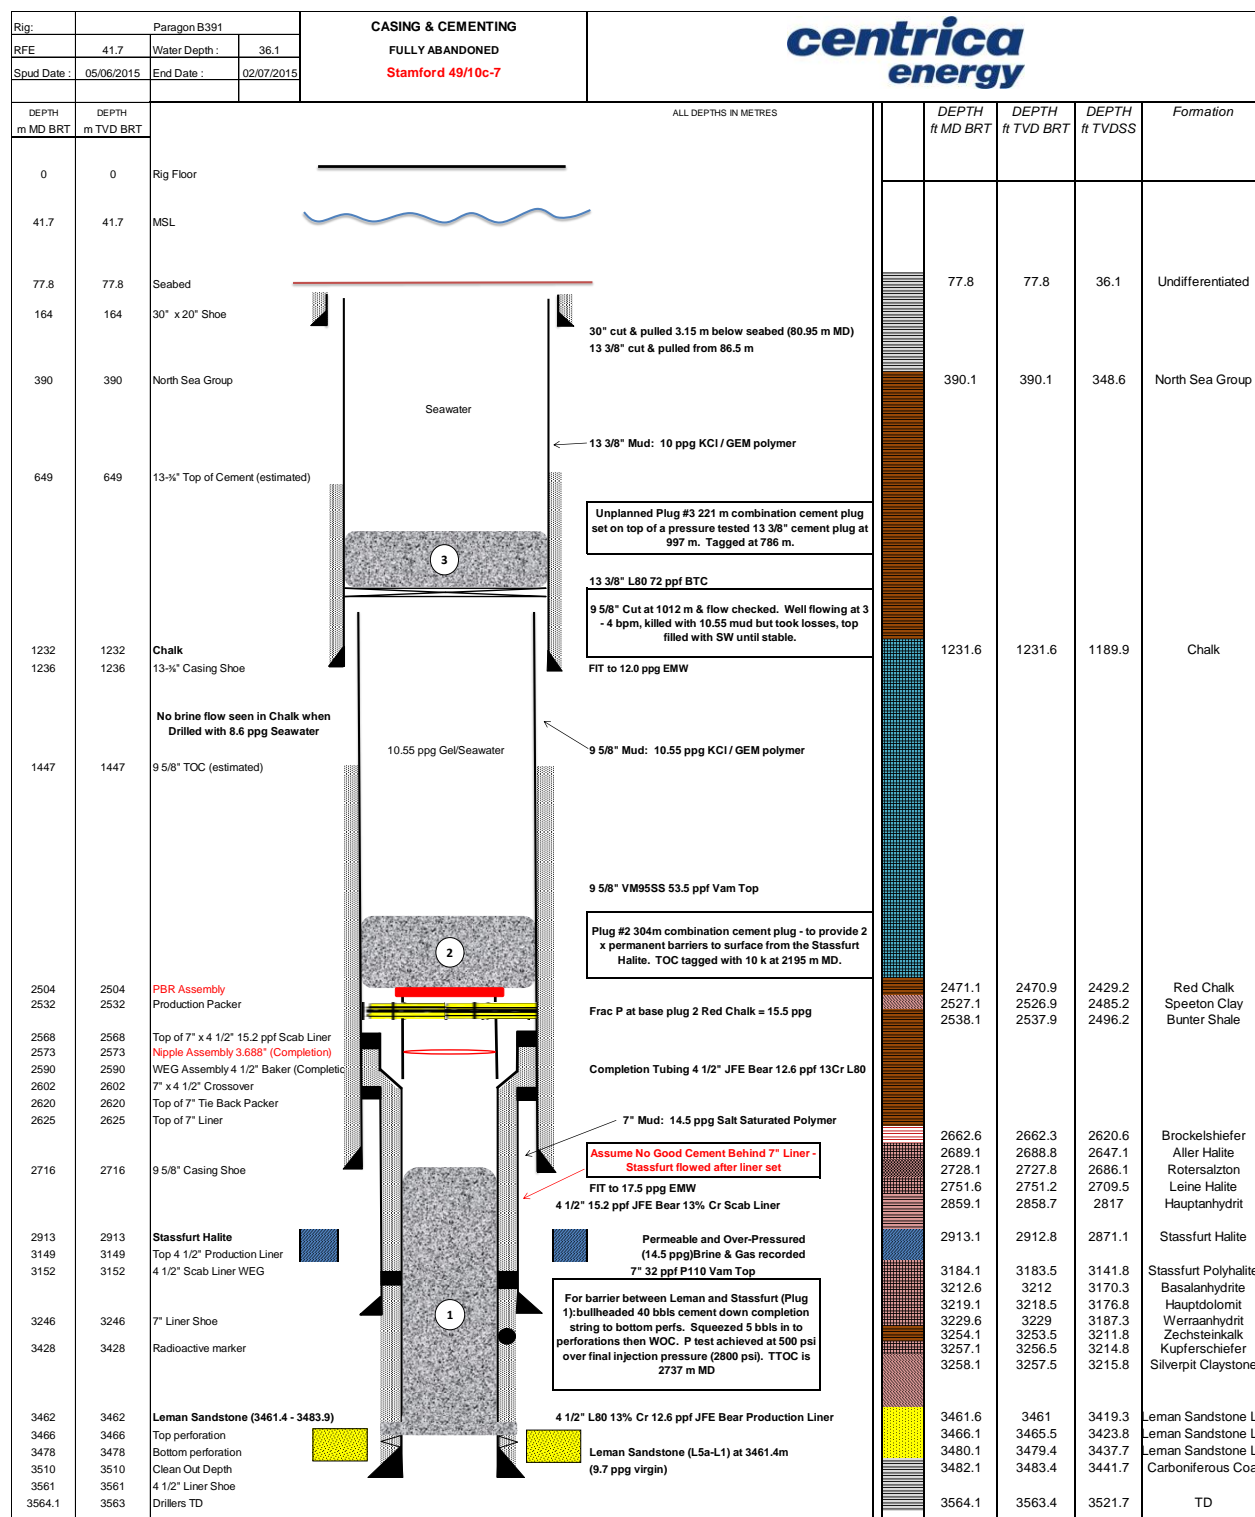
Figure A.1.1: Abandoned Well Schematic

The 9-5/8” casing was cut at 1,012m where brine flow was observed from the shallow Chalks. The well was displaced to 10.55ppg WBM and the 9-5/8” subsequently recovered. The well was then displaced back to seawater and a 221m combination cement plug was set in the 13-3/8” casing, tagged at 786m, providing 2 barriers for isolating the Chalks.

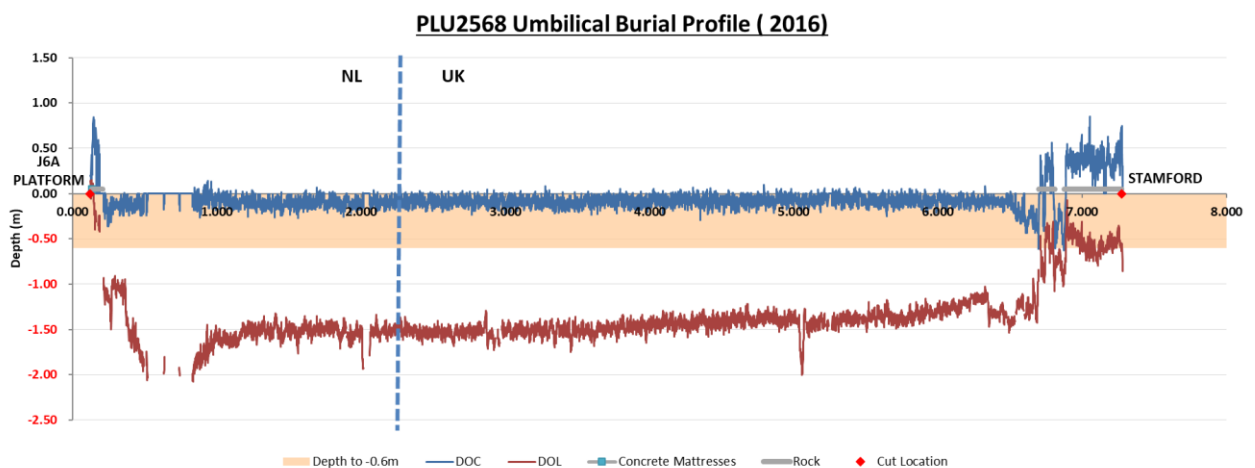
Figure B.2.1: PLU2568 Burial Profile (2016)<sup>3</sup>

<sup>3</sup> Gaps in a burial profile graph can arise in cases where the pipe-tracker is unable to track the umbilical or pipeline reliably. Typically, a pipe-tracker will move along just above the seabed, and its ability to track can be hampered if the pipeline or umbilical is too deep or if there's not enough material (steel) within the umbilical to allow a signal to be reflected-back to the tracker. Typically this can mean that there is at least 800mm depth of cover (DOC). Given the general profile of the umbilical we believe that it remains buried and stable in those areas where no tracking data were recorded.
