Construction noise and vibration Monthly Report – January 2019

London Borough of Camden

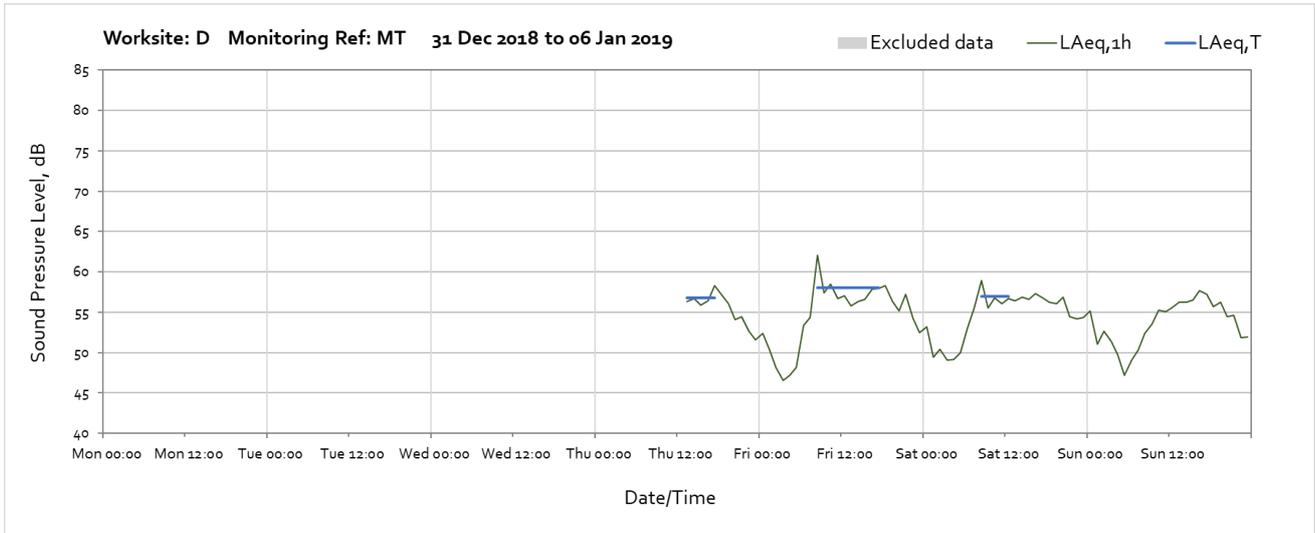
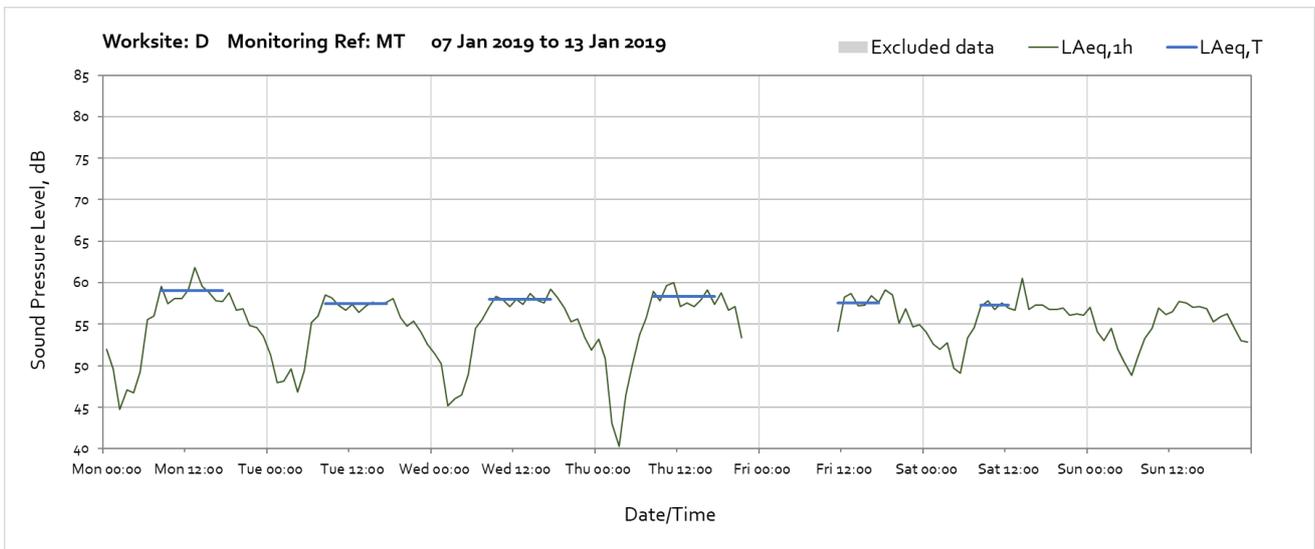
Worksite: D – Monitoring Ref: MT

Note – Missing data between 00:00 on Tuesday 1st and 13:00 on Thursday 3rd due to a loss of power at the noise monitor.

Note – Missing data between 22:00 on Thursday 10th and 11:00 on Friday 11th January due to a loss of power at the noise monitor.

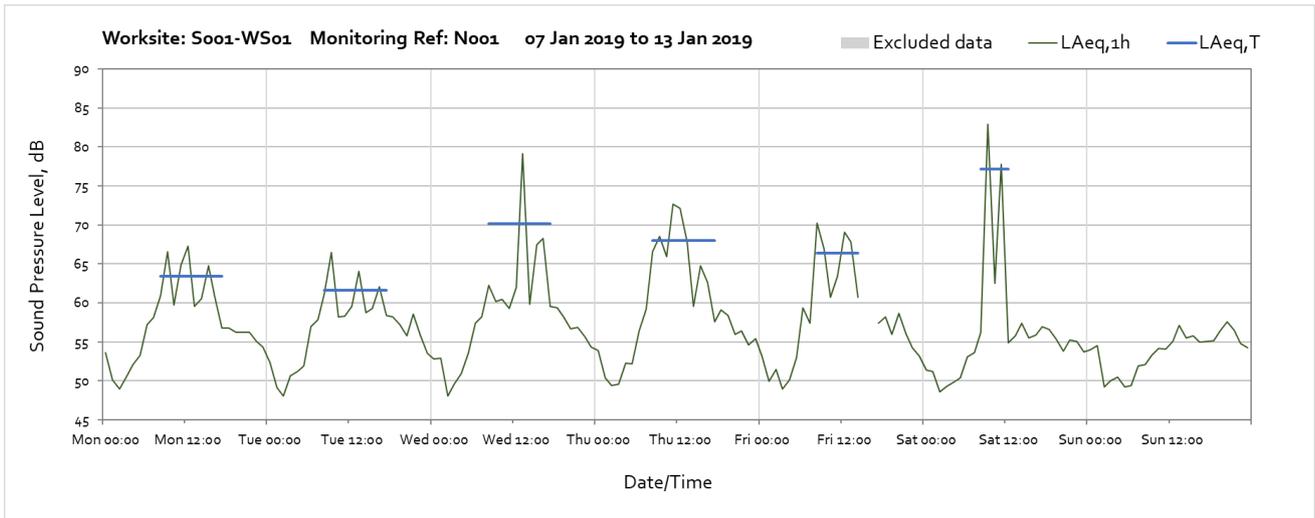
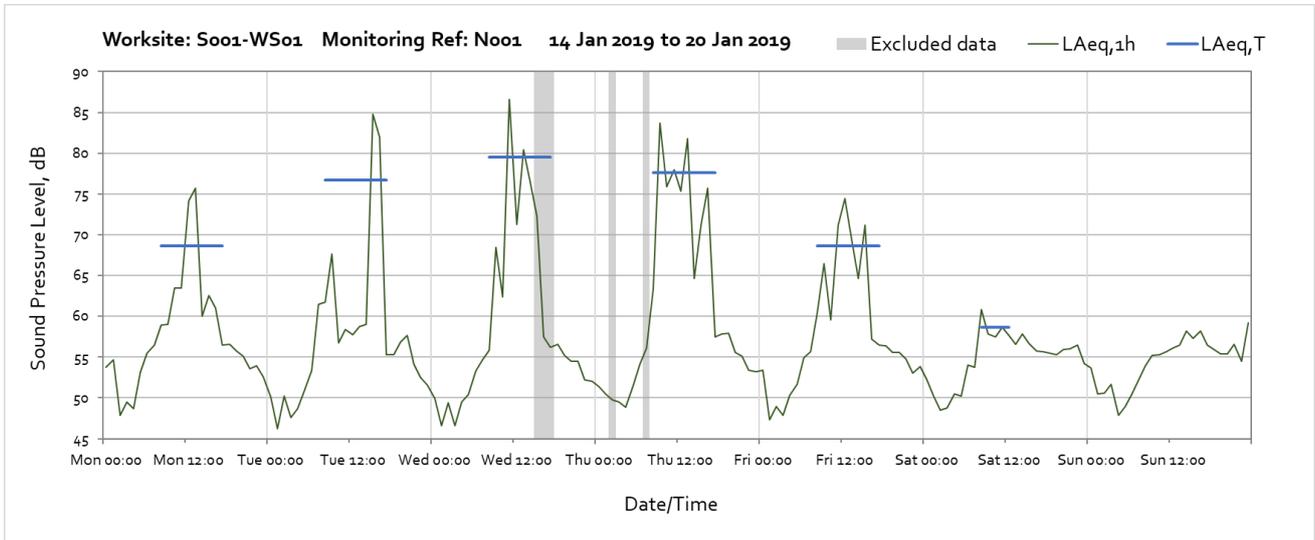
Worksite: S001-WS01 – Monitoring Ref: N001

Note – High noise levels on the early hours of the 1st January were due to New Year’s Eve celebrations and have been excluded to calculate values in Table 5.

Note – Missing data between 15:00 and 17:00 on Friday 11th January due to a loss of power at the noise monitor.

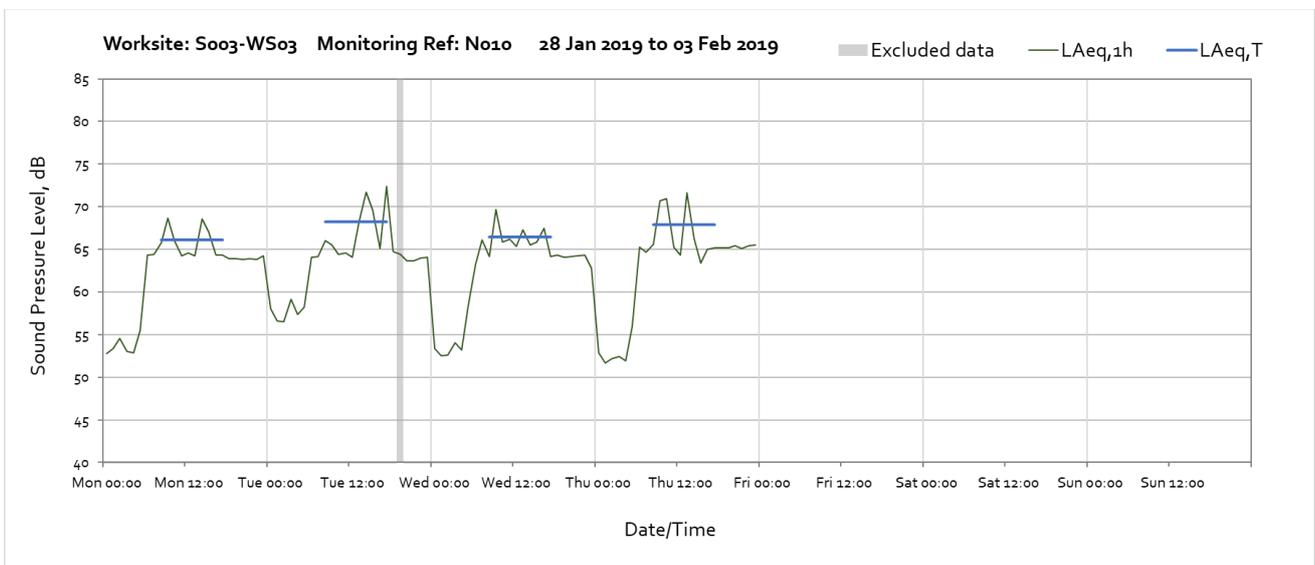
Worksite: S003-WS03 – Monitoring Ref: N010

Note – High noise levels during the night of the 14th and 19th January are thought to be due to noise from mechanical plant at a nearby hotel. No HS2 construction activities were taking place in proximity to this location during this period

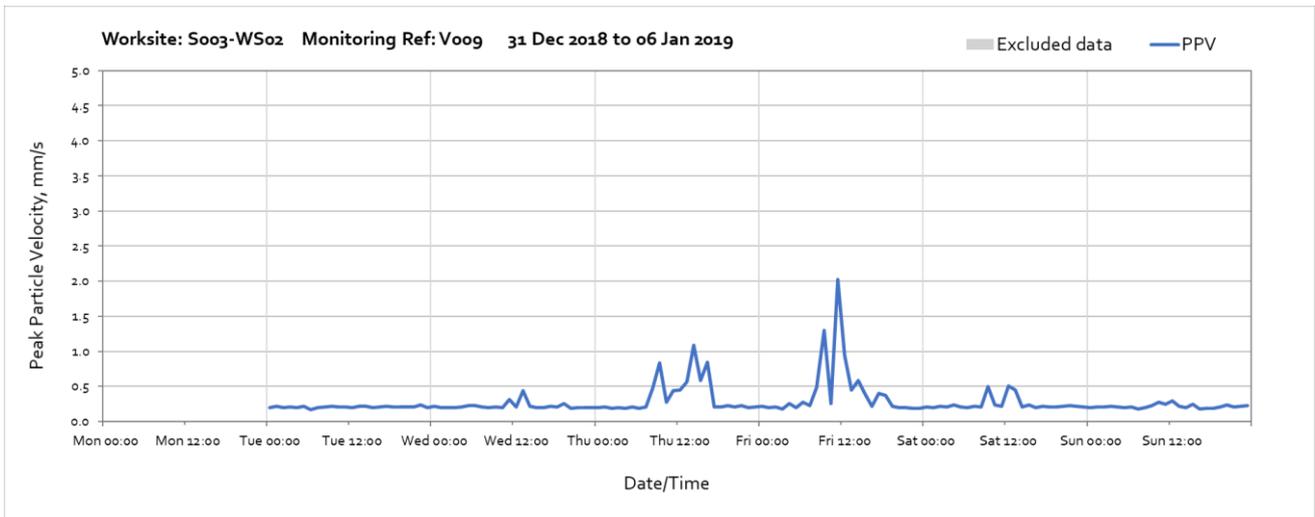
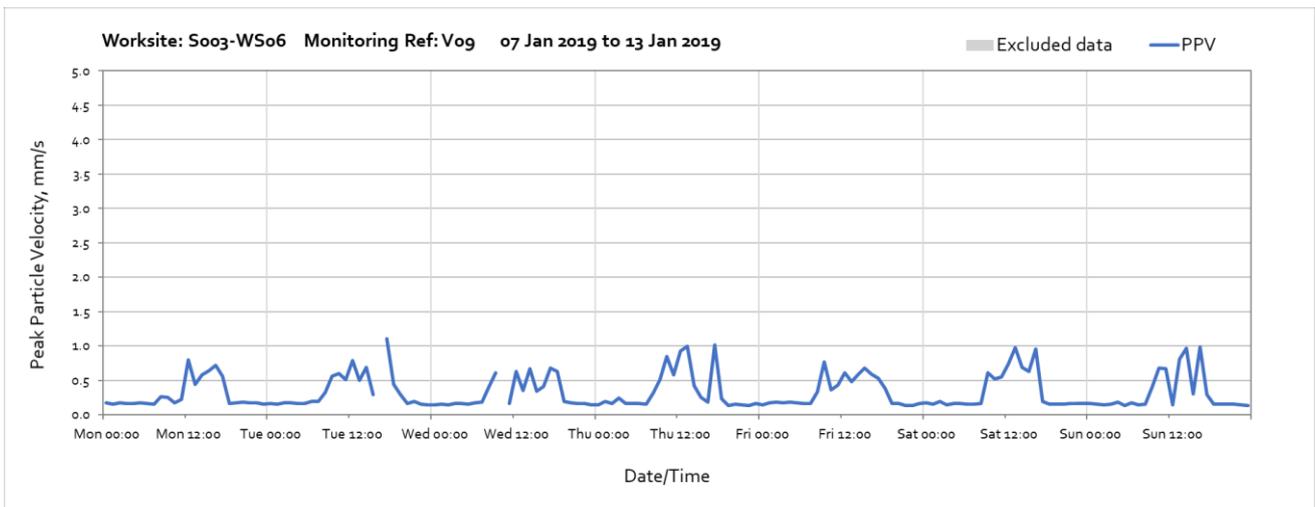
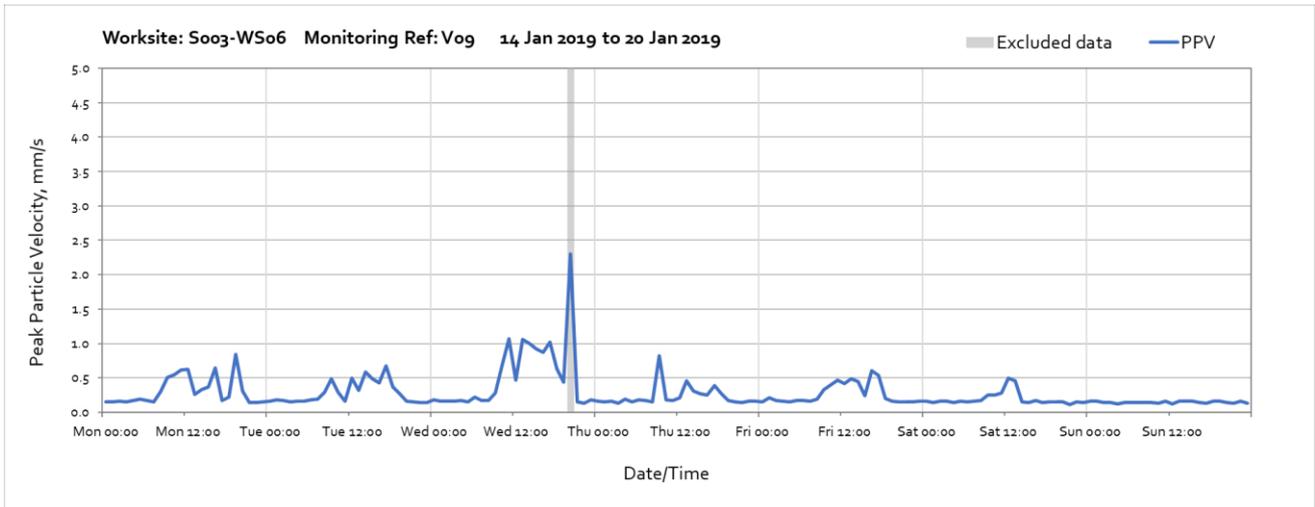
Worksite: S003-WS02 – Monitoring Ref: V09

Note – Missing data at 16:00 on the 8th January and at 10:00 on the 9th January were during handling of the vibration monitor.

Note – High vibration levels at 20:00 on the 16th January were due to localized vibration events in close proximity to the monitor and were not due to HS2 construction works.

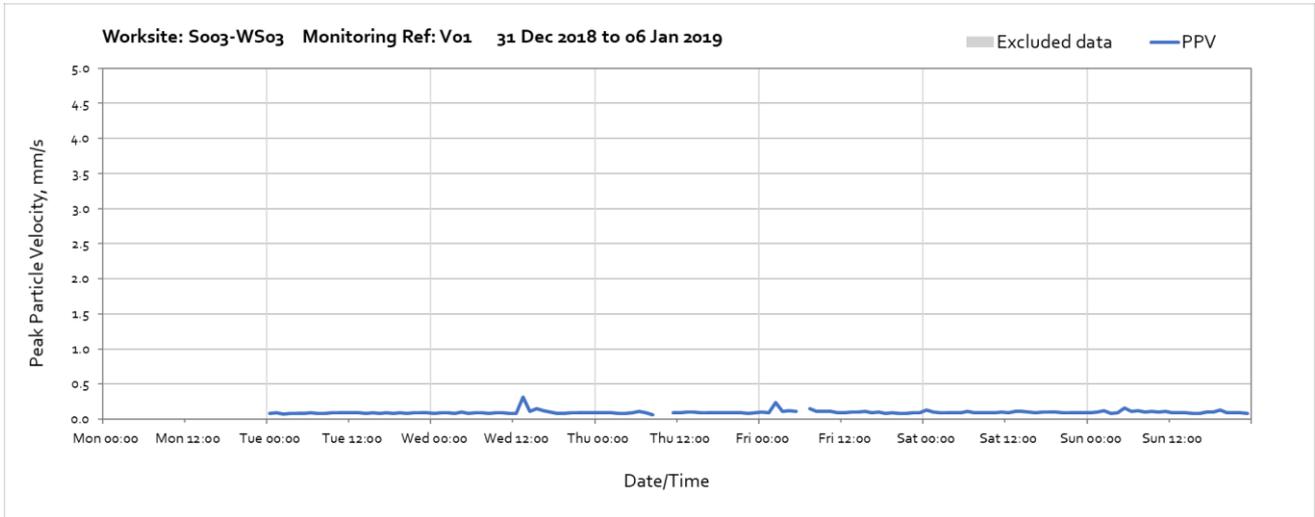
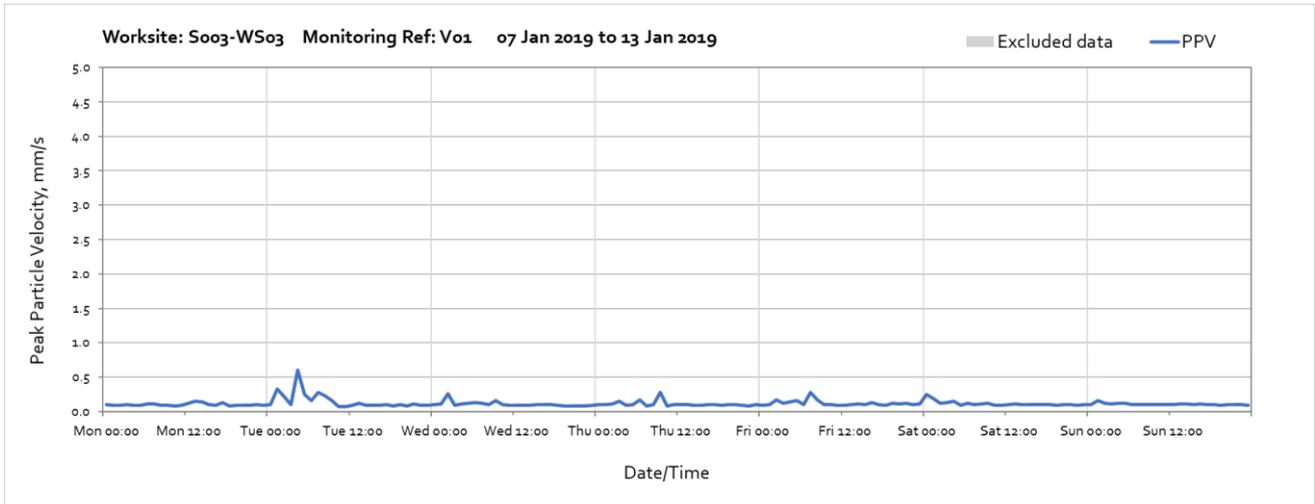
Worksite: S003-WS03 – Monitoring Ref: V01

Note – Missing data between 09:00 and 11:00 on the 3rd January were during handling of the vibration monitor.
 Missing data at 6:00 on the 4th January due to temporary disruption.

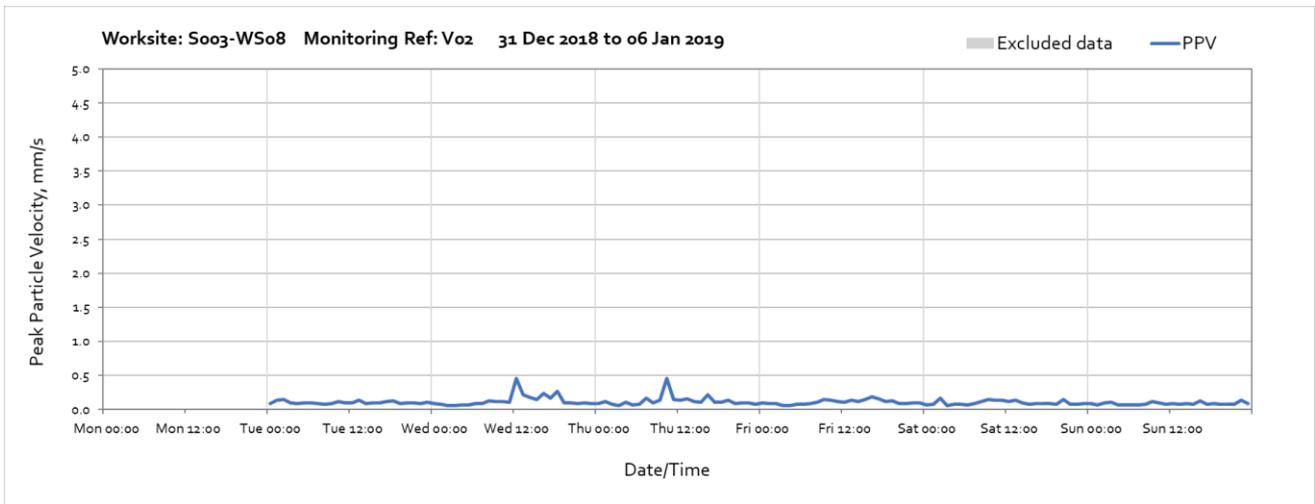
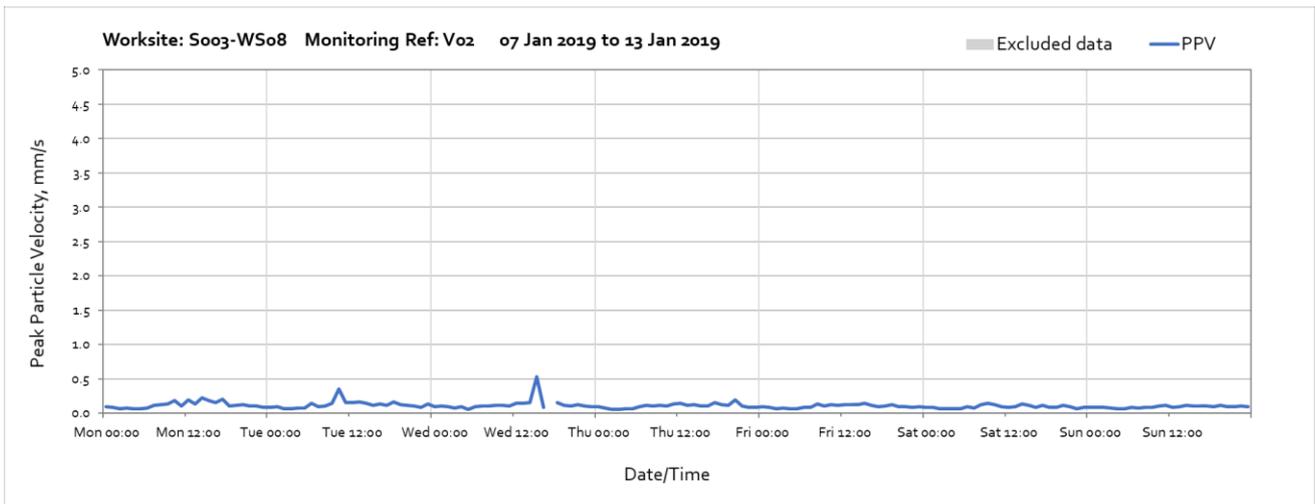
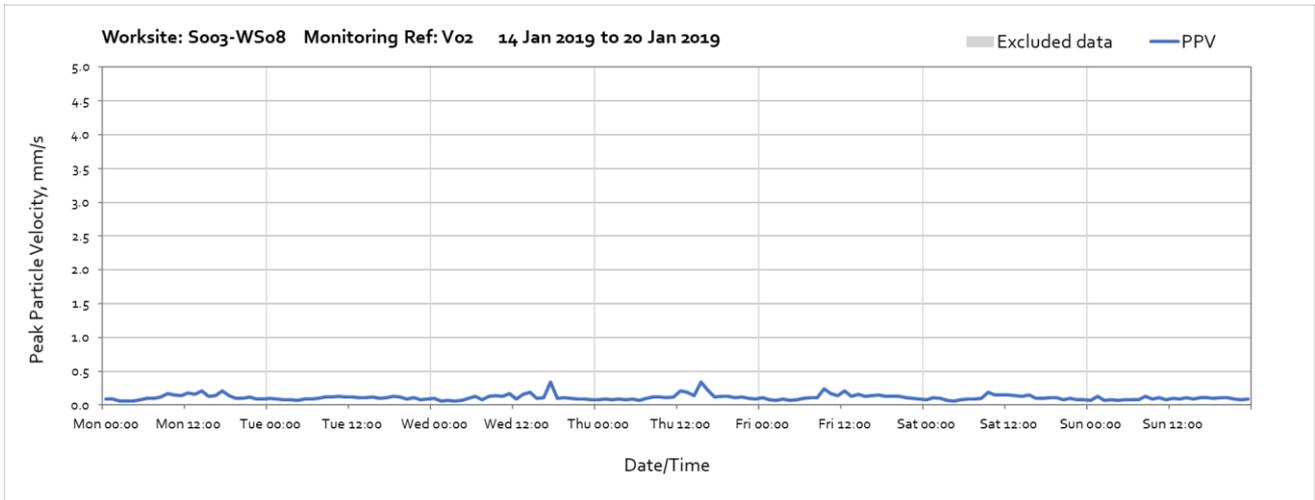
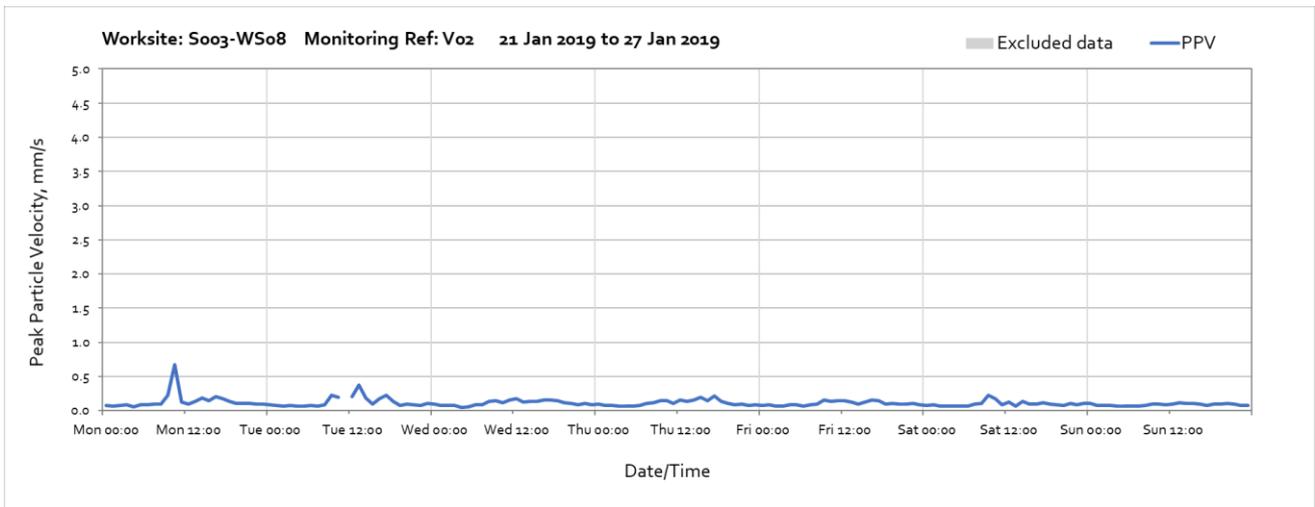
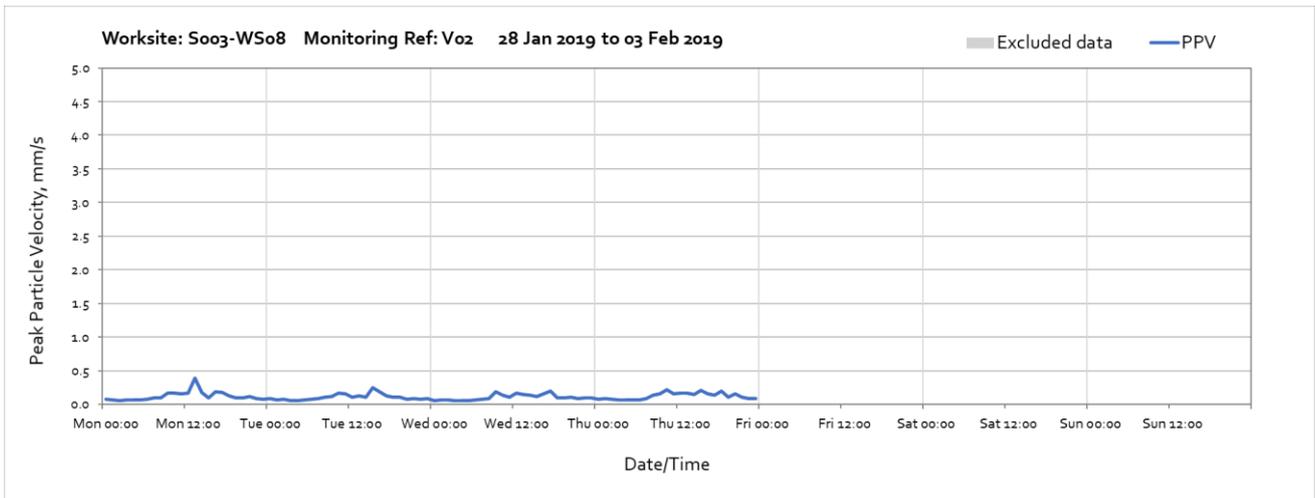
Worksite: S003-WS08 – Monitoring Ref: V02

Note – Missing data at 16:00 on the 9th January were during handling of the vibration monitor.

Note – Missing data at 11:00 on the 22nd January were during handling of the vibration monitor.
