Grenfell Investigation into Potential Land Contamination Impacts

Stage 1 Overarching Report

Royal Borough of Kensington and Chelsea

Project number: 60595731

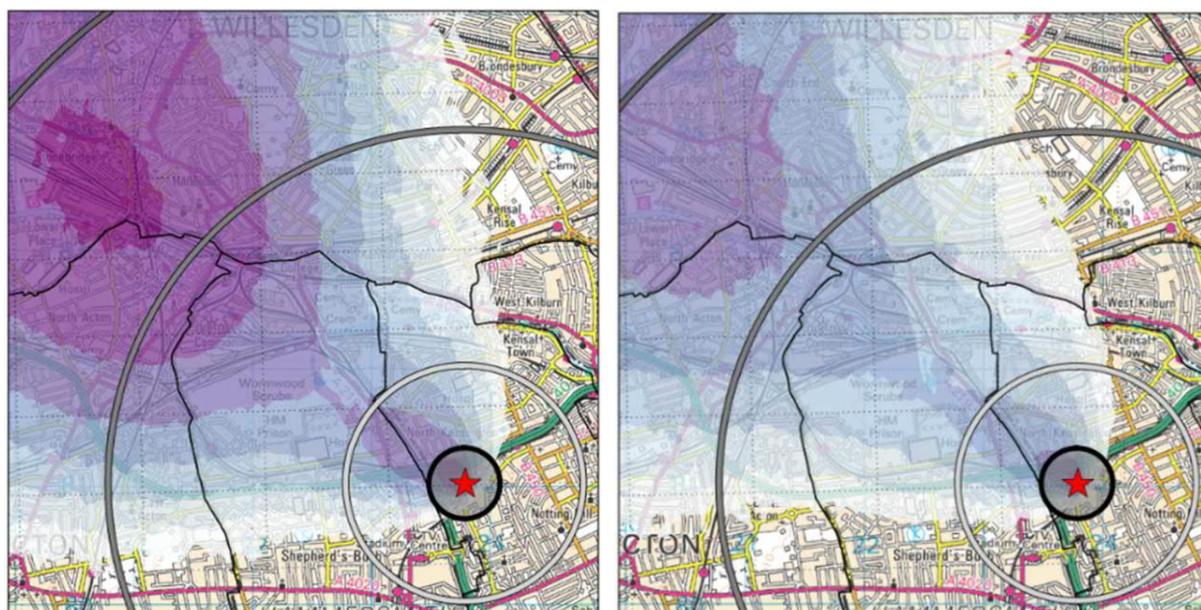
Figure 1. Copy of Figure 9f and 10f from Met Office report FRTR 637

The Met Office produced a number of model outputs for varying particle sizes and densities that provide an indication of the area over which smoke particles may have been deposited. What the modelling does not provide is absolute values for the deposited mass of particles in any one area, because of the uncertainties and limitations in the approach. The modelling suggests that particles were deposited up to 5km away (the limit of the images provided in the report), and that deposition may have been heaviest within a relatively narrow area up to 1-2km of the Tower and then a much broader area from 2km onwards.

The authors make clear the limitations of the modelling; namely:

- It doesn't consider particles larger than 100µm (0.1mm), and therefore does not attempt to model the dispersal and deposition of debris emitted during the fire.
- The model cannot reliably predict deposition within 300m of the Tower.
- There is a lack of knowledge on the nature of the particles emitted (size, density, and shape).
- There are uncertainties in the meteorological conditions and the source emission estimates.

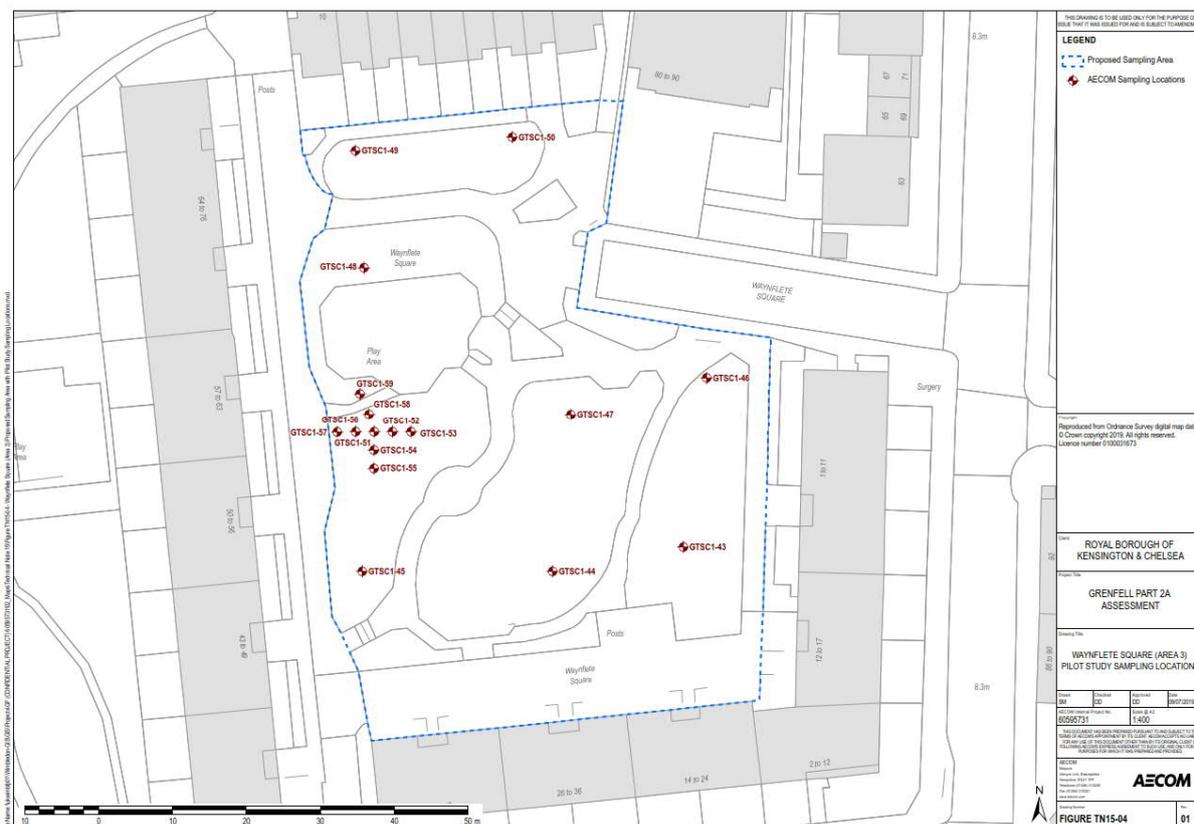
Figure 3. Pilot study sampling locations (based on TN17-01)

Soil samples were collected from nine locations along 20m sampling grids, at depths of 0-5cm and 10-15cm to explore the variation of COPC concentrations with depth. Eight additional samples (2.5m apart) were collected at one grid location in a radial pattern from the central sample, to explore the possibility of variation in COPC concentration on a smaller scale. The sampling locations within Waynflete Square are shown on **Figure 3**.
