Grenfell environmental checks – Stage 1 results

The following is designed to help you understand and navigate the information provided within the full Stage 1 report.

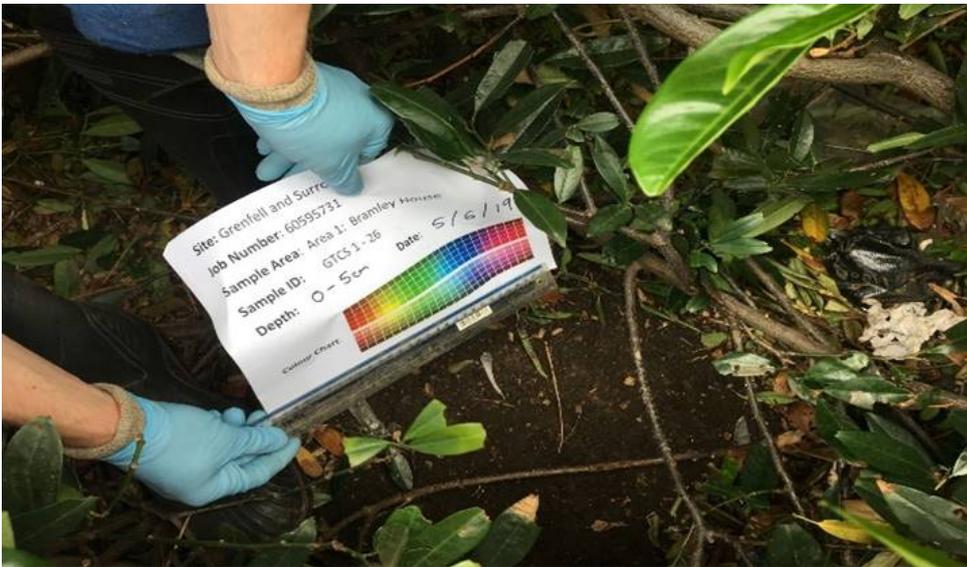
The image below shows a record of one of the samples being taken, including the sampling location being measured and the details of the sample recorded.

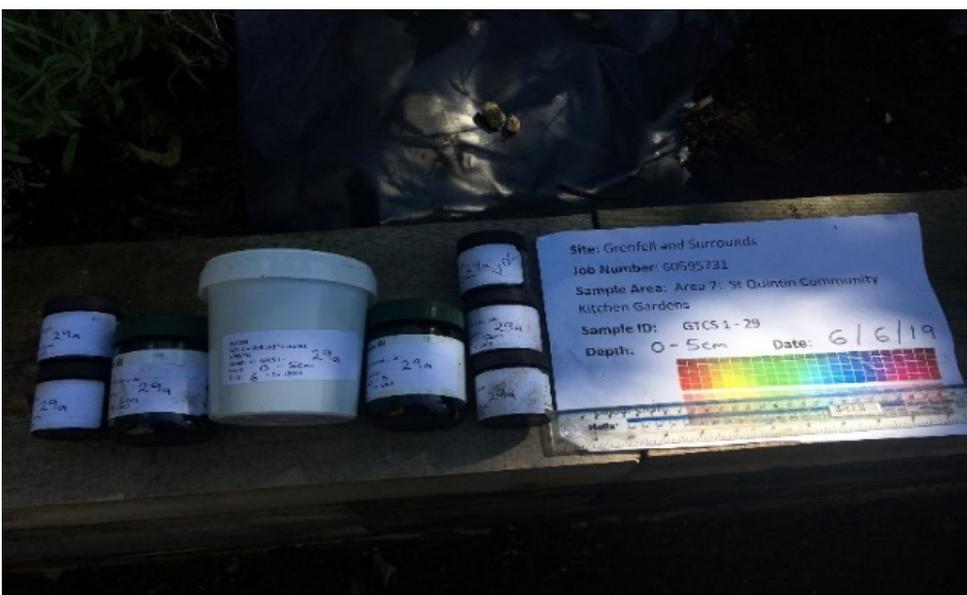
The second image shows the stored samples and the information about the location of the samples, ready to send to the laboratory for analysing.
