SAFETY FLYER TO THE FISHING INDUSTRY

Fatal man overboard from the creel boat *Sea Mist* (BF918)

Macduff, Scotland on 27 March 2019

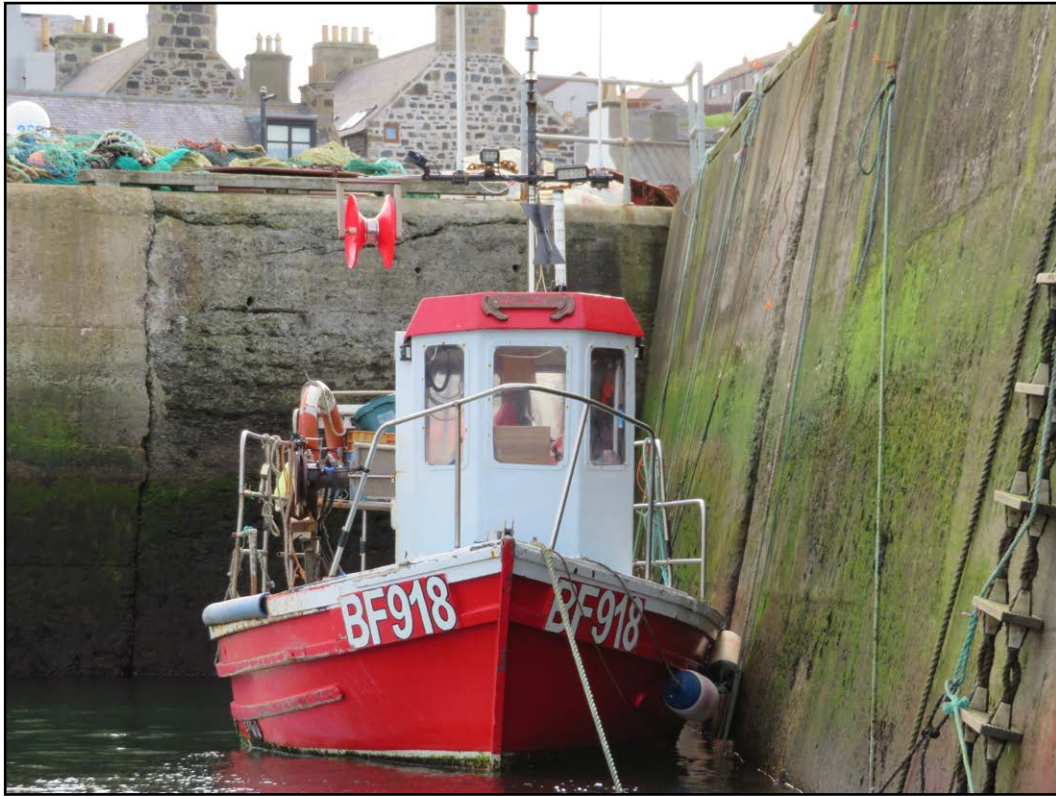
Sea Mist was set up for self-shooting and the skipper usually remained in the wheelhouse while shooting creels. However, it was evident from the discovery of one of his boots entangled in the back rope that on this occasion he was on the working deck while the gear was being shot.

1. There was no means of separating the crew from the fishing gear on *Sea Mist*'s deck. It is unknown why the skipper was on deck while shooting his gear, however, the presence of a physical barrier between him and the back rope would probably have prevented this accident.
