Perenco UK Limited  
Welland Decommissioning Programmes  
CLOSE OUT REPORT

**Post – Consultation Draft**

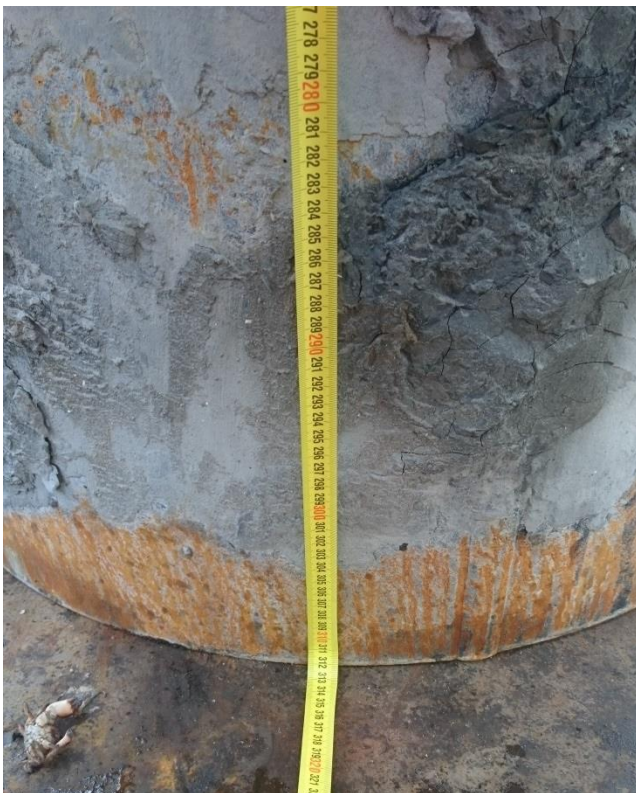
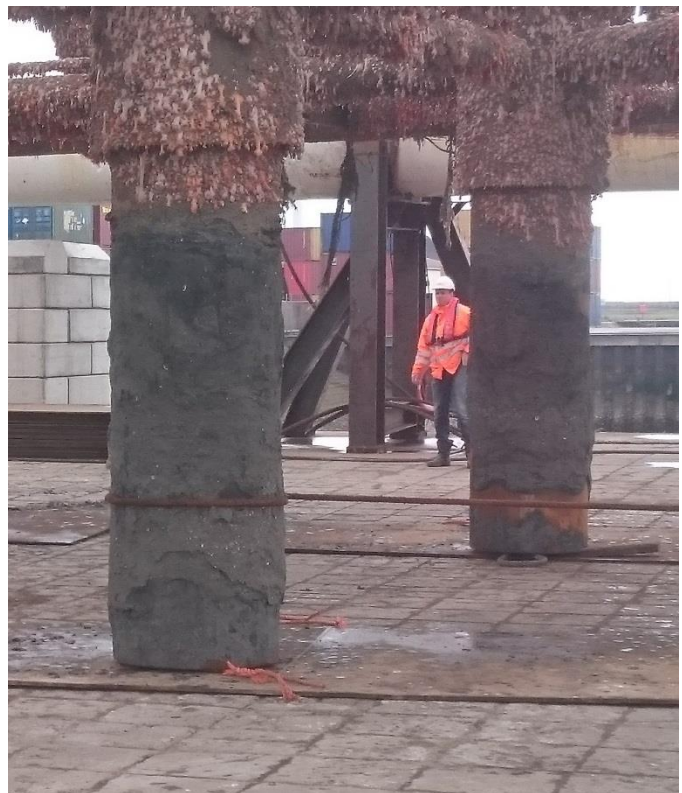
The geotechnical investigation carried out by Structural Analysis and Geotechnical Engineering Ltd in the Welland field in 1987 found that the stiff clay layer commenced 1.5m below the seabed. This was confirmed when the WHPS were removed. The bottom 1.5m – 2.0m of the WHPS piles were coated with stiff grey clay. The summary table of ground conditions from the original geotechnical investigations carried out for. The wellhead structures is reproduced in Figure 1.5 below. Fig 1.6 shows the stiff grey clay stuck to the surface of the bottom sections of the piles. This proves that wells 3's conductor was cut off well below the top 300mm of the stiff clay layer.

Fig 1.6 – Photos illustrating Stiff grey clay stuck to bottom 1.5 - 2.0m of cut WHPS pile

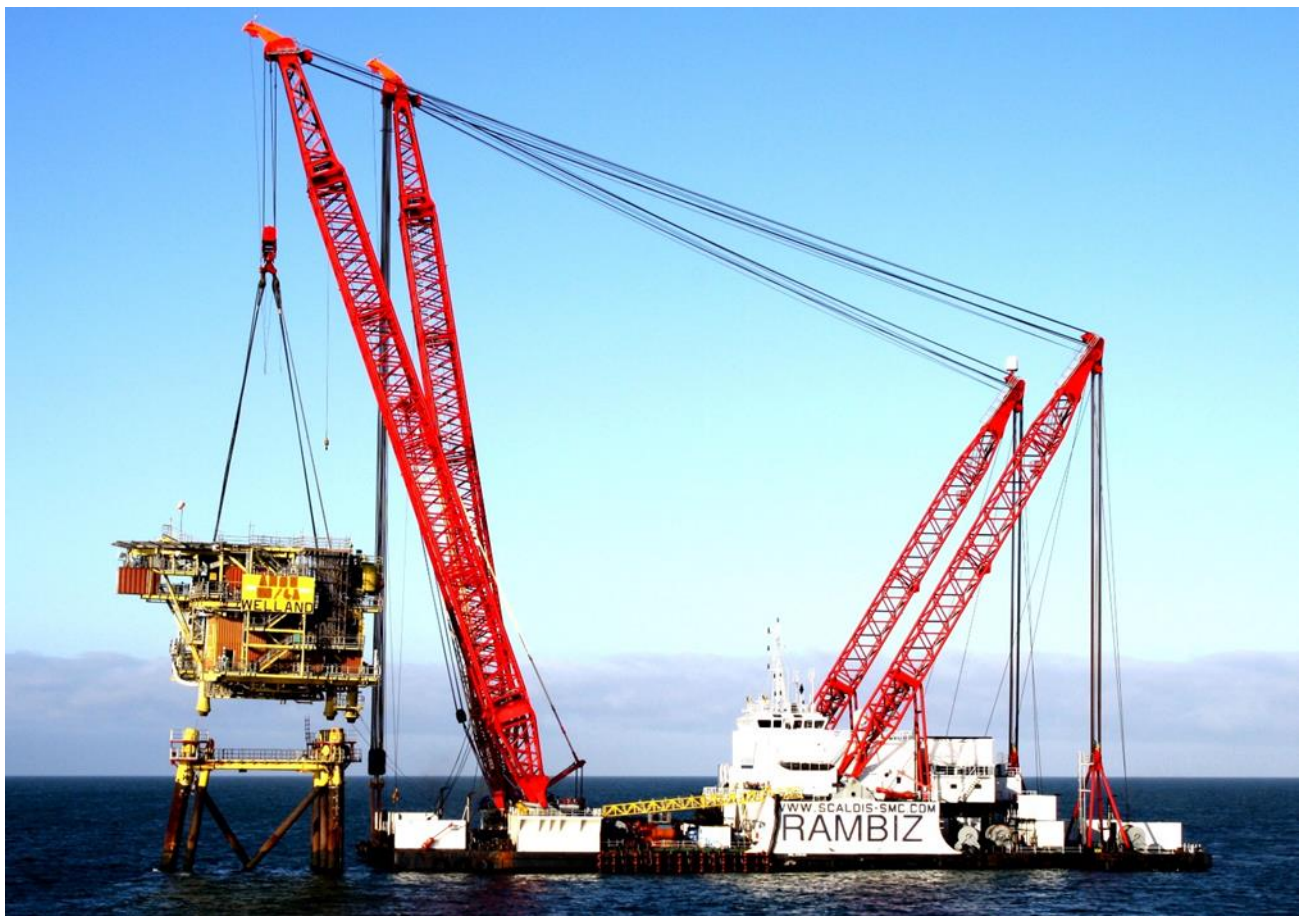
**Fig 1.7 - Rambiz HLV Lifting Welland Topside**

The first suitable weather window occurred in early January 2011, Rambiz mobilised to the field and installed her anchors with the assistance of the anchor handling tug Fairplay 31. Scaldis riggers connected the lift

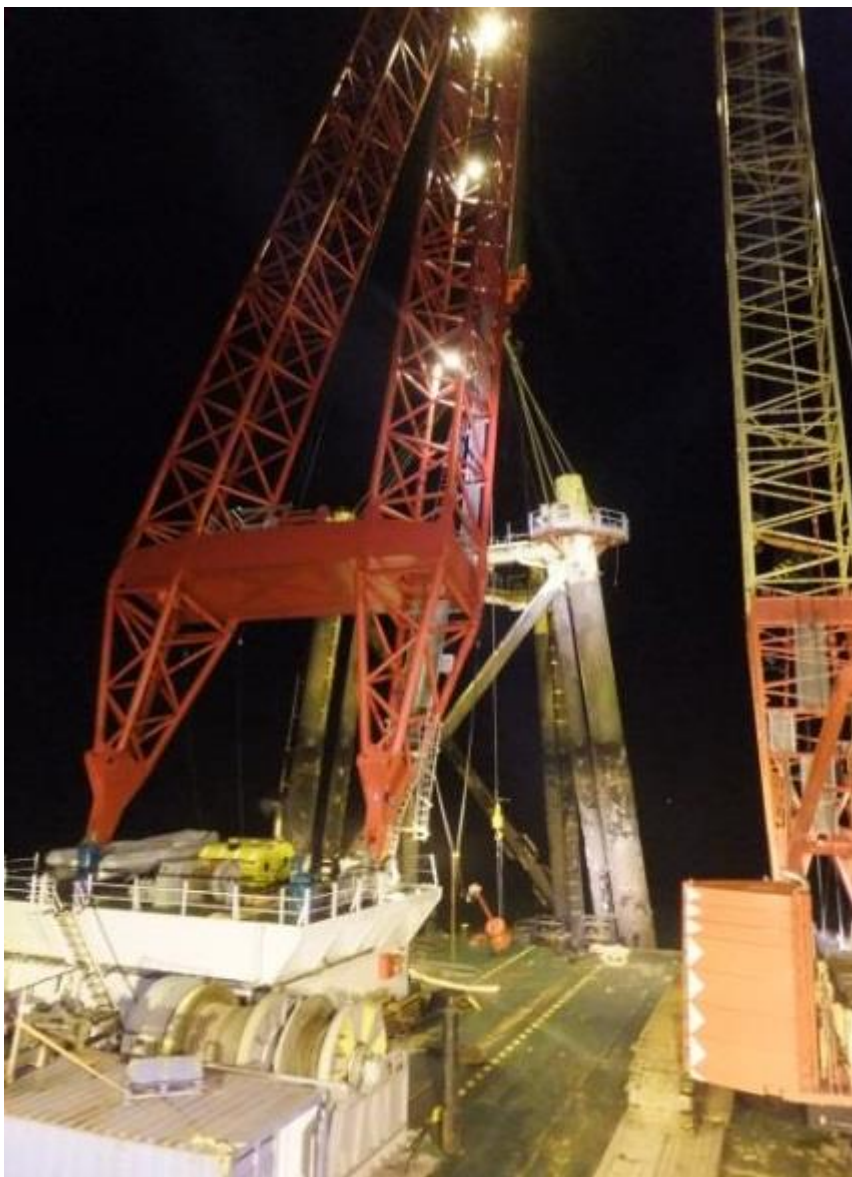
Given that the operation took place in winter, the activity schedule needed built-in flexibility to cope safely with weather interruptions. For every sub-phase of the operation at least one 'safe fall-back position' was identified and appropriate arrangements were put in place. For severing the piles just below the topside, the structural engineers Overdick and cutting contractor Proserv developed a novel cut design that would keep the legs centred on the piles and avoid any damage to the existing stabbing cones inside the piles, which were needed to align the topside on the transport barge grillage.

Proserv conducted several mock-up tests to fine tune the set up and achieve the correct result. In addition to the shape of the cut, a set of contingency clamp-on devices were designed, these would have allowed the platform to survive a severe storm condition even with all the legs cut. This was just one of several contingency solutions developed for a variety of scenarios.

On completion of cutting, the latest weather forecast was reviewed by all parties (MWS, Perenco, Rambiz master and Scaldis project team) and authorisation to lift the 960t Welland topside was agreed.

The lifting operations proceeded smoothly with the three cut points separating cleanly. Rambiz moved away from the jacket structure on its anchor cables, making room for the transit barge and tugs to move into position. Docking with pre-installed grillages was achieved at the first attempt followed by sea-fastening, certifications and towing to Flushing in the Netherlands.

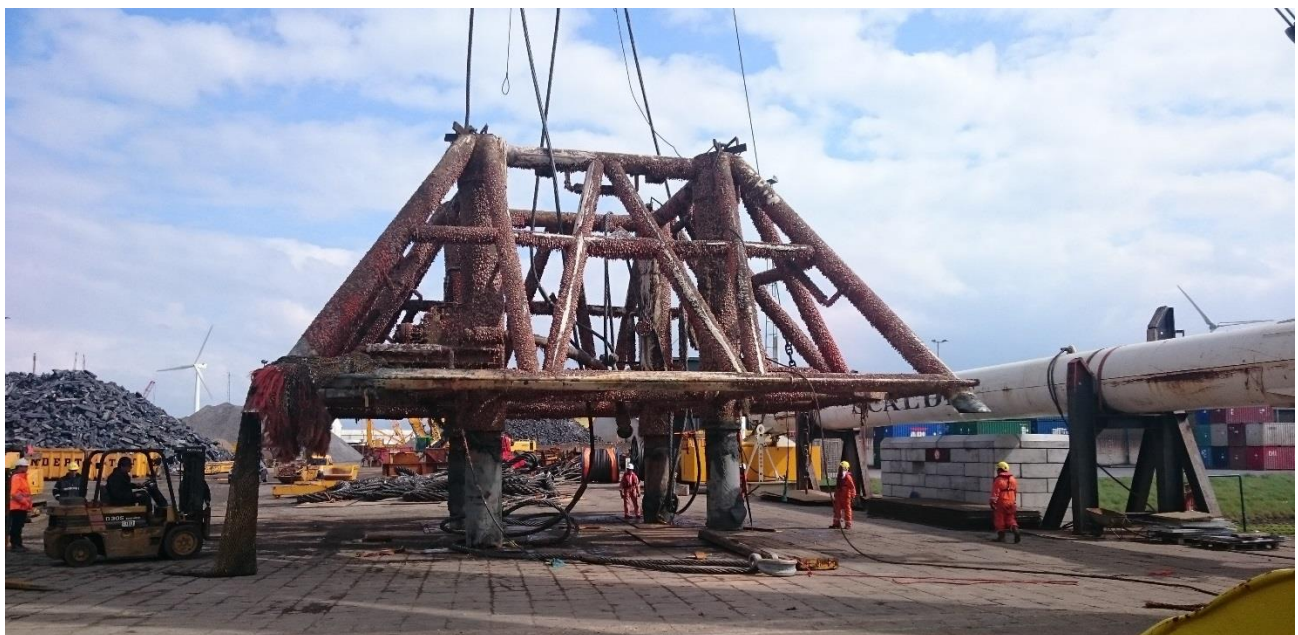
**Fig 1.11 - Welland WHPS Lifted Onshore**

The original wellhead protection structure (WHPS) removal methodology described in the decommissioning programme was to dredge the seabed around and inside the structure using ROVs and divers, to allow the piles to be severed externally by diamond wire cutting or explosive severance. The normal method of dredging the piles and internally cutting them below seabed level, using an internal abrasive water jet cutting tool was not viable because the piles on all three structures had been filled with grout.

The Contractor Boskalis mooted an alternative approach, they proposed building a remotely operated tool that would bore / dredge out the grout in the pile, thereby allowing access for an internal cutting tool. Removing the WHPS in this way brought many benefits: it was inherently safer, as it would allow the WHPS to be removed without divers; it was also far more environmentally friendly, as no external dredging needed to be carried out to form a large crater in the seabed for external cutting access. This was the approach that was adopted and the Decommissioning Programme was revised to reflect this change in methodology.

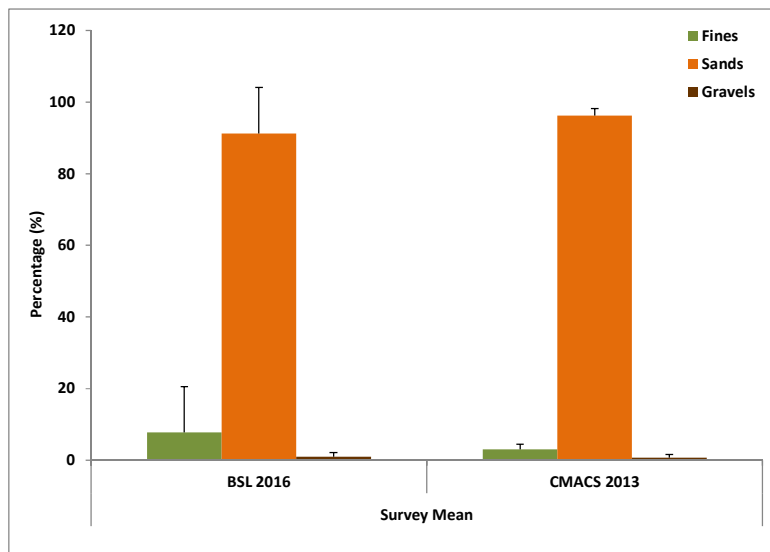
A comparison with previous data collected by CMACS in 2013 revealed no significant change in the proportions of fines, sand and gravel between the surveys with only a slight increase in percentage fines (~+5%) and a decrease in the proportion of sand (~-5%) recorded during the current survey (refer to Figure 1).

Figure 1 Comparison of Particle Size Distribution with Historical Data

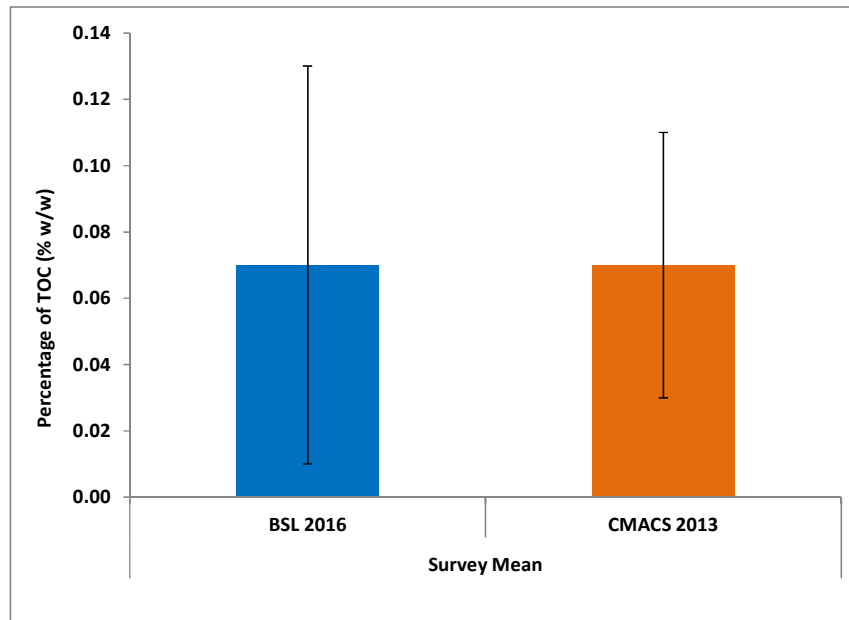
TOC concentrations were compared with previous data and remained unchanged between both surveys, showing a consistent mean value of 0.07% (Figure 2). A slightly higher level of 0.13% was recorded at one of the historical stations which coincided with the higher percentage of fines found at this station.

Figure 2 Comparison of Total Organic Carbon with Historical Data
