# AAIB Bulletin S4/2014

### SERIOUS INCIDENT

<b>Aircraft Type and registration:</b>	B787-8, ET-AOP
<b>No &amp; Type of Engines:</b>	2 General Electric GENx-1B turbofan engines
<b>Year of Manufacture:</b>	2012 (MSN 34744)
<b>Location:</b>	London Heathrow Airport
<b>Date &amp; Time (UTC):</b>	12 July 2013 at 1534 hrs
<b>Type of Flight:</b>	Not applicable
<b>Persons on Board:</b>	None
<b>Injuries:</b>	Not applicable
<b>Nature of Damage:</b>	Extensive heat damage in upper portion of rear fuselage
<b>Information Source:</b>	AAIB Field Investigation

This Special Bulletin contains information on the progress of the investigation into a ground fire on an unoccupied Boeing 787-8, registration ET-AOP, at London Heathrow Airport on 12 July 2013. It follows the publication of Special Bulletin S5/2013 on 18 July 2013.

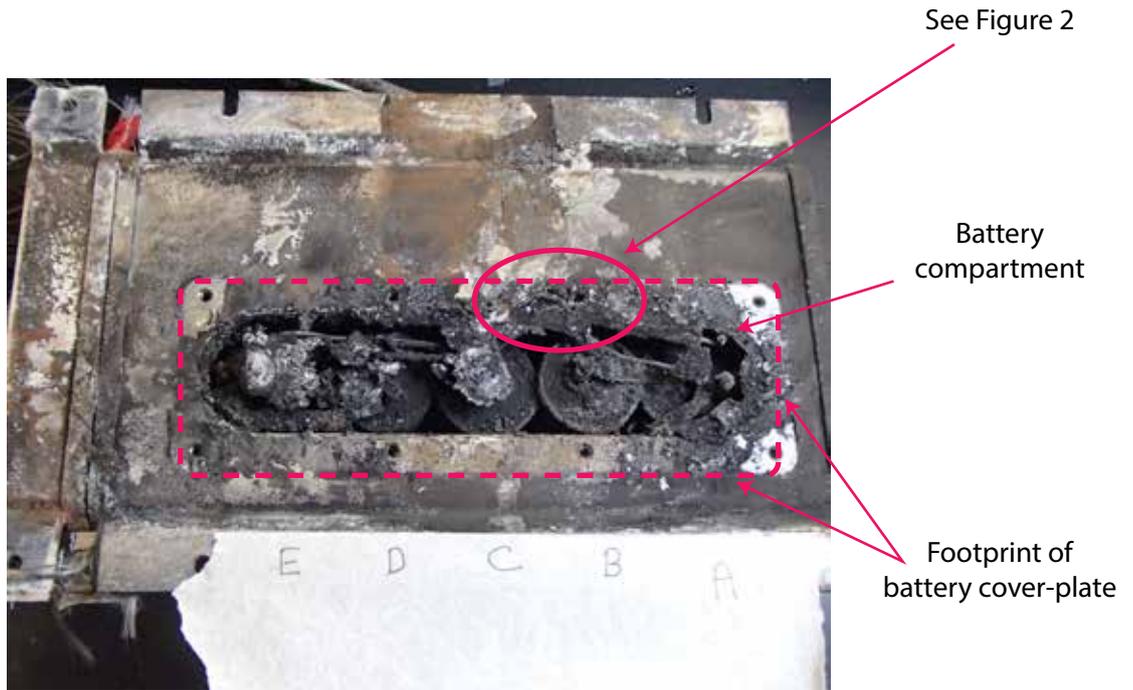
**Figure 1**

Significantly, the ELT battery wires were found to be improperly installed, in that they had been crossed and pinched together between the battery cover-plate and the ELT case, adjacent to one of the cover-plate fasteners (Figures 1 and 2). The cover-plate was notably bulged in this location, as the wires prevented it from sitting flush against the ELT case.

ELT case with battery cover-plate removed; tops of battery cells visible

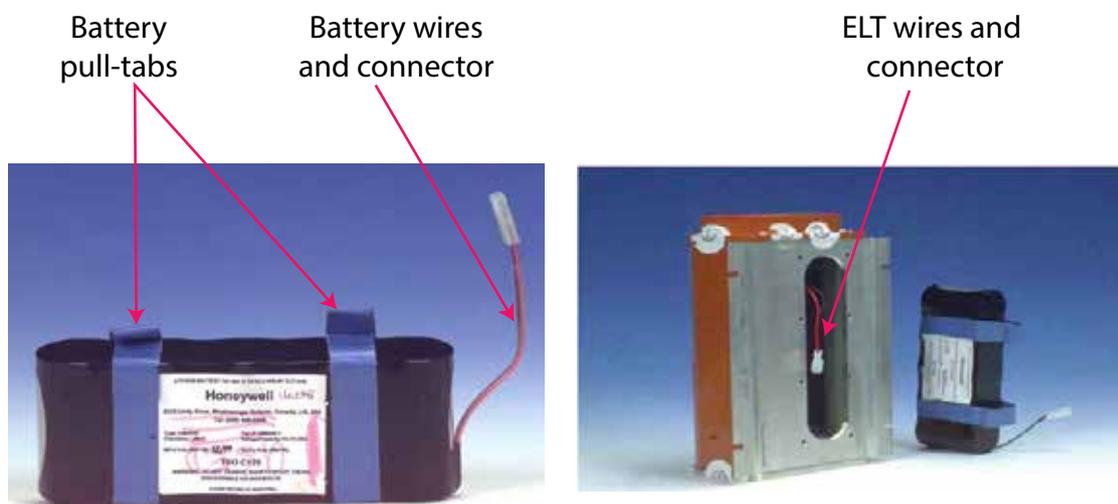
**Figure 3**

The ELT is powered by a five-cell, non-rechargeable 'lithium-metal'<sup>3</sup> battery, installed in the transmitter unit (Figure 3) and manufactured by Ultralife Corporation, under contract to Instrumar Limited.

ELT battery pack and ELT transmitter unit, showing battery compartment
