BOEING 737
OPERATIONS MANUAL

AN ANALYSIS OF THE IMPACT BETWEEN THE AIRCRAFT AND THE TOWER, AND SUBSEQUENT FLIGHT PATH

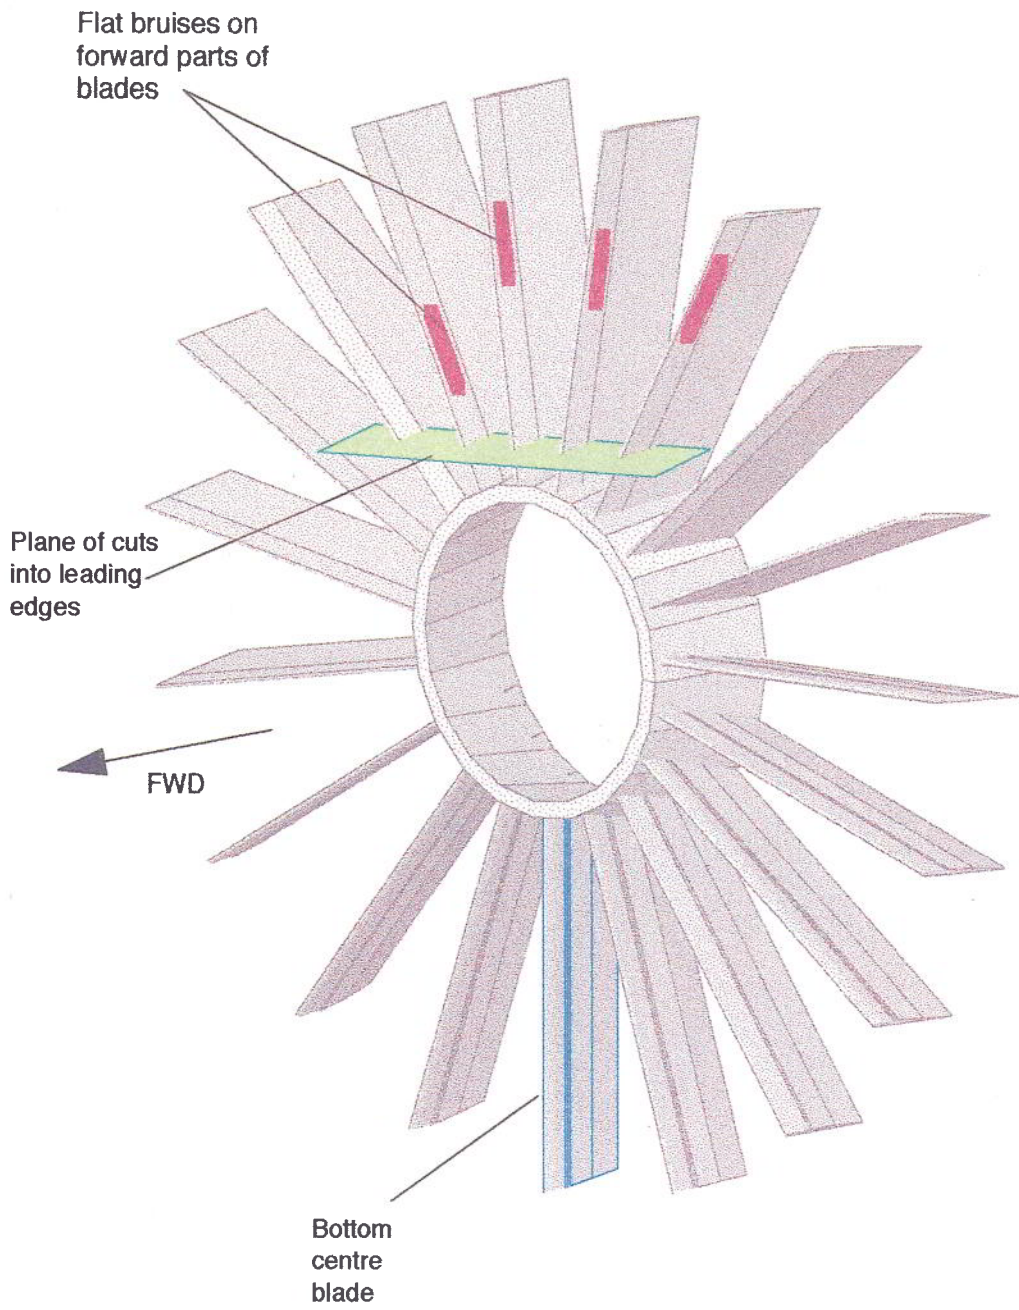
The following evidence was noted on the left engine wreckage (see Figure 4):

- A series of deep chordwise cuts into the left engine compressor stator blades was found. These cuts were all in the same plane and had evidently been produced simultaneously. The cuts displayed highly serrated fracture faces consistent with high speed tearing, such as would occur if stator had been driven into the free edge of one of the flanges of the angle-iron tower elements. The orientation of the plane of these cuts, in terms of both longitudinal (pitch) and lateral (roll) angles in relation to the engine axes is illustrated in Figure 4 (the blue coloured blade is at engine bottom centre).

- Several broader regions of leading edge bruising were also apparent on several of the stator blades at locations just above the cuts. Each bruise was of similar form and width (typically 65 mm), and had evidently been caused by contact with the flat side of one or more of the angle-iron elements of the tower structure. The thick magenta lines in Figure 4 indicate the positions of these bruises.

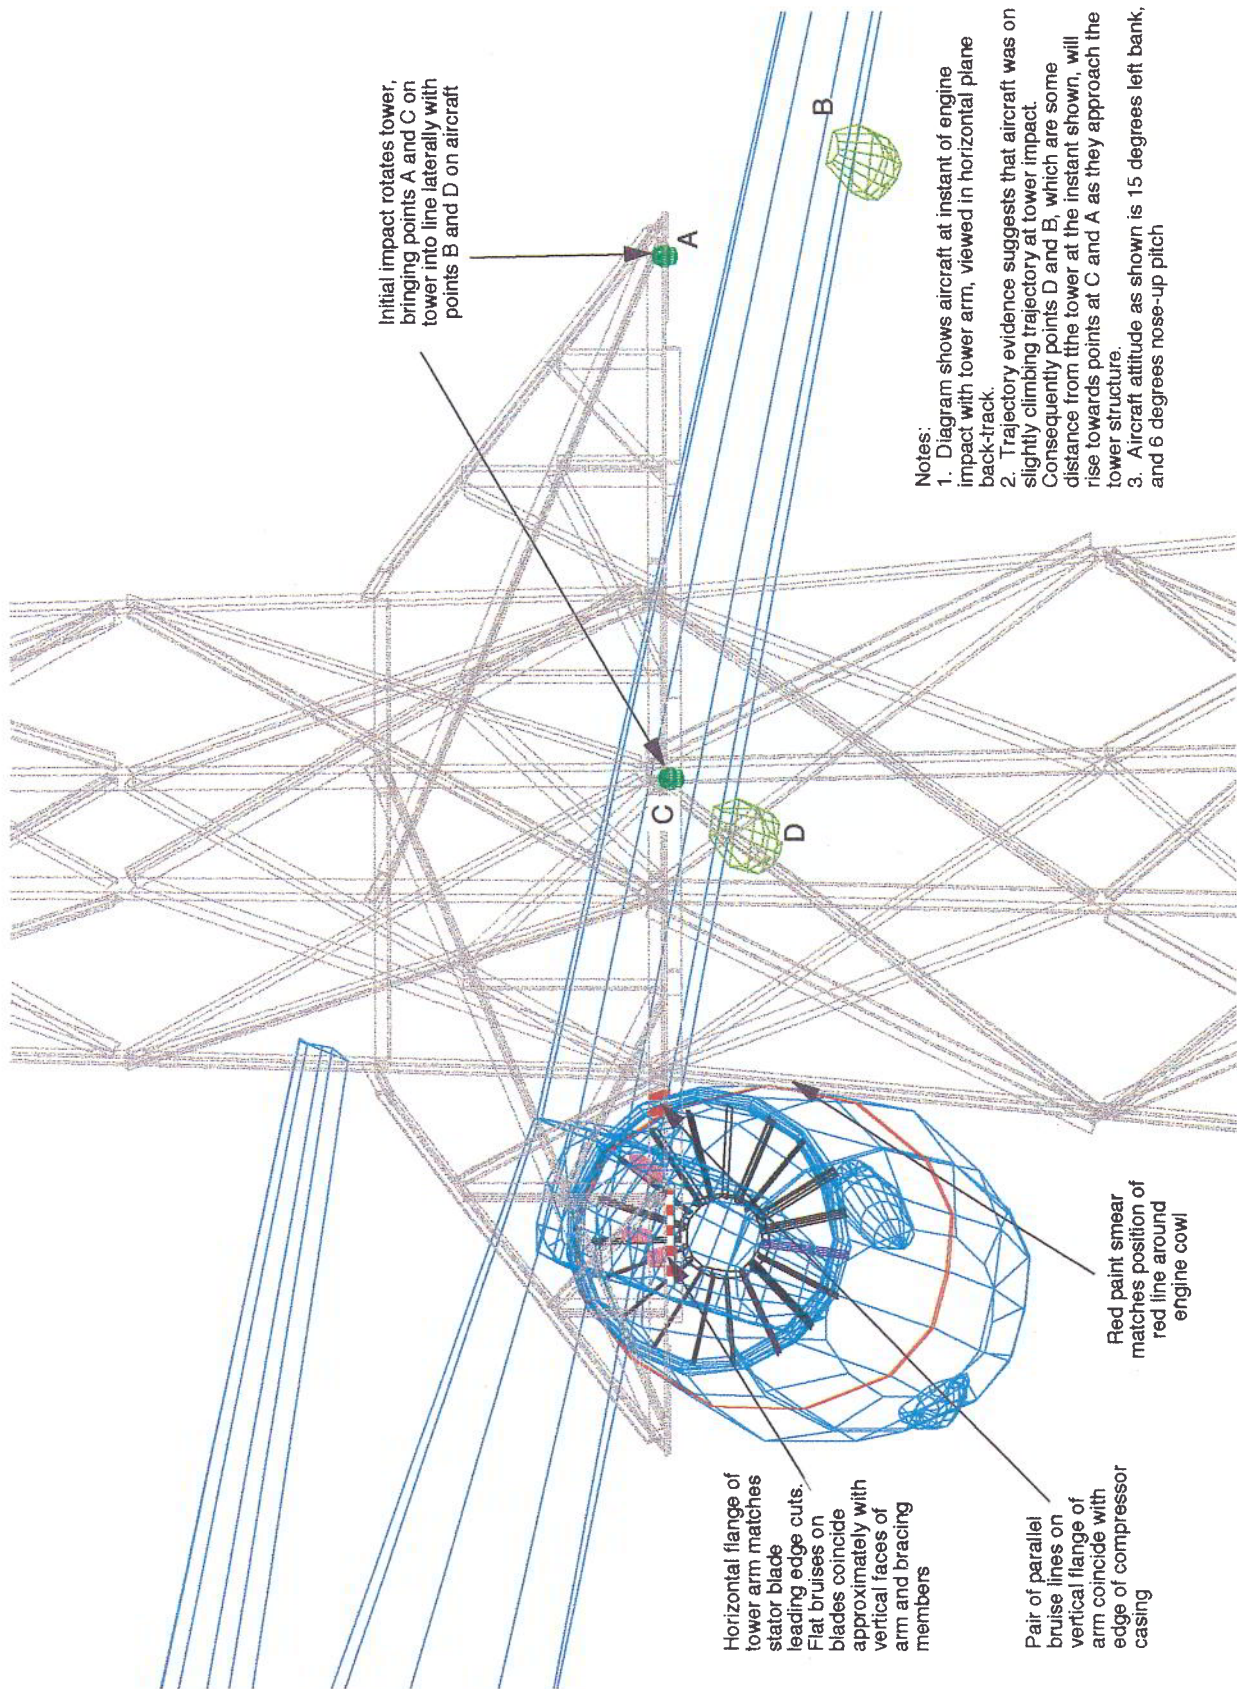
Figure 5 shows the best fit achieved between the aircraft/engine and the tower computer models. With the aircraft positioned in this attitude, the position of the left engine stator damage matches almost exactly with the region of heavy localised damage and sooting on the mid-conductor support arm on the approach side of the tower. Furthermore:

Top phase conductor cable on uptrack side of tower runs down and under belly as far as landing gear. As aircraft continues forward, cable cuts rearward into central part of right landing gear door, and runs between upper edge of left door and lower fuselage skin.

The weight, bulk, and highly deformed nature of the tower wreckage precluded a physical reconstruction of the aircraft and tower wreckage, in the conventional manner, to facilitate correlation of impact witness marks. Instead, three-dimensional computer models were constructed of the upper part of the tower and the aircraft, the latter comprising the external form of the aircraft overall with more detailed modelling of the landing gear door and engine stator assembly. The correlation between damage marks on both tower and aircraft components, caused during the initial stages of the tower collision and detailed in the preceding section, was then explored by adjusting the relative position of the computer model of the aircraft in relation to that of the tower until a reasonable match was achieved.

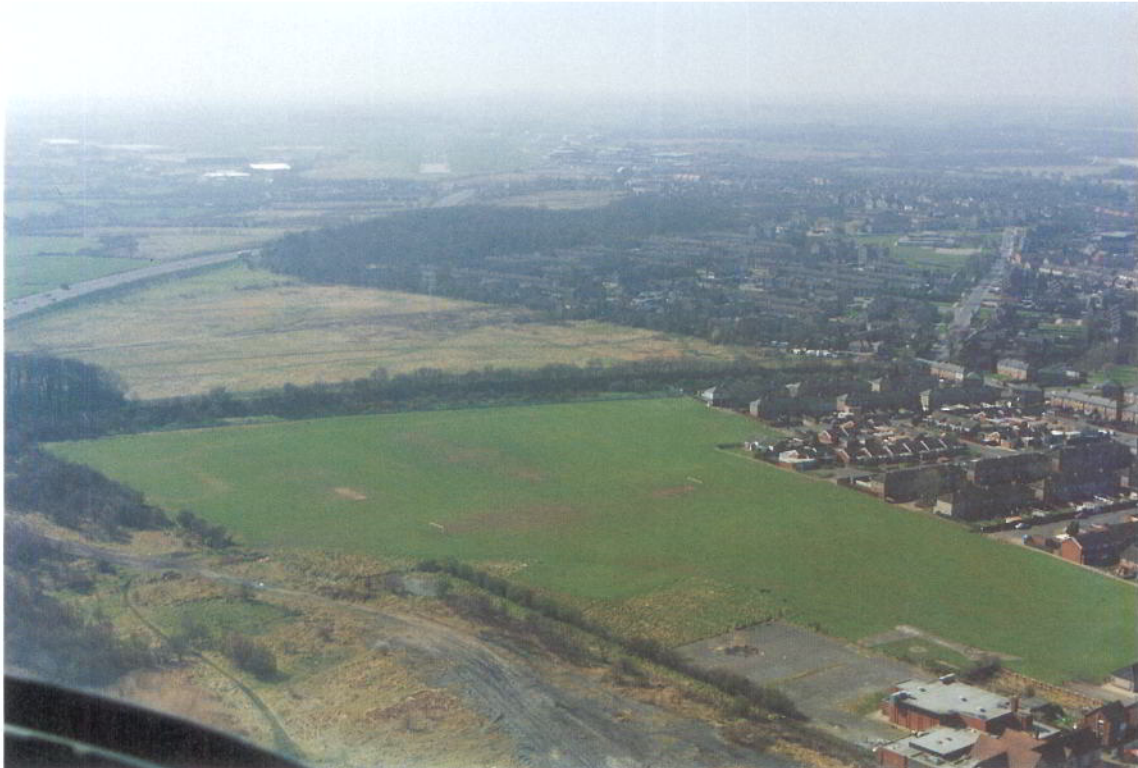
Coventry Runway 23 Approach - Range approx. 2 miles

VIEW OF APPROACH AREA FROM NORMAL GLIDEPATH

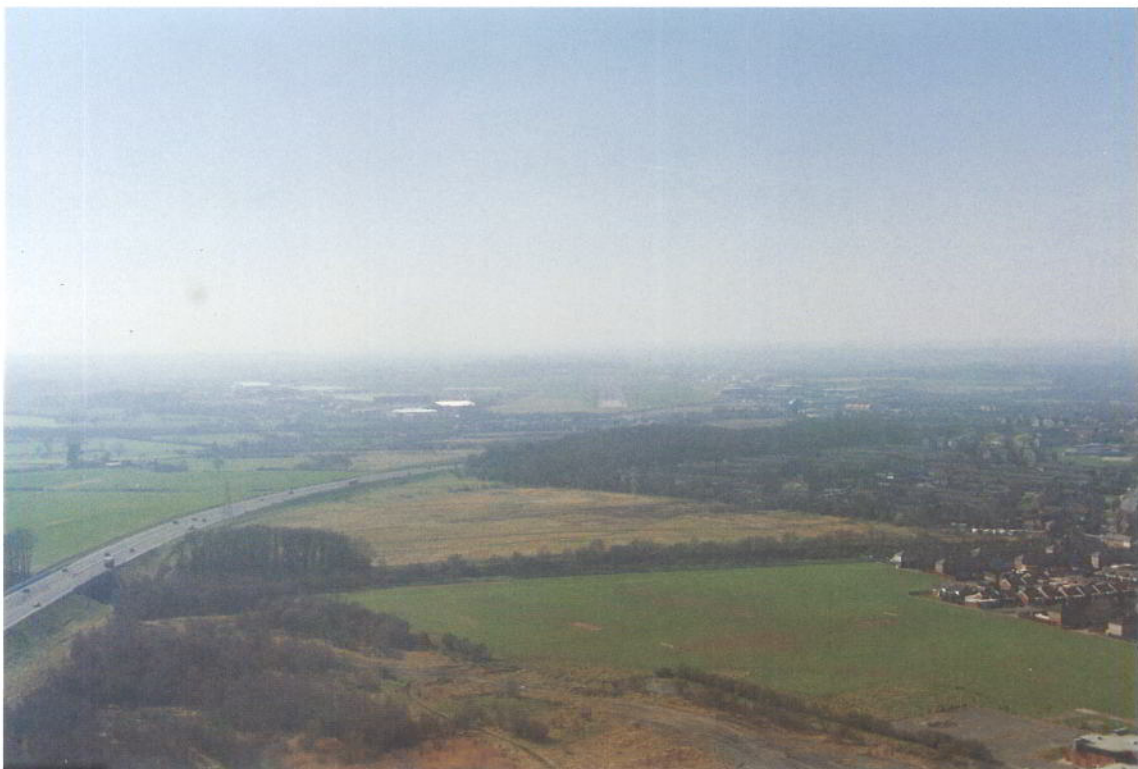
VIEW OF APPROACH AREA FROM LOW GLIDEPATH
