**ACCIDENT**

<b>Aircraft Type and Registration:</b>	Falcon (3) 195 Hang Glider, No Registration	
<b>No &amp; Type of Engines:</b>	None	
<b>Year of Manufacture:</b>	2010	
<b>Date &amp; Time (UTC):</b>	28 October 2011 at 1249 hrs	
<b>Location:</b>	Darley Moor Airfield, Derbyshire	
<b>Type of Flight:</b>	Training	
<b>Persons on Board:</b>	Crew - 1	Passengers - None
<b>Injuries:</b>	Crew - 1 (Fatal)	Passengers - N/A
<b>Nature of Damage:</b>	Substantial	
<b>Commander's Licence:</b>	None	
<b>Commander's Age:</b>	16 years	
<b>Commander's Flying Experience:</b>	13 dual aerotow launches	
<b>Information Source:</b>	AAIB Field Investigation

**Synopsis**

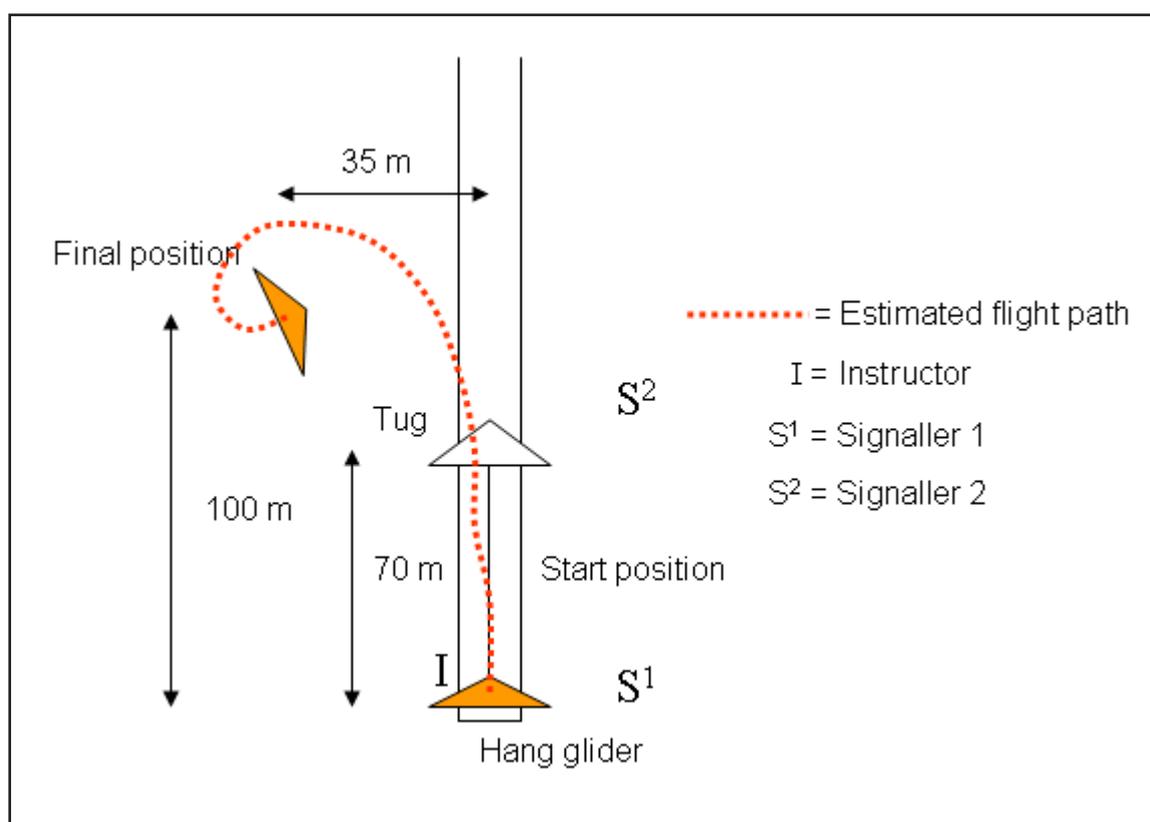
**Figure 1**

The hang glider was lying on a disused section of a concrete/asphalt runway, located approximately 35 m to the side of the runway from which it had taken off and approximately 100 m from the launch point (see Figure 1). The tow rope was found a little further along the runway in use and was lying at an angle of approximately 30° to the direction of the runway. The

Diagram of the accident site

hang glider was complete and intact, apart from the control frame which had suffered impact damage. The leading edge on the left side of the wing appeared to have struck the ground first, as the sail cloth along its length was torn. Some dismantling of bracing wires had taken place as part of the efforts to rescue the pilot.

<sup>1</sup> This signal was passed from the hang glider pilot to the towing pilot via the instructor and two Signallers (see Figure 1).

A number of people were involved with this aerotow launch procedure. As well as the towing pilot and the student pilot, there was the instructor, with a radio, who was on the ground, alongside the student pilot at the start of the launch. There was an observer (Signaller 1) by the hang glider, equipped with a bat to signal when all was ready for the tow to start, and an observer (Signaller 2) ahead of the towing aircraft to receive and relay these signals to the towing pilot (see Figure 1).

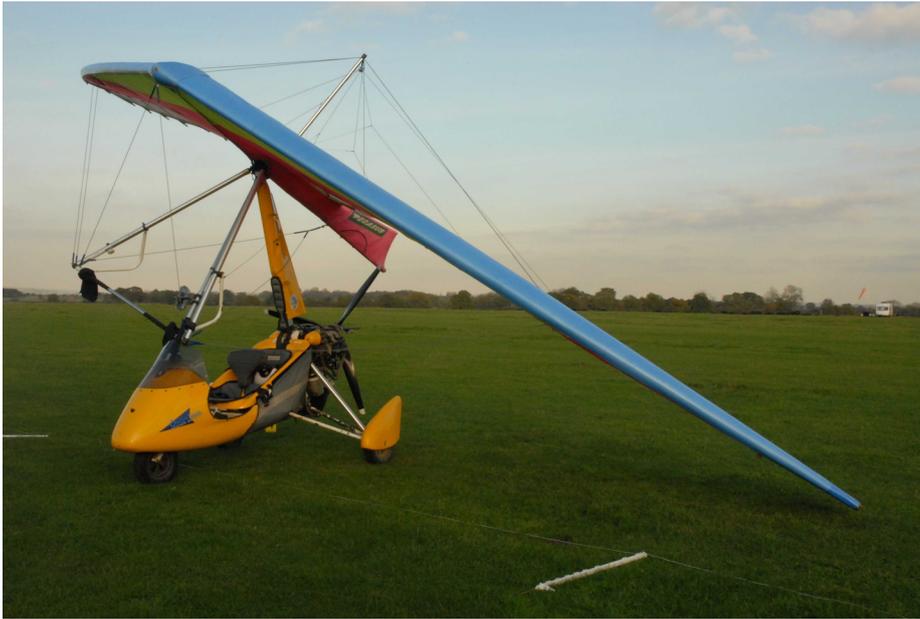
**Figure 2**

The Pegasus Quantum 15-912 (see Figure 2) is an advanced weight-shift controlled aircraft, operating on a Permit to Fly. It had been modified to include factory modification PG134, which installs a towing hook mechanism, automatic and manual release mechanisms and a rear-view mirror. The procedures and limitations for towing operations using this equipment are set out in the Glider Tug manual, which is a supplement to the Operator's manual. The aircraft had also been modified to include an optional rear hang point for the wing. This provided a slower range of trim speeds, 37 to 55 mph, and is intended for use in this type of towing operation. The wing was rigged to this rear hang point. Towing operations were conducted at a speed of 40 to 41 mph, although, due to the characteristics of the towing aircraft, the speed would reach a higher speed at lift off.

Towing aircraft, G-WHEE  
(courtesy Derbyshire Constabulary)

The aircraft, G-WHEE, was found to be in satisfactory condition and the towing equipment operated normally. The Certificate of Validity of the Permit to Fly was in date and the aircraft had the required placards displayed. No defects were identified that could affect the towing operation.

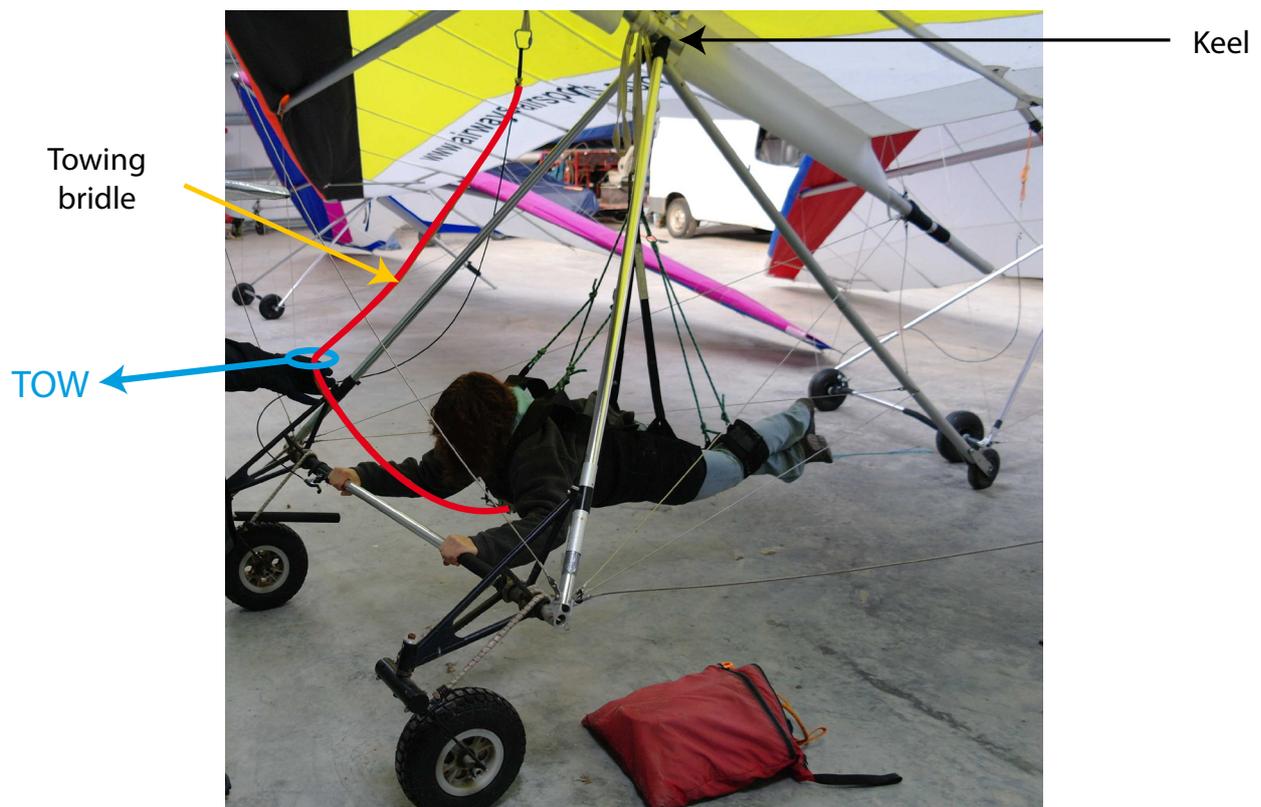
**Figure 3**

Additional wheels had been fitted to allow ground launching with the pilot in a prone position. A castoring main wheel was attached to each end of the control bar and incorporated rubber bungees to allow a

degree of suspension. An extension to the keel allowed the fitment of a tailwheel. (A similar arrangement is showing in Figure 3.) The additional landing gear weighed approximately 28.5 lb.

Similar hang glider showing pilot position and bridle arrangement

A towing bridle was attached to a point on the keel forward of the control frame and incorporated a quick release fitting which was operated by a lever, similar to a bicycle brake lever, on the right hand side of the control bar. The other end of the towing bridle was attached to the pilot's chest with another independent quick release fitting which could be operated by the pilot. The end of the towline was fitted with a ring, through which the towing bridle passed (see Figure 3). Operating either release allowed the towing bridle to pass through the ring on the towline, releasing the tow.
