The falling overboard and recovery of a young child from the passenger ferry *SNOWDROP* Seacombe Ferry Terminal, River Mersey 14 October 2013

SUMMARY

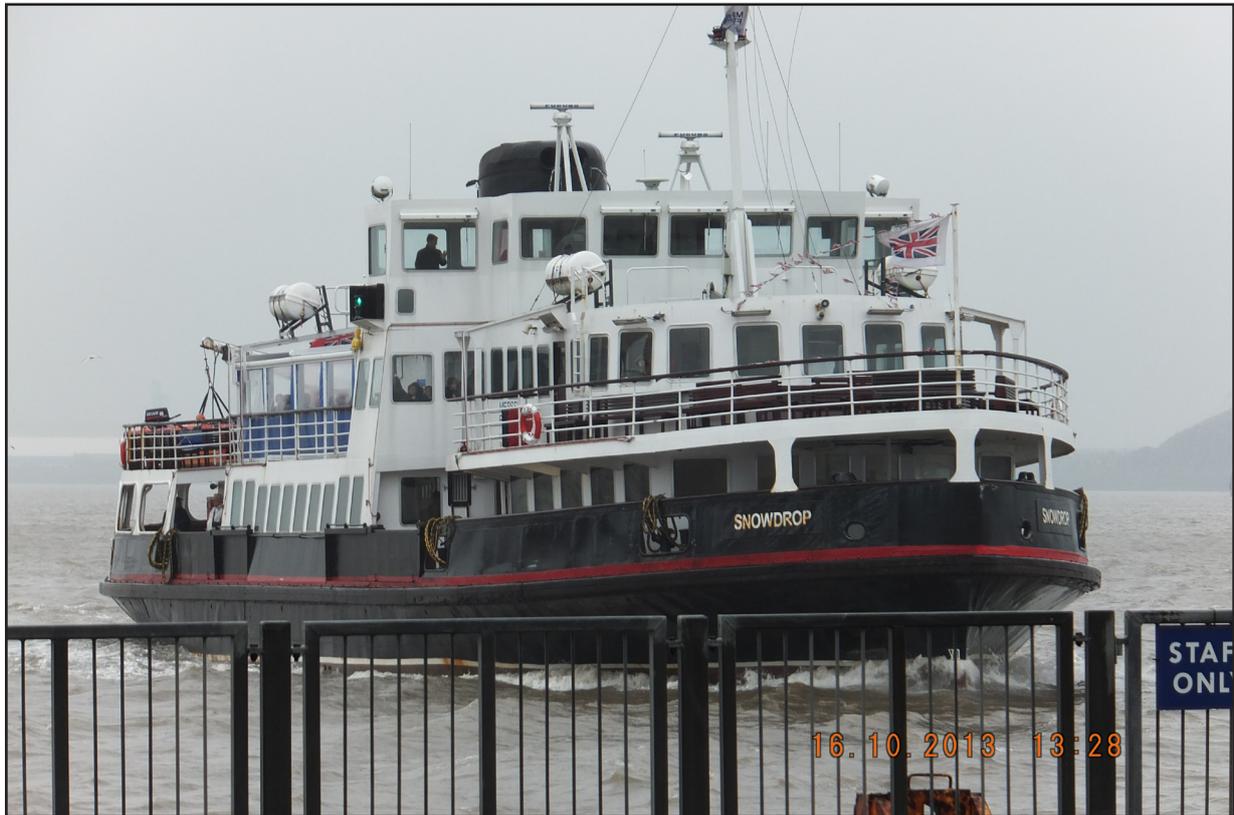
Figure 1: Snowdrop

Snowdrop (**Figure 1**) was one of two, Class V¹ passenger ferries operated on the River Mersey by Merseytravel. The ferry was originally built to carry 1200 passengers but was certified to carry 650 passengers. During peak times², the ferries operated a 10 minute commuter service between the Liverpool and Seacombe terminals. Between 1000 and 1600 they provided an hourly service, calling at Merseytravel's Pier Head (Liverpool), Seacombe and Woodside (Birkenhead) ferry terminals (**Figure 2**).

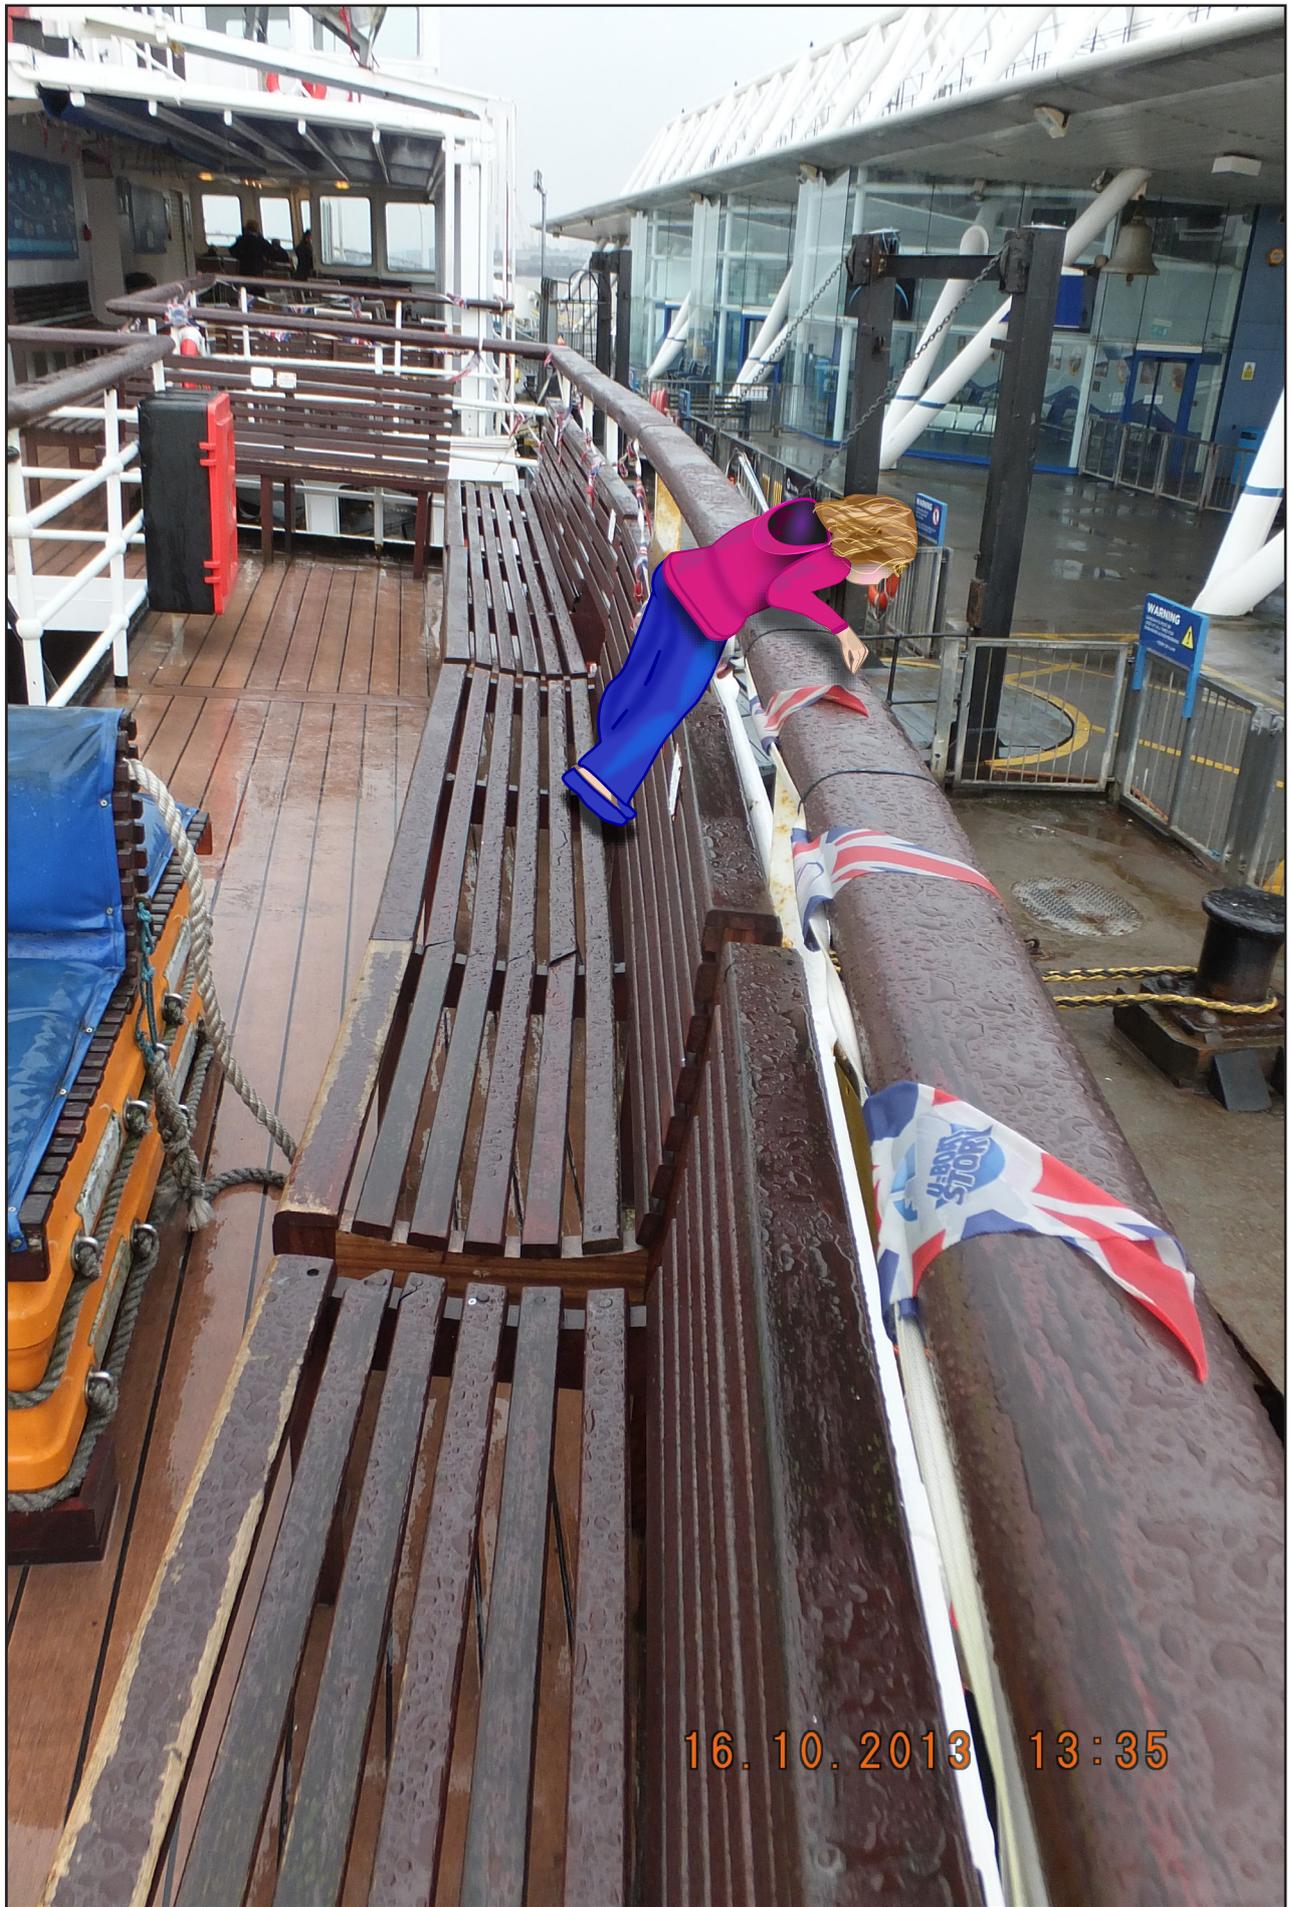
Figure 3: Position of child prior to falling overboard

At about 1427, *Snowdrop* arrived at the Seacombe ferry terminal and was manoeuvred starboard side onto the terminal pier. The deck crew passed the fore and aft mooring ropes to the pier stageman³ and the ferry was secured alongside. The ferry's two propulsion engines were then de-clutched from the propellers and the deck crew lowered the gangway. By the time the passengers had started to disembark, the party had re-grouped on the starboard aft side of the promenade deck. One of the children, a 3 year old girl, was standing on one of the inward facing outboard passenger seats (**Figure 3**) and was watching the activities on the pier below.

To get a better view of what was happening, the 3 year old girl leant over the backrest of the seat and rested her stomach on top of the ship's side guardrail. At the same time, one of the boys was energetically jumping on and off the same seat while the parents chatted. At one point, the boy was reprimanded by his mother for standing on his tiptoes on the seat and leaning over the guardrail.

At 970mm tall, the child was about 340mm taller than the top of the guardrail when she stood on the seat (**Figure 3**). This meant that she would still have been too short, even if she had stood on the tips of her toes, to lean over the guardrail. Therefore, to get into a position to lie on her stomach on top of the guardrail capping, she must have climbed up the seat back. The gaps between the horizontal wooden slats on the seat back would have made this easier to achieve.

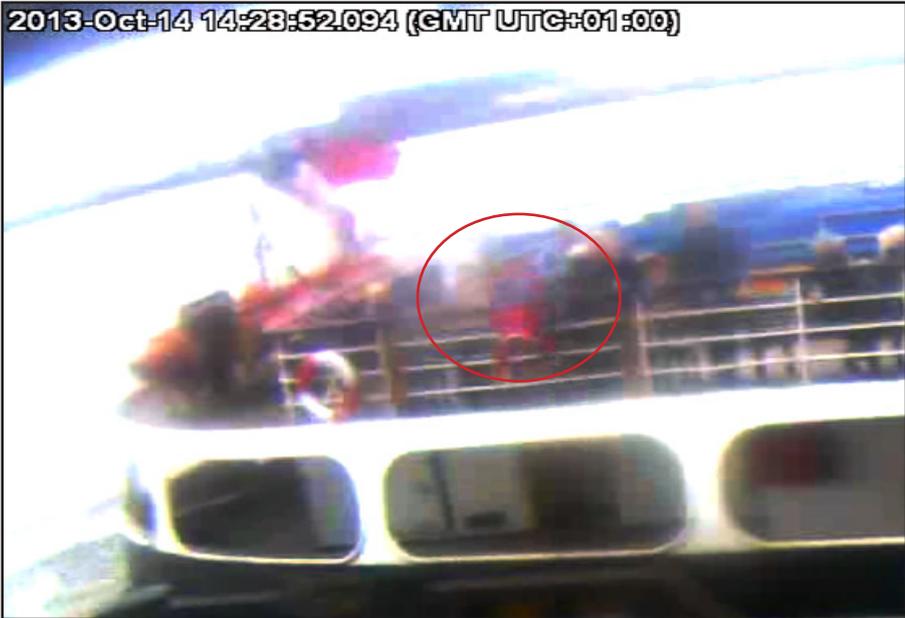
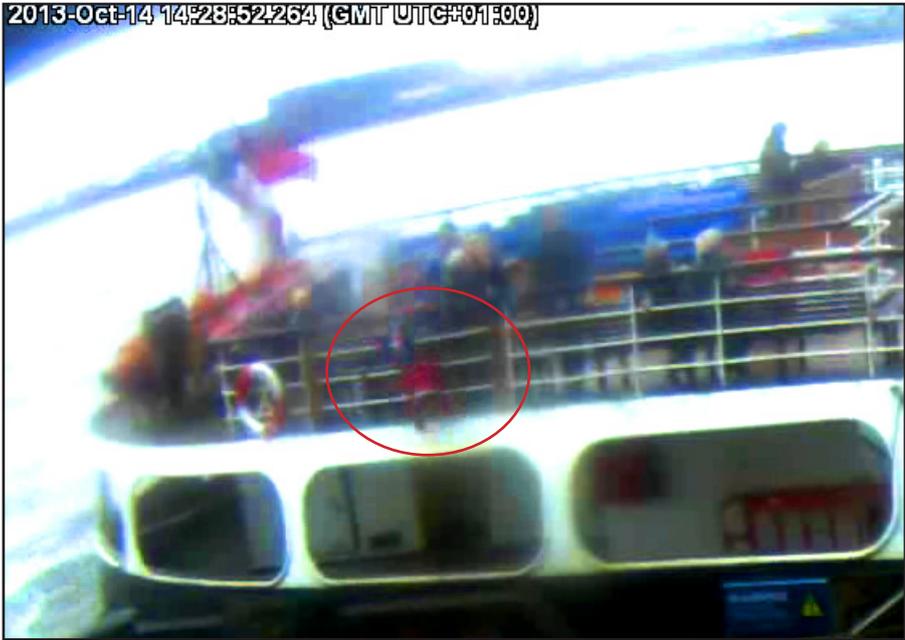
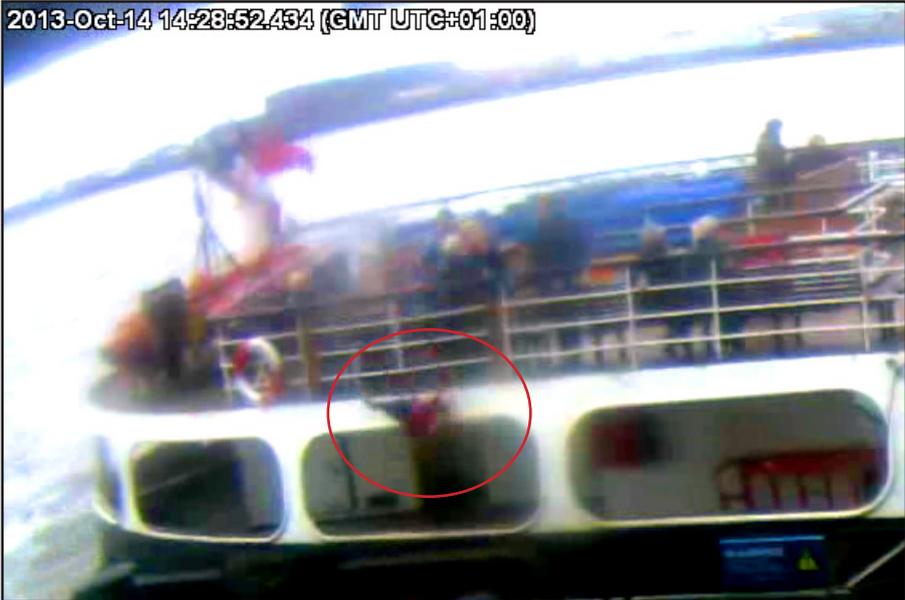
Figure 4: Seacombe pier CCTV footage of child falling

At 1429, with the parents distracted by the energetic behaviour of the other children, the 3 year old girl leaned a little further over the guardrail and suddenly fell overboard (**Figure 4**). She cartwheeled during the fall and fell between the pier's rubber tyre fendering⁴ and the vessel, and into the water (**Figure 5**). *Snowdrop*'s master, who was standing at the starboard bridge wing counting the passengers as they disembarked, saw an object fall and told his mate that something had been dropped overboard.

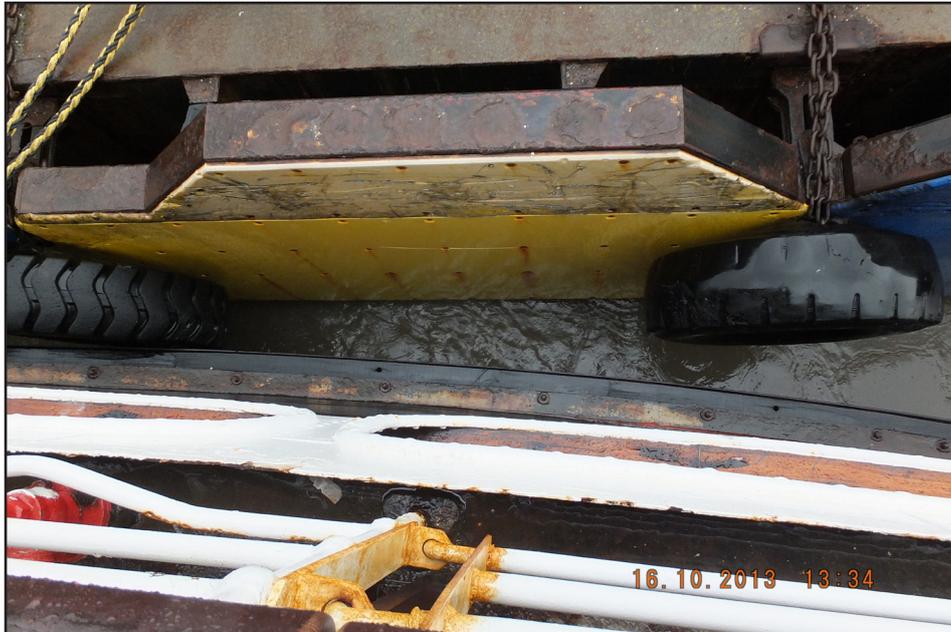
Figure 5: Gap between *Snowdrop* and Seacombe terminal fendering

The deck crew lowered a mooring rope from the deck of the ferry to the waterline. The mate then grabbed hold of this and used it to support himself and the child in the water. The mate, having drifted under the fender, was unable to see

anyone above, but he could hear the engineer's voice and when he saw the engineer's outstretched hand he quickly passed the child to him. The engineer lifted the child up and passed her to the stageman on the pier.

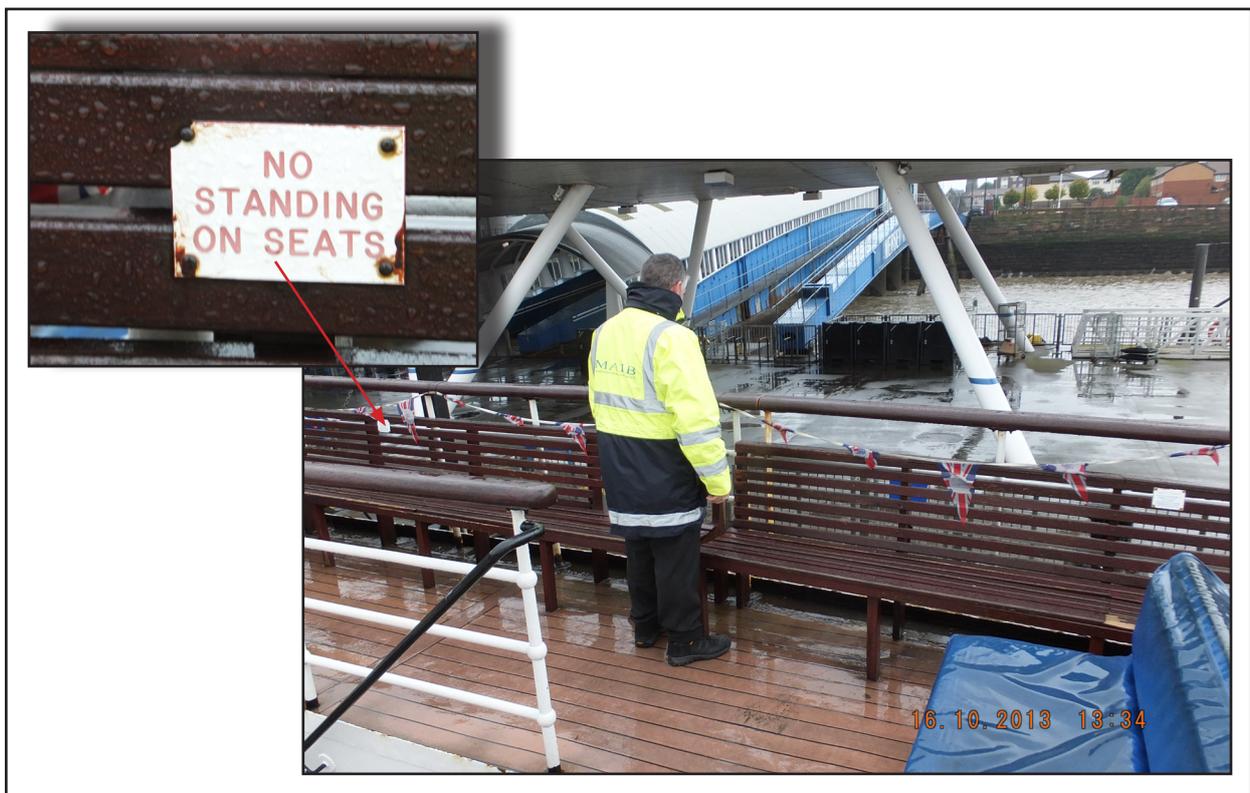
Figure 6: *Snowdrop* promenade deck seating against guard rail and warning signs

Snowdrop's promenade deck ship's side guardrails were 1100mm high. They were fabricated from mild steel and had four horizontal steel rails that were supported and secured to the deck by vertical steel stanchions (**Figure 6**). Varnished hardwood capping was fitted to the upper horizontal rail.

The promenade deck passenger seats were constructed from hardwood planks and had a horizontal slat design. The outboard seats faced inward with the seats back up against the ship's side guardrails (**Figure 6**). The ferry had always had seating positioned along the outboard edge of the promenade deck but there had been several different types of seats fitted since build. The seating the 3 year old was standing on had been installed approximately 10 years previously.

The deck to seat height was about 460mm with the distance between the seat and the top of the capping rail approximately 635mm. The horizontal backrest slats were about 40mm high with a space of approximately 20mm separating them. Attached to the backrest slats at varying intervals were traffolyte signs, engraved with the warning: *NO STANDING ON SEATS* (**Figure 6**).

The side guardrail on board *Snowdrop* exceeded the specified minimum height requirements of 915mm for a Class V passenger vessel. However, the position of the seating around the outer edge of the promenade deck provided a platform for passengers to stand on; and when they did, the effective height of the guardrail was reduced to 635mm.

Given that passengers enjoying a river cruise were more likely to want to look out from the vessel at the river and shoreline, than face inboard, the probability of children, in particular, wanting to stand or kneel on the seating, was entirely foreseeable. The design of the seating also made it easier for the young child to climb on to the top of the guardrail. The gaps between horizontal wooden slats on the seat back provided toe holds for little feet to push against.

The controls put in place by Merseytravel to prevent this type of accident relied on passenger compliance, parental control and crew vigilance. Despite the warning signs on the seat backs, the public address announcements and the crew patrols, experience showed that passengers would continue to stand on the seats and climb on the guardrails.

It was therefore inevitable that the control measures would eventually be circumvented, and that better safeguards were required in order to maintain an effective height of guardrail during normal operations. On board *Snowdrop*, such actions could have included raising the guardrail behind the seats, or moving the seats away from the ship's side guardrails.
