Report on the investigation of
a fatal accident to the skipper of fishing vessel

Our Boy Andrew

9 miles east of Eddystone Rocks

24 March 2011

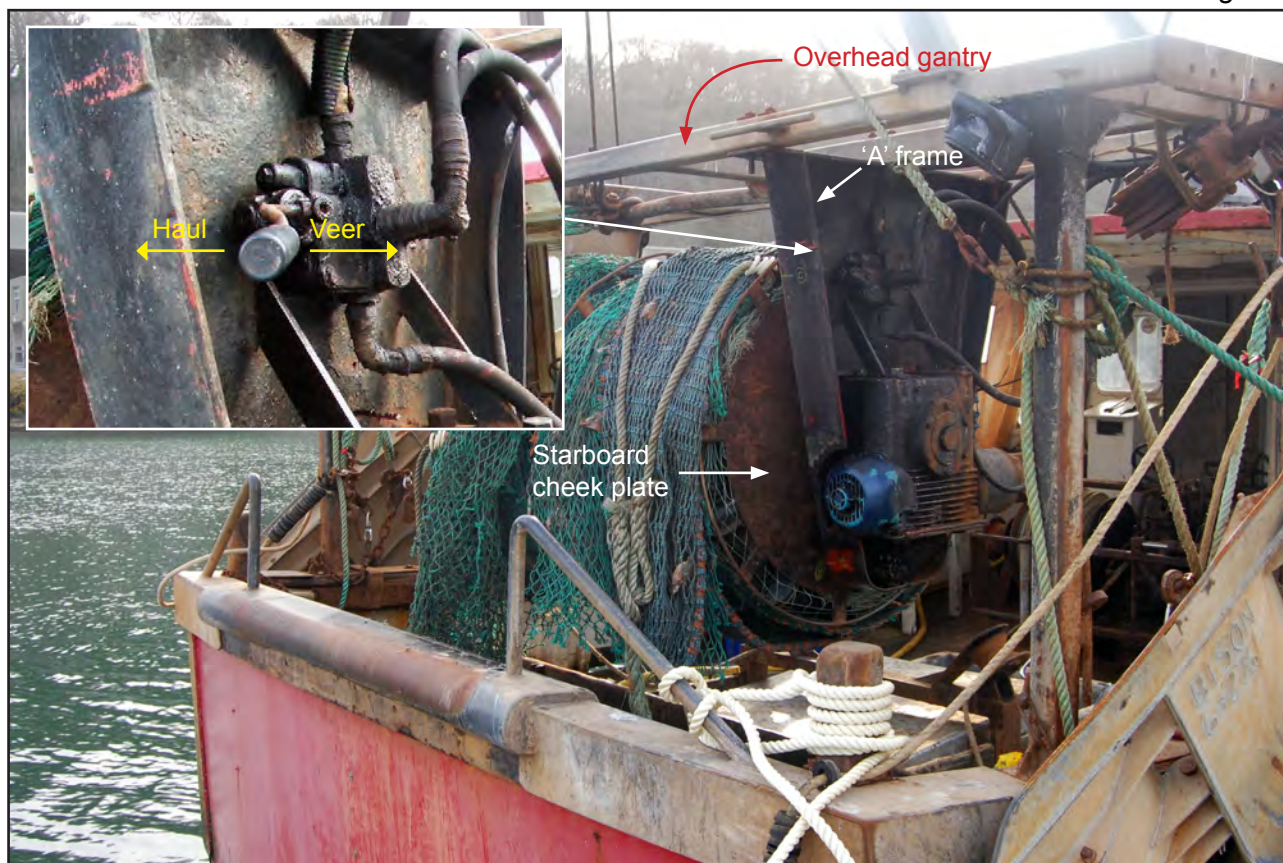
Figure 2

Net drum - showing location of control lever

A selector valve, located on deck, distributed hydraulic power to either the trawl winch or the net drum. The net drum was operated by means of a single control lever located on the outboard side of the starboard 'A' frame that supported the net drum.

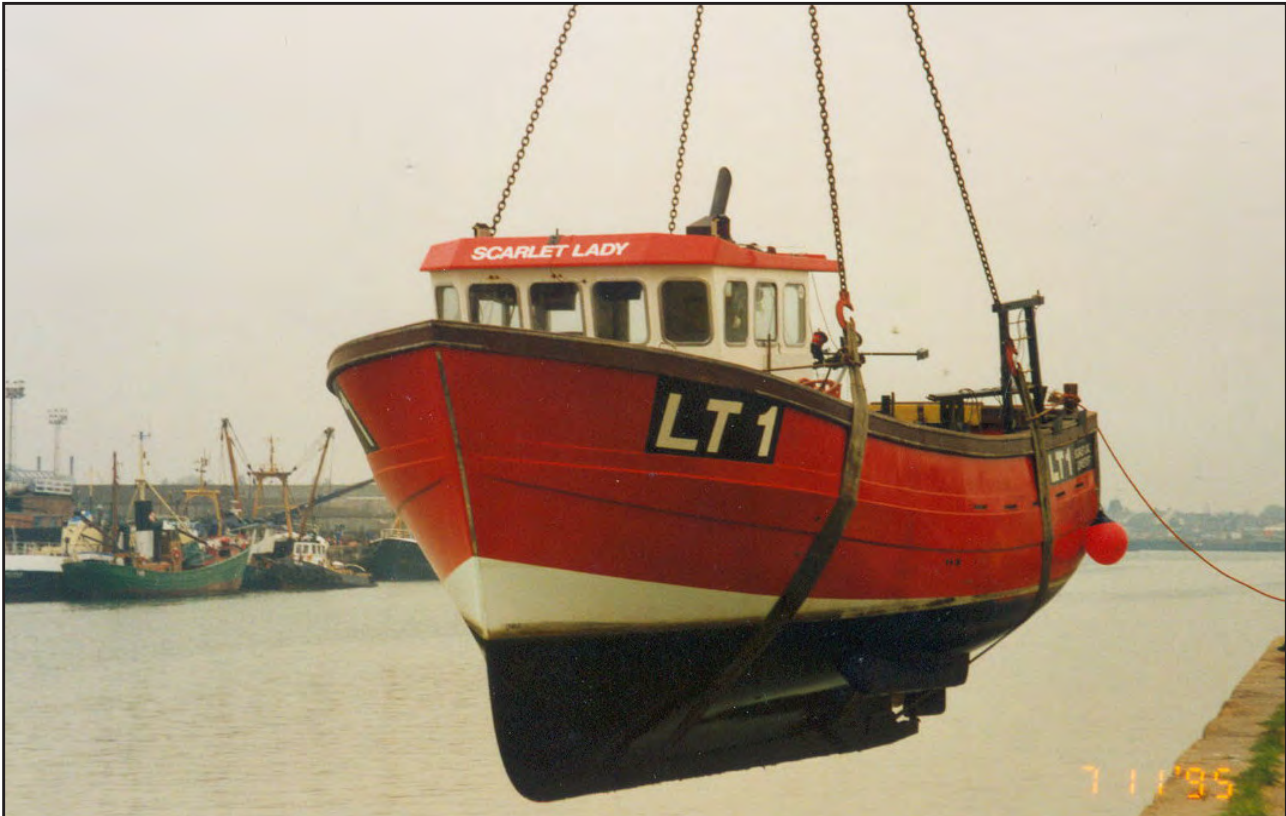
Ex-Scarlet Lady in 1995

Our Boy Andrew (ex-*Scarlet Lady*), was built in Norfolk in 1989 using a standard Cygnus 33 hull design (**Figure 3**).

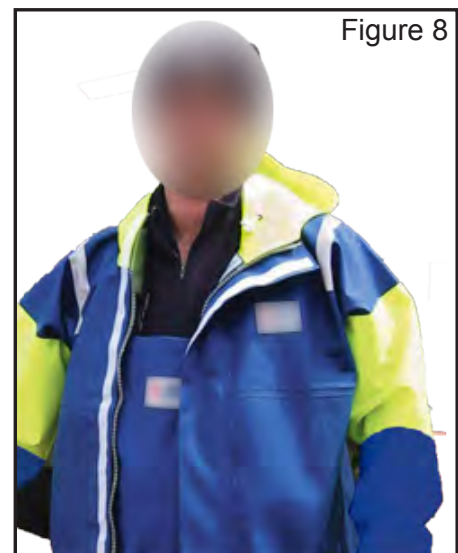
Figure 8

Similar type of clothing to that worn by the skipper

The skipper normally wore a commercially available fishermen's bib and a jacket which incorporated a storm hood similar to that shown in **Figure 8**.

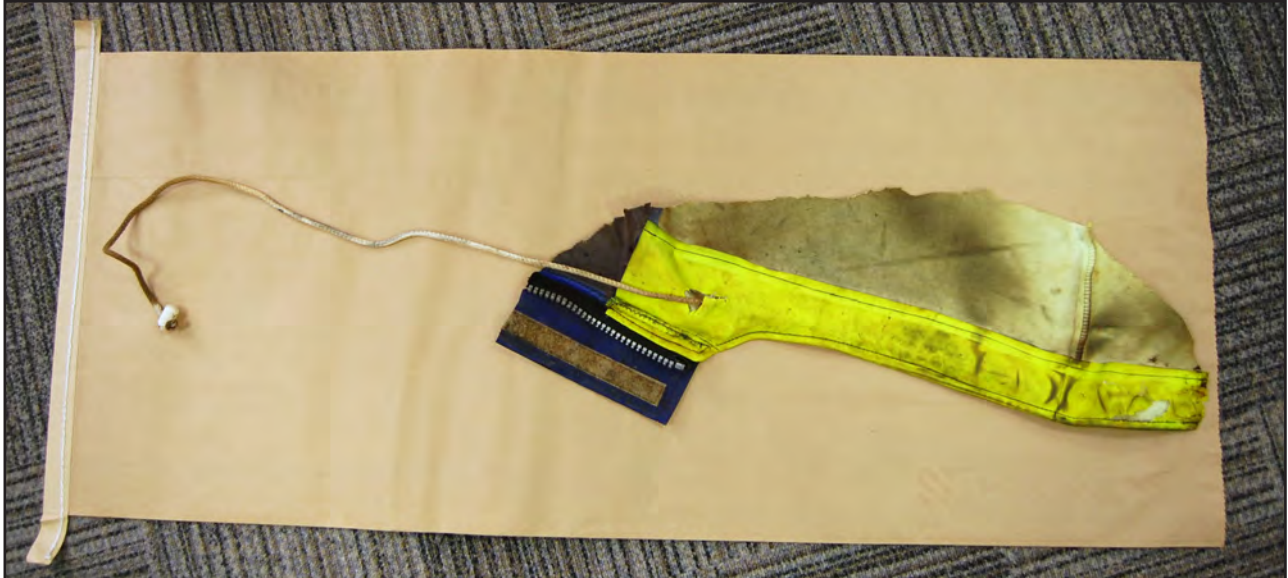
Figure 9

Partial storm hood with drawstring and toggle found on net drum

The net drum was examined and found with the skipper's cap and a remaining part of his jacket (**Figure 9**) trapped between the turns of the net (**Figure 10**). The net drum was manually turned and the cap and the jacket part came free after the first turn. However, it took a further two turns to reach the end of the storm hood

Both ends of the skipper's storm hood drawstring (**Figure 9**) were noticeably dirty compared to the rest of the line that would have normally remained within the seam of the hood. This indicated that the drawstring would have been routinely exposed for about 15cm on either side of the hood, potentially creating a snag hazard.

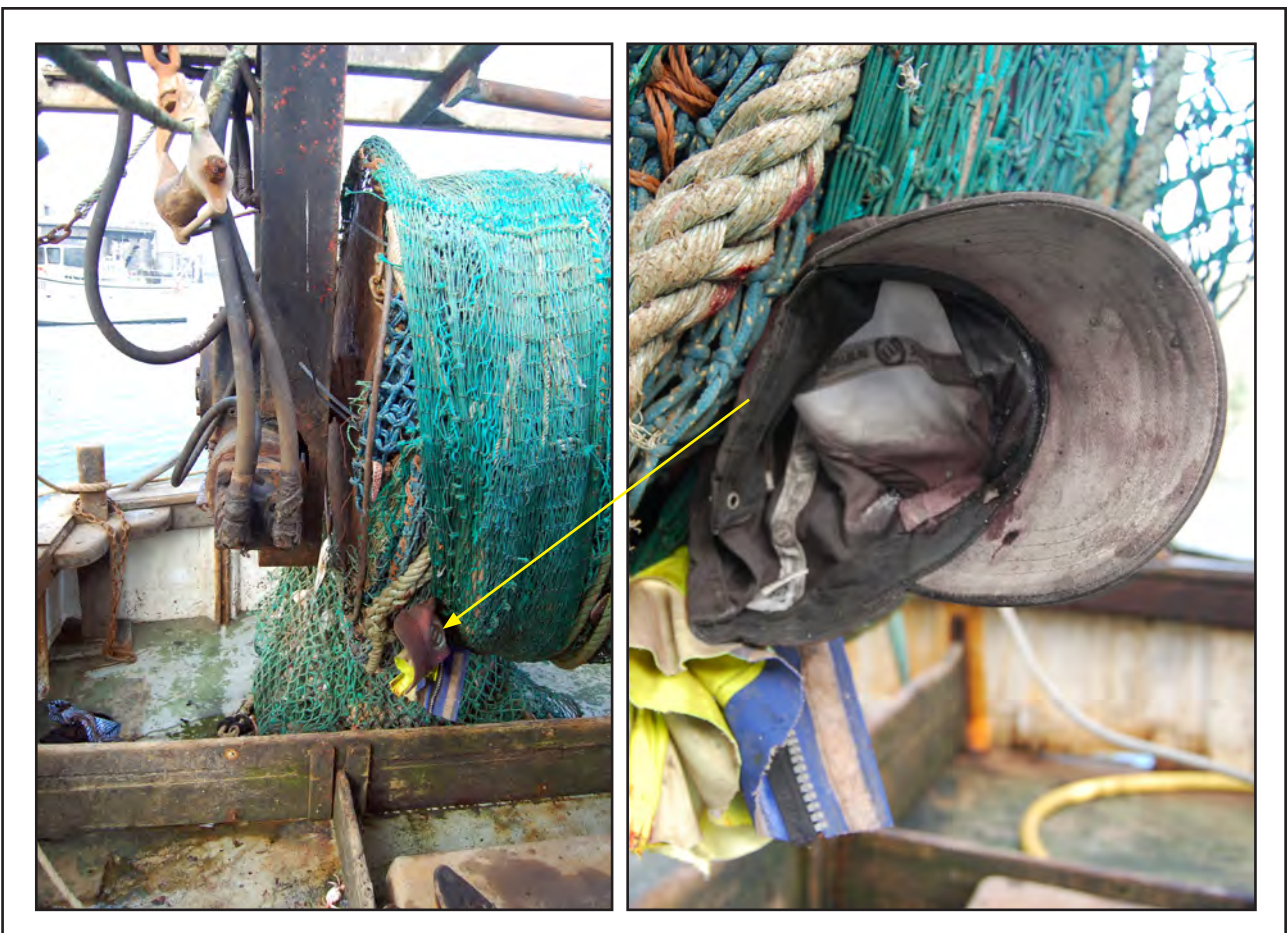
Figure 10

Net drum showing location of trapped cap and partial jacket

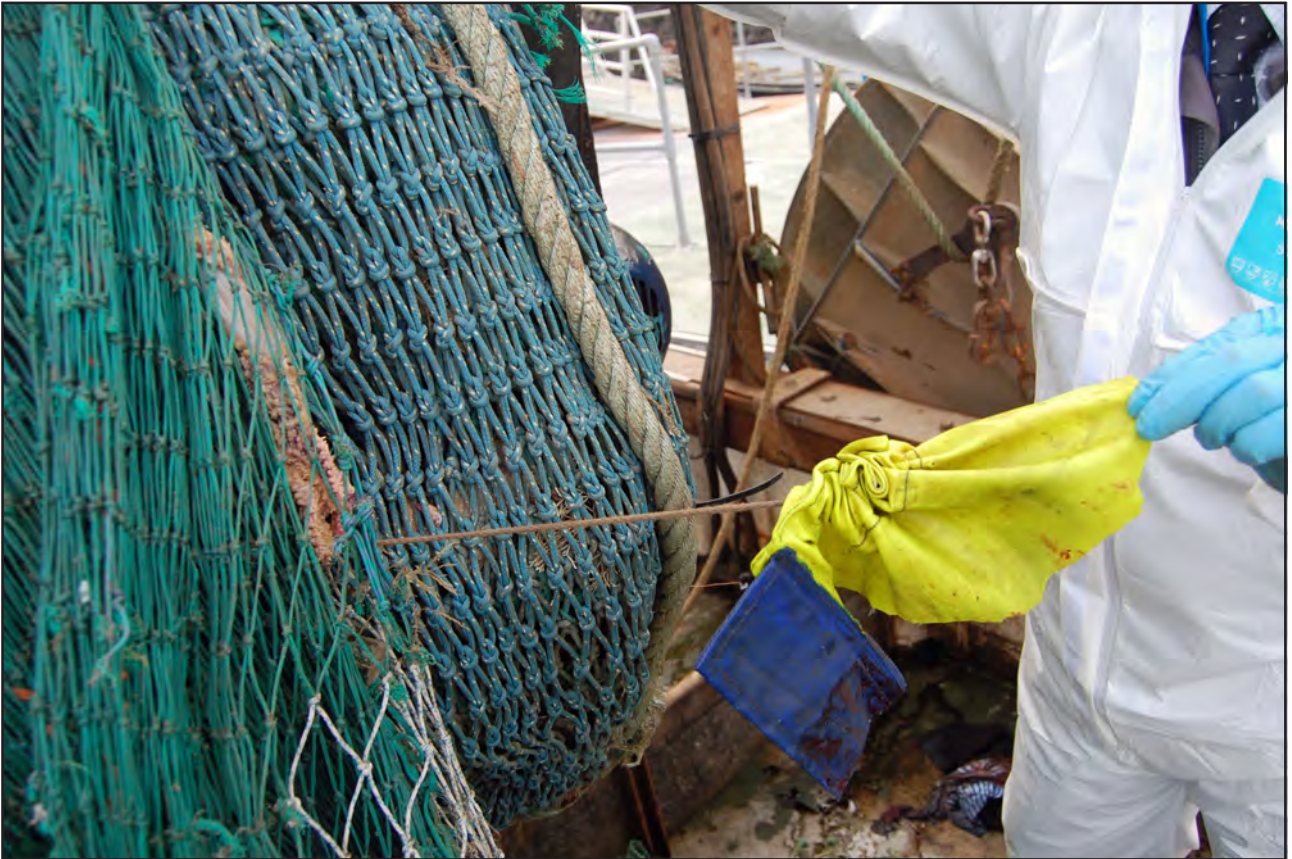
Figure 11

Partial storm hood and drawstring leading across to port drum

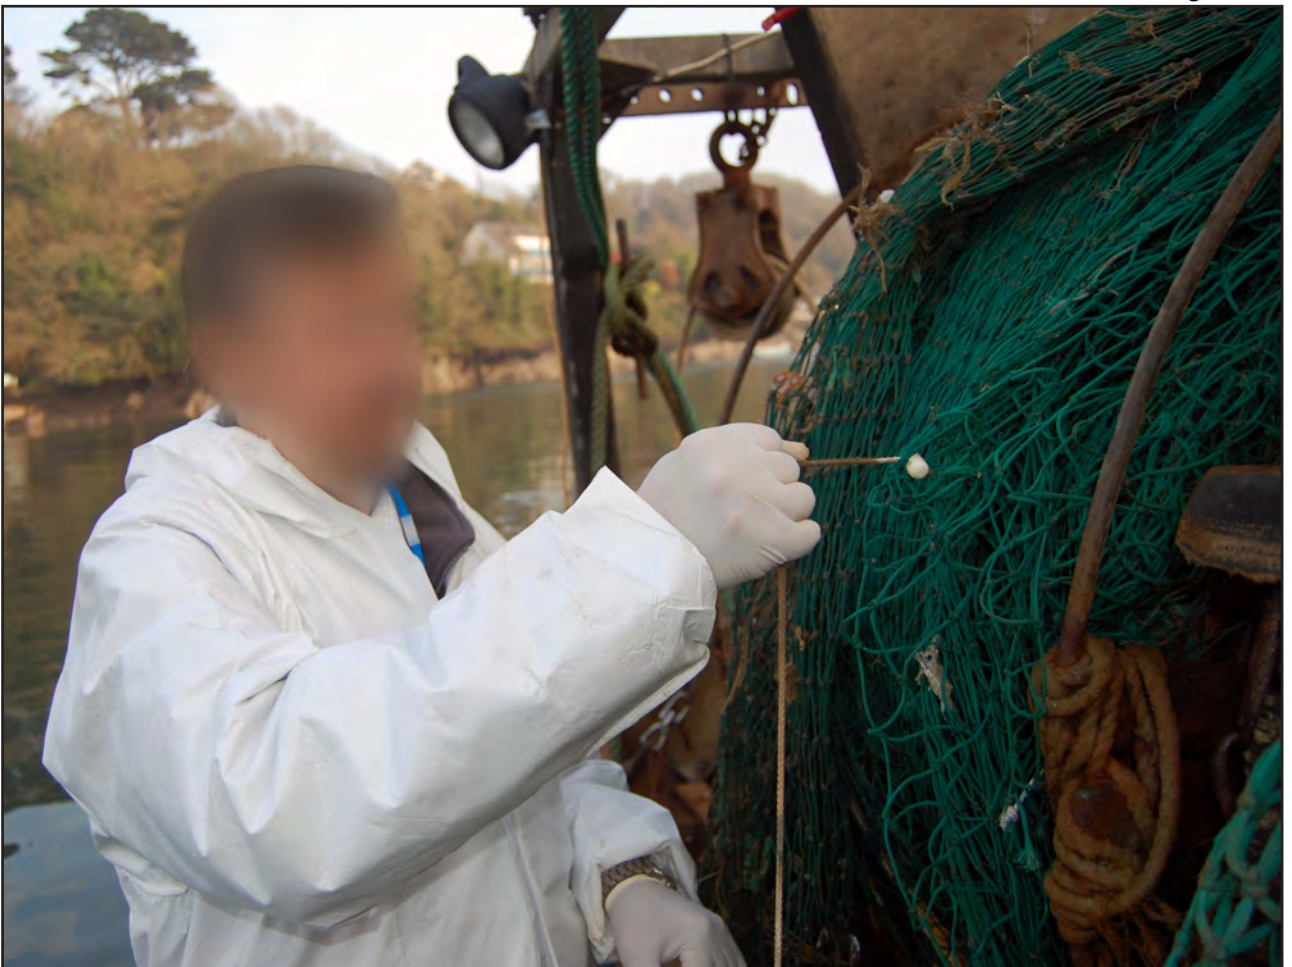
Figure 12

Storm hood drawstring with toggle embedded in net

Analysis of the evidence indicated that the accident occurred when the cod end was about 10 metres from the net drum. It is believed that the skipper was manually guiding the net onto the drum when the left-hand side toggle of his storm hood became entangled in the net. This would have caused the skipper to be pulled towards the rotating drum. Evidence indicates that he then reached towards the operating lever to stop the motor but was unsuccessful. The net drum stopped rotating when the cod end became wedged between the net drum and the overhead gantry. The skipper died as a result of injuries to his upper body.

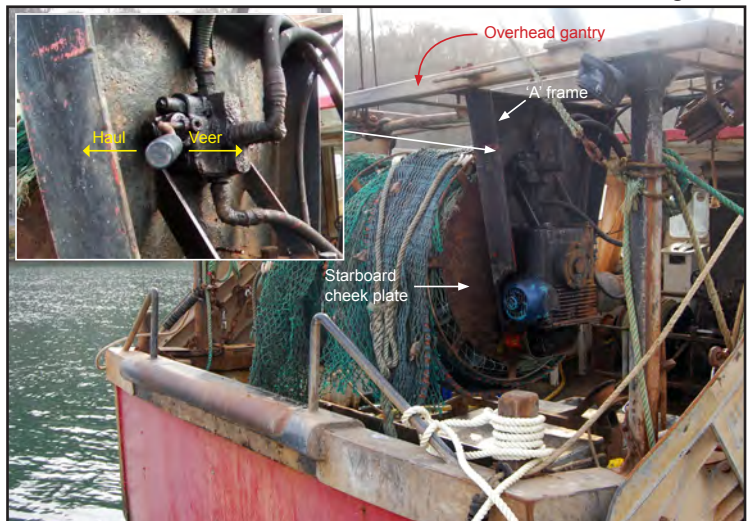
Figure 3

A drawstring toggle on the left-hand side of the stormhood on the skipper's jacket became entangled in the net (**Figure 3**) when the cod end was about 10 metres from the net drum. This would have caused the skipper to be pulled towards the rotating drum. Evidence indicates that he then reached towards the operating lever to stop the motor but was unsuccessful. The net drum stopped rotating when the cod end became wedged between the net drum and the overhead gantry. The skipper died as a result of injuries to his upper body.

The investigation concluded that a drawstring toggle on the left-hand side of the storm hood on the skipper's jacket had become entangled in the net as it was being hauled on board. Evidence indicated that the skipper had then reached towards the operating control lever to stop the net drum. He was unable to do so, and died as a result of injuries to his upper body.
