Report on the investigation of
the loss of the fishing vessel

Auriga

off Portavogie, Northern Ireland

**Report No 3/2006
February 2006**

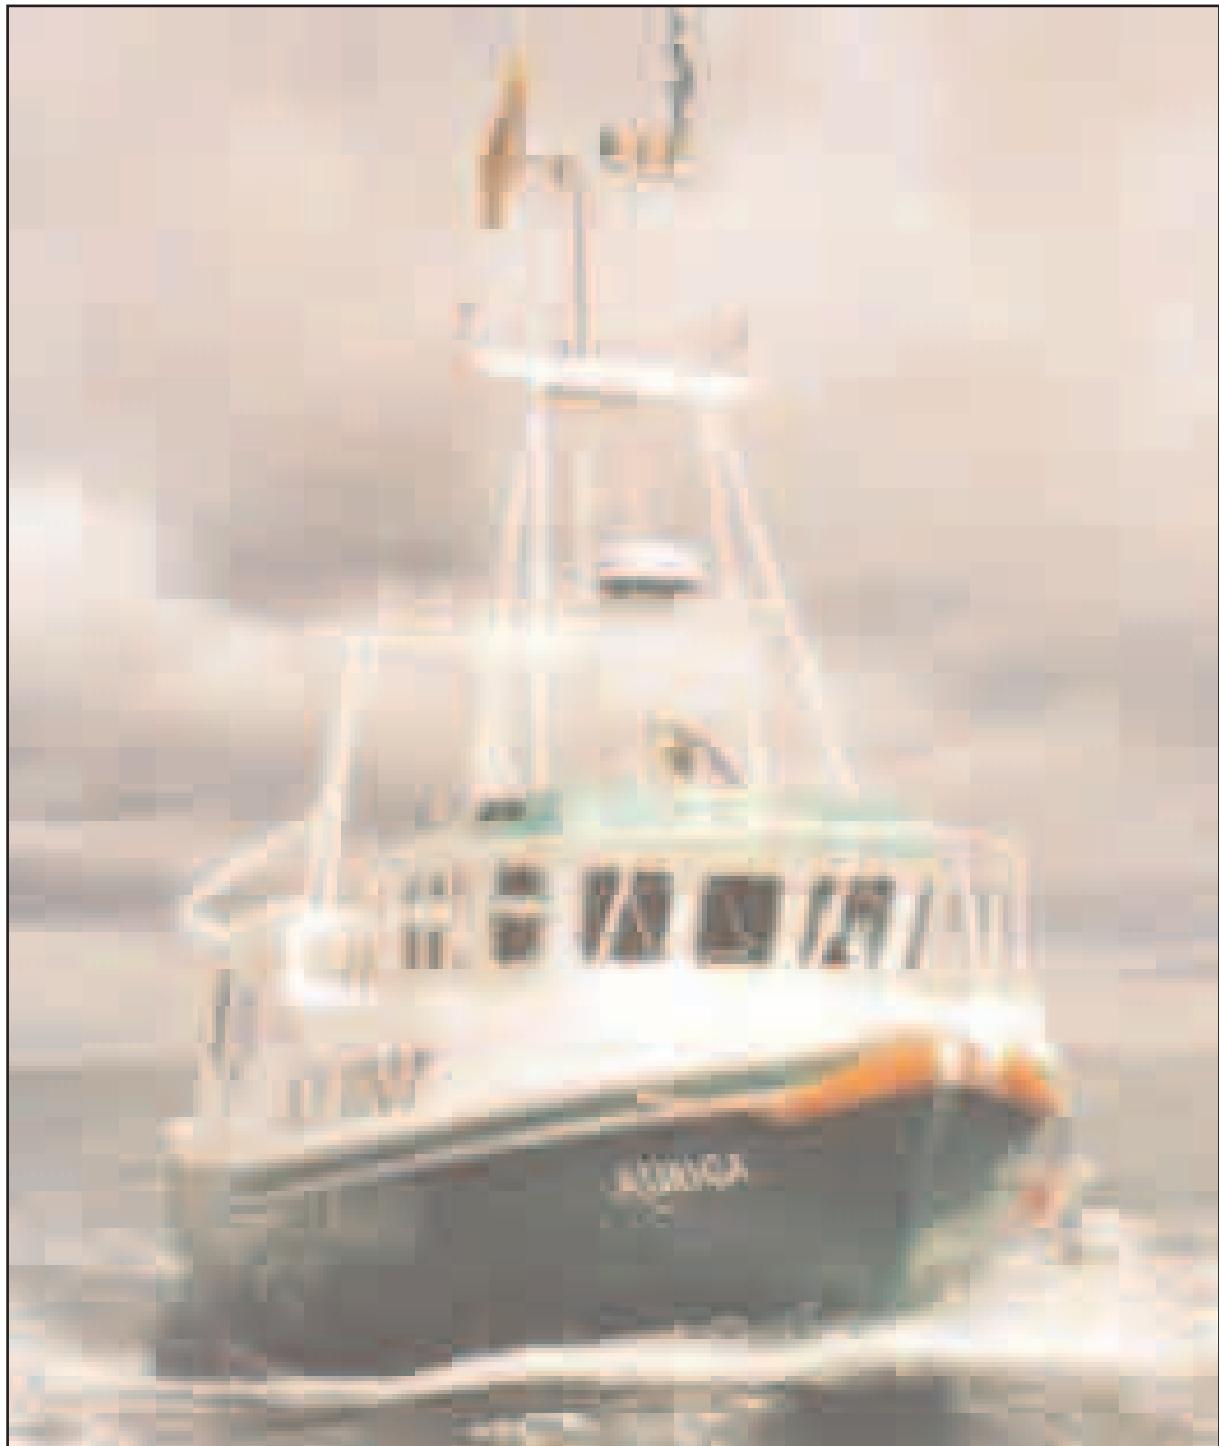
Figure 1

On 30 June 2005, the fishing vessel *Auriga* (**Figure 1**) capsized and sank about 6 miles north-east of Portavogie, Northern Ireland. The skipper and his crewman were both rescued from the stricken vessel's liferaft. Sea conditions at the time were slight with light SSE winds.

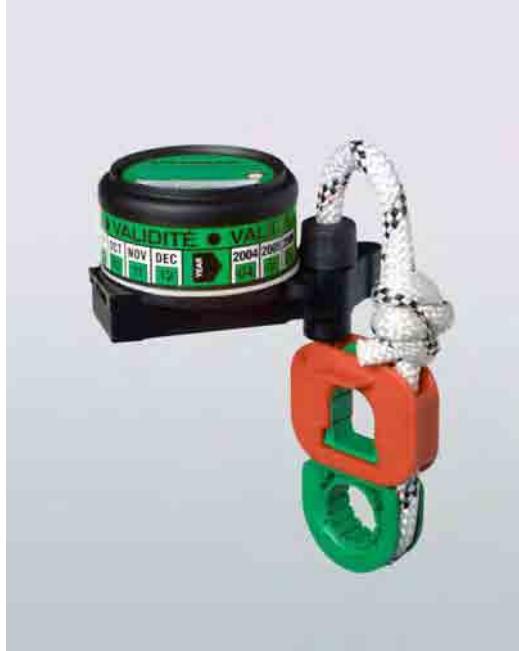
HRU for liferafts of four or less persons

Auriga's liferaft, however, was one produced for the leisure industry and, although it did its job well in this instance, it did not meet the more stringent requirements that are applicable to SOLAS type rafts. Non-SOLAS type liferafts do not afford the same levels of protection, or equipment, as found in type approved systems. The Ocean Safety four man liferaft carried on *Auriga* contained an ORC survival pack, which had minimal location aids and no food or water. Given that improved survival kits would involve additional costs, operators would benefit from having a "grab bag" containing essential survival aids, such as the vessel's location aids, in a convenient place on the vessel.

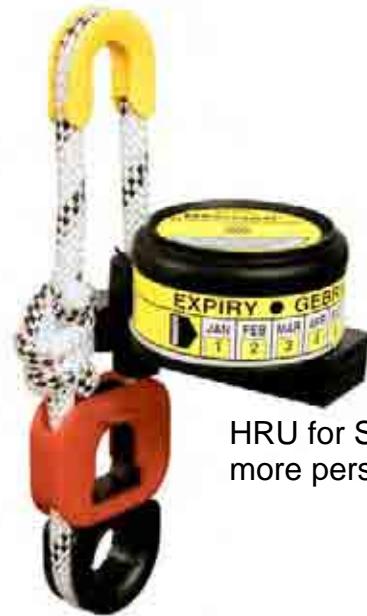
HRU for SOLAS type liferafts of six or more persons

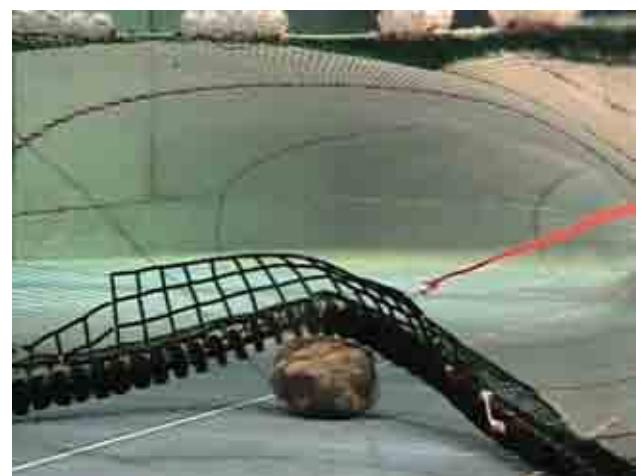
A 4 foot diameter boulder hits the flip up rope and gets directed beneath the groundgear
