Report on the investigation of

the capsizing of

Breakaway 5

River Bure, Norfolk

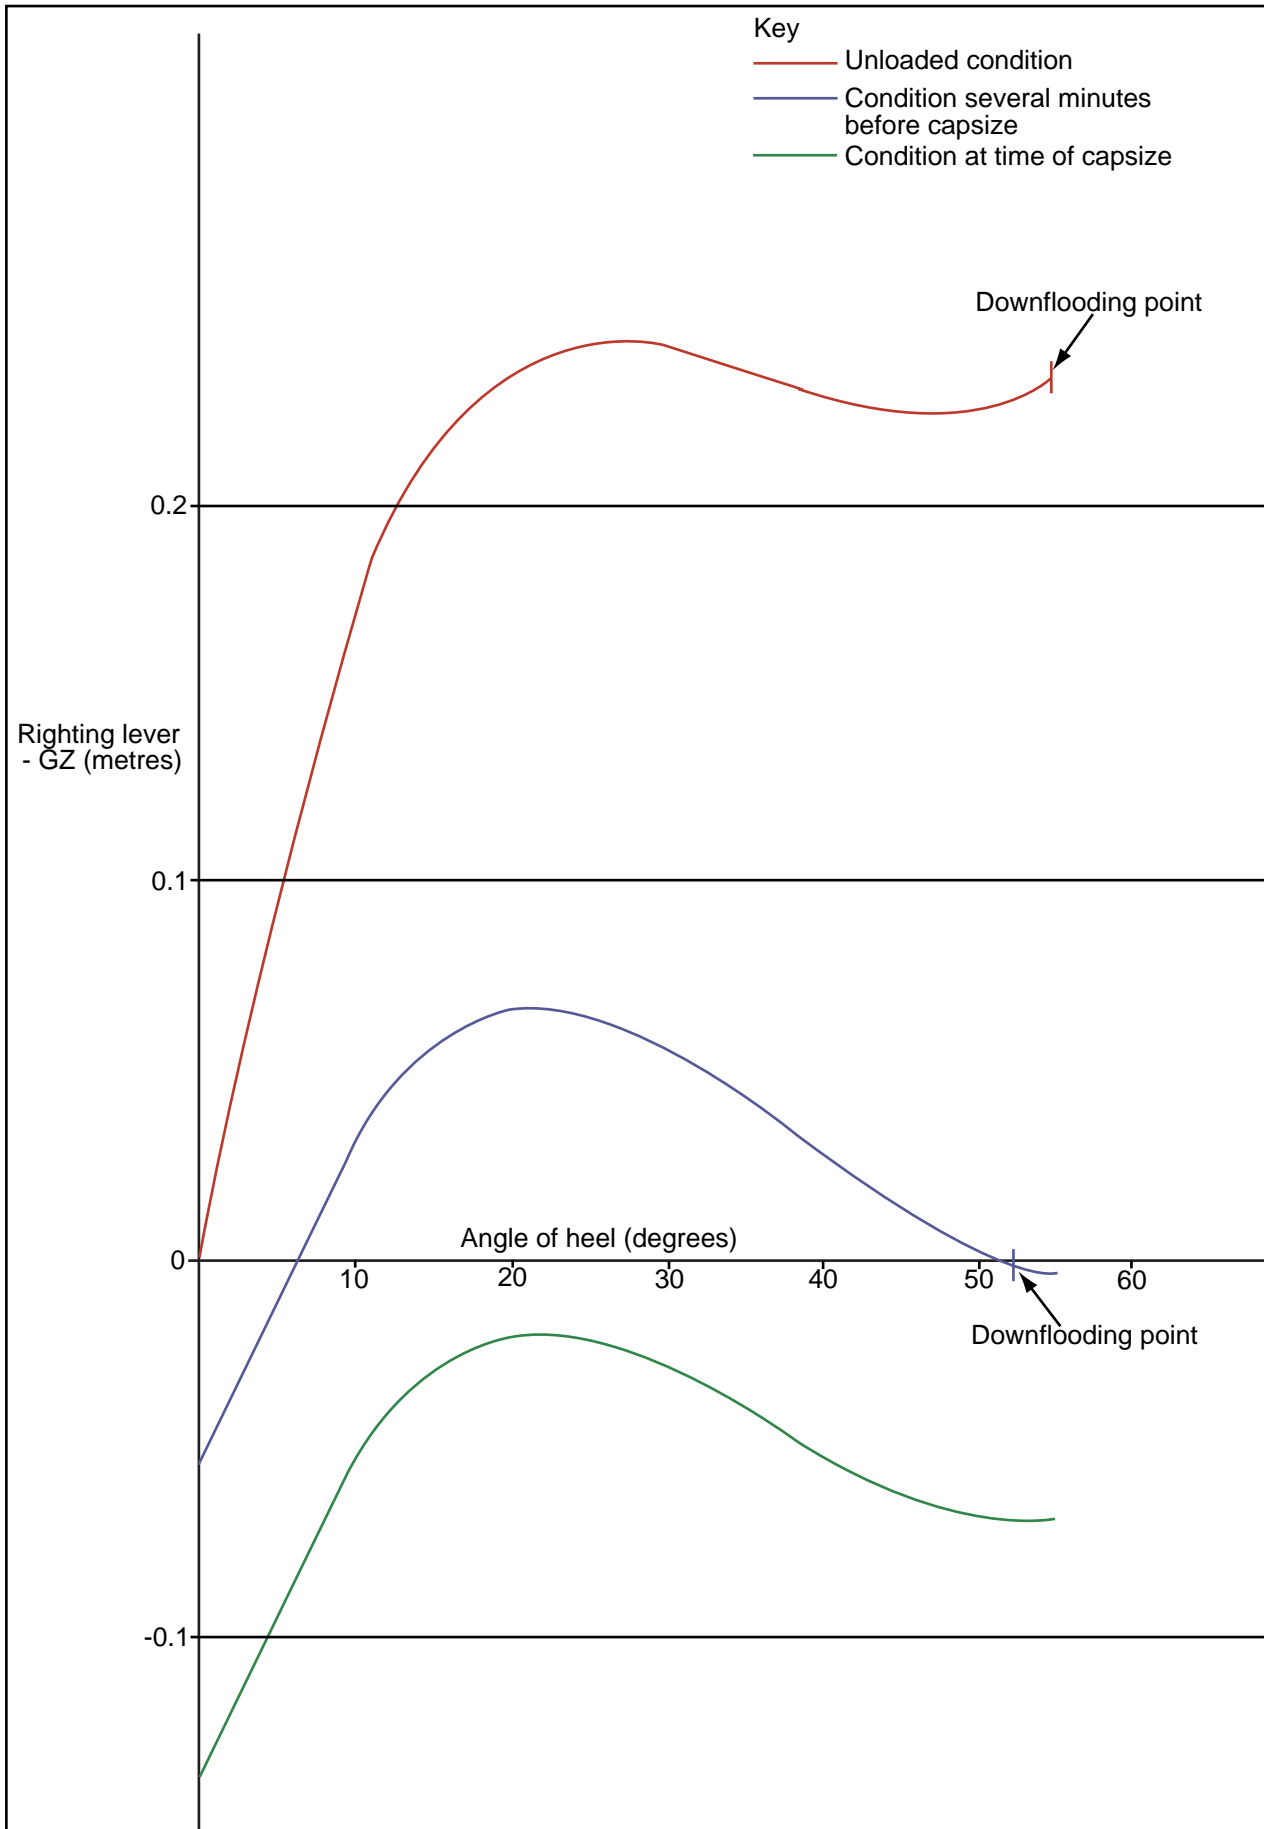
Figure 6

An inclining experiment to determine the craft's stability characteristics was conducted by the MAIB on 29 July 2003 using one of *Breakaway 5*'s sister vessels. An identical hull was also accurately measured using a theodolite. With the assistance of computer modelling, the information gathered from the inclining test and measurement of the hull was then used to determine the craft's stability in three conditions: the unloaded condition; an approximation of the condition several minutes before the accident; and the condition at the time of capsize. The resulting stability curves for these conditions are shown at **Figure 6**. A summary of the inclining test is at **Annex F**. This data is based on the vessel being static, and therefore does not take into account any dynamic effects such as heel induced by the vessel turning.

Breakaway 5 - GZ curves

From the stability data shown at **Figure 6**, it is evident from the area below the GZ curve that the boat's standard of stability in the unloaded condition is good. Indeed, it almost meets the requirements for vessels operating at sea. In the approximated condition several minutes before the accident, although there is an initial list of about 6° to starboard, a positive righting moment up to about a 50° heel remains. In the condition at the time of capsize, however, which was achieved by moving just three of the party in the previous condition, stability is reduced to the extent that the righting levers do not reach a positive value.

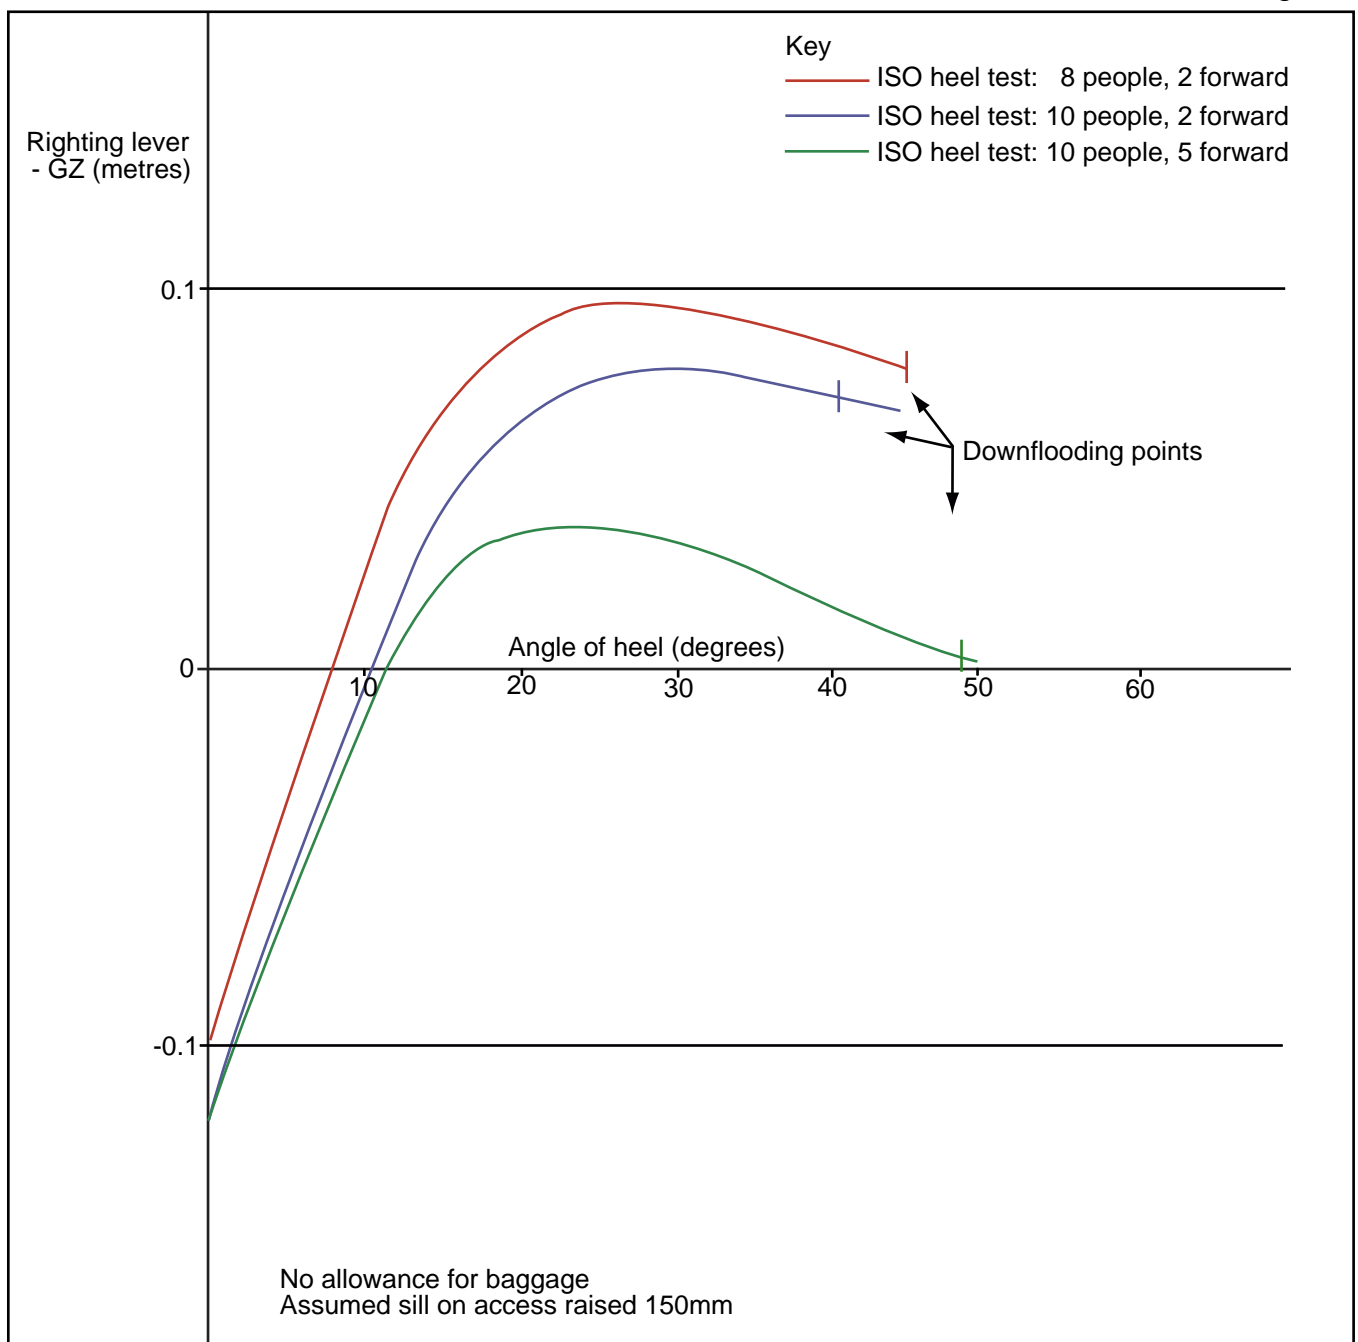
Figure 7

Although the angle of heel achieved during the test was permissible, the area below the GZ curve produced from the *Breakaway's* condition during the offset load test (five people on the foredeck and five in the cockpit) (**Figure 7**) indicates that only a small amount of stability remained. This stability can soon be diminished by several factors, such as the weights of the passengers being

Breakaway GZ curves - test conditions

greater than allowed for, and the positions of the passengers being more extreme than expected, both of which contributed to *Breakaway 5*'s capsize. The methodology of the standard does not allow a margin of safety to allow for such possible variations, for the possible differences in the interpretation of the conduct of the offset test, or any dynamic effects when a vessel is underway. If it did, more confidence could be placed in its validity in all cases.
