Report on the investigation of

the capsizing of

Breakaway 5

River Bure, Norfolk

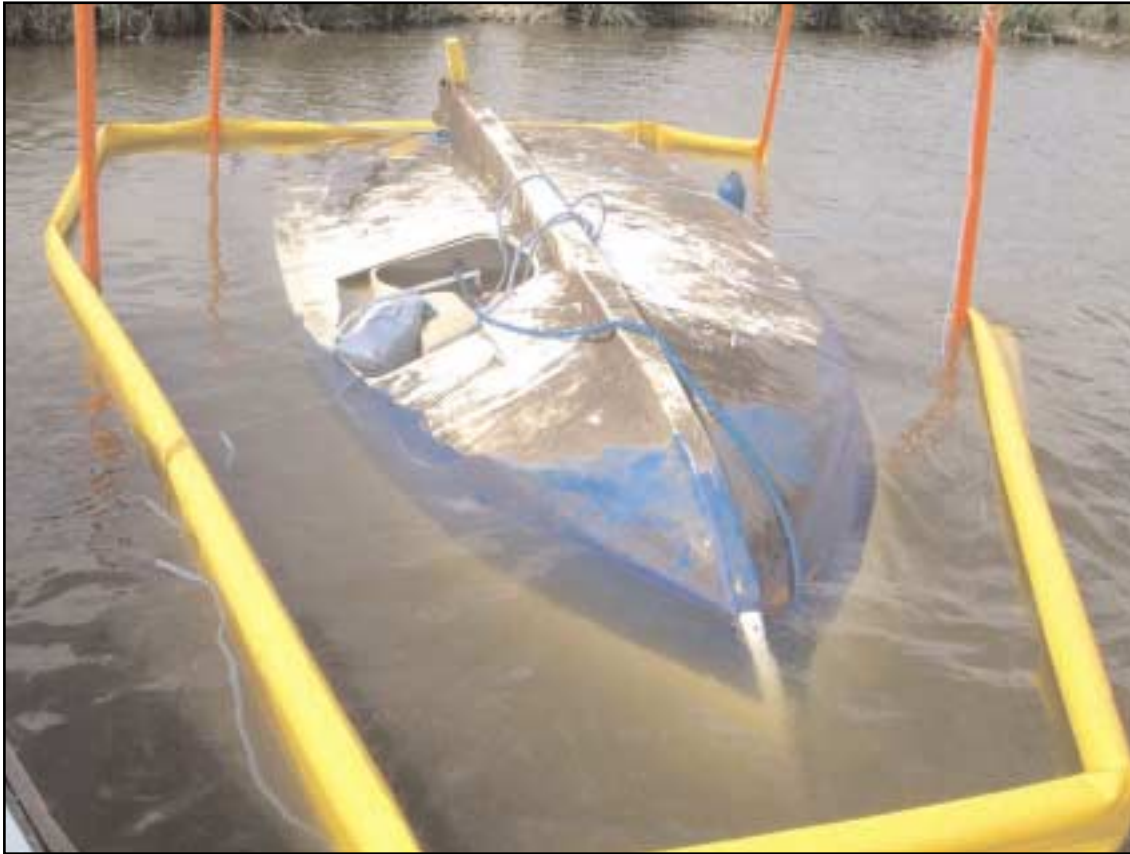
Figure 2

On 20 July, MAIB inspectors visited *Breakaway 5* at the scene of the accident. Other than the hole cut to allow the removal of the two trapped people, and a very shallow scratch running along the length of the underside of the boat's hull on her starboard side, no other significant damage was evident (**Figure 2**).

Photograph of *Breakaway 5* capsized

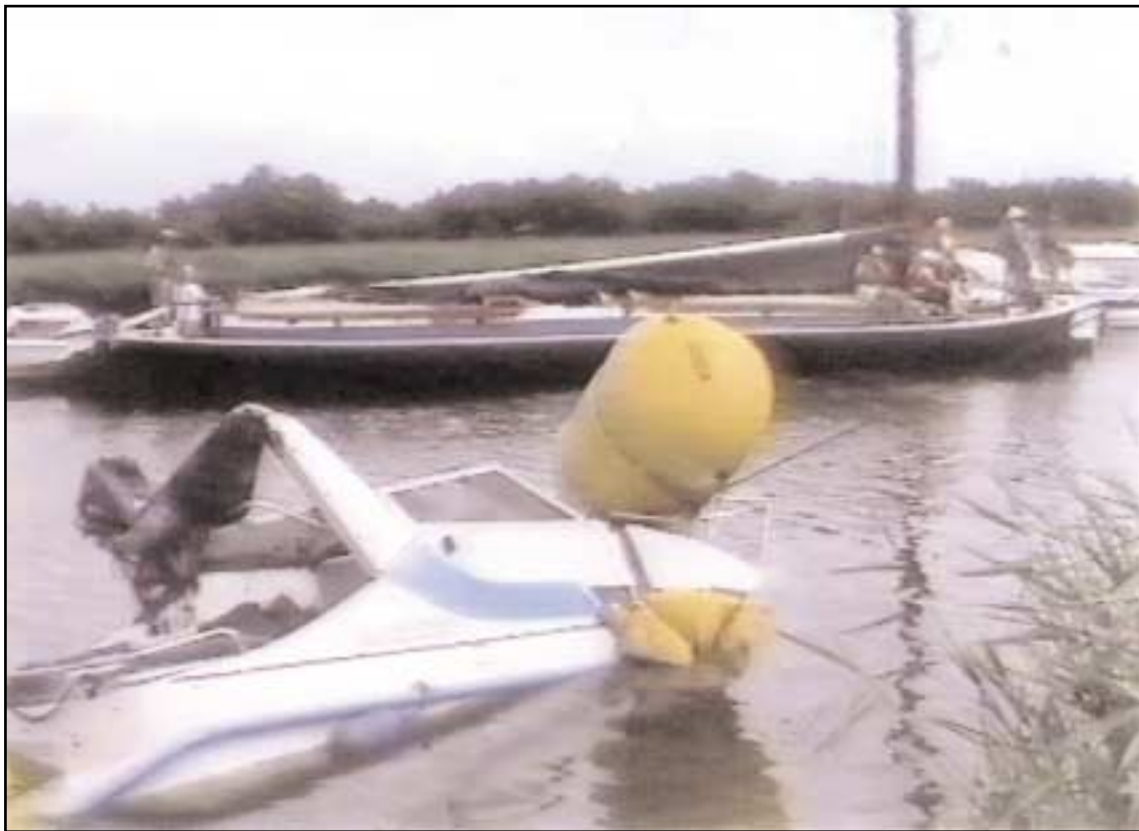
Figure 3

On 22 July, a temporary repair was made to the hole in the hull of *Breakaway 5*, which was then righted and refloated by the Norfolk Constabulary, assisted by the Broads Authority (**Figure 3**).

Photograph taken during the recovery of *Breakaway 5*

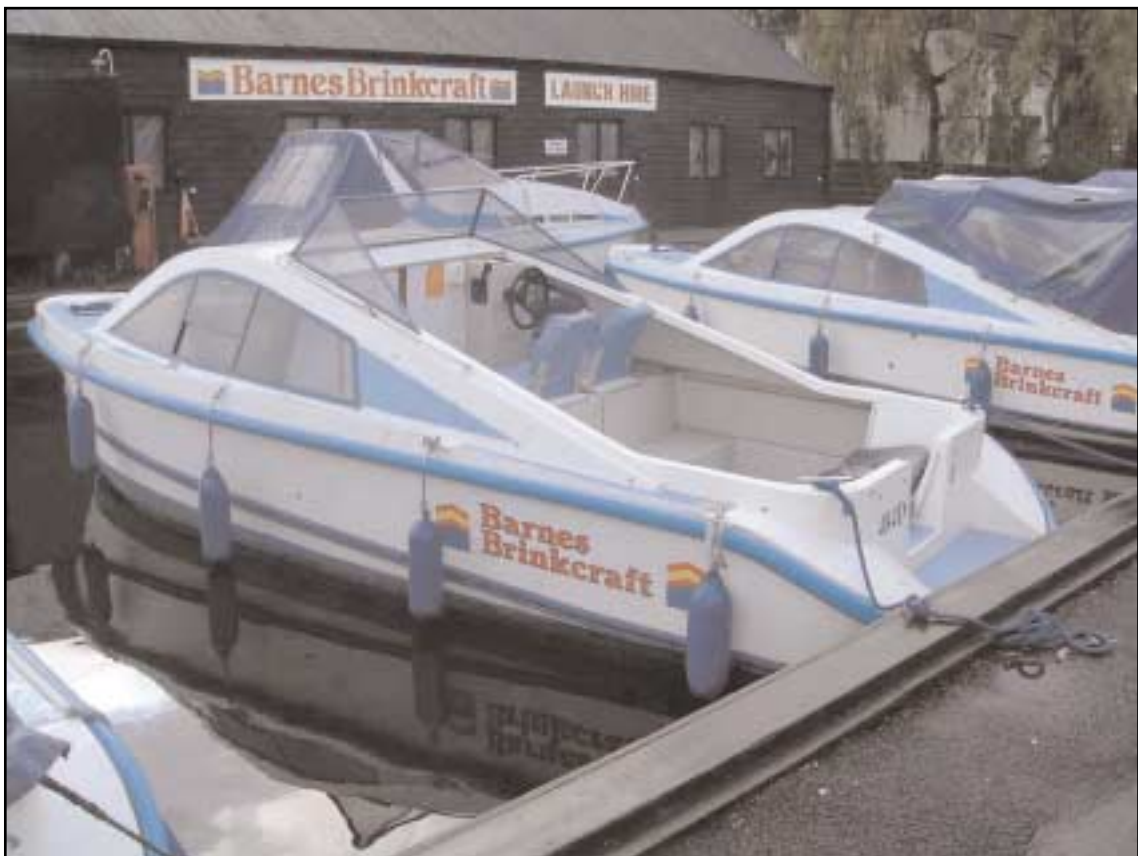
Figure 5

Photograph of a Picnic
