Report on an investigation
of the loss of the skipper from
Girl Alice (LH523)
1.5 miles south-east of Burnmouth
19 November 2000

Report No 17/2001

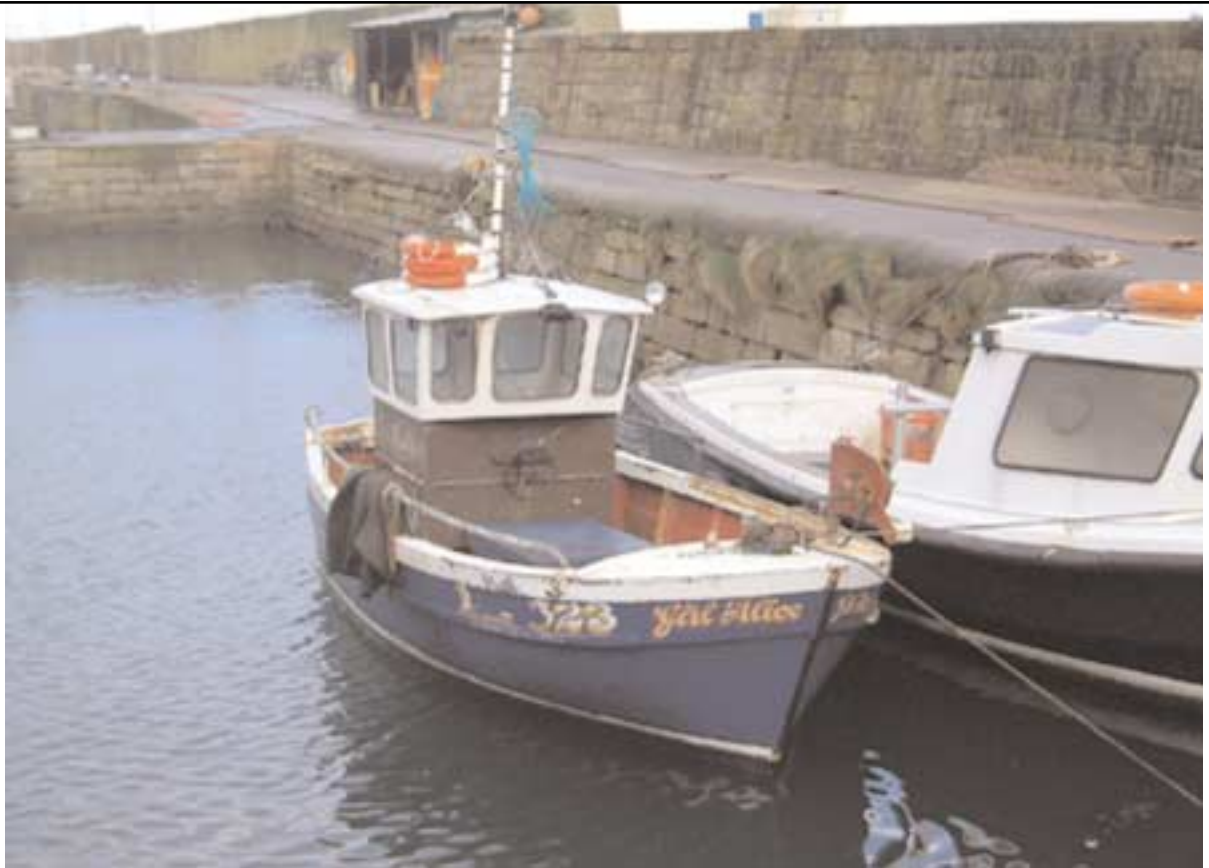
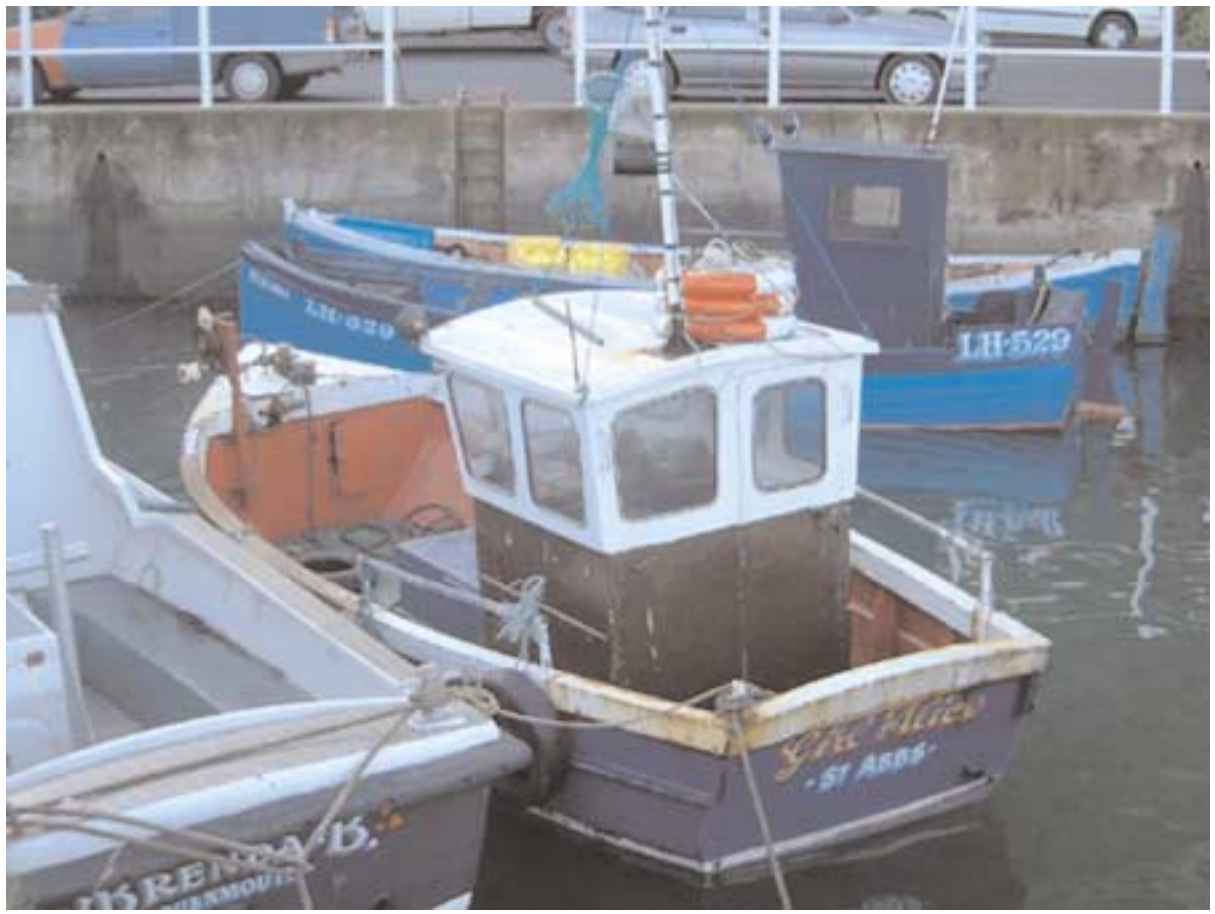
1.1 DESCRIPTION OF VESSEL (Figure 1 and 2)

Girl Alice was built in 1990 as a glass reinforced plastic (GRP) open boat, with a non-watertight working deck.

The wheelhouse was situated aft with access via a door in the rear. The steering wheel was extended through to the forward side of the wheelhouse; however, there were no engine controls or emergency stops placed outside it. The pot hauler and pot hauling area were on the port forward side of the vessel.

The main engine, incorporating a wet exhaust, was fitted on engine beds attached to the hull framing of the vessel forward of the wheelhouse, and protruded through the main deck with a rigid covering.

The bulwarks surrounding the main deck area were 670mm high.

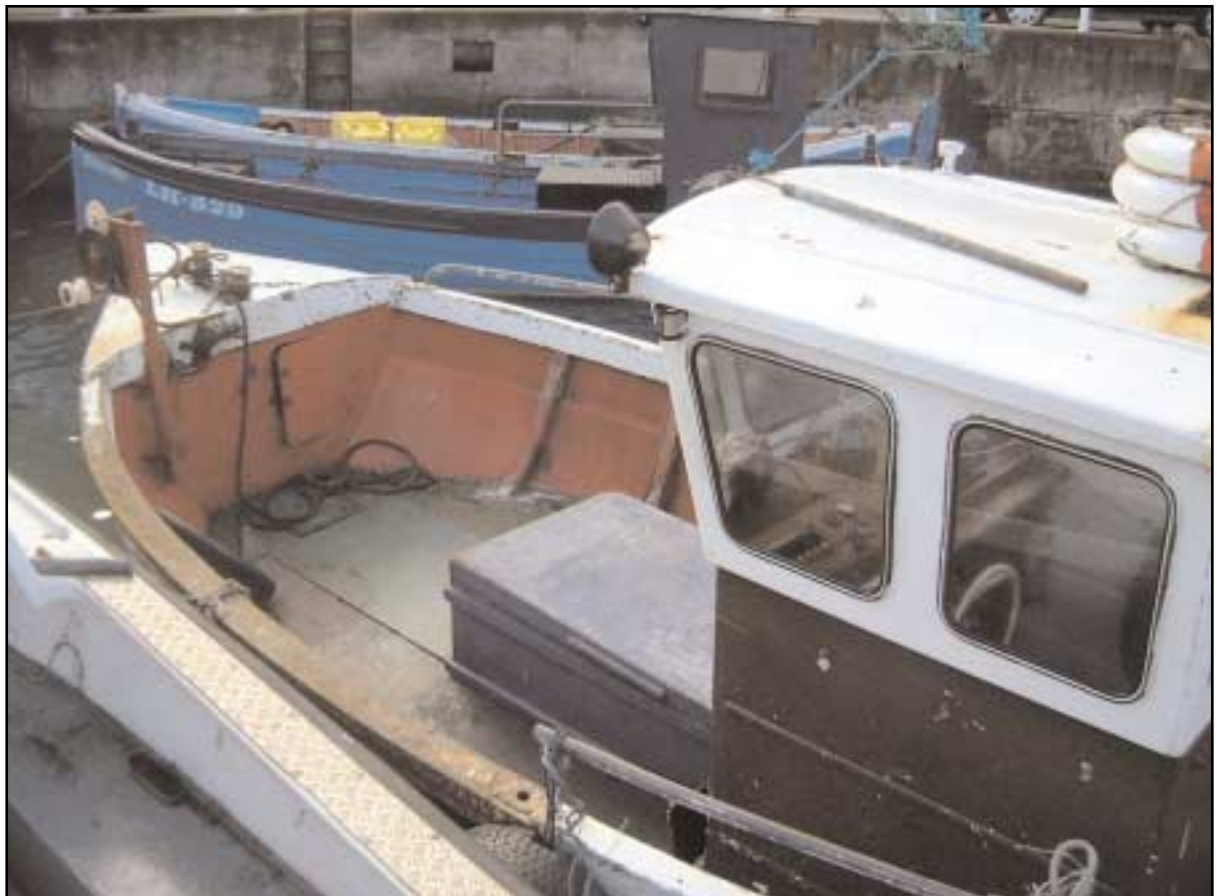
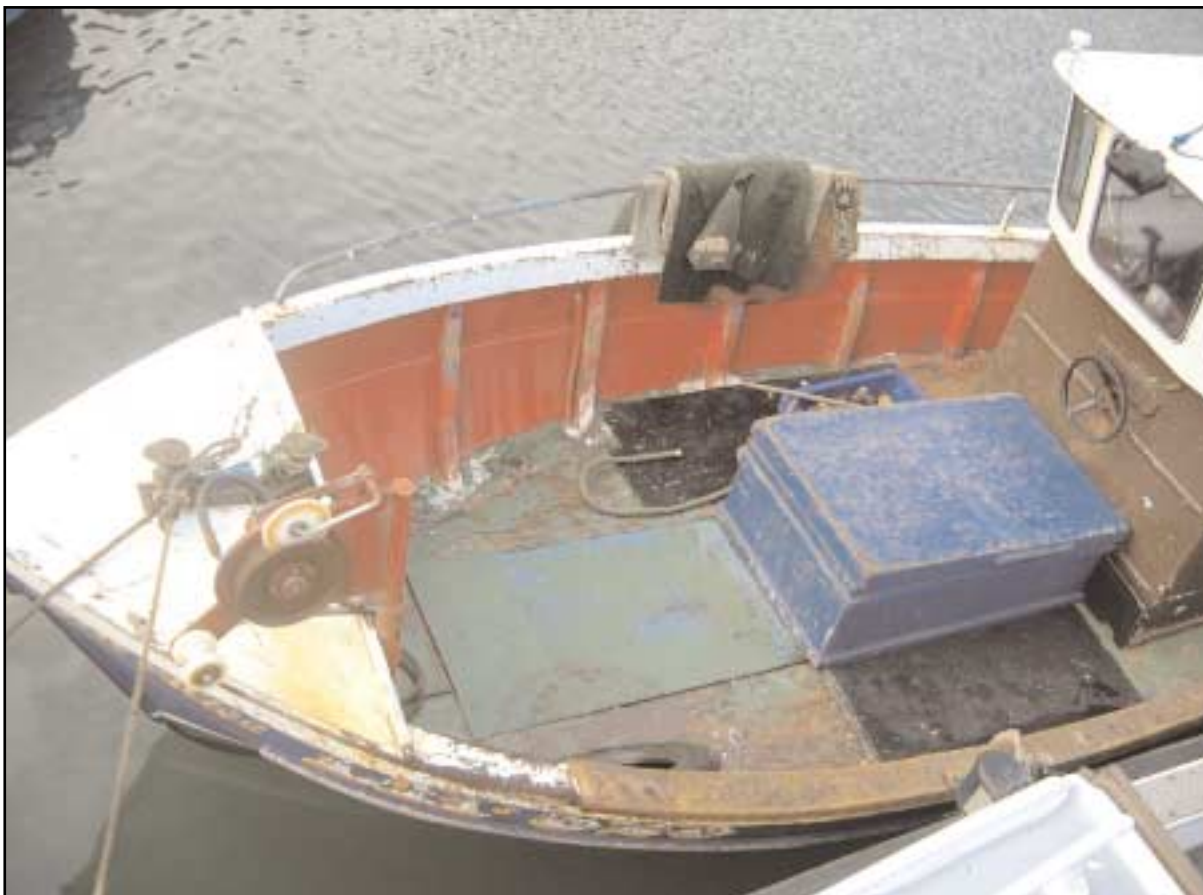
Figure 2a

Girl Alice - views of the working deck

Since there were no engine controls or emergency stops at the working position on deck, the skipper had to go into the wheelhouse from the after end to slow or stop the vessel in the event of gear becoming snagged or other emergency.

1. Include the recommendation that such boats be fitted with engine and steering controls at, or near, the pot hauling controls, in any reprint of its leaflet entitled *Single Handed Operation*.
