Rail Accident Investigation Branch

Rail Accident Report

Fatal accident involving a track worker at Saxilby 4 December 2012

Report 21/2013
v2 August 2014

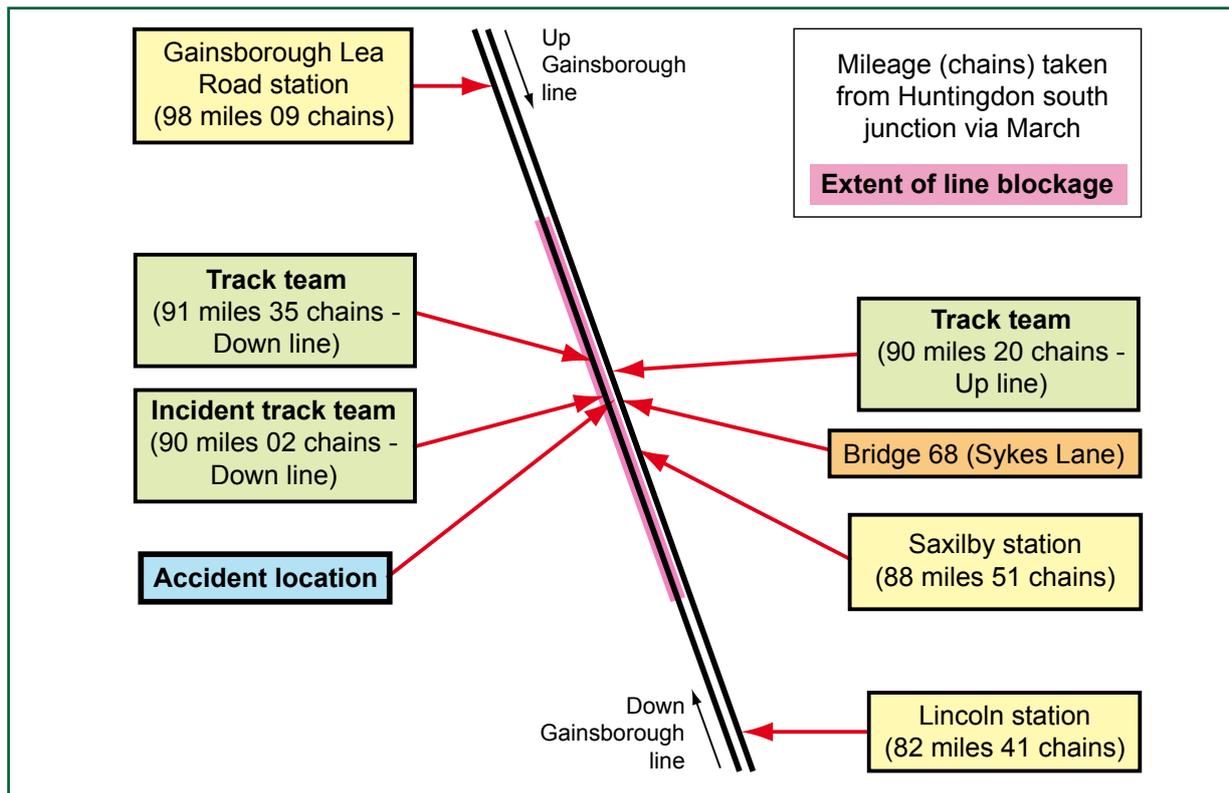
Figure 2: Line diagram showing the locations of the work groups and extent of the line blockage

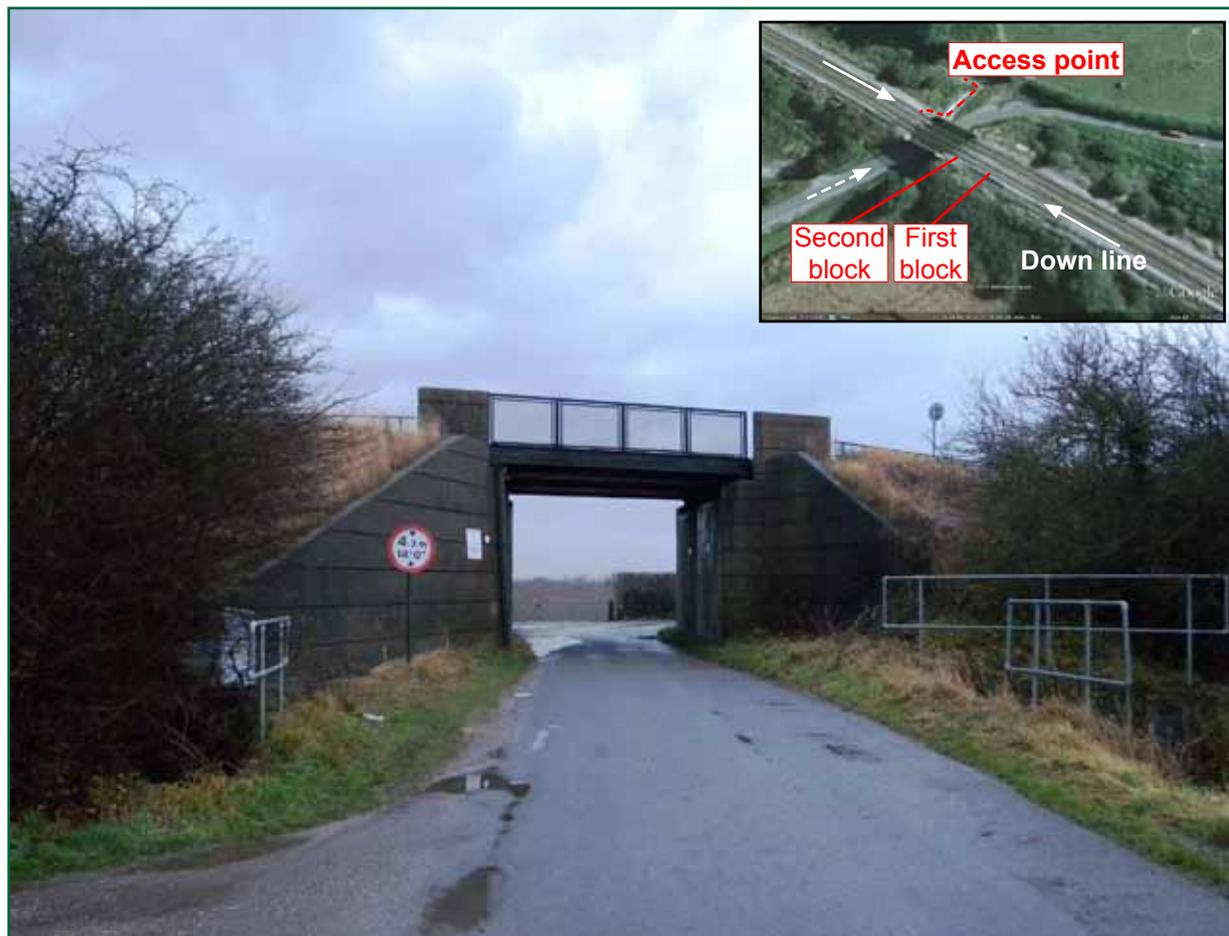
Figure 3: Sykes Lane underbridge and (inset) Google Earth image showing locations of access point and areas of work for the first and second line blockage

- 7 The route between Lincoln and Gainsborough Lea Road comprises twin-track non-electrified lines used by passenger and freight services. The line used by trains travelling towards Lincoln is designated the up line and that towards Gainsborough is designated the down line. The site of the accident was in the space between the up and down lines (known as the 'six-foot') near to Sykes Lane underbridge (figures 1 and 2), which is approximately eight miles from both Lincoln and Gainsborough. The maximum permitted speeds for trains on the up line at this location is 50 mph (80 km/h) (figures 3 to 5).

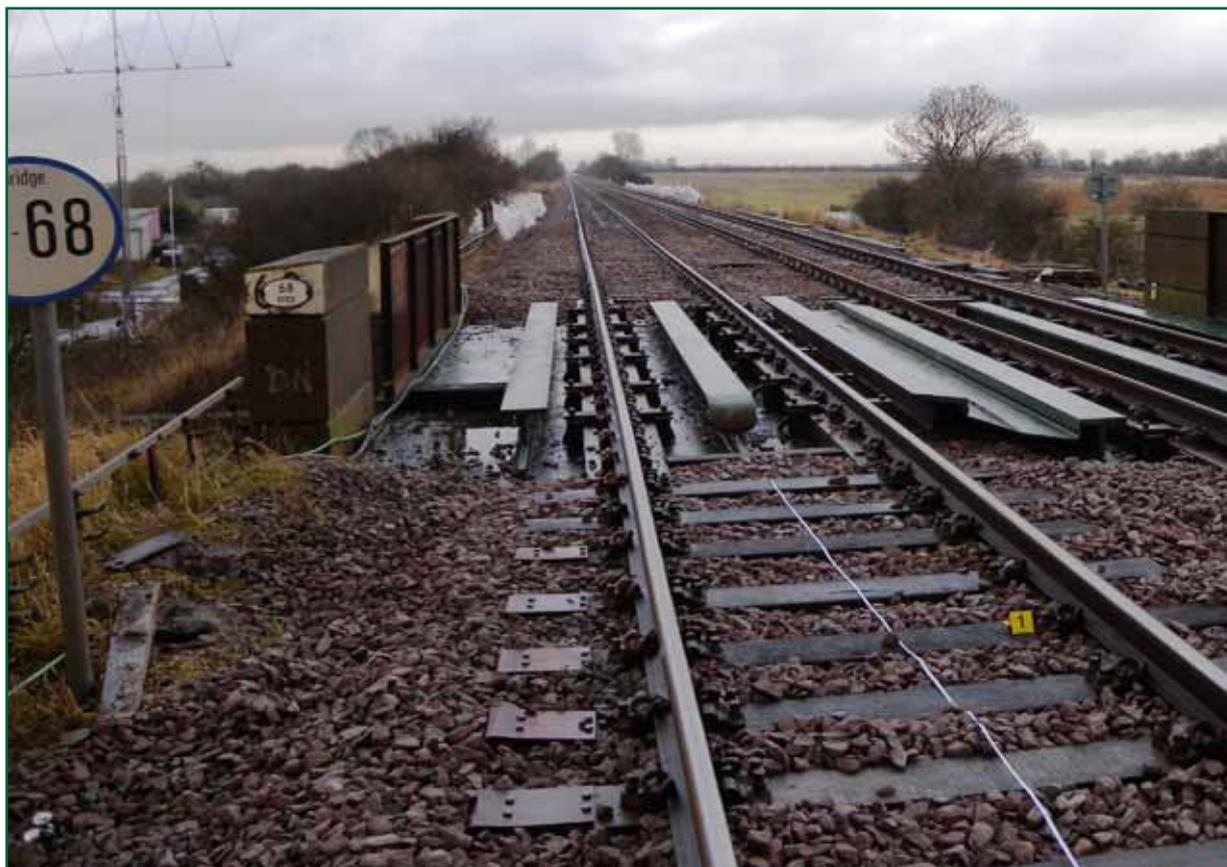
Figure 4: The scene of the accident, looking along the down line, showing the available view of trains approaching on the up line

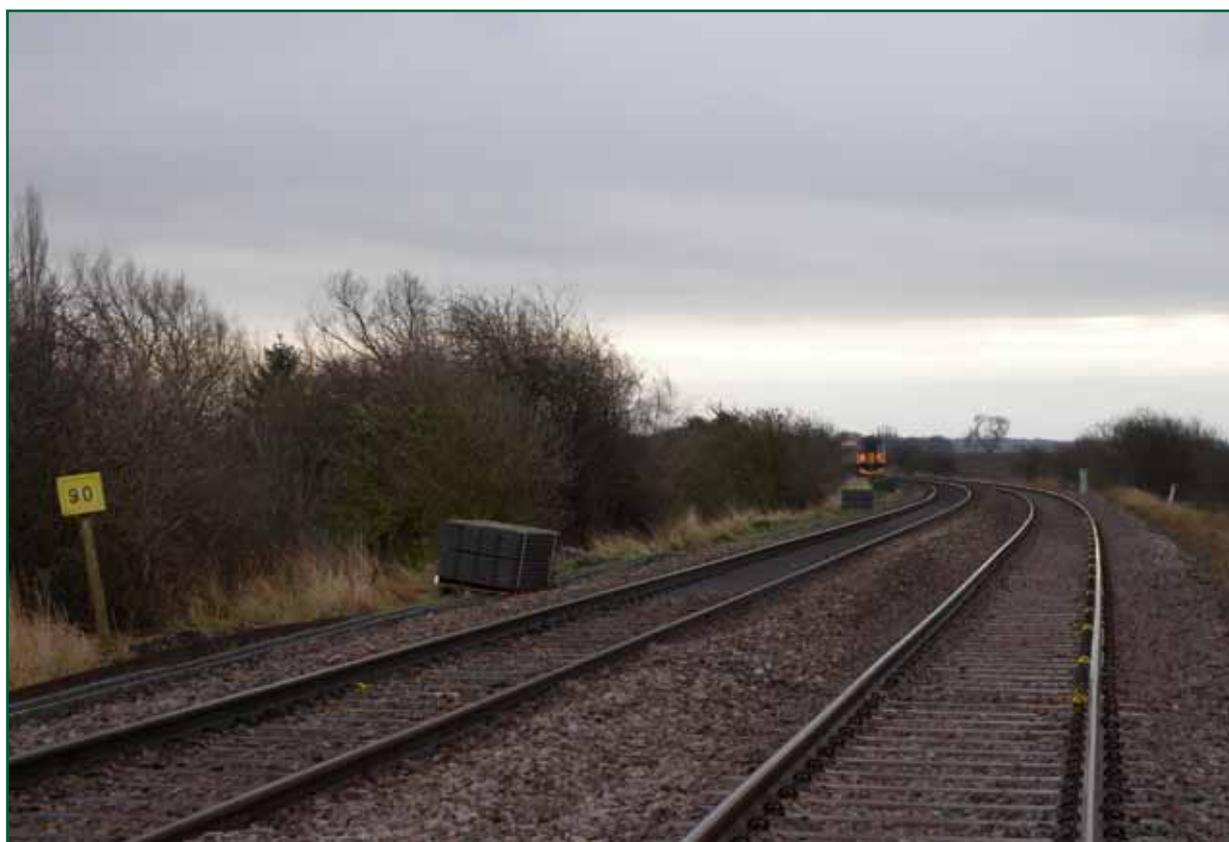
Figure 5: The down line at the scene of the accident, looking in the opposite direction to figure 4, showing the available view of down trains

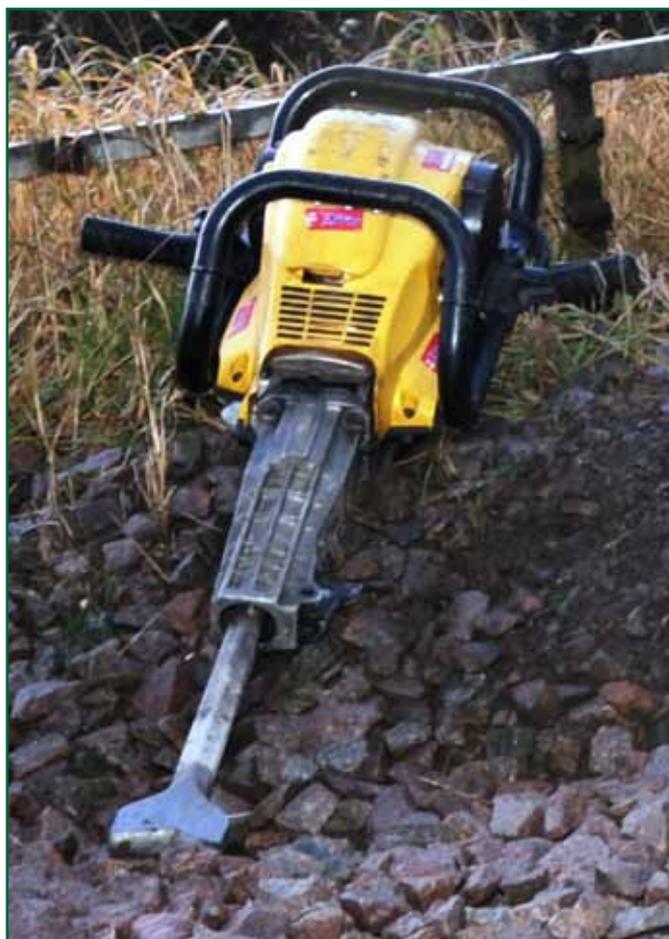
Figure 6: Hammer used at the time of the accident

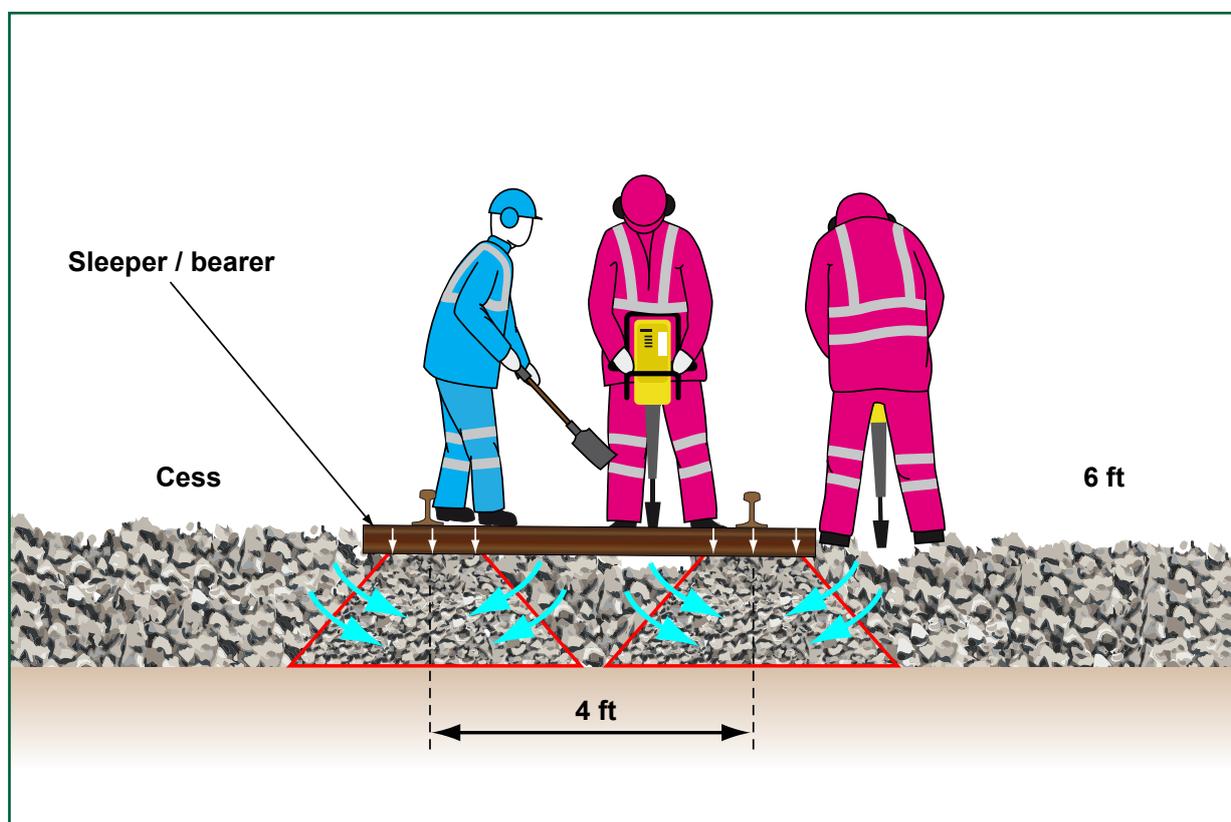
Figure 7: Diagram showing how Hammers are used to cross pack the ballast

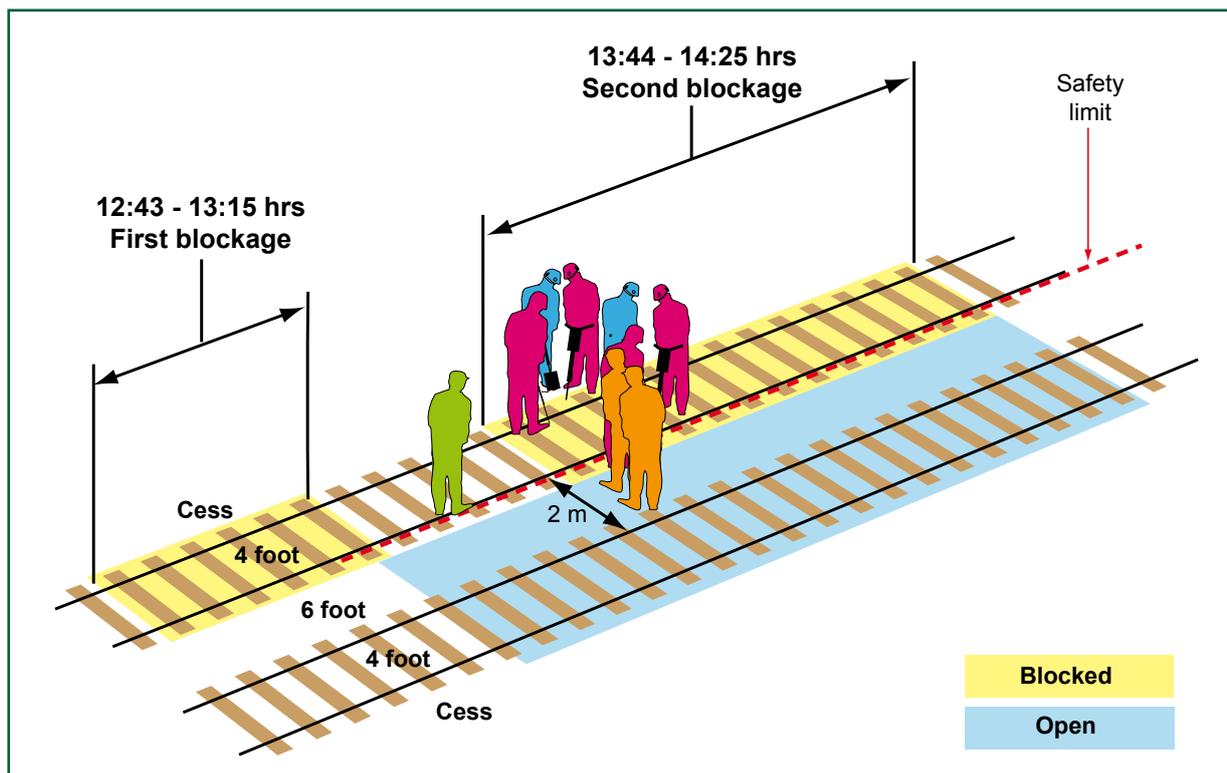
Figure 8: Diagram based upon witness evidence showing the areas of the first and second line blockage and positions of: the hammer operators (coloured pink); staff using shovels (blue); the COSS's original position (green); and location during the second line blockage (orange)

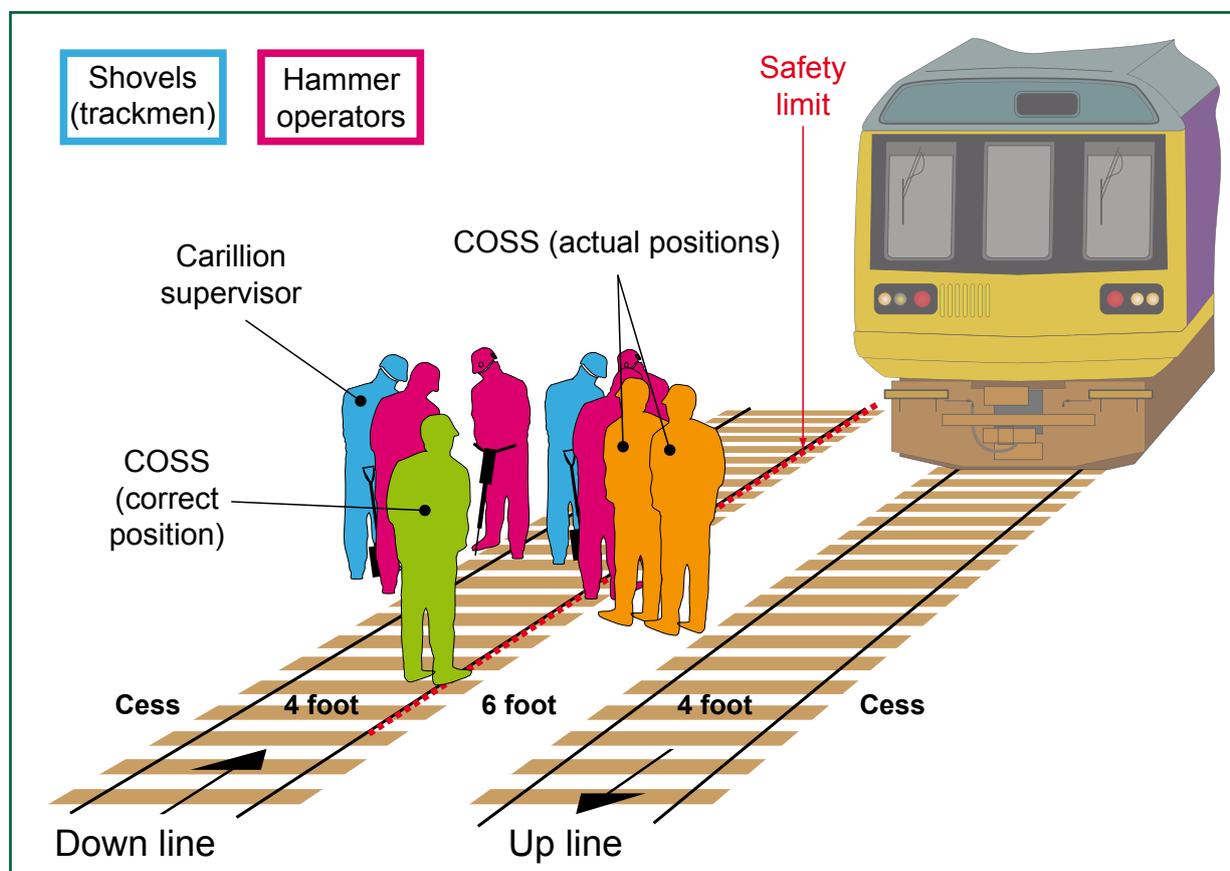
Figure 9: Diagram based upon witness evidence showing the final positions of trackmen: hammer operators (coloured pink) working in the cess, four foot and six foot area on the down line; staff using their shovels (blue); the COSS's original position (green); and location prior to the accident (orange)

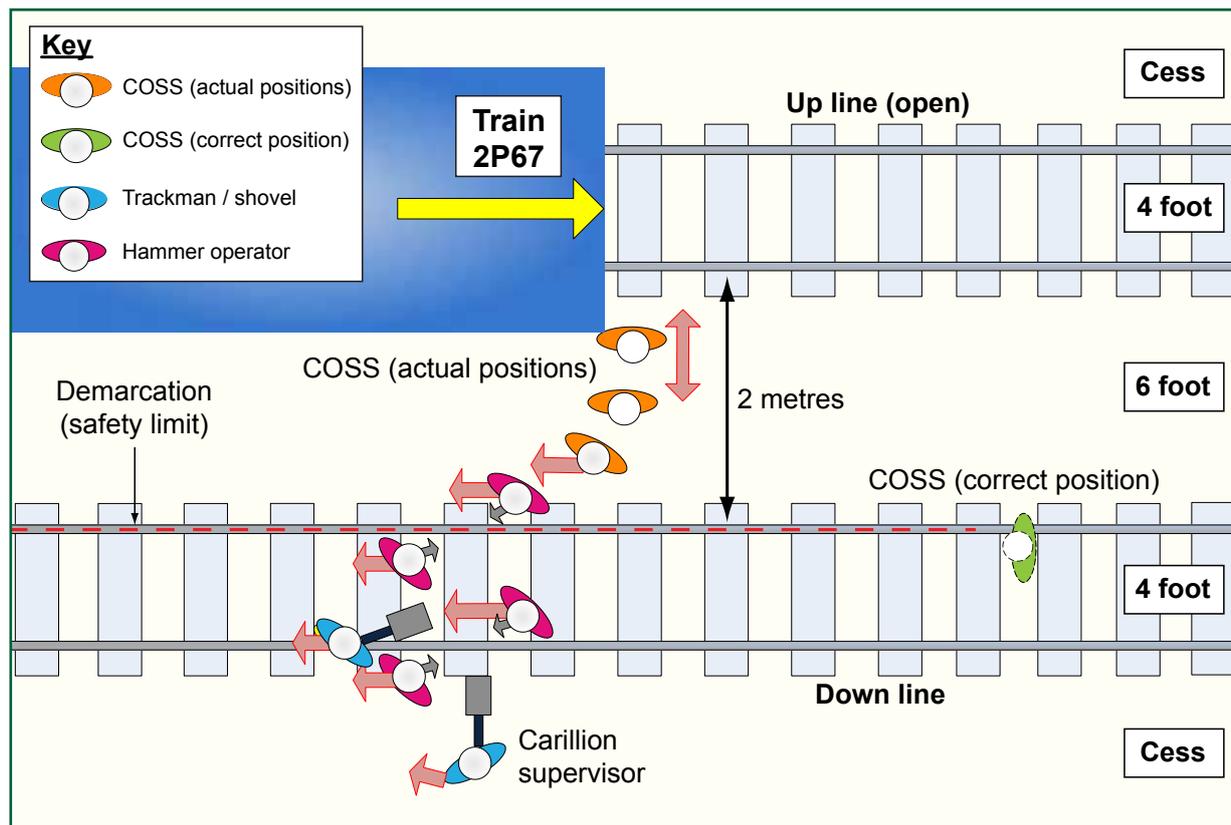
Figure 10: Diagram based upon witness evidence showing position of the COSS at the time of the accident

23 As train 2P67 approached the worksite, the train driver observed the COSS step back into the path of his train (figure 10). The train driver applied the *emergency brake*, but the train struck and fatally injured the COSS. The train driver made an emergency call to route control in York at 13:54 hrs. York control room contacted Lincolnshire Police and East Midlands Ambulance services and British Transport Police. York route control also contacted the Saxilby signaller who attempted to call the COSS. Members of the track gang went to the assistance of the COSS, but it was soon apparent that he had succumbed to his injuries. A manager from Carillion attended the site and obtained a first account of the accident from the track gang.

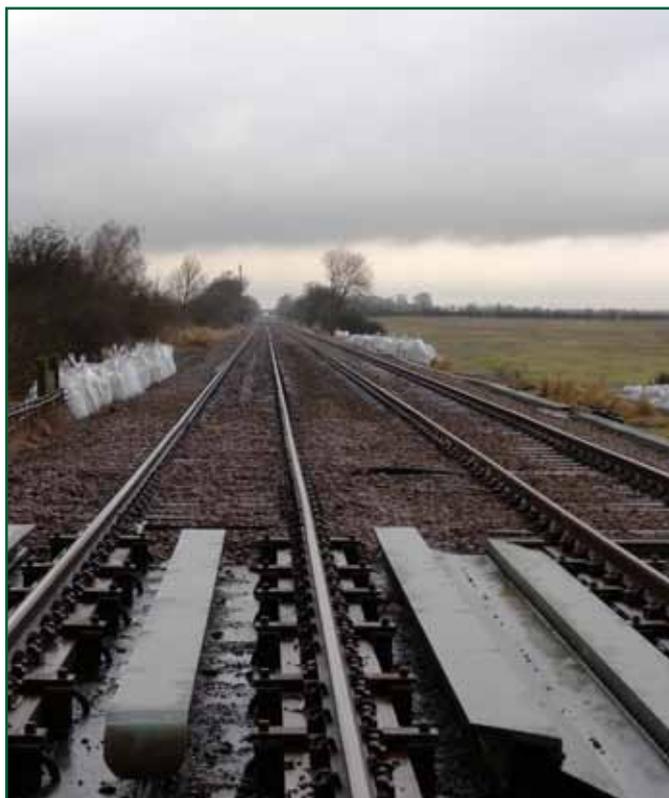
Figure 11: Image taken from the four-foot of the down line showing the extensive sighting distance of trains approaching on the up line

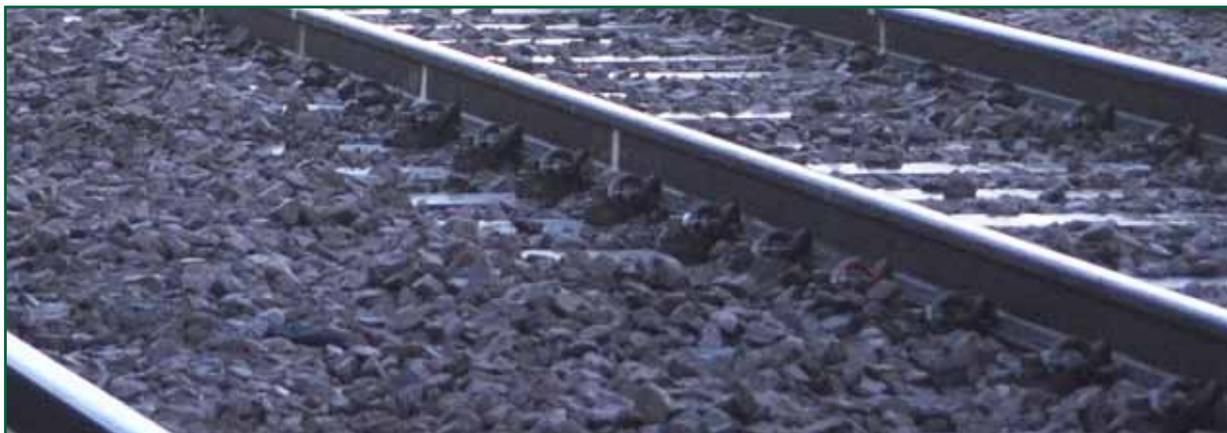
Figure 12: The scene of the accident looking at the area of work on the down line with ballast tidied around the sleeper ends within the six-foot

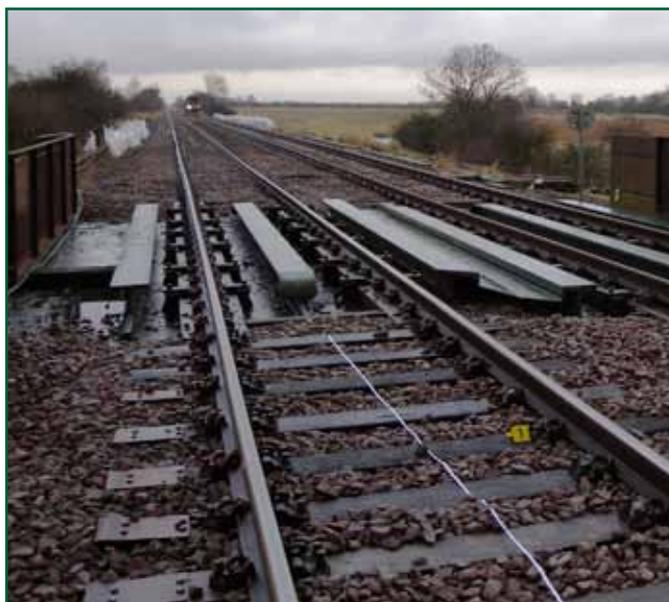
Figure 13: Image taken from the four-foot of the down line showing an up line train approaching underbridge 68 (approx. 200 to 250 metre distance from the location of the accident)

- 62 A reconstruction undertaken by the RAIB showed that from a distance of 200 to 250 metres, a train driver would have had difficulty in distinguishing if a person was standing in an unsafe position if that person was located in the six-foot, but to the rear of people working in close proximity to each other (figures 13 and 14).

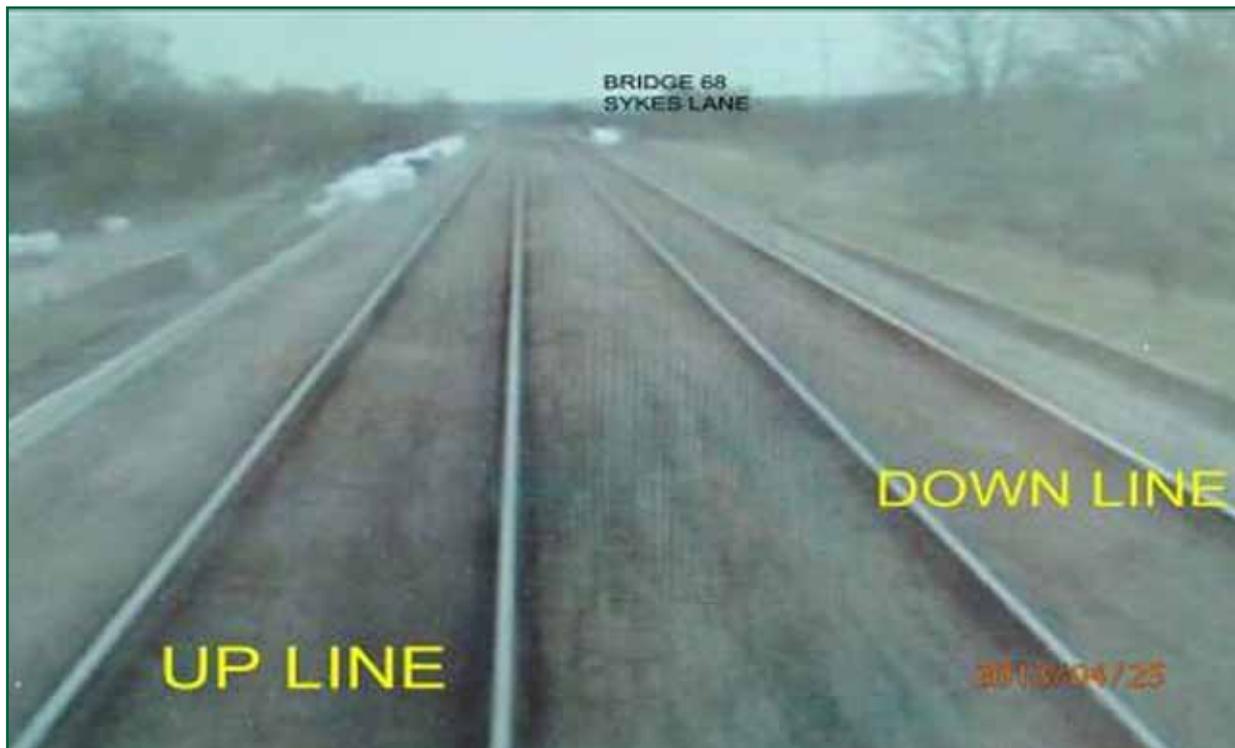
Figure 14: Reconstruction image showing the view from a cab of train travelling on the up Gainsborough line approaching Sykes Lane (approx 250 metre distance)

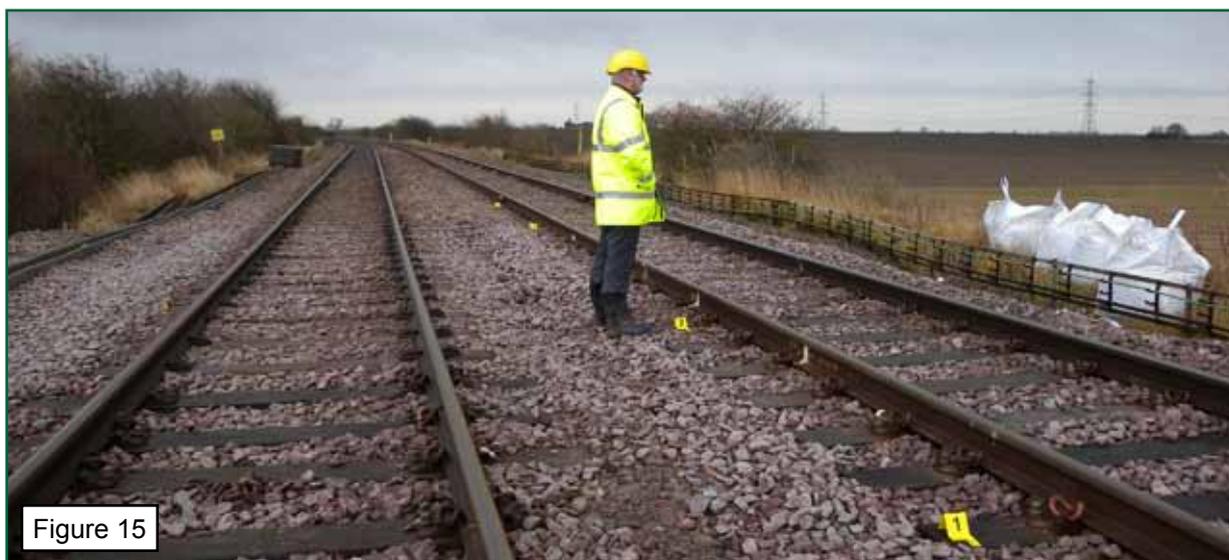
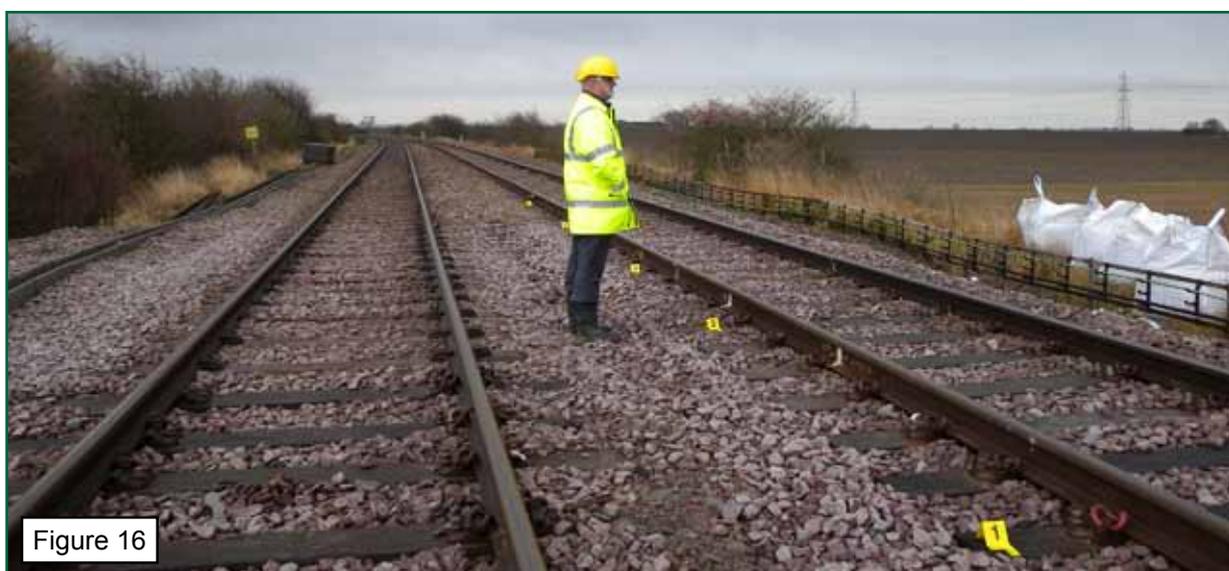
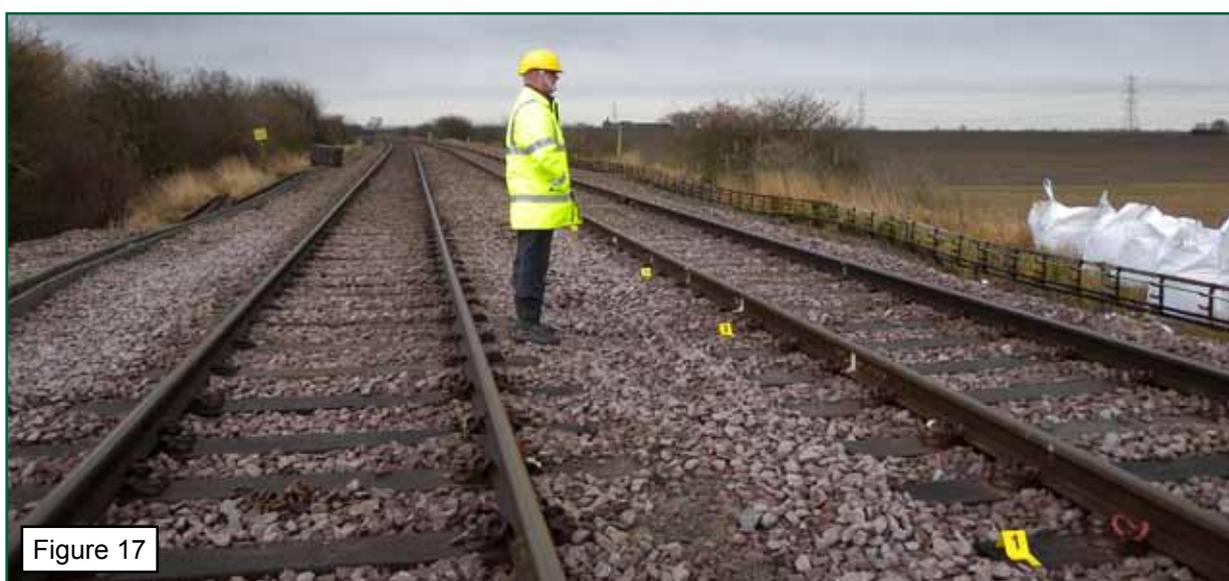
Figures 15 to 17: Police/RAIB reconstruction showing the location of the COSS: standing in the six-foot next to the six-foot rail of the down line (top); within the six-foot (middle); and next to the six-foot rail of the up line (bottom) at the time of the accident.

- 63 Members of the track gang stated that they did not hear the train's horn being sounded and were therefore unaware of its approach. Although the COSS and other track workers operating the hammers were not wearing ear defenders (which might have masked the sound of the train horn being sounded), the noise created by the machinery¹³ may have prevented them from hearing the approaching train¹⁴ (figures 15 to 17).

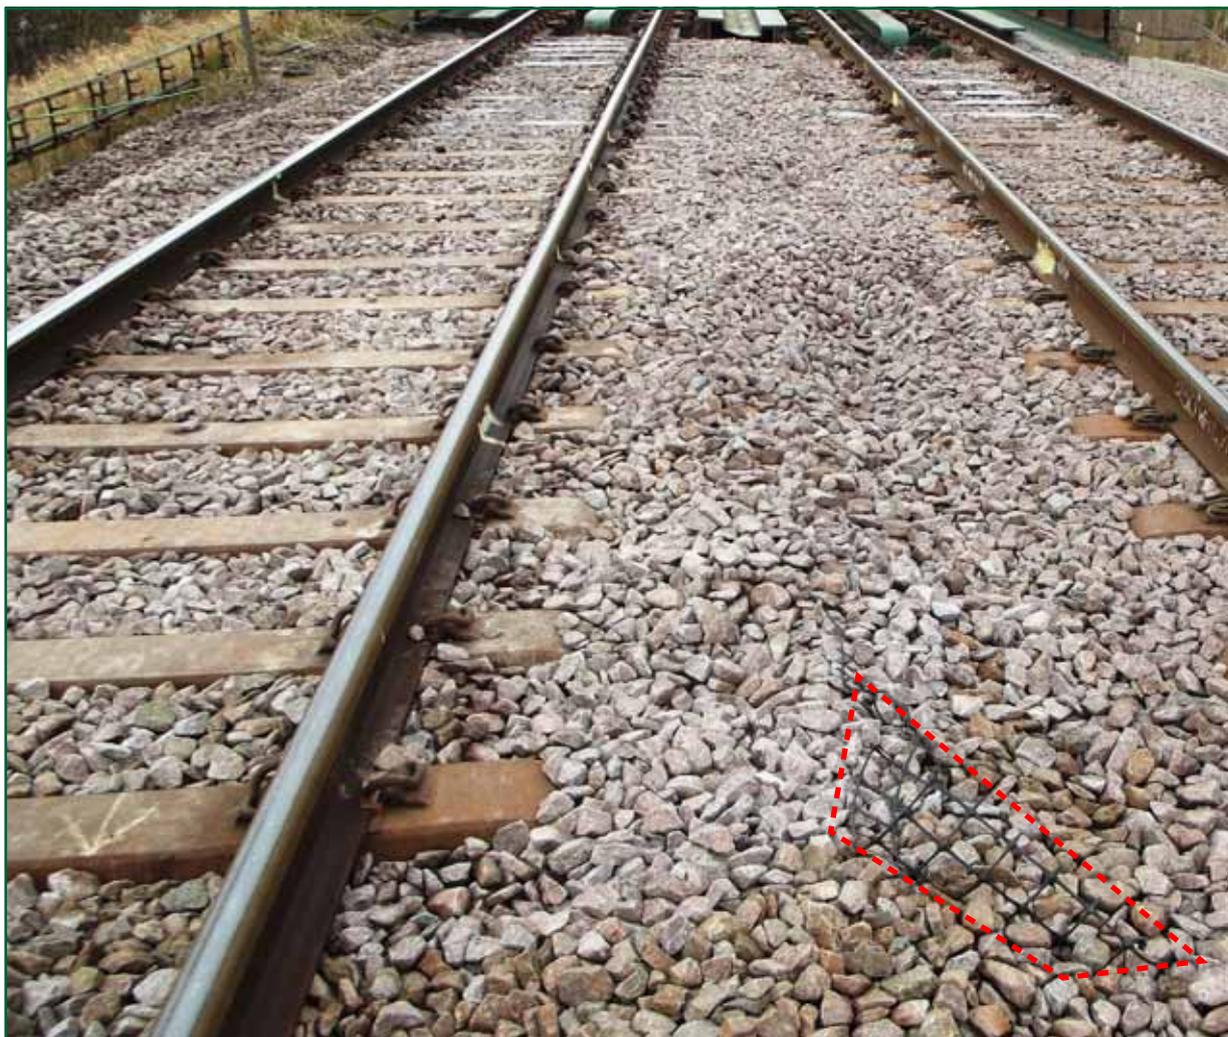
Figure 18: The geomesh at the site of the accident
