Rail Accident Investigation Branch

Rail Accident Report

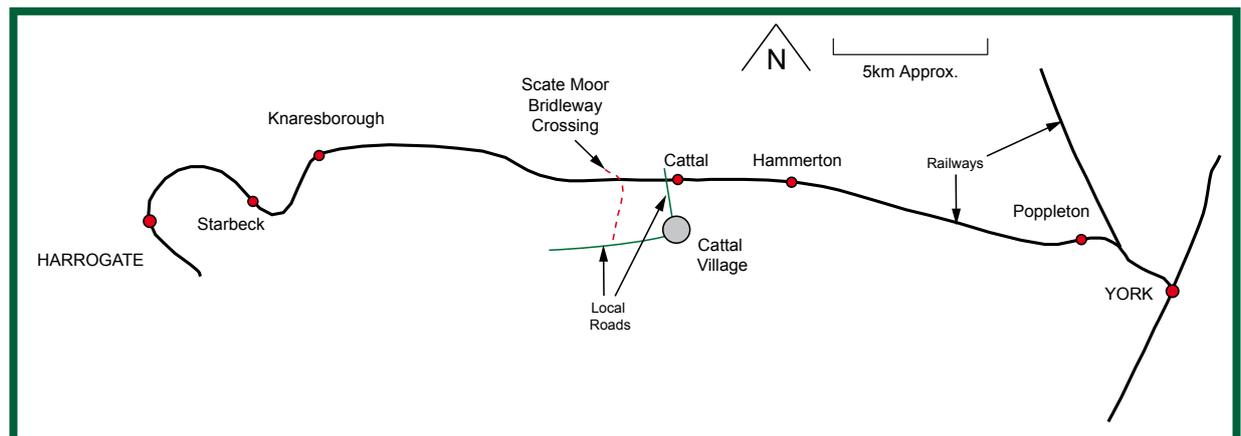
Figure 2: Railway map showing location of Scate Moor crossing

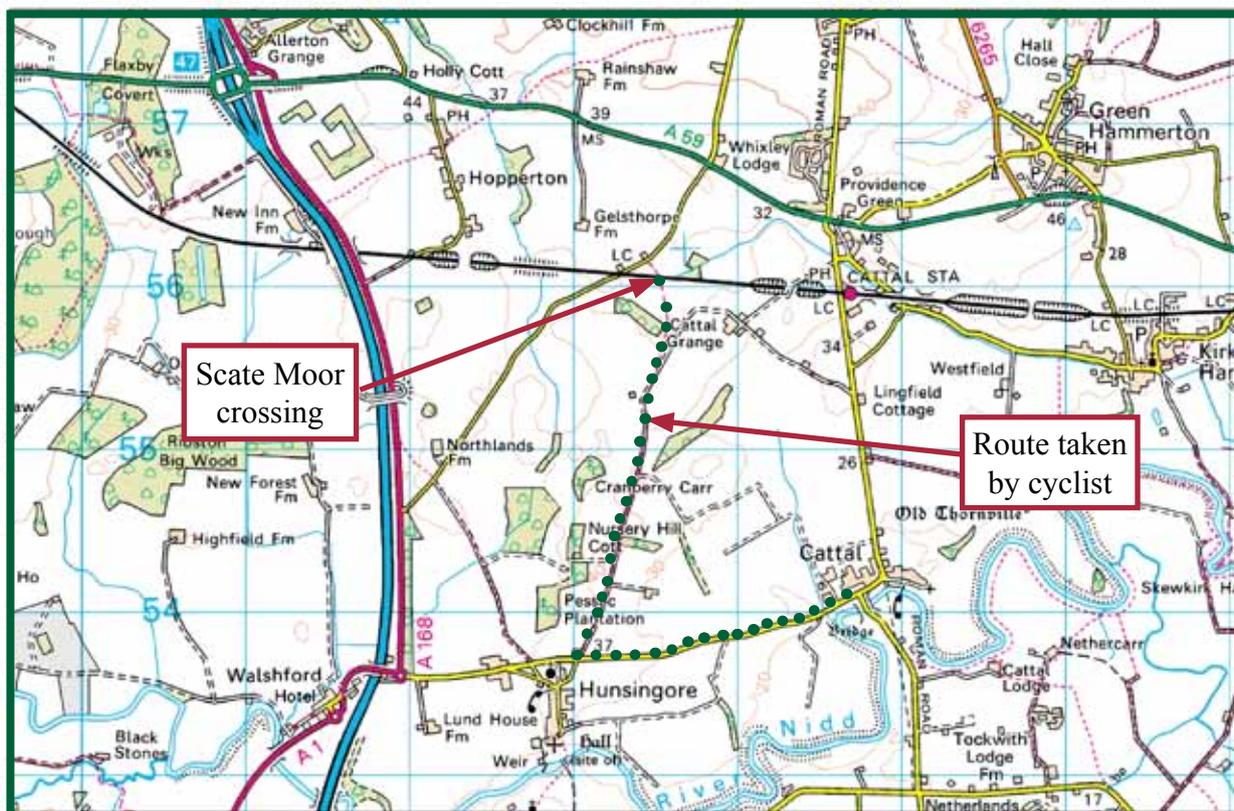
Figure 7: Map showing the cyclist's route

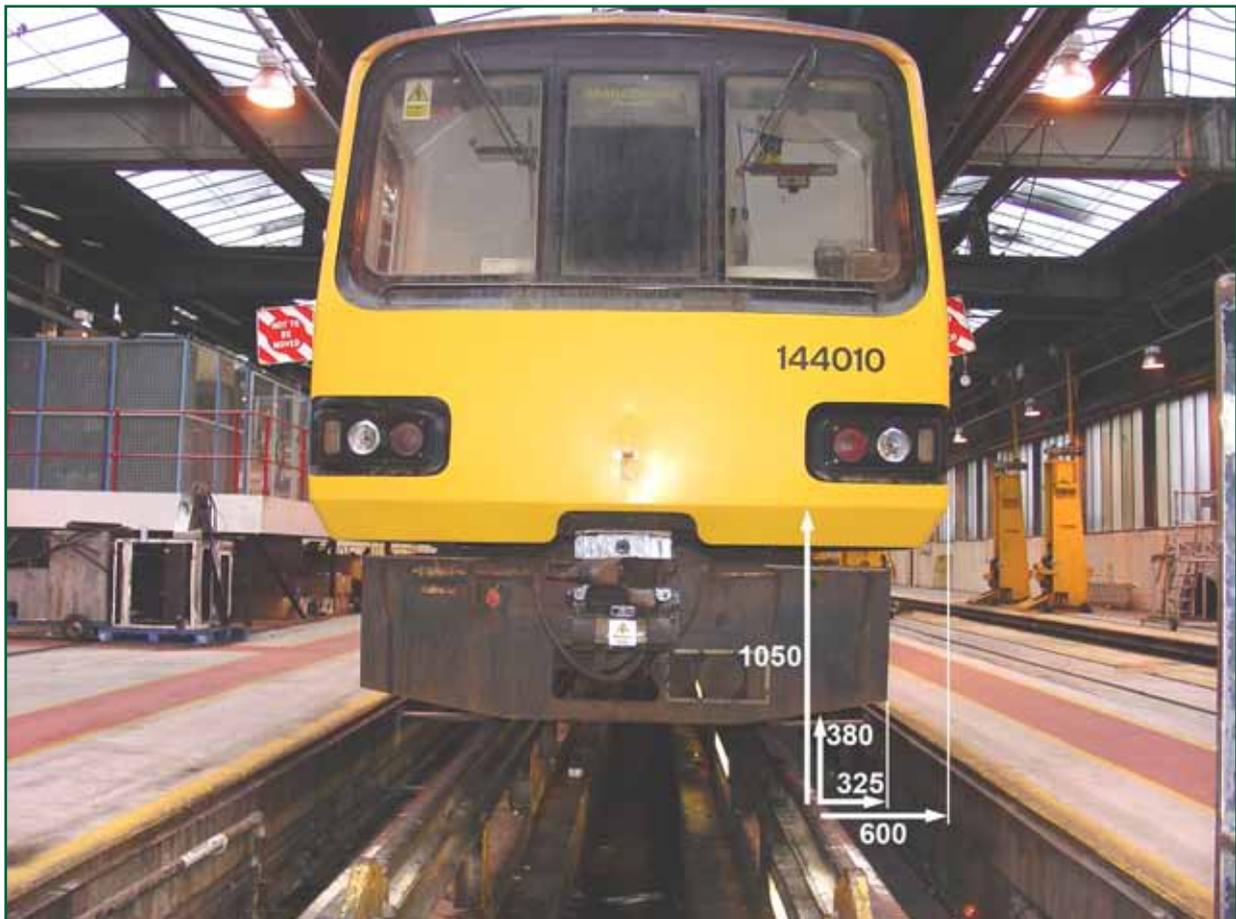
Figure 8: A class 144 DMU showing measured dimensions (mm) from the rail

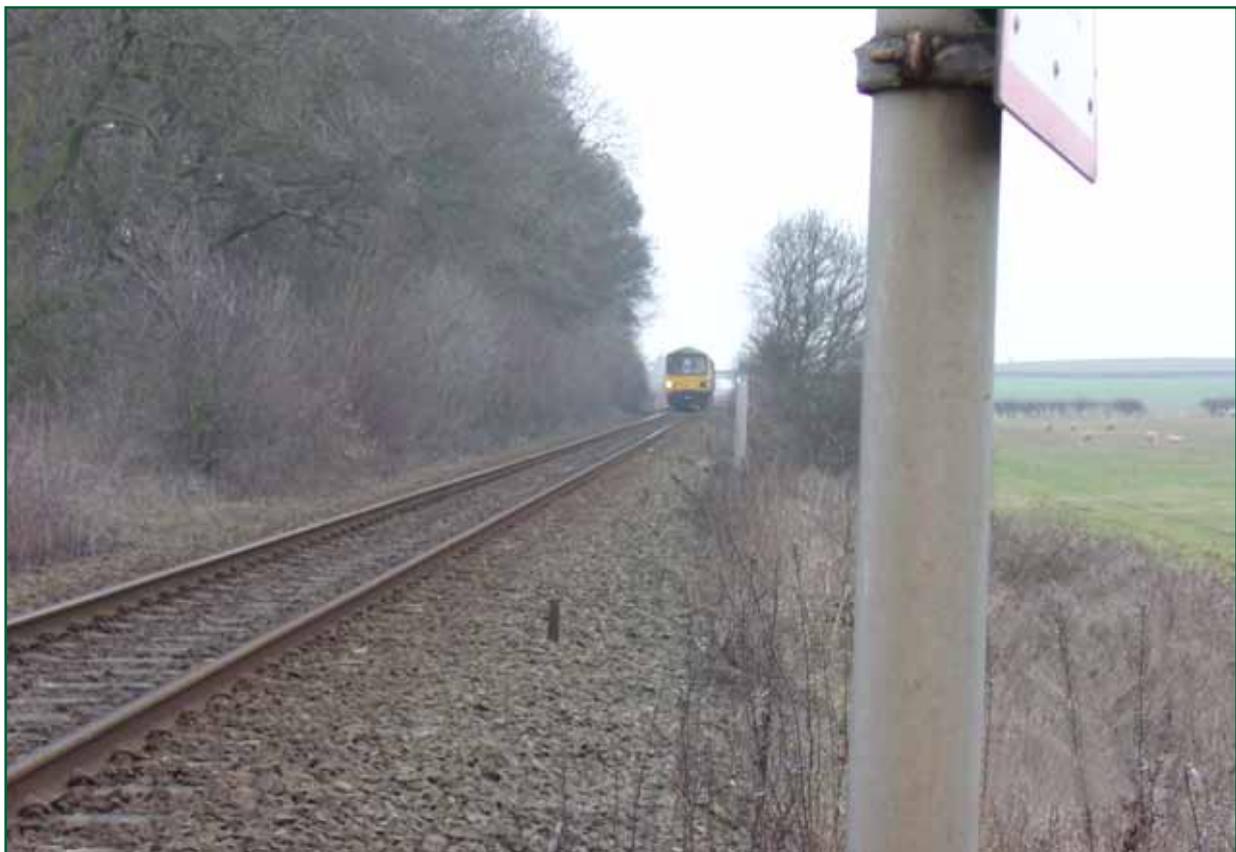
Figure 10: A class 144 DMU approaching the crossing in daylight – approximately 250 m and 12 seconds from the crossing
