**URGENT FIELD SAFETY NOTICE**

Product Name: **Alaris® SmartSite® Needle-Free Valve**  
Product Reference: **2000E7D**  
Lot Numbers: **Various lots with Polycarbonate Material**  
FSCA Identifier: **RA-2014-01-01**  
Date: **February 2014**  
Type of Action: **Removal & Destruction of Affected Products**

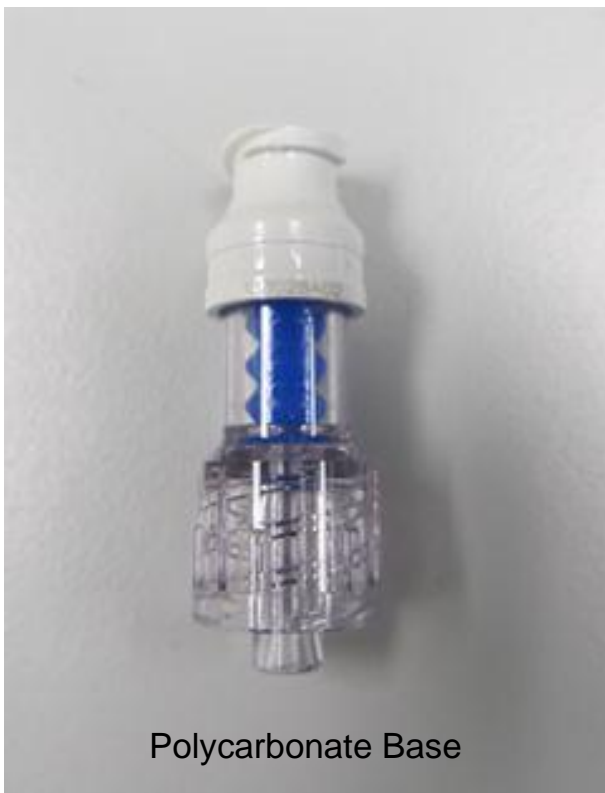
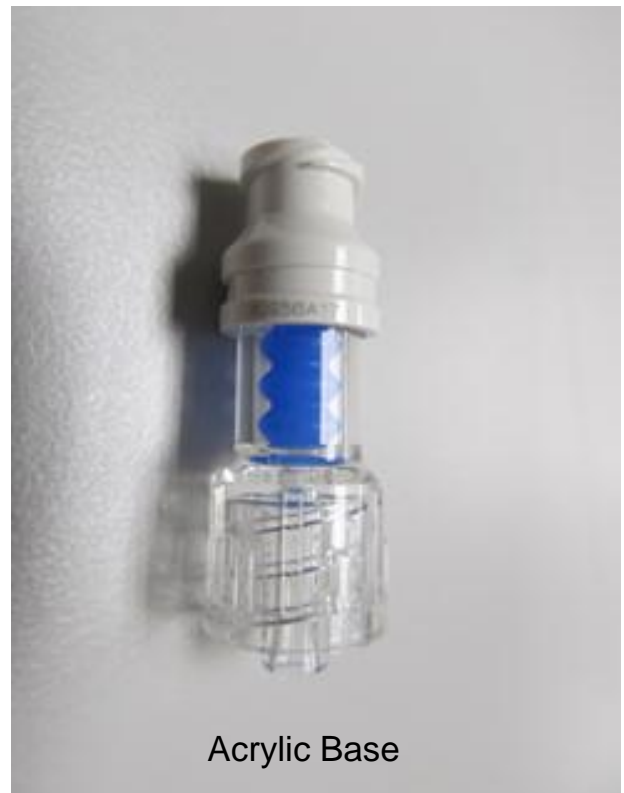
SmartSite with acrylic material does not appear to cause these incompatibility issues and is not affected by this FSCA. There is a visible colour difference between the polycarbonate and acrylic base. The polycarbonate material is bluish-grey whilst the acrylic material is clear. As shown in the pictures below.

The root cause is still under investigation. Preliminary analysis has indicated that SmartSite with polycarbonate material may cause incompatibility issues with the male Luer or thread housing when attaching to a female Luer.
