FIELD SAFETY NOTICE**LINET ELEGANZA STANDARD & DELUXE MODEL BEDFRAMES (PREFIX 1GS... & 1GL...)**

Type of action: Inspection & fitting of weld strengthening brackets.

FSN-A0025

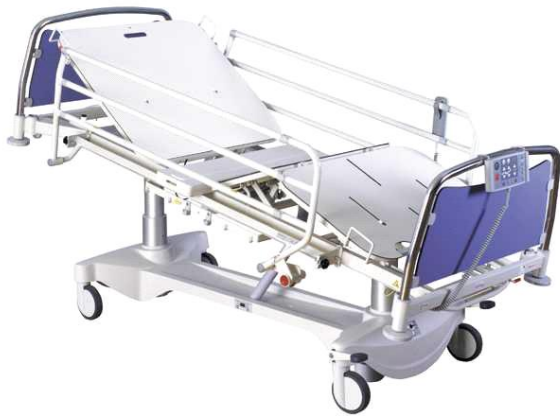
Recent reports have identified a number of bedframes that have reported cracked or damaged welds in one particular area of the bedframe. The fault is related to a sporadic occurrence of cracking or breaking welds connecting the patient surface (frame) to the main lifting column assembly. The two column assemblies are connected to the frame, each by two brackets. The cause of the damage is possible vibration during transport or stressing of the device during possible overloading conditions experienced over time. The design is compliant to the relevant standards for Hospital bedframes and although an update to the bedframe was undertaken in December 2005 (Standard & Deluxe models) so bedframes manufactured after this date are unaffected. However, there remains the possibility that bedframes manufactured until December 2005 may experience failures. The risk to safety is considered to be minimal and there are no reported incidences as a result of this issue.

1. Using the Supervisor Control Panel / Patient handset raise the Backrest to its full working height.
2. Inspect the weld joints as detailed in fig 01 below. Ensure the paint surrounding the welds is not flaking, showing signs of rust and the weld joints are intact. Inspect both the RH and LH weld fillets, above and below the Mattress Platform.
3. We would recommend that Bedframes displaying the above symptoms are removed from service at the earliest opportunity for the fitment of the strengthening brackets.

- If evidence of any cracking welds is identified, we would recommend that the bedframe be removed from service at the earliest opportunity for the fitment of the strengthening brackets.

- If evidence of any broken welds is identified, we would recommend that the bedframe is removed from service at the earliest opportunity and you contact Linet UK for technical advice. Please see '*Technical Reference Person*' below for technical advice.

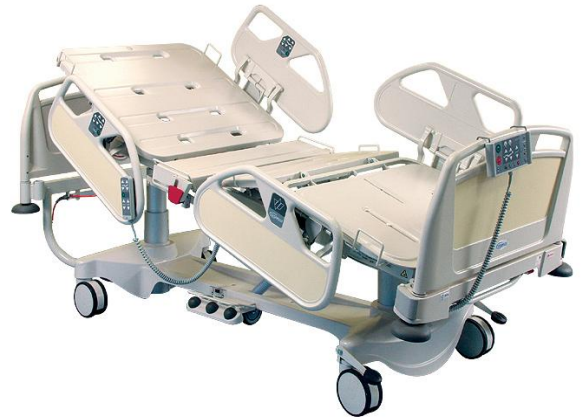
1. Using the Supervisor Control Panel / Patient handset raise the Kneebreak together with the mechanical Legrest Ratchet, to its full working height.
2. Inspect the weld joints as detailed in fig 02 below. Ensure the paint surrounding the welds is not flaking, showing signs of rust and the weld joints are intact. Inspect both the RH and LH weld fillets, above and below the Mattress Platform.
3. We would recommend that Bedframes displaying the above symptoms are removed from service at the earliest opportunity for the fitment of the strengthening brackets.
