Drowning of a Passenger on *Sapphire Princess* East China Sea 7 August 2014

SUMMARY

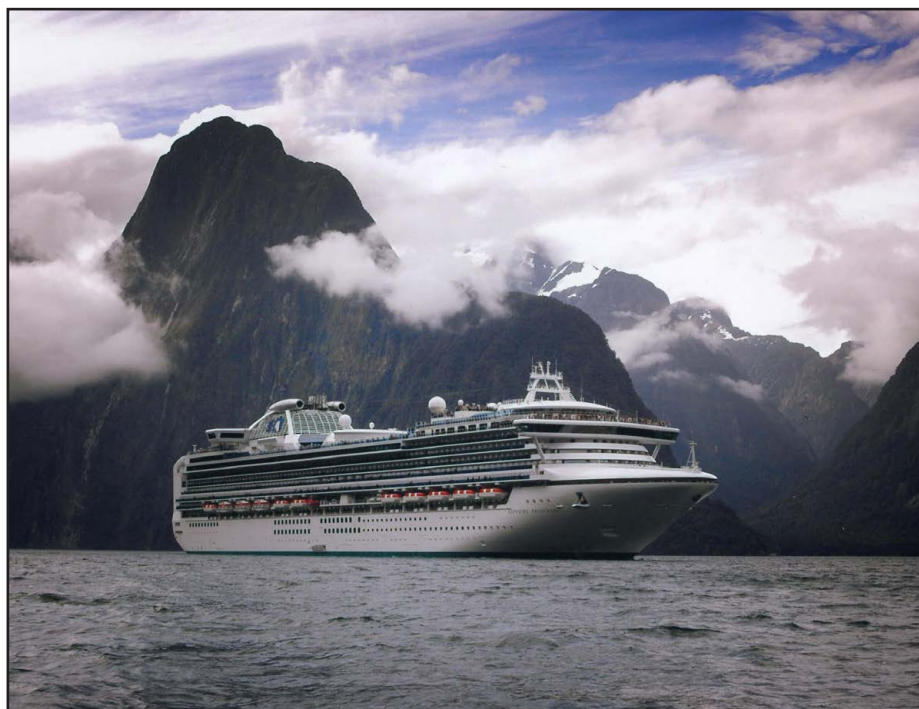
Figure 1: *Sapphire Princess*

Sapphire Princess (**Figure 1**) had transferred from the Caribbean Sea to the Asian market at the beginning of the 2014 summer season. Shanghai, China, was the ship's predominant turnaround port. The majority of the passengers were
