**ACCIDENT**

<b>Aircraft Type and Registration:</b>	Europa, G-TAGR	
<b>No &amp; Type of Engines:</b>	1 Rotax 912 ULS piston engine	
<b>Year of Manufacture:</b>	2004 (Serial no: PFA 247-13061)	
<b>Date &amp; Time (UTC):</b>	1 July 2015 at 1120 hrs	
<b>Location:</b>	Bolt Head Airfield, Devon	
<b>Type of Flight:</b>	Private	
<b>Persons on Board:</b>	Crew - 1	Passengers - None
<b>Injuries:</b>	Crew - None	Passengers - N/A
<b>Nature of Damage:</b>	Tail and rear fuselage cracked, left wing and aileron damage	
<b>Commander's Licence:</b>	Private Pilot's Licence	
<b>Commander's Age:</b>	73 years	
<b>Commander's Flying Experience:</b>	1,126 hours (of which 118 were on type) Last 90 days - 32 hours Last 28 days - 11 hours	
<b>Information Source:</b>	Aircraft Accident Report Form submitted by the pilot

**Synopsis**

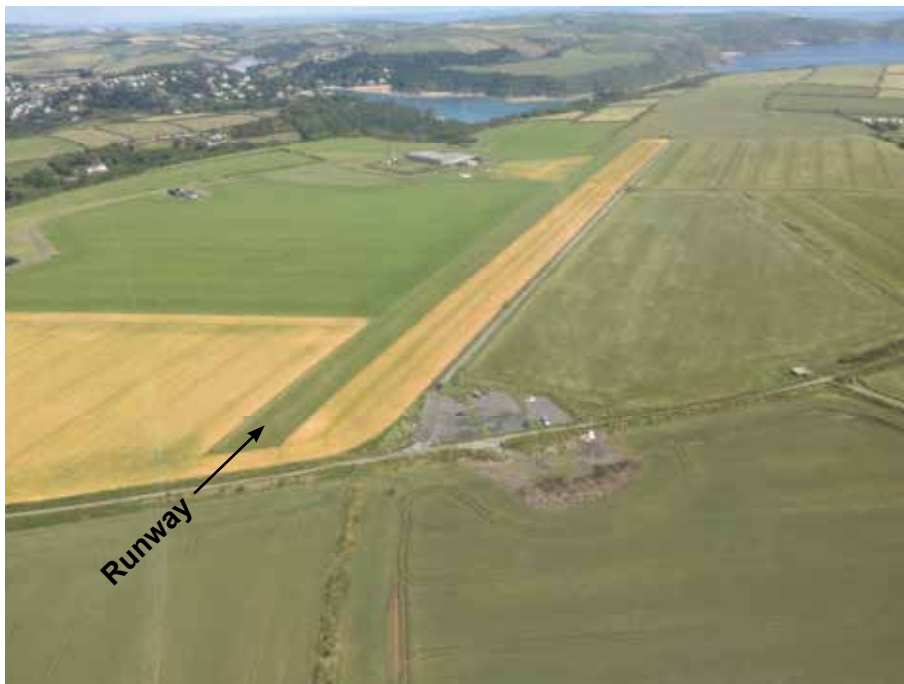
**Figure 1**

G-TAGR arrived, in loose formation with two others, from the north, intending to land on Runway 11. As the pilot turned right downwind, he looked at the airfield and saw a long strip of pale brown vegetation which he took to be the runway (Figure 1). He made his approach to this strip and only realised his mistake as he flared and the wheels sank into what was actually a crop of barley growing to the right of the grass runway. The aircraft slowed very rapidly, yawed through 180° and came to a halt in about 18 m.

View looking along Runway 11 showing a barley crop growing along its southern edge, with more barley and a green corn field to the north. Pictures taken at different times of the year show that contrast and colours vary with ripeness of the crops.

*'JULY 2015 - WARNING - THE STRIP OF CROPS TO THE SOUTH OF THE RUNWAY CAN BE DECEPTIVE AND CAN APPEAR TO BE RUNWAY - IT IS NOT , IT IS 3FT HIGH CROPS - INBOUND PILOTS MUST POSITIVELY IDENTIFY THE RUNWAY AND LAND ON THE MOWN GRASS PER OUR PLATE AND PHOTOS, NOT ON THE CROPS .'*
