The South East Asia Community Access Programme (SEACAP) Rural Roads

Monitoring Programme in Lao PDR
(SEACAP 17)

MONITORING REPORT

May 2013

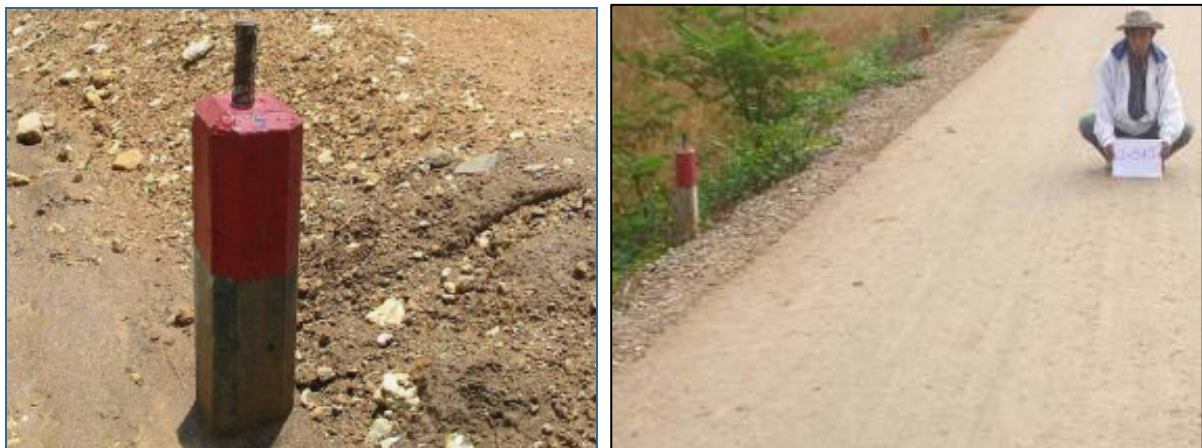
Figure 1: SEACAP Monitoring Beacon

During the course of the project a series of beacons were constructed along both sides of the trial sections, at spacing of 10 m. An example beacon is shown in Figure 1. These beacons serve two purposes:

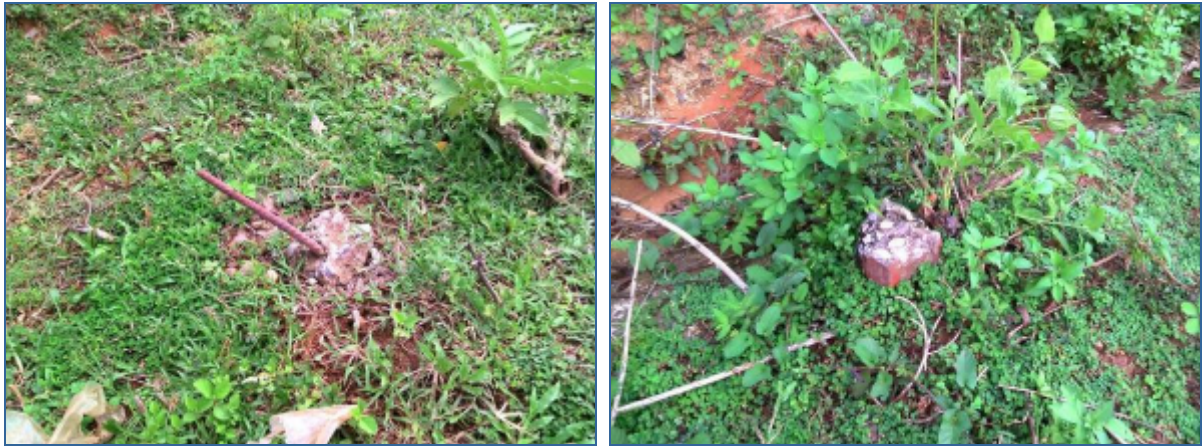
Figure 2: Removed and Damaged Monitoring Beacon

However, it was noticed on a subsequent site visit in November 2007 that many of the monitoring beacons had been destroyed, as shown in Figure 2. The beacons were removed as a result of safety concerns and the potential risk posed to cyclists and motorcyclists using the road.

As a result of safety issues, it is clear that use of similar beacons in future will not be adequate. During the condition surveys carried out in October 2012 the survey team were able to identify the remains of monitoring beacons, and with the combined use of a GPS unit, locate the chainage of these beacons. Then, using a measuring tape and spray paint the data capture locations were marked on the road.

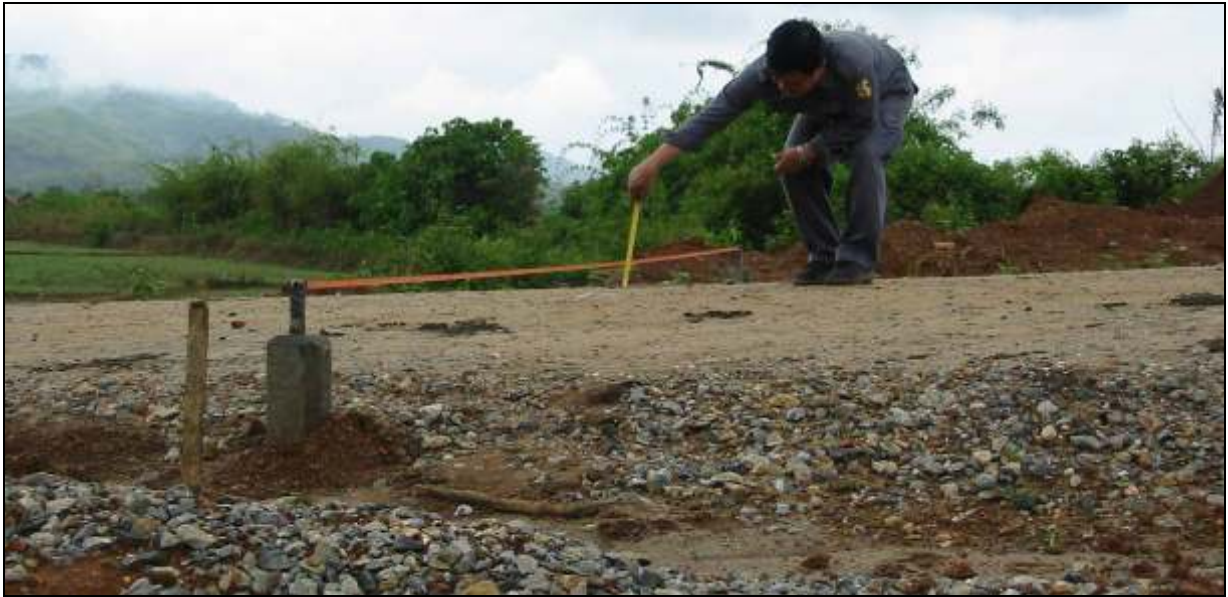
Figure 3: Recording Surface Deformation by Dipped Levels in 2007

As mentioned previously, the vandalism to the monitoring beacons constructed along the trial sections meant that the method for collection of surface deformation data had to be adapted. The monitoring beacons were fundamental in the previous method of taking dipped levels from a measuring tape suspended between the metal re-bar encased in each monitoring beacon, as shown in Figure 3.

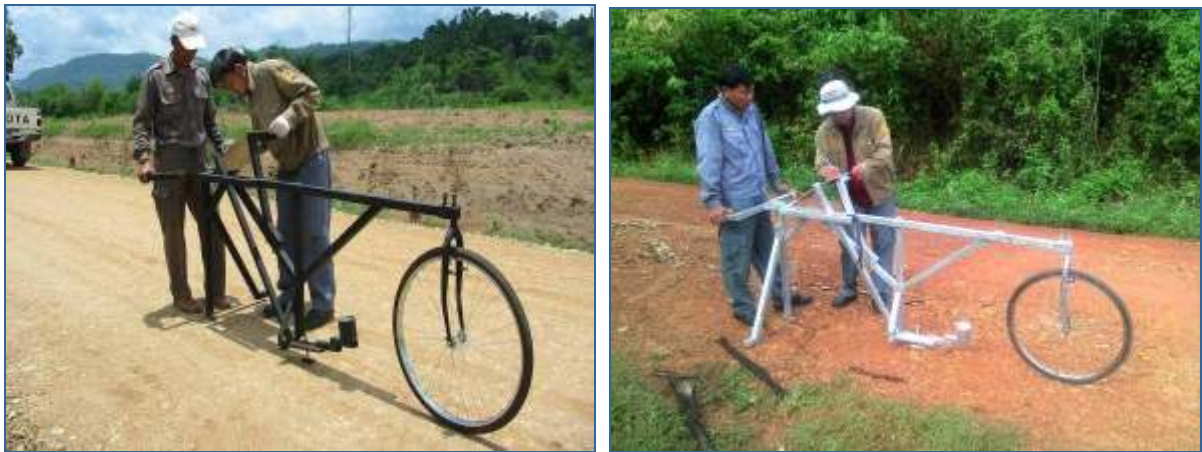
Figure 4: Using a MERLIN to calculate IRI

To determine roughness, 200 measurements were taken at regular intervals using the MERLIN apparatus, as shown in Figure 4. For each measurement, the MERLIN was rested on the road with the wheel in its normal position. The rear foot, probe and stabiliser were in contact with the road surface and the position of the pointer on the chart was marked.

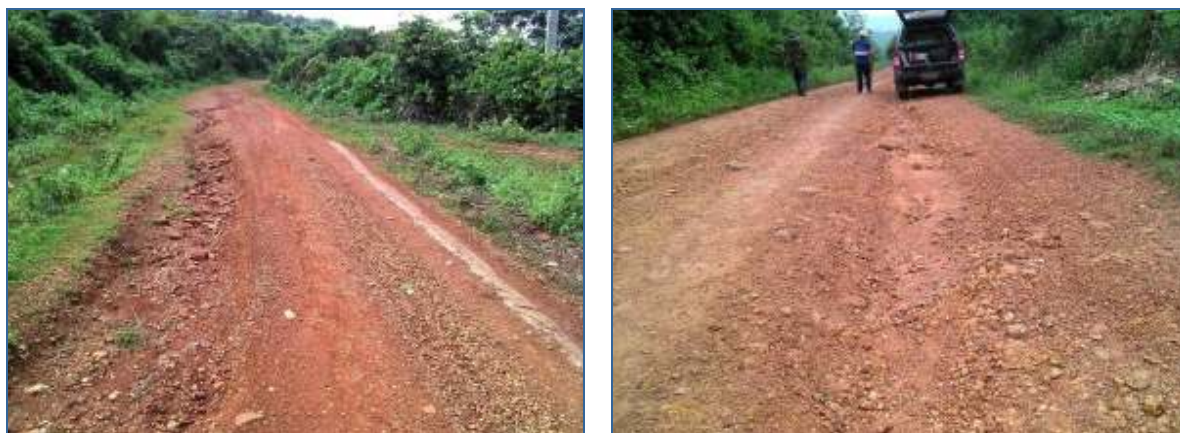
Figure 5: Erosion channels on Untreated Steep Section

Under the EOD ethos, it is intended that the gravel and earth pavement options are applied on undemanding, level sections of road. It is evident in areas that were not treated under this contract that these surfacing options are not sufficient on steep gradients. It is also evident that water running down the surface of the road can cause significant erosion channels, as shown in Figure 5. This reinforces the need to apply more substantial surfacing options on sections of steep gradient (typically gradients of 6% or more⁽⁶⁾) and highlights the unsuitability of gravel wearing course in these sections.

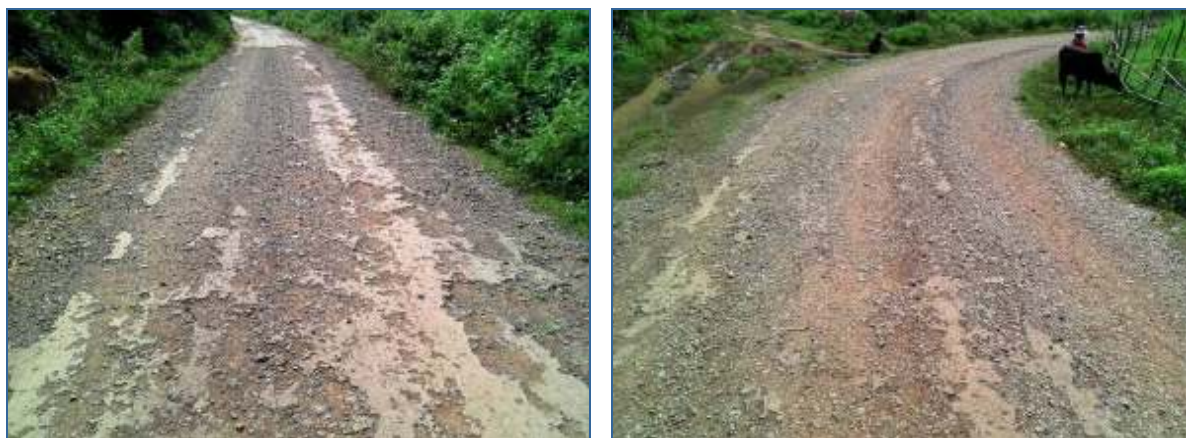
Figure 6: Deterioration of Single Sand Seal

Three different bituminous pavements were constructed as part of the SEACAP trials; a sand seal, a single Otta seal and a single Otta seal with a sand cover seal. As of October 2012, the single sand seal is in poor condition with areas of severe deterioration including pot holes, surface ravelling and edge break. There are areas where there are no remnants of the seal itself and only the crushed rock sub base remains, as seen in Figure 6. This deterioration likely began shortly after construction in 2007,

as erosion of the seal and shallow potholes were recorded during the LTEC-OTB survey in 2009. The deterioration is thought to be due to the location and terrain in which the surfacing was applied, however the life time of a single sand seal is in the region of 2-4 years and this level of deterioration could be expected. The sand seal was constructed on two slopes either side of a free flowing river crossing, and it is believed that during events of heavy rainfall significant water flowing along the carriageway has led to excessive wear of this section.

Regarding the bituminous surfaces, Otta seals are in good condition, with little significant profile differences measured. However, the sand seals have deteriorated badly over the past five years. In many places they have completely disintegrated, as shown in Figure 6 previously. This has resulted in a drop in profile being observed along the sand seal sections which is consistent with the thickness of the surfacing plus some material loss from the base – average loss was 32 mm.

The single sand seals performed poorly and in many areas the seal has completely disintegrated. As a result, they are not recommended for use on future LVRRs. They do not provide a durable surface - the consequences of which are poor road condition within a short period of time and/or high maintenance costs. No country can afford excessive road maintenance costs, but this is particularly so in the case of the many countries where LVRRs are prevalent. As a result, it is recommended that practitioners consider more robust surfacing options such as concrete (slabs or geocells), Otta seals or concrete paving bricks rather than single sand seals.

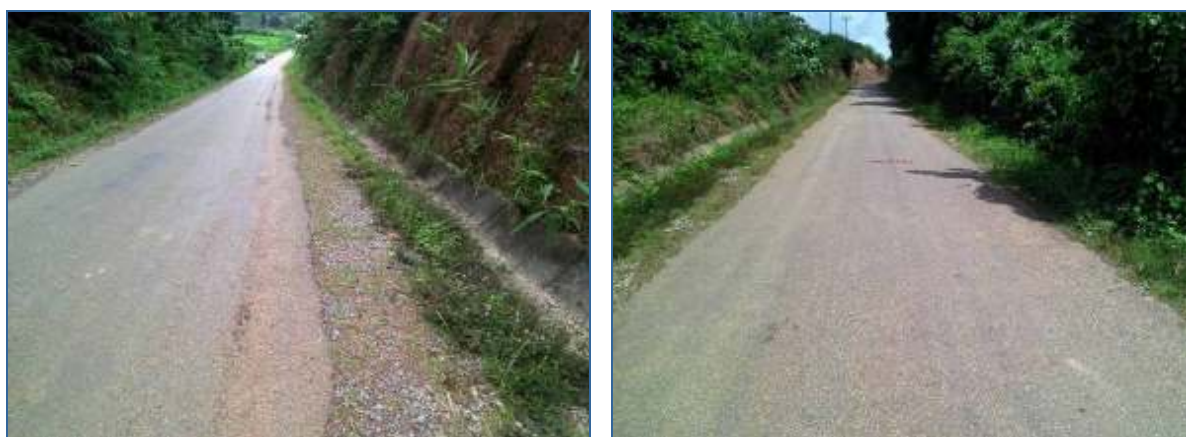
Figure 8: Typical Single Otta Seal with Sand Cover Seal Section Showing Some Edge Break

The double Otta seal and Otta seal with a sand cover seal were constructed adjacent to each other. Overall, both have performed well and are in good condition, albeit with some minor defects which could be rectified through routine maintenance. Deterioration of the Otta seal with sand cover seal appears to be greater than that of the double Otta seal. The measured edge break and material loss is in the region of 100 mm at the double Otta seal section in comparison to approximately 150-200 mm where the sand cover seal is used - as can be seen in Figure 7 and Figure 8. There are a higher number of pot holes and areas of distress on the Otta seal with sand cover seal than that of the double Otta seal. However, as also noted in 2009, these are more an issue of surface deterioration rather than of structural problems.

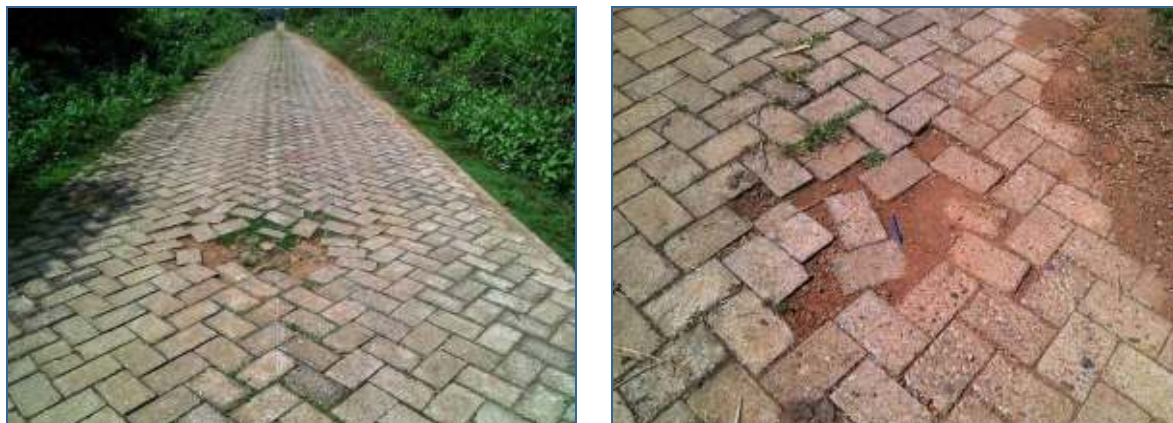
Figure 10: Concrete block section showing typical extent distress but as can be seen on left, general condition is very good and distress is easily repairable

The few minor problem areas are highlighted by some loose blocks, caused either by edge break where vehicles are using the shoulders or by blocks in the centreline of the carriageway that have been removed, as seen in Figure 10. These missing blocks could also be a result of broken or damaged blocks which were observed in 2009.

However these areas of missing blocks have been repaired by local villagers using a mixture of earth, gravel and small stones, providing suitable short-term maintenance solution with the surrounding blocks remaining firmly in place. Cracked blocks were observed in both the 2009 and 2012 survey; however, they could be easily replaced during routine maintenance.

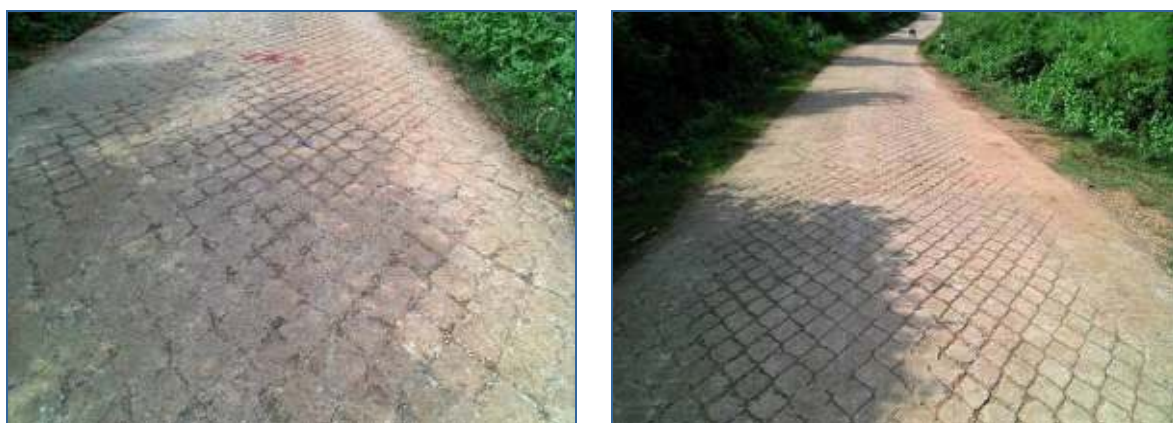
Figure 12: Bamboo Reinforced Concrete Sections in Excellent Condition

Results from an engineering perspective have also been positive, with the majority of pavements performing very well. The concrete surfaces, such as bamboo reinforced concrete and geocells are in excellent condition, with very little deterioration observed. Similarly the concrete paving bricks have proven to be a very durable surfacing and are still in very good condition after 5 years trafficking. The Otta seals have performed well, however, at this stage they would benefit from some routine maintenance to repair a number of potholes and some edge break. Regardless of some minor defects, overall it is felt that these surfaces have proven themselves to be appropriate options for low volume rural road (LVRR) construction and should be considered for use on future projects.

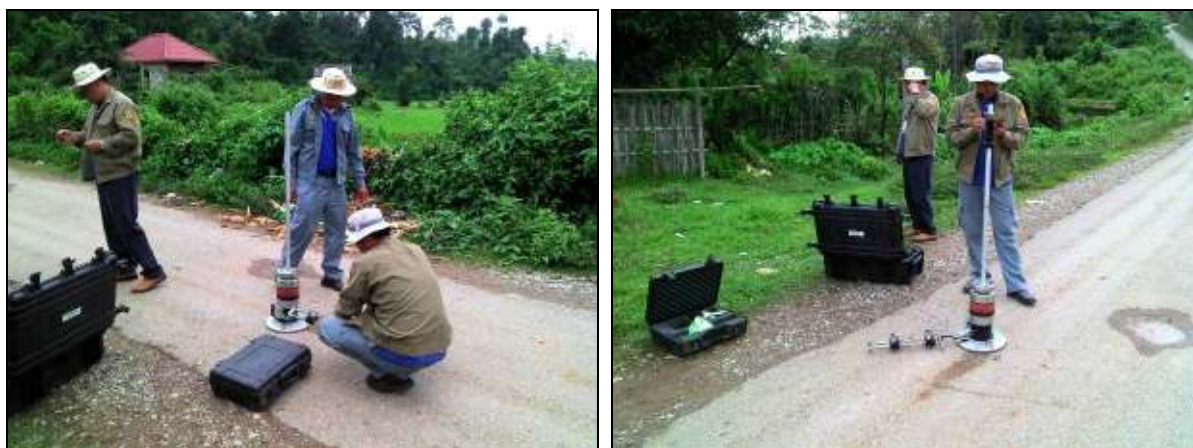
Figure 18: Photographs Showing LWD Equipment and Testing Underway

Deflections are measured by three sensors, one located centrally underneath the load plate and two further sensors located at 300 mm and 500 mm from the load plate respectively (see Figure 18). These give the deflections δ_1 , δ_2 and δ_3 , which will be discussed later.

In the LWD test results on segmental block and concrete pavements, there were some issues both with the deflections observed and with the moduli that the analysis returned. It is likely that the LWD is not suitable for use on these pavements and should be used on un-sealed and bituminous sections only.

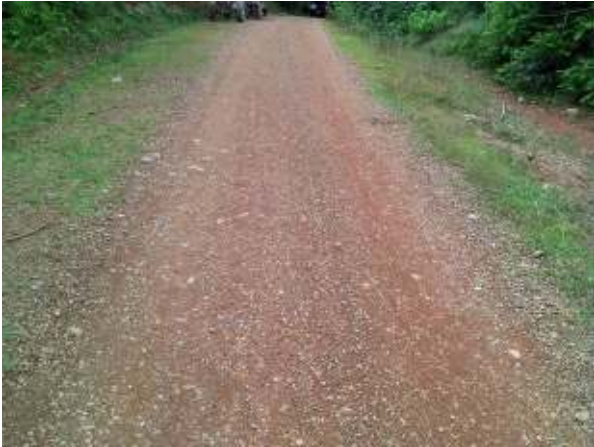
| Road 1.1 NEC Standard Gravel | |
|---|---|
| 0+505 | 0+505 |

| Road 1.1 NEC Standard Gravel | |
|---|---|
| A photograph of a dirt road at station 0+505 in 2007. A person wearing a hat and light-colored shirt is crouching on the road surface, possibly taking a sample. The road is reddish-brown and appears to be made of compacted earth or gravel. | A photograph of the same road at station 0+505 in 2012. The road surface is covered with a layer of reddish-brown gravel, and the surrounding area is green with vegetation. |

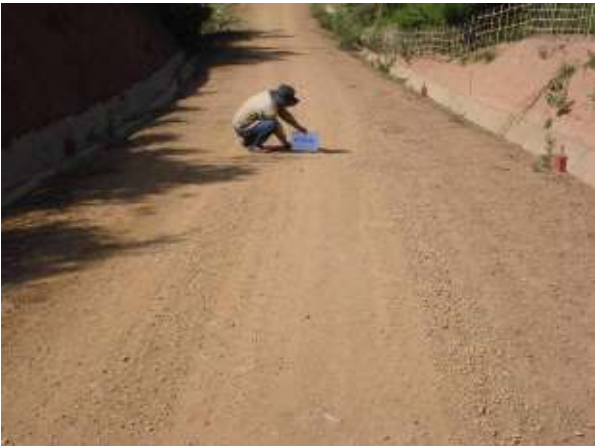
| Road 1.1 NEC Standard Gravel | |
|---|---|
| 0+605 | 0+605 |

| Road 1.1 NEC Standard Gravel | |
|---|---|
| A photograph of a dirt road at station 0+605 in 2007. A person wearing a hat and light-colored shirt is crouching on the road surface. The road is reddish-brown and appears to be made of compacted earth or gravel. | A photograph of the same road at station 0+605 in 2012. The road surface is covered with a layer of reddish-brown gravel, and the surrounding area is green with vegetation. |

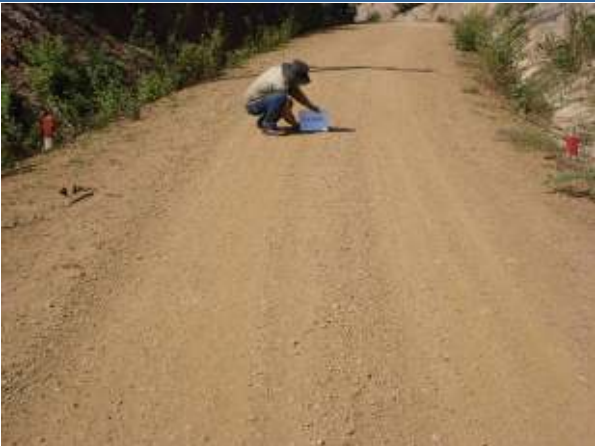
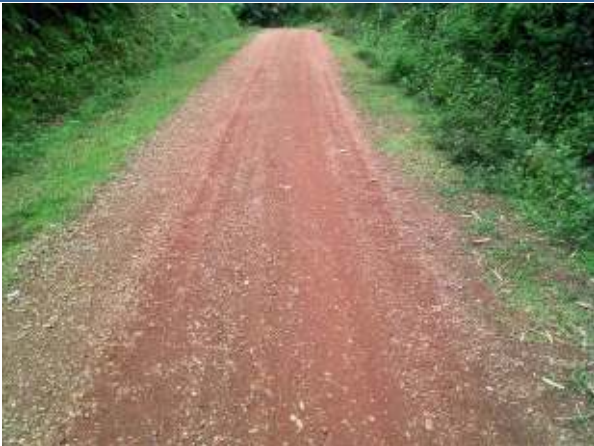
| Road 1.1 NEC Standard Gravel | |
|---|---|
| 0+695 | 0+695 |

| Road 1.1 NEC Standard Gravel | |
|---|---|
| A photograph of a dirt road at station 0+695 in 2007. A person wearing a hat and light-colored shirt is crouching on the road surface. The road is reddish-brown and appears to be made of compacted earth or gravel. | A photograph of the same road at station 0+695 in 2012. The road surface is covered with a layer of reddish-brown gravel, and the surrounding area is green with vegetation. |

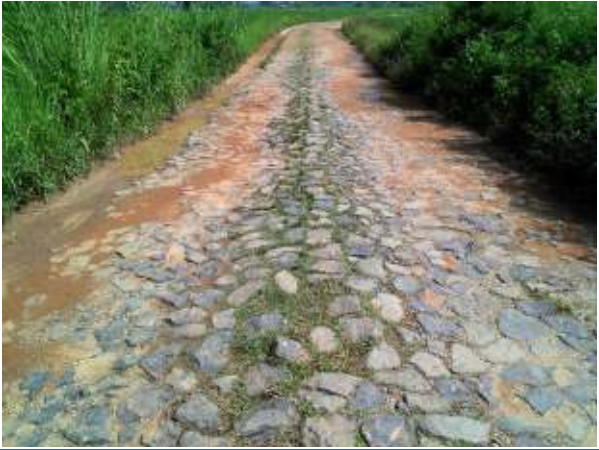
| Road 2 Hand Packed Stone | |
|---|--|
| 0+805 | 0+805 |

| Road 2 Hand Packed Stone | |
|---|--|
| A wide, straight dirt road with a light brown, sandy surface. A person is standing in the middle of the road, facing away from the camera, wearing a dark shirt and light-colored pants. The road is flanked by dry, grassy fields under a clear sky. | A close-up view of the road surface, showing a dense layer of irregular, dark grey stones packed together. The stones are set in a reddish-brown soil. The road is flanked by green vegetation. |

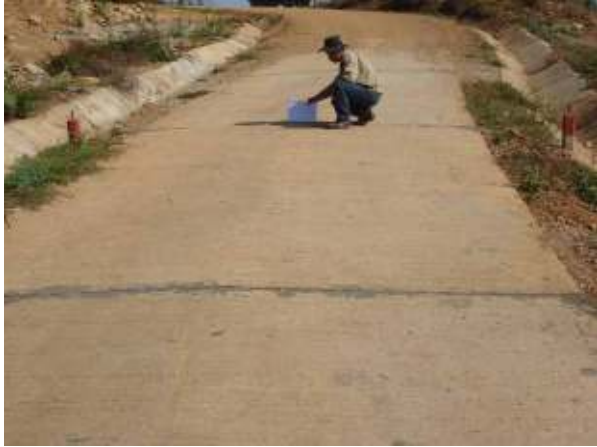
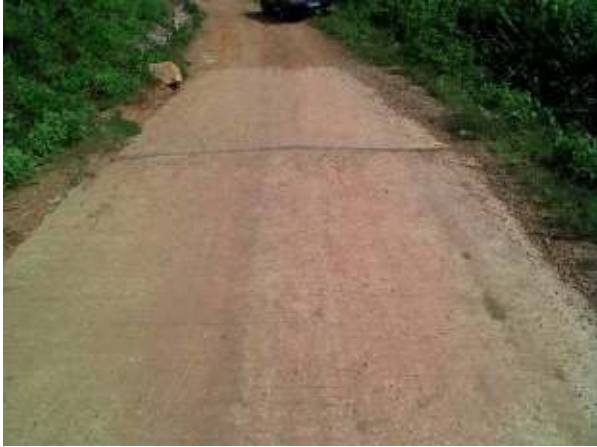
| Road 5 Bamboo Reinforced Concrete | |
|---|---|
| 2+515 | 2+515 |

| Road 5 Bamboo Reinforced Concrete | |
|---|---|
| A photograph of a road in 2007. A person is kneeling on the road surface, possibly measuring or inspecting it. The road is light-colored and appears to be made of concrete or a similar material. There are some small red markers or stakes on the sides of the road. | A photograph of the same road in 2012. The road surface is now a reddish-brown color, possibly due to a different material or a change in the surface texture. The surrounding vegetation is more dense and green. |

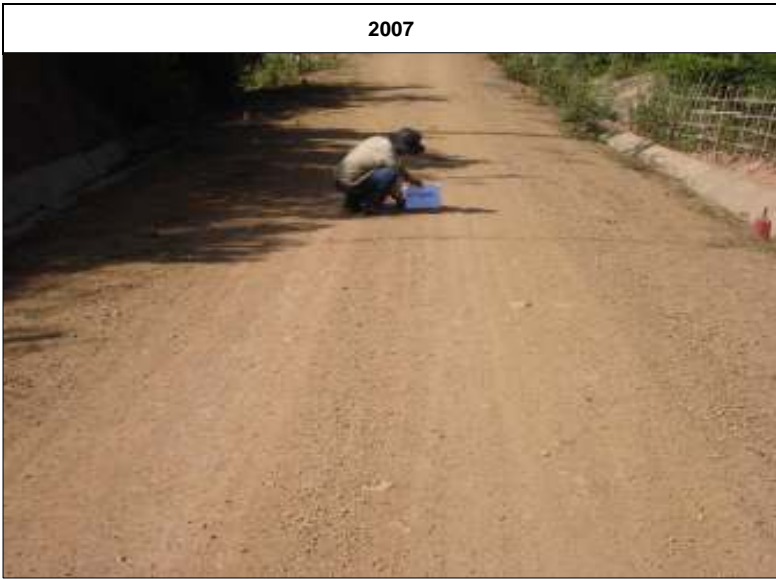
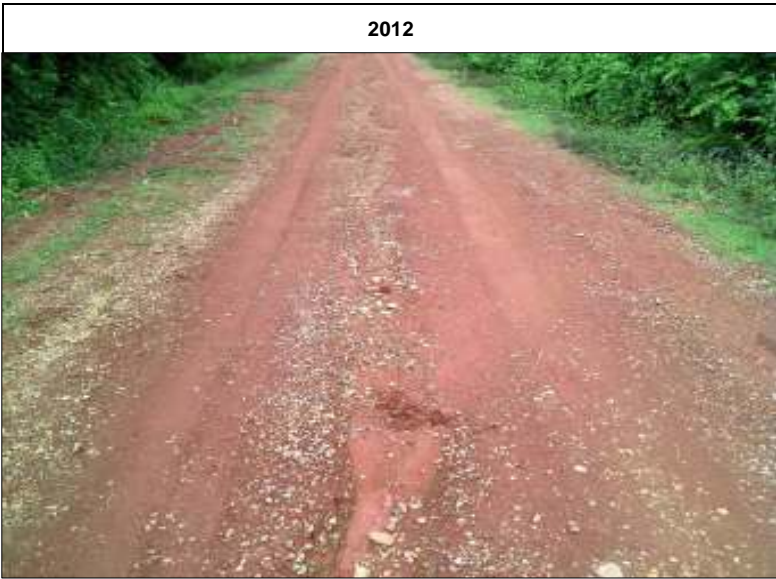
Road 1.1

| | 500.00 | 750.00 | 1000.00 | 1250.00 | 1500.00 | 1750.00 | 2000.00 | 2250.00 | 2500.00 | 2750.00 | 3000.00 | 3250.00 | 3500.00 | 3750.00 | 4000.00 | 4250.00 | 4500.00 | 4750.00 | 5000.00 | 5250.00 | | | | Average Loss |
|---|---|---|---|---|---|---|---|---|---|---|---|---|---|---|---|---|---|---|---|---|--|--|--|---|
| Difference (2009 - 2012) | - | - | - | - | - | - | 52 | - | 40 | - | 42 | - | 53 | - | 70 | - | 87 | - | - | - | | | | 57 |
| Total: | | | | | | | | | | | | | | | | | | | | | | | | 164 mm |

Gravel (0.675km)

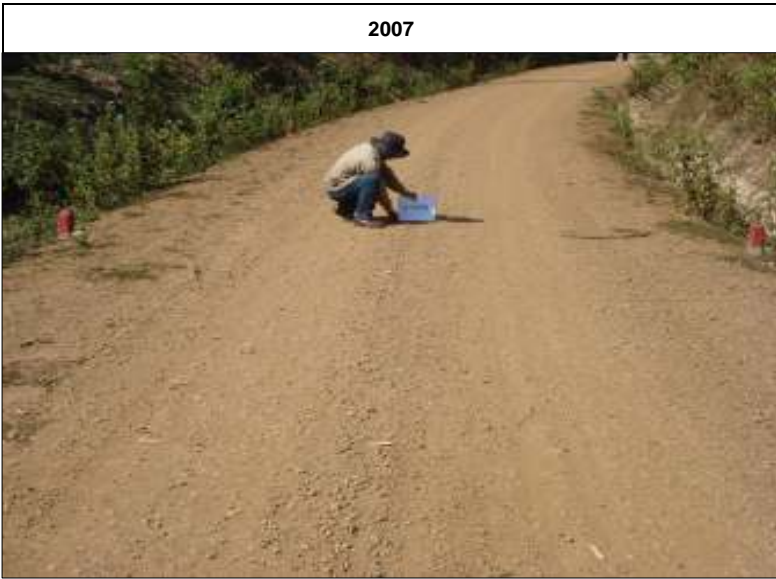
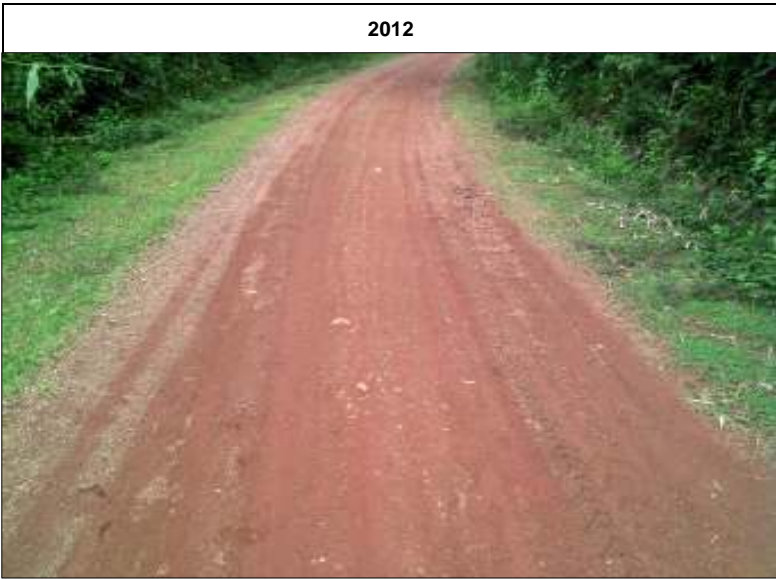
Road 1.3

| | 500.00 | 750.00 | 1000.00 | 1250.00 | 1500.00 | 1750.00 | 2000.00 | 2250.00 | 2500.00 | 2750.00 | 3000.00 | 3250.00 | 3500.00 | 3750.00 | 4000.00 | 4250.00 | 4500.00 | 4750.00 | 5000.00 | 5250.00 | | | | Average Loss |
|---|---|---|---|---|---|---|---|---|---|---|---|---|---|---|---|---|---|---|---|---|--|--|--|---|
| Difference (2009 - 2012) | - | - | - | - | - | - | 63 | - | 71 | - | 75 | - | 56 | - | 39 | - | 28 | - | - | - | | | | 55 |
| Total: | | | | | | | | | | | | | | | | | | | | | | | | 140 mm |

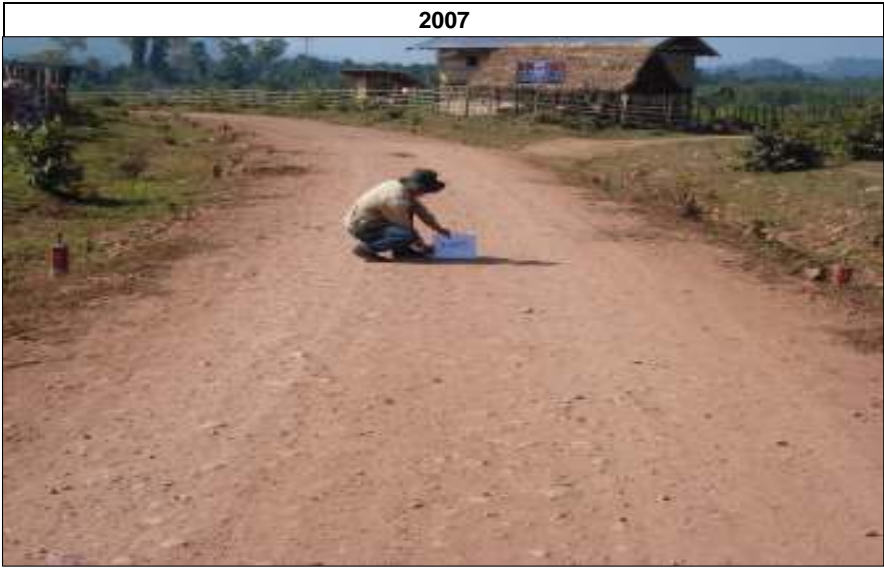
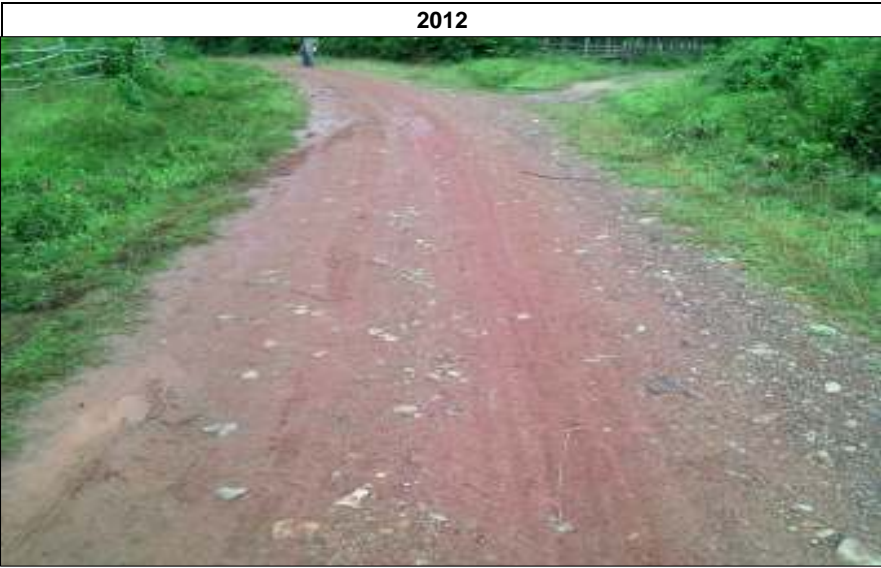
Road Number 1.3

| | X | 500.00 | 750.00 | 1000.00 | 1250.00 | 1500.00 | 1750.00 | 2000.00 | 2250.00 | 2500.00 | 2750.00 | 3000.00 | 3250.00 | 3500.00 | 3750.00 | 4000.00 | 4250.00 | 4500.00 | 4750.00 | 5000.00 | 5250.00 | 5500.00 | | | Average Losses |
|---|---|---|---|---|---|---|---|---|---|---|---|---|---|---|---|---|---|---|---|---|---|---|--|--|---|
| Difference (2009 - 2012) | | - | - | - | - | 38 | - | 53 | - | 58 | - | 65 | - | 69 | - | 64 | - | 57 | - | - | - | - | | | 57 |
| Total: | | | | | | | | | | | | | | | | | | | | | | | | | 106 mm |

Gravel (1.345km)

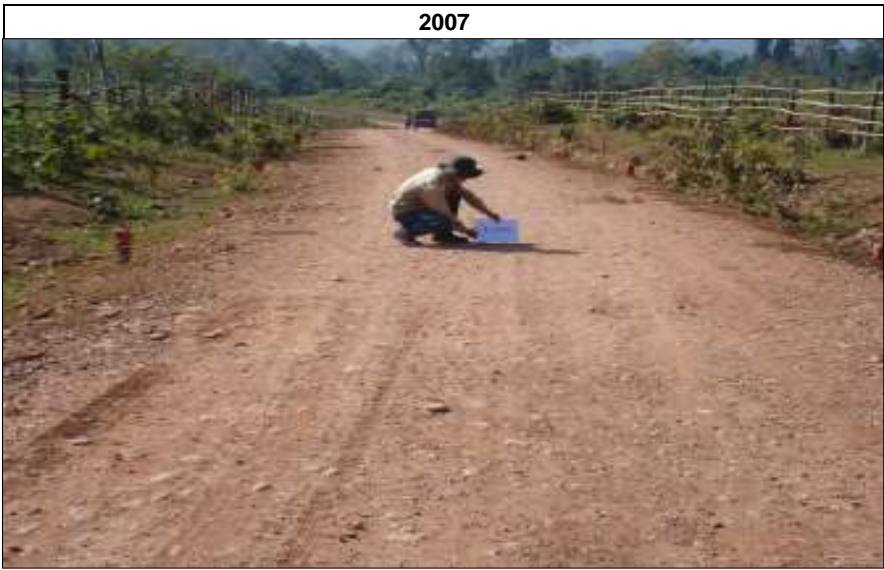
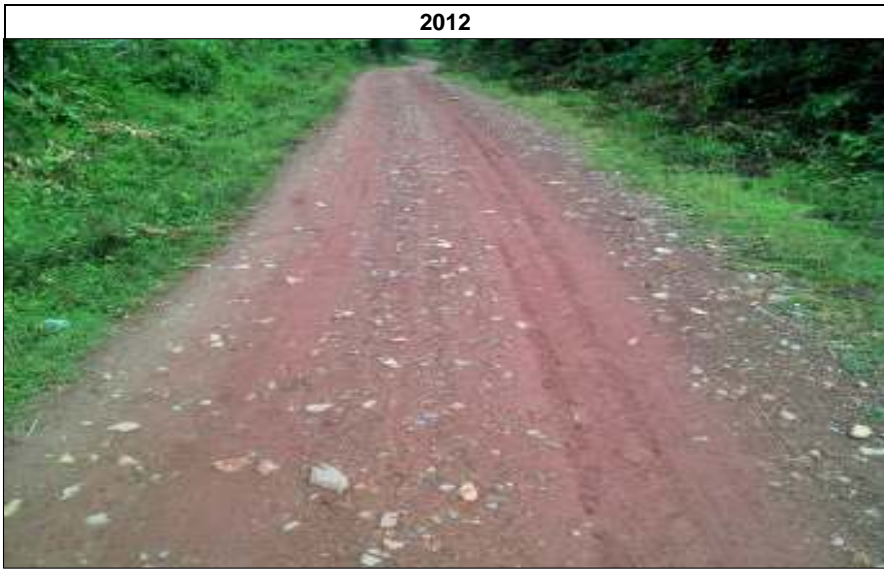
Road 2.0

| | X | 500.00 | 750.00 | 1000.00 | 1250.00 | 1500.00 | 1750.00 | 2000.00 | 2250.00 | 2500.00 | 2750.00 | 3000.00 | 3250.00 | 3500.00 | 3750.00 | 4000.00 | 4250.00 | 4500.00 | 4750.00 | 5000.00 | 5250.00 | 5370.00 | | | Average Losses |
|---|---|---|---|---|---|---|---|---|---|---|---|---|---|---|---|---|---|---|---|---|---|---|--|--|---|
| Difference (2009 - 2012) | | - | - | - | - | 4 | - | 31 | - | 40 | - | 50 | - | 63 | - | 56 | - | 50 | - | - | - | - | | | 42 |
| Total: | | | | | | | | | | | | | | | | | | | | | | | | | 189 mm |

Road 2
Gravel (0.475km)

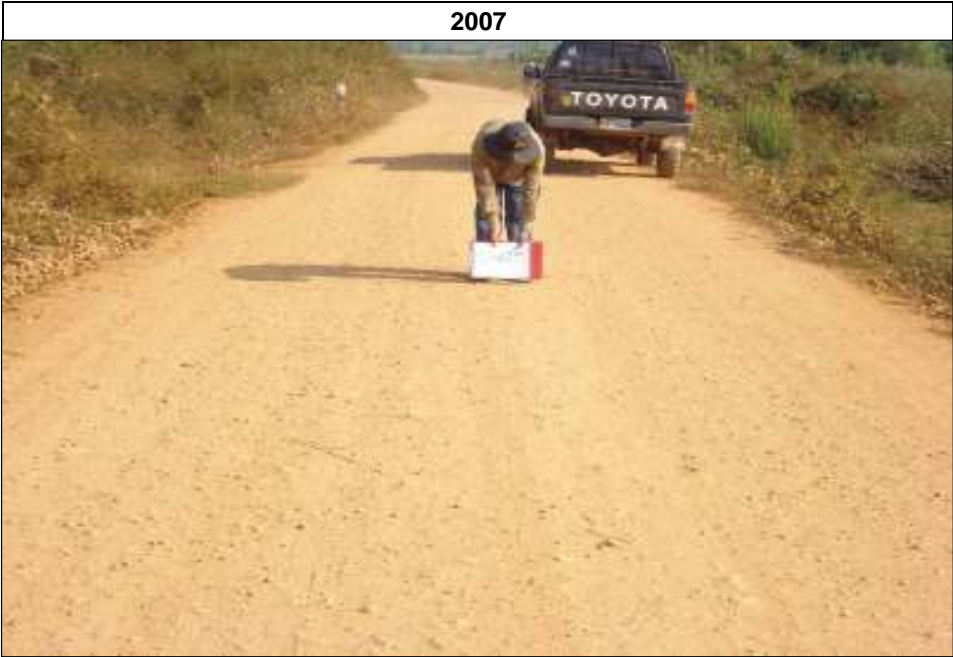
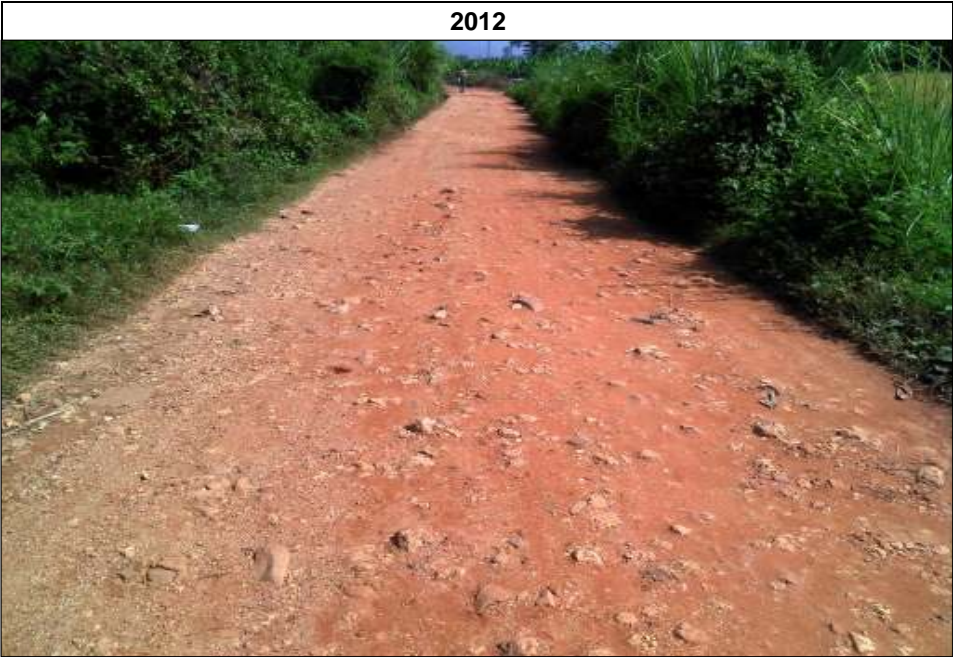
Road 2
Gravel (0.545km)

| | 500.00 | 750.00 | 1000.00 | 1250.00 | 1500.00 | 1750.00 | 2000.00 | 2250.00 | 2500.00 | 2750.00 | 3000.00 | 3250.00 | 3500.00 | 3750.00 | 4000.00 | 4250.00 | 4500.00 | 4750.00 | 5000.00 | | | | | | | Average Losses |
|---|---|---|---|---|---|---|---|---|---|---|---|---|---|---|---|---|---|---|---|--|--|--|--|--|--|---|
| Difference (2009 - 2012) | - | - | - | - | 40 | - | 64 | - | 71 | - | 69 | - | 70 | - | 60 | - | 57 | - | 48 | | | | | | | 60 |
| Total: | | | | | | | | | | | | | | | | | | | | | | | | | | 101 |

As was to be expected, gravel sections have lost their wearing courses during the past 5 years and no maintenance has been carried out to re-gravel. This is not surprising; however, it does highlight the maintenance needs of these pavements particularly in wet areas where annual gravel loss can be expected to be high.

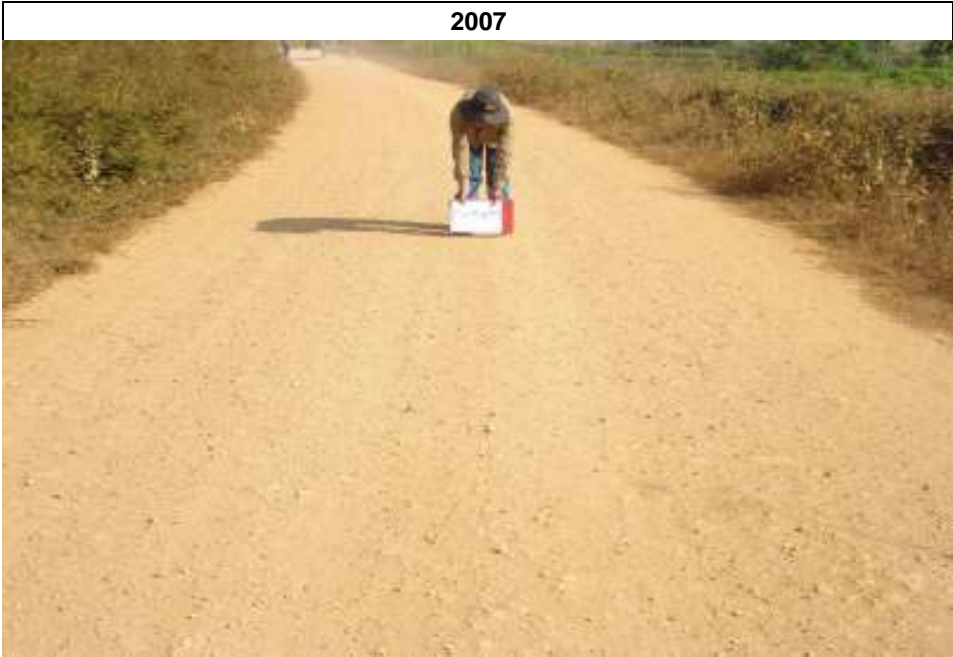
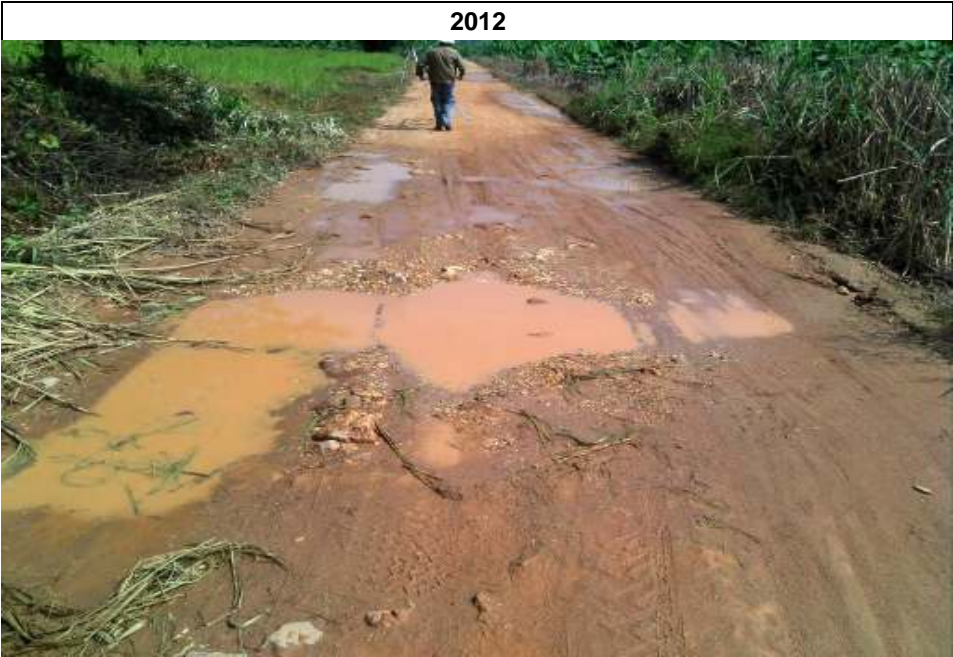
Road 2
Hand Packed Stone (0.725km)

| | 500.00 | 750.00 | 1000.00 | 1250.00 | 1500.00 | 1750.00 | 2000.00 | 2250.00 | 2500.00 | 2750.00 | 3000.00 | 3250.00 | 3500.00 | 3750.00 | 4000.00 | 4250.00 | 4500.00 | 4750.00 | 5000.00 | | | | | | | Average Losses |
|---|---|---|---|---|---|---|---|---|---|---|---|---|---|---|---|---|---|---|---|---|--|--|--|--|--|---|
| Difference (2009 - 2012) | - | - | - | - | 85 | - | 91 | - | 129 | - | 147 | - | 130 | - | 133 | - | 57 | - | 66 | - | | | | | | 105 |
| Total: | | | | | | | | | | | | | | | | | | | | | | | | | | 189 |

Following observations of traffic behaviour and road-user opinion along the demonstration sections in Lao and Tanzania, the use of hand packed stone and mortared stone should be limited to cases where alternative surface methods are not feasible. When this is the case, they should be limited to short lengths as the inherent roughness of the pavements has been said to cause damage to vehicles, and has been the cause of road accidents.

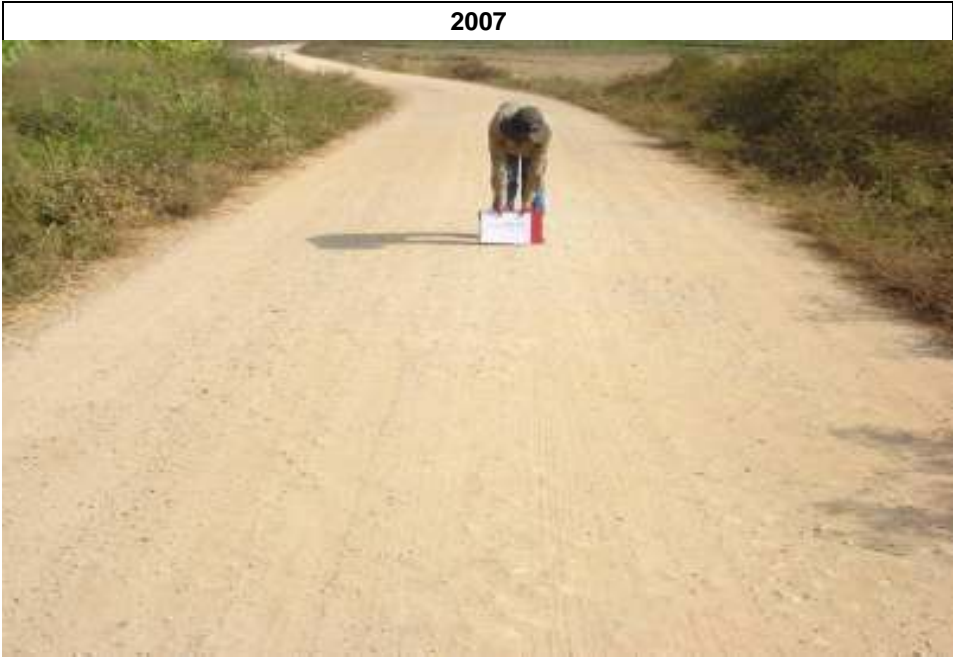
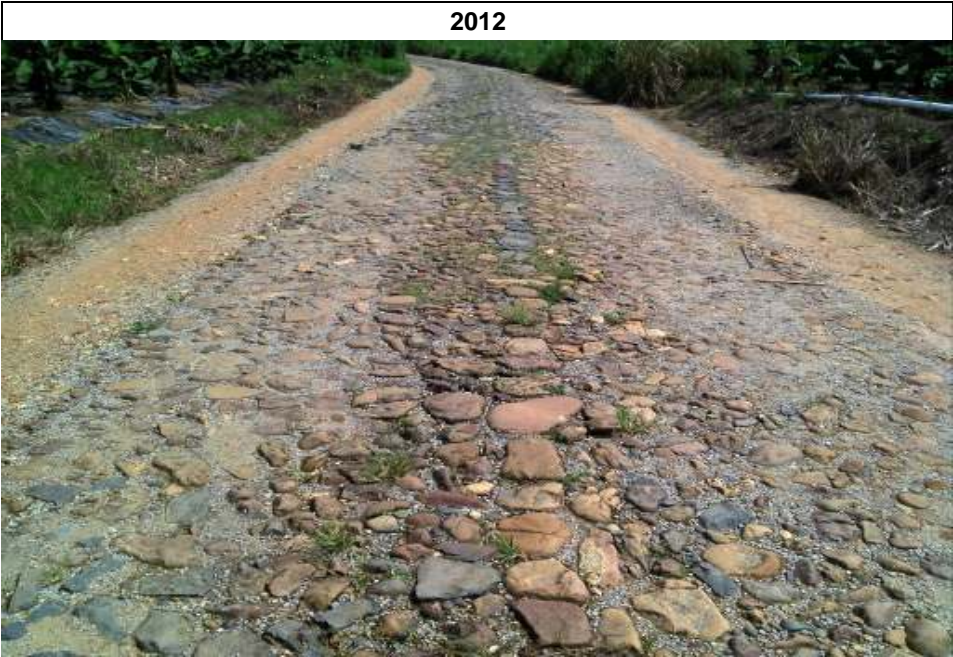
Road 2
Hand Packed Stone (0.795km)

| | 500.00 | 750.00 | 1000.00 | 1250.00 | 1500.00 | 1750.00 | 2000.00 | 2250.00 | 2500.00 | 2750.00 | 3000.00 | 3250.00 | 3500.00 | 3750.00 | 4000.00 | 4250.00 | 4500.00 | 4750.00 | 5000.00 | | | | | | | Average Losses |
|---|---|---|---|---|---|---|---|---|---|---|---|---|---|---|---|---|---|---|---|--|--|--|--|--|--|---|
| Difference (2009 - 2012) | - | - | - | - | 42 | - | 36 | - | 35 | - | 15 | - | 31 | - | 24 | - | 24 | - | 5 | | | | | | | 27 |

Total: 49

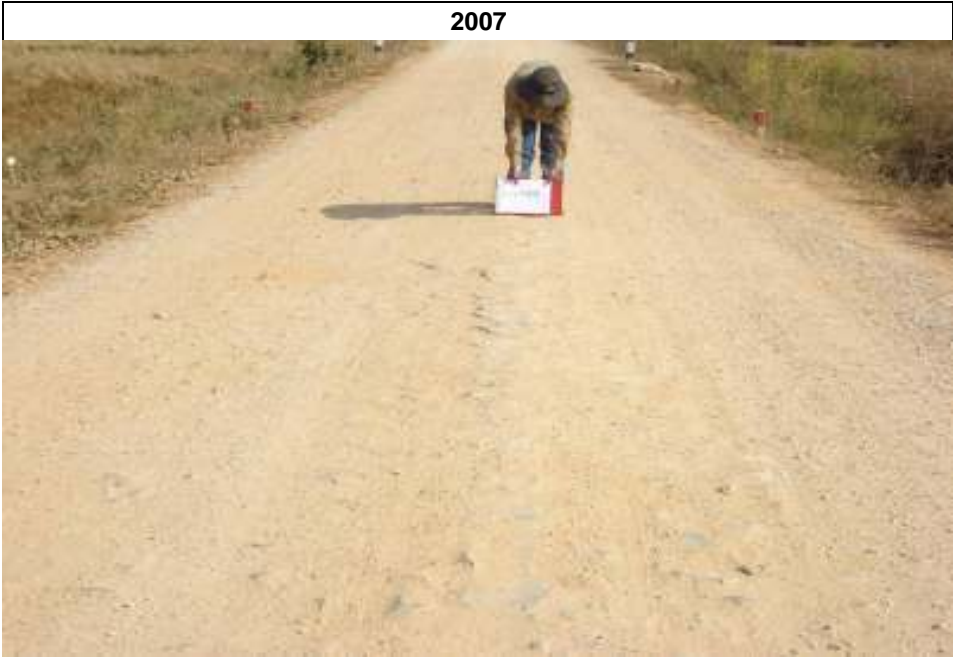
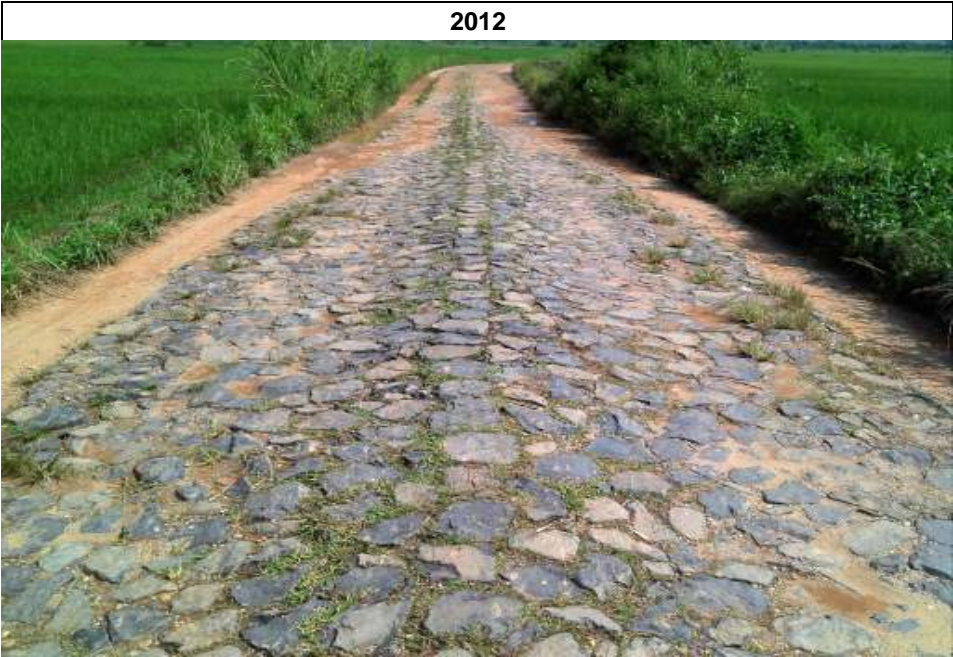
Road 2
Hand Packed Stone (0.965km)

| | 500.00 | 750.00 | 1000.00 | 1250.00 | 1500.00 | 1750.00 | 2000.00 | 2250.00 | 2500.00 | 2750.00 | 3000.00 | 3250.00 | 3500.00 | 3750.00 | 4000.00 | 4250.00 | 4500.00 | 4750.00 | 5000.00 | | | | | | | Average Losses |
|---|---|---|---|---|---|---|---|---|---|---|---|---|---|---|---|---|---|---|---|--|--|--|--|--|--|---|
| Difference (2009 - 2012) | - | - | - | - | 54 | - | 29 | - | 17 | - | 10 | - | -6 | - | -6 | - | 2 | - | -21 | | | | | | | 10 |
| Total: | | | | | | | | | | | | | | | | | | | | | | | | | | 44 |

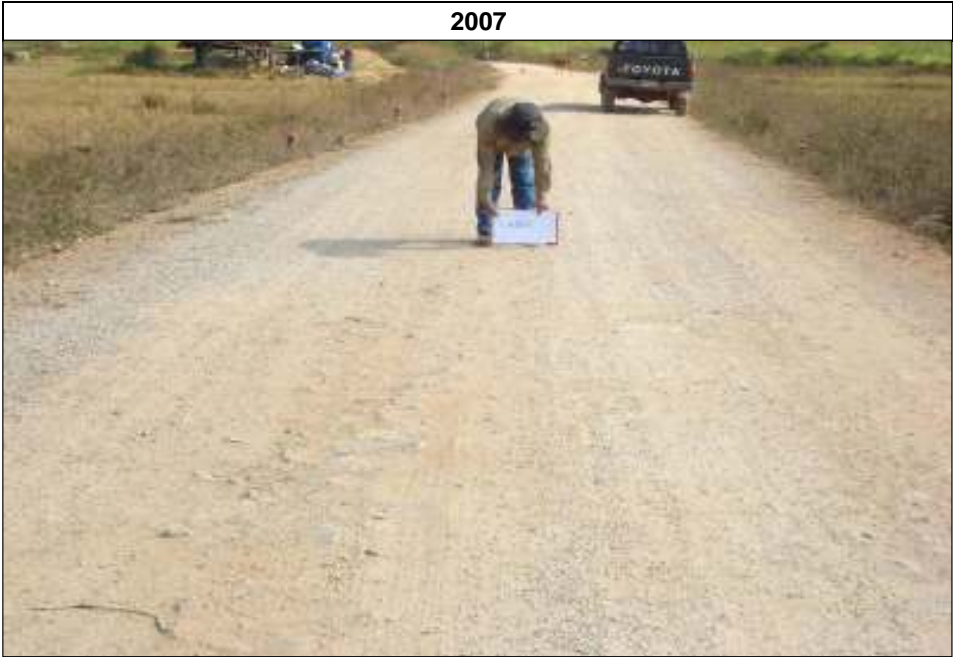
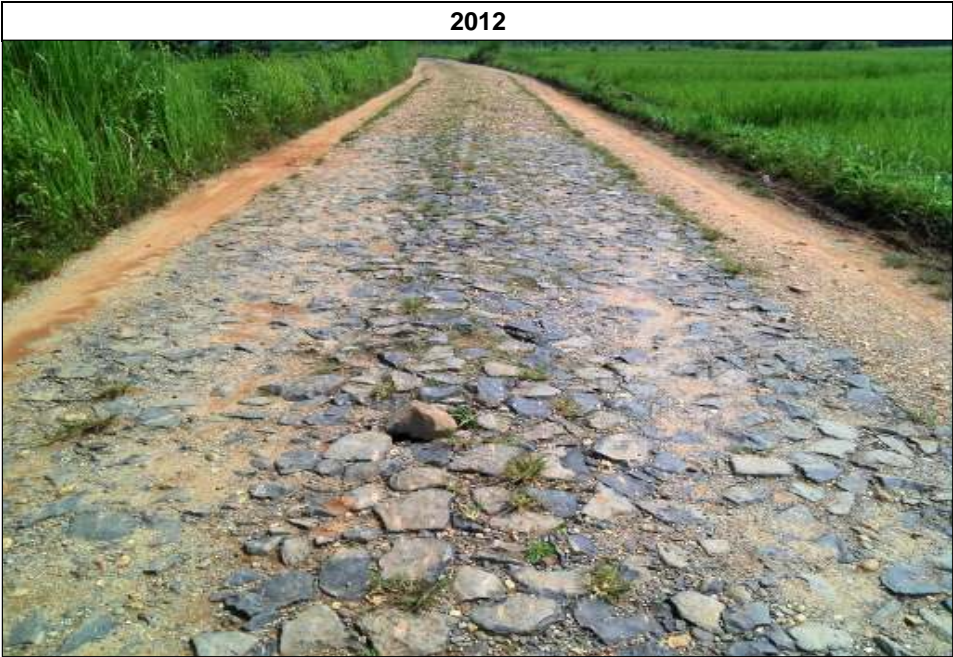
Road 2
Hand Packed Stone (1.035km)

| | 500.00 | 750.00 | 1000.00 | 1250.00 | 1500.00 | 1750.00 | 2000.00 | 2250.00 | 2500.00 | 2750.00 | 3000.00 | 3250.00 | 3500.00 | 3750.00 | 4000.00 | 4250.00 | 4500.00 | 4750.00 | 5000.00 | | | | | | | Average Losses |
|---|---|---|---|---|---|---|---|---|---|---|---|---|---|---|---|---|---|---|---|--|--|--|--|--|--|---|
| Difference (2009 - 2012) | - | - | - | - | -1 | - | 9 | - | 8 | - | 10 | - | 0 | - | -12 | - | -27 | - | -38 | | | | | | | -6 |

Total: 6
