The South East Asia Community Access Programme (SEACAP) Rural Roads

Monitoring Programme in Lao PDR
(SEACAP 17)

MONITORING REPORT

May 2013

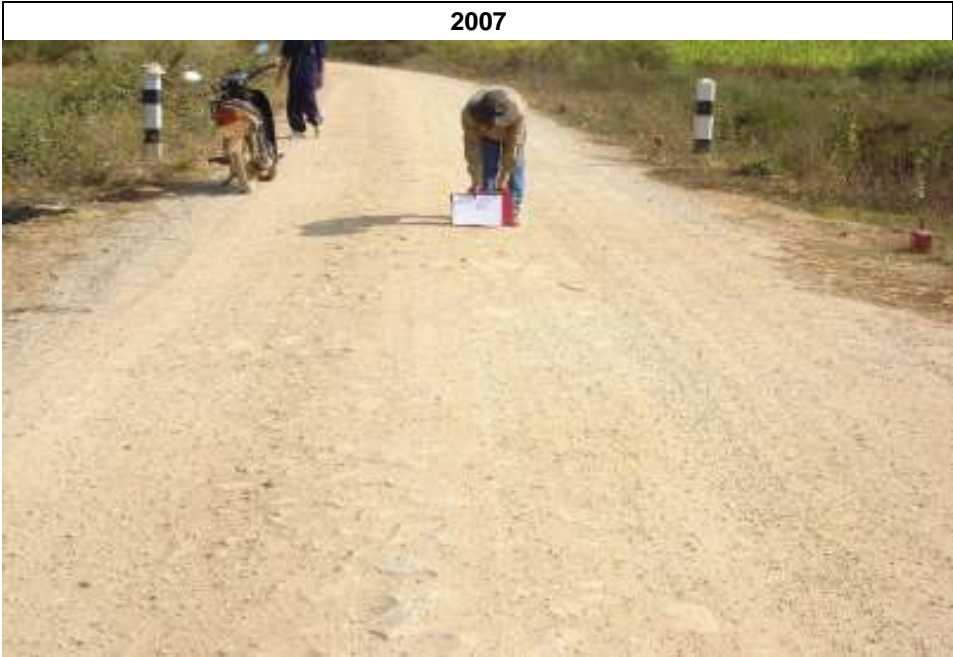
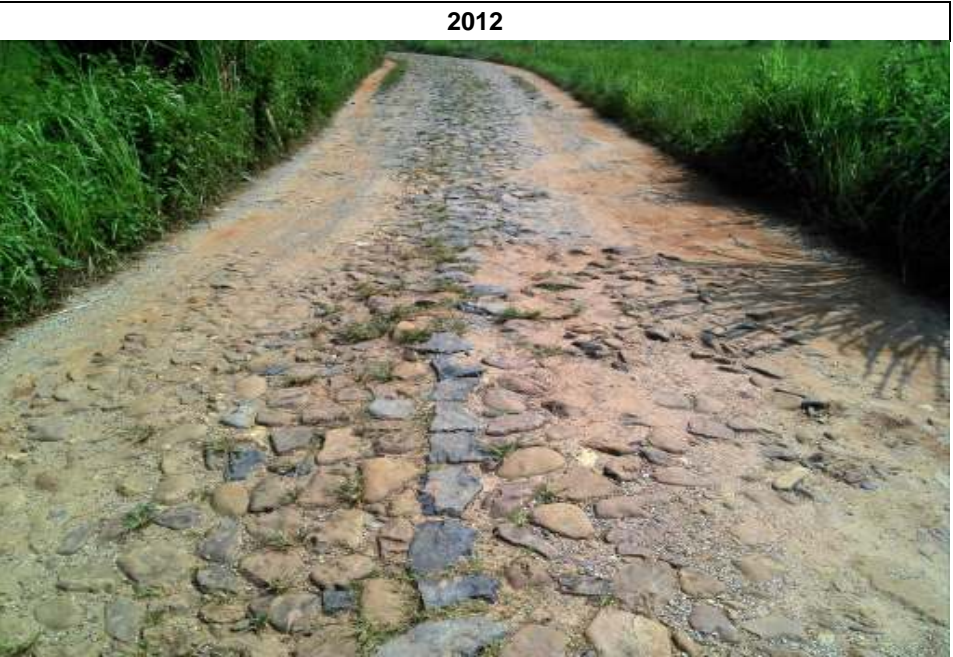
| | 500.00 | 750.00 | 1000.00 | 1250.00 | 1500.00 | 1750.00 | 2000.00 | 2250.00 | 2500.00 | 2750.00 | 3000.00 | 3250.00 | 3500.00 | 3750.00 | 4000.00 | 4250.00 | 4500.00 | 4750.00 | 5000.00 | | | | | | | Average Losses |
|---|---|---|---|---|---|---|---|---|---|---|---|---|---|---|---|---|---|---|---|--|--|--|--|--|--|---|
| Difference (2009 - 2012) | - | - | - | - | 83 | - | 64 | - | 25 | - | 12 | - | 0 | - | 1 | - | 0 | - | 10 | | | | | | | 24 |
| Total: | | | | | | | | | | | | | | | | | | | | | | | | | | 32 |

Road 3.2
Single Otta Seal (0.175km)

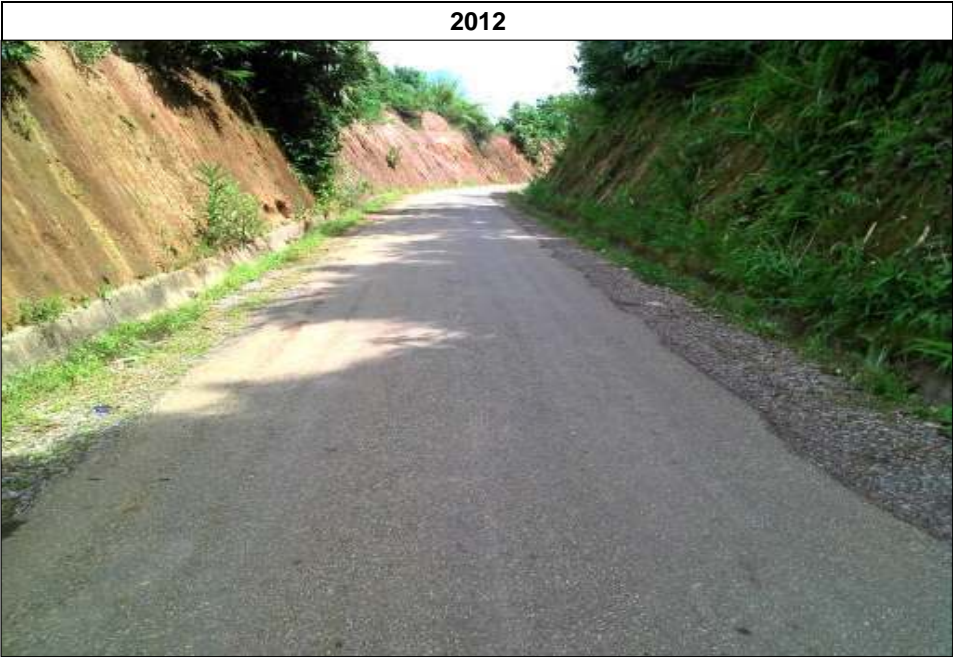
Road 3.2
Single Otta Seal (0.245km)

| | 500.00 | 750.00 | 1000.00 | 1250.00 | 1500.00 | 1750.00 | 2000.00 | 2250.00 | 2500.00 | 2750.00 | 3000.00 | 3250.00 | 3500.00 | 3750.00 | 4000.00 | 4250.00 | 4500.00 | 4750.00 | 5000.00 | | | | | | | Total Losses |
|---|---|---|---|---|---|---|---|---|---|---|---|---|---|---|---|---|---|---|---|--|--|--|--|--|--|---|
| Difference (2007 - 2012) | - | - | - | - | -5 | - | -7 | - | 10 | - | 10 | - | -2 | - | -1 | - | -6 | - | -50 | | | | | | | -6 |
| Total: | | | | | | | | | | | | | | | | | | | | | | | | | | 23 mm |

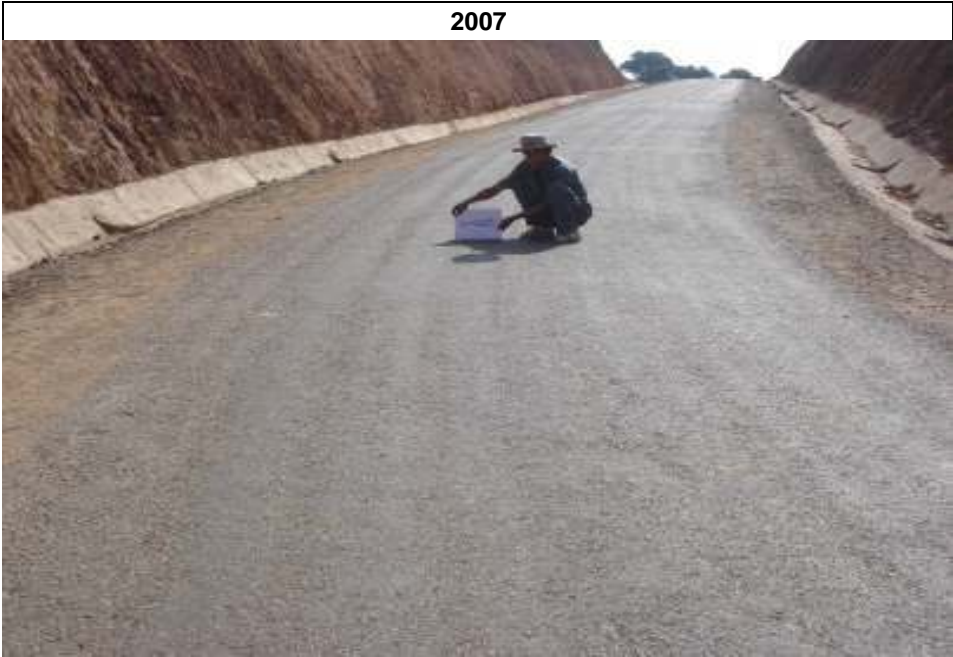
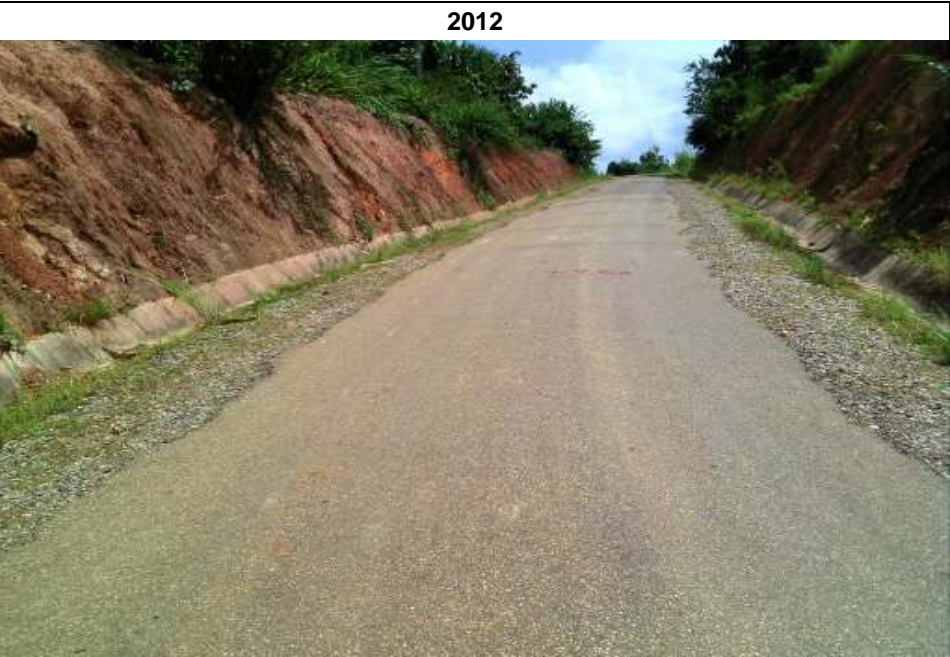
Road 3.2
Double Otta Seal (0.445km)

| | 500.00 | 750.00 | 1000.00 | 1250.00 | 1500.00 | 1750.00 | 2000.00 | 2250.00 | 2500.00 | 2750.00 | 3000.00 | 3250.00 | 3500.00 | 3750.00 | 4000.00 | 4250.00 | 4500.00 | 4750.00 | 5000.00 | | | | | | | Total Losses |
|---|---|---|---|---|---|---|---|---|---|---|---|---|---|---|---|---|---|---|---|--|--|--|--|--|--|---|
| Difference (2007 - 2012) | - | - | - | - | -15 | - | -3 | - | 9 | - | 15 | - | 14 | - | - | - | - | - | - | | | | | | | 4 |
| Total: | | | | | | | | | | | | | | | | | | | | | | | | | | 19 mm |

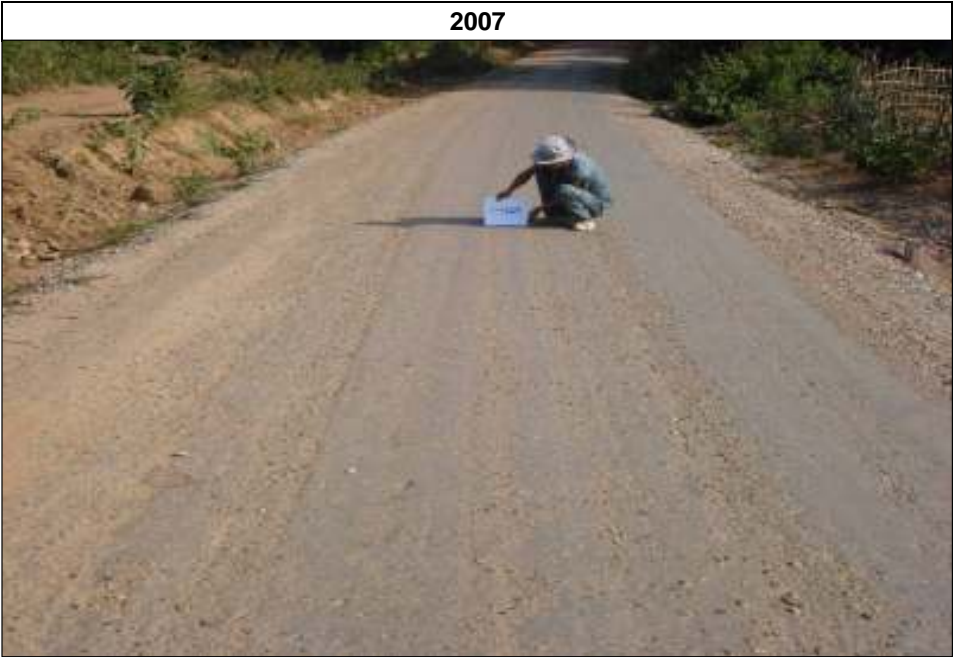
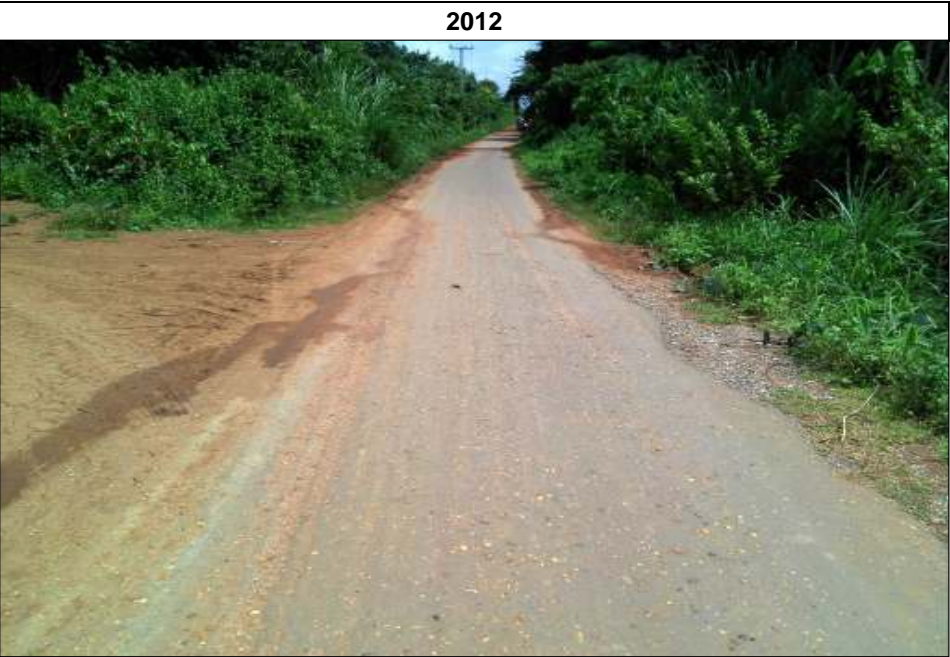
Road 3.2
Double Otta Seal (0.505km)

| | 500.00 | 750.00 | 1000.00 | 1250.00 | 1500.00 | 1750.00 | 2000.00 | 2250.00 | 2500.00 | 2750.00 | 3000.00 | 3250.00 | 3500.00 | 3750.00 | 4000.00 | 4250.00 | 4500.00 | 4750.00 | 5000.00 | | | | | | | Total Losses |
|---|---|---|---|---|---|---|---|---|---|---|---|---|---|---|---|---|---|---|---|--|--|--|--|--|--|---|
| Difference (2007 - 2012) | - | - | - | - | -39 | - | -16 | - | -6 | - | 12 | - | 16 | - | 12 | - | 30 | - | -12 | | | | | | | 0 |
| Total: | | | | | | | | | | | | | | | | | | | | | | | | | | 4 mm |

It has been identified on the double Otta seal and Otta seal with sand cover seal sections that there was a certain amount of edge break that, without treatment, could lead to further deterioration of the carriageway. Similarly the District Engineer in Bagamoyo, Tanzania has recently taken action to construct stone pitching along the edges of the bituminous demonstration sections along the Bago – Talawanda road, in order to limit the effects of edge break along these sections. It is recommended

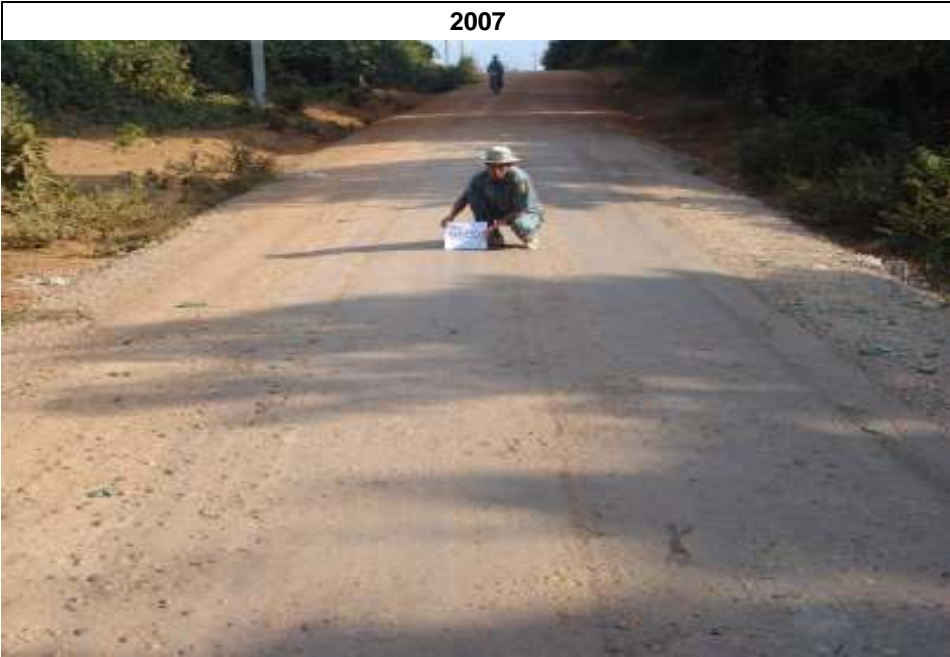
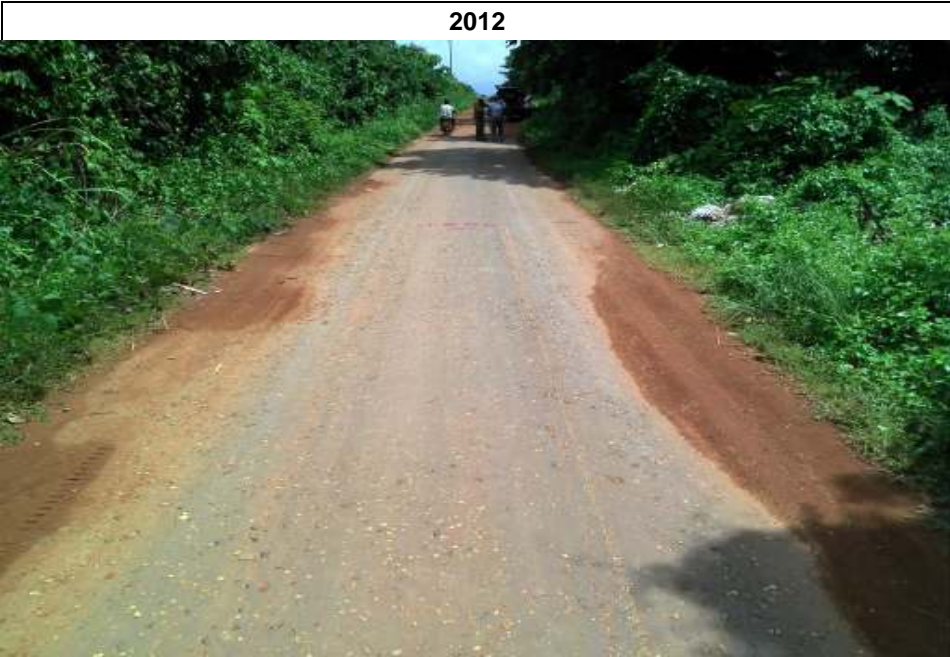
Road 3.2

| | 500.00 | 750.00 | 1000.00 | 1250.00 | 1500.00 | 1750.00 | 2000.00 | 2250.00 | 2500.00 | 2750.00 | 3000.00 | 3250.00 | 3500.00 | 3750.00 | 4000.00 | 4250.00 | 4500.00 | 4750.00 | 5000.00 | | | | | | | Total Losses |
|---|---|---|---|---|---|---|---|---|---|---|---|---|---|---|---|---|---|---|---|--|--|--|--|--|--|---|
| Difference (2007 - 2012) | - | - | - | - | -6 | - | 6 | - | 19 | - | 40 | - | 23 | - | 24 | - | -6 | - | -19 | | | | | | | 10 |
| Total: | | | | | | | | | | | | | | | | | | | | | | | | | | 14 mm |

Engineered Natural Surface (0.825km)

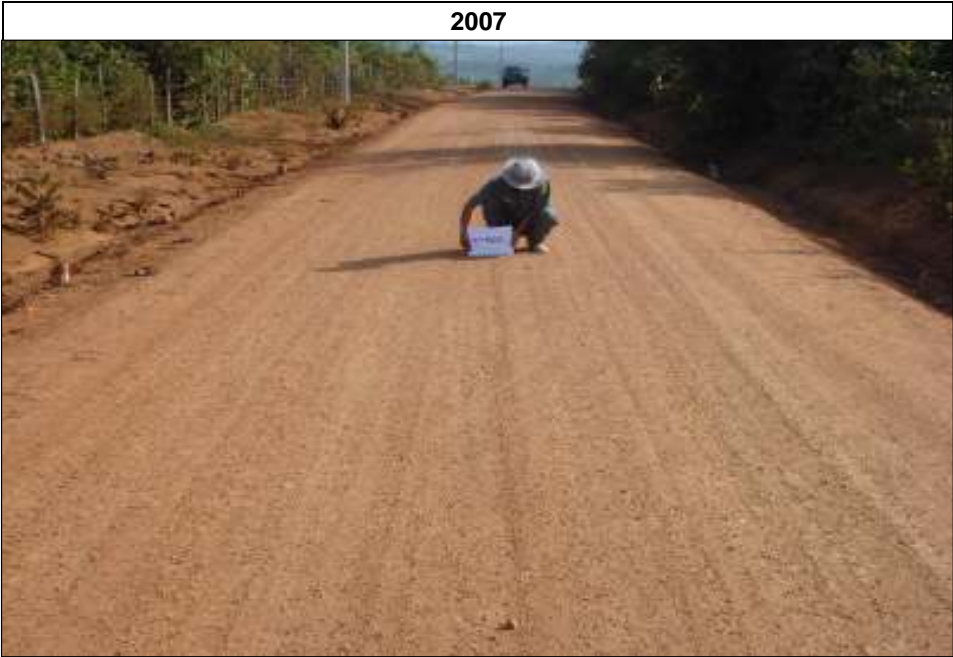
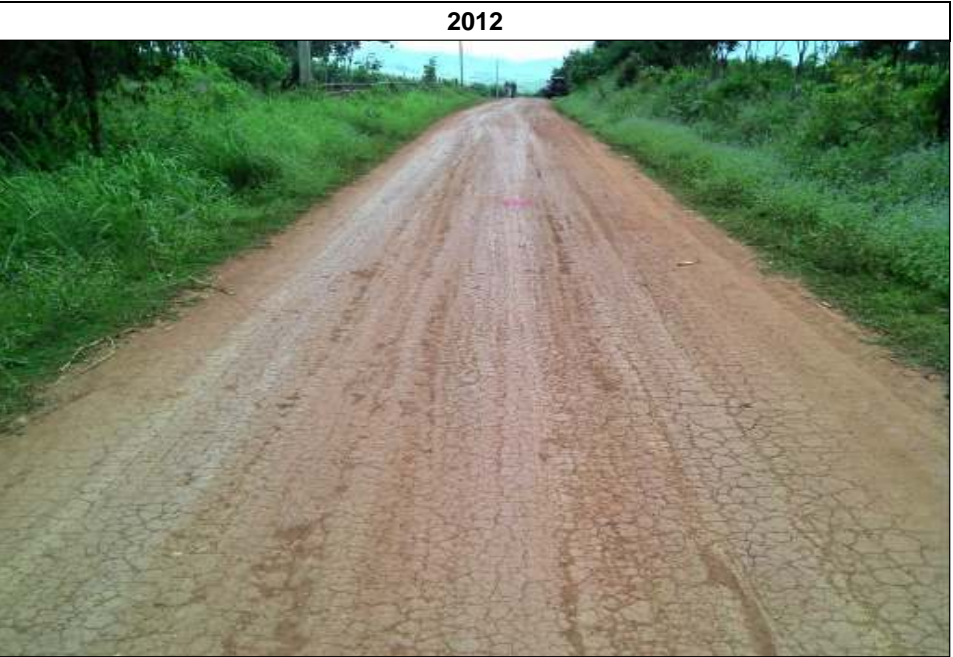
Road 3.2
Engineered Natural Surface (0.895km)

| | 500.00 | 750.00 | 1000.00 | 1250.00 | 1500.00 | 1750.00 | 2000.00 | 2250.00 | 2500.00 | 2750.00 | 3000.00 | 3250.00 | 3500.00 | 3750.00 | 4000.00 | 4250.00 | 4500.00 | 4750.00 | 5000.00 | | | | | | | Total Losses |
|---|---|---|---|---|---|---|---|---|---|---|---|---|---|---|---|---|---|---|---|--|--|--|--|--|--|---|
| Difference (2007 - 2012) | - | - | - | - | 38 | - | 70 | - | 92 | - | 105 | - | 110 | - | 102 | - | 52 | - | 22 | | | | | | | 74 |
| Total: | | | | | | | | | | | | | | | | | | | | | | | | | | 111 mm |

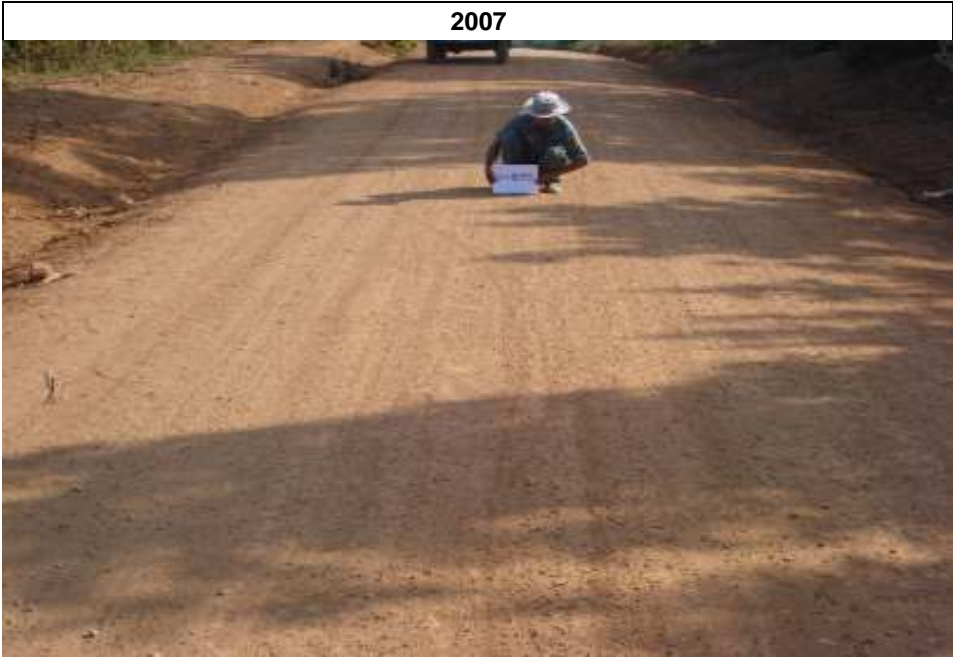
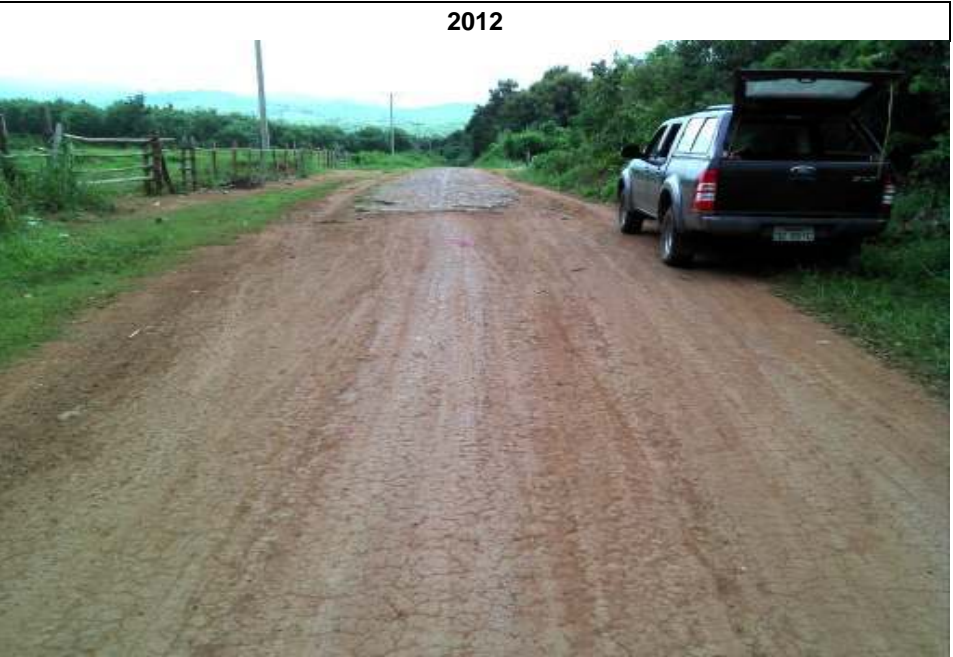
Road 3.2
Mortared Stone (1.225km)

| | 500.00 | 750.00 | 1000.00 | 1250.00 | 1500.00 | 1750.00 | 2000.00 | 2250.00 | 2500.00 | 2750.00 | 3000.00 | 3250.00 | 3500.00 | 3750.00 | 4000.00 | 4250.00 | 4500.00 | 4750.00 | 5000.00 | | | | | | Total Losses |
|---|---|---|---|---|---|---|---|---|---|---|---|---|---|---|---|---|---|---|---|--|--|--|--|--|---|
| Difference (2007 - 2012) | - | - | - | - | 63 | - | 108 | - | 124 | - | 120 | - | 145 | - | 94 | - | 23 | - | -17 | | | | | | 83 |
| Total: | | | | | | | | | | | | | | | | | | | | | | | | | 108 mm |

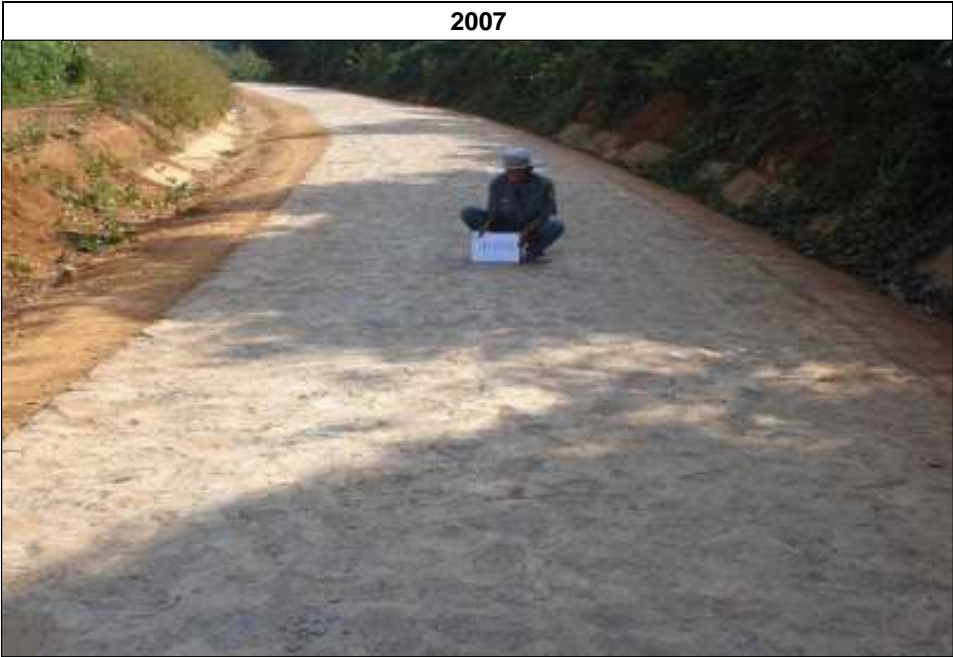
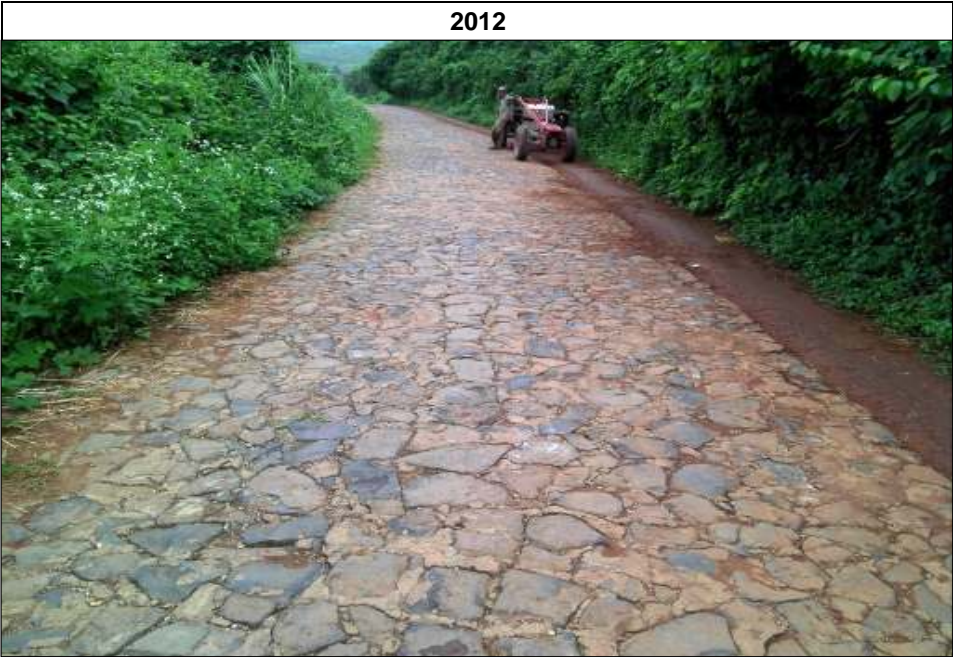
Road 3.2
Mortared Stone (1.295km)

| | 500.00 | 750.00 | 1000.00 | 1250.00 | 1500.00 | 1750.00 | 2000.00 | 2250.00 | 2500.00 | 2750.00 | 3000.00 | 3250.00 | 3500.00 | 3750.00 | 4000.00 | 4250.00 | 4500.00 | 4750.00 | 5000.00 | | | | | | Total Losses |
|---|---|---|---|---|---|---|---|---|---|---|---|---|---|---|---|---|---|---|---|--|--|--|--|--|---|
| Difference (2007 - 2012) | - | - | - | - | 28 | - | 3 | - | 30 | - | 0 | - | -1 | - | -5 | - | -21 | - | -86 | | | | | | -6 |
| Total: | | | | | | | | | | | | | | | | | | | | | | | | | 24 mm |

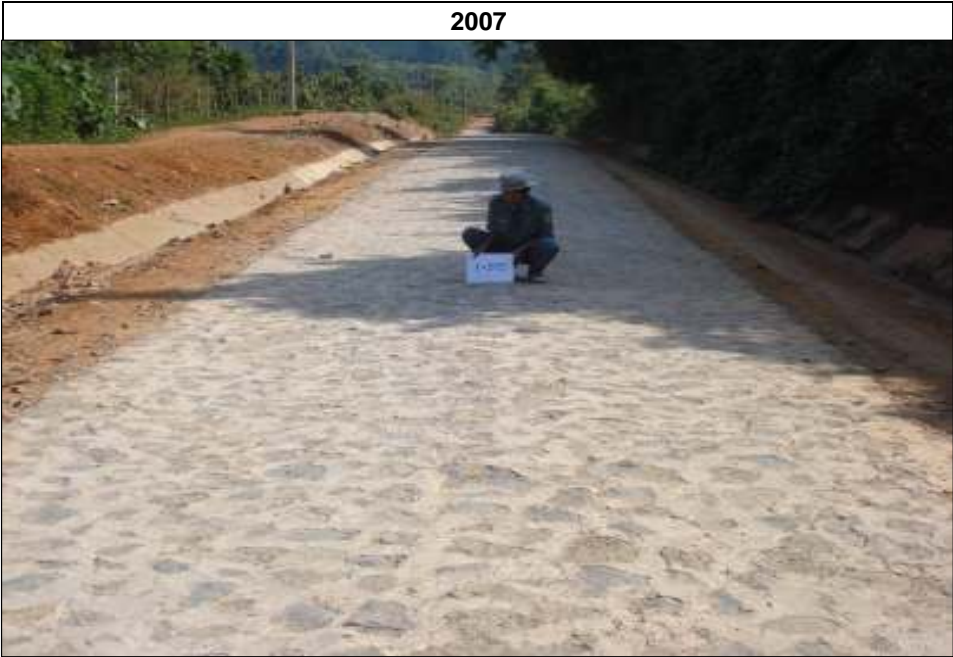
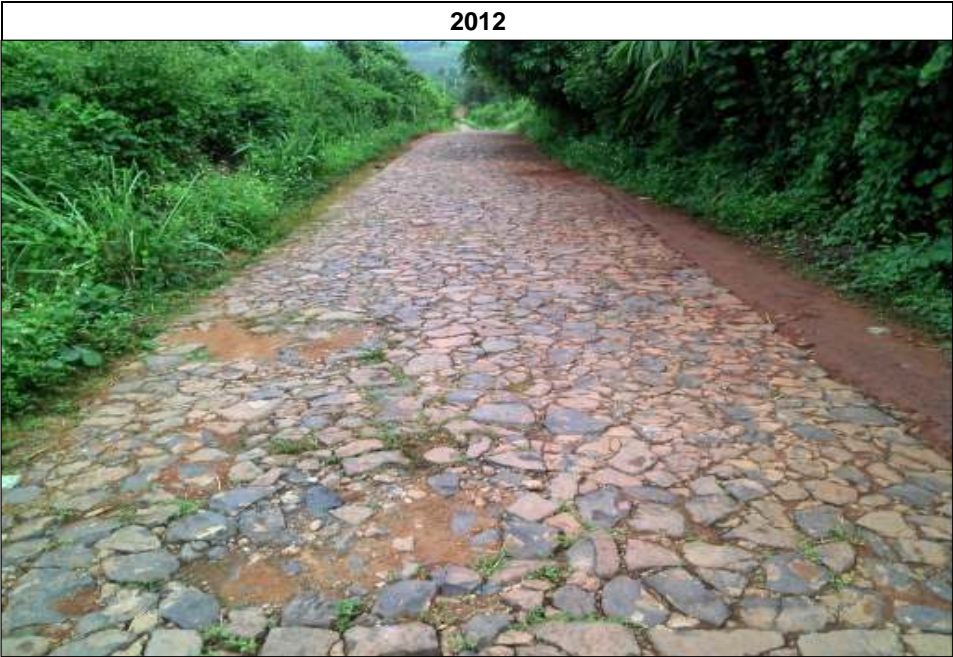
Road 3.2
Mortared Stone (1.395km)

| | 500.00 | 750.00 | 1000.00 | 1250.00 | 1500.00 | 1750.00 | 2000.00 | 2250.00 | 2500.00 | 2750.00 | 3000.00 | 3250.00 | 3500.00 | 3750.00 | 4000.00 | 4250.00 | 4500.00 | 4750.00 | 5000.00 | | | | | | Total Losses |
|---|---|---|---|---|---|---|---|---|---|---|---|---|---|---|---|---|---|---|---|--|--|--|--|--|---|
| Difference (2007 - 2012) | - | - | - | - | -39 | - | -18 | - | 1 | - | 0 | - | -20 | - | -42 | - | -70 | - | -100 | | | | | | -36 |
| Total: | | | | | | | | | | | | | | | | | | | | | | | | | -10 mm |

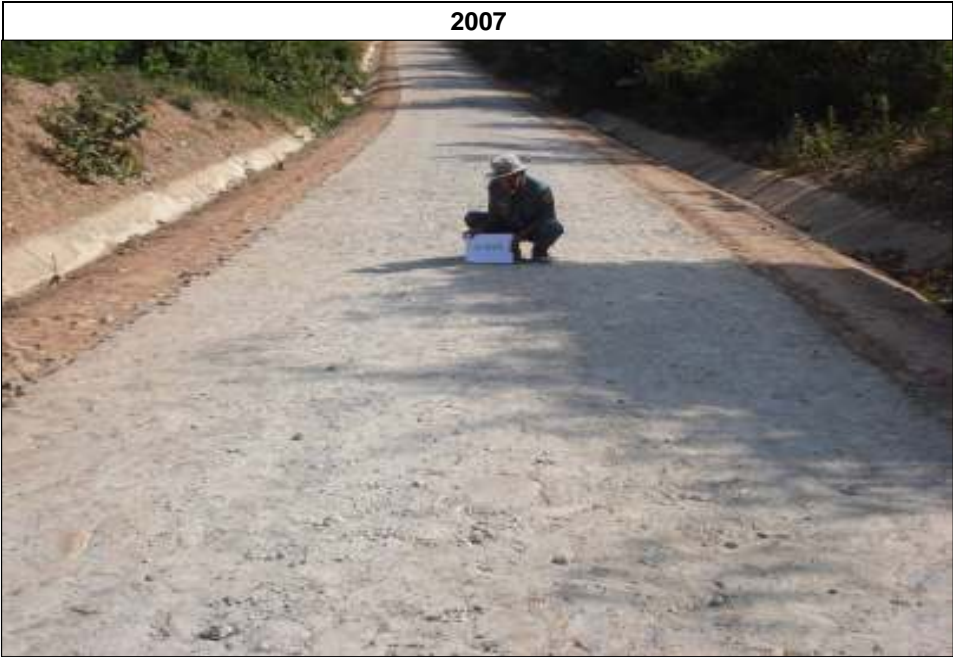
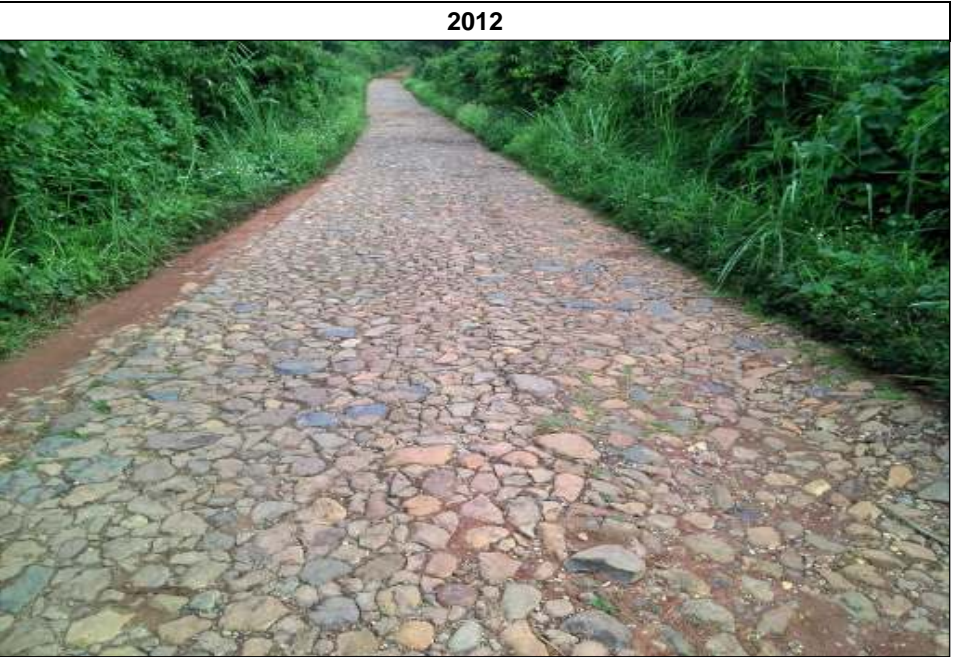
Road 3.2

| | 500.00 | 750.00 | 1000.00 | 1250.00 | 1500.00 | 1750.00 | 2000.00 | 2250.00 | 2500.00 | 2750.00 | 3000.00 | 3250.00 | 3500.00 | 3750.00 | 4000.00 | 4250.00 | 4500.00 | 4750.00 | 5000.00 | | | | | | Total Losses |
|---|---|---|---|---|---|---|---|---|---|---|---|---|---|---|---|---|---|---|---|--|--|--|--|--|---|
| Difference (2007 - 2012) | - | - | - | - | 22 | - | 63 | - | 41 | - | 0 | - | 8 | - | 50 | - | 5 | - | - | | | | | | 27 |
| Total: | | | | | | | | | | | | | | | | | | | | | | | | | 37 mm |

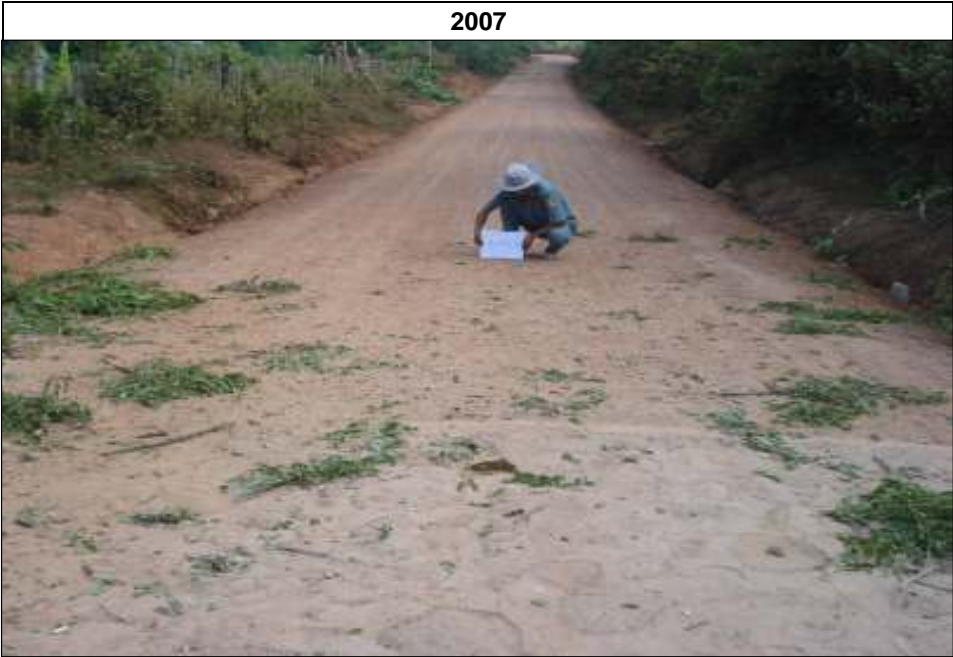
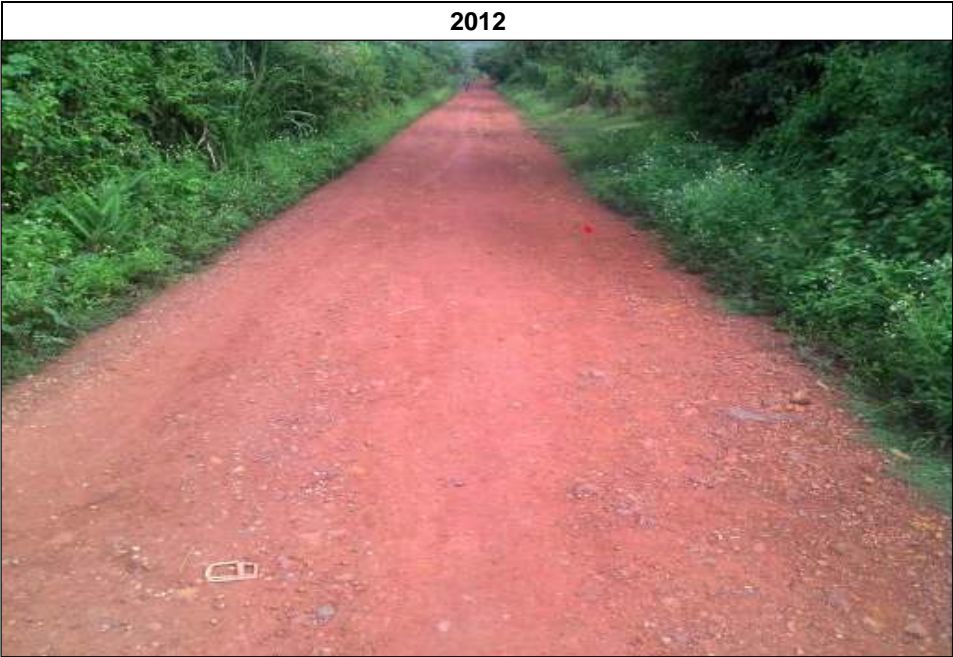
Road 3.2
Gravel (1.595km)

| | 500.00 | 750.00 | 1000.00 | 1250.00 | 1500.00 | 1750.00 | 2000.00 | 2250.00 | 2500.00 | 2750.00 | 3000.00 | 3250.00 | 3500.00 | 3750.00 | 4000.00 | 4250.00 | 4500.00 | 4750.00 | 5000.00 | | | | | | Total Losses |
|---|---|---|---|---|---|---|---|---|---|---|---|---|---|---|---|---|---|---|---|--|--|--|--|--|---|
| Difference (2007 - 2012) | - | - | - | - | 120 | - | 105 | - | 87 | - | 100 | - | 95 | - | 88 | - | 47 | - | - | | | | | | 92 |
| Total: | | | | | | | | | | | | | | | | | | | | | | | | | 121 mm |

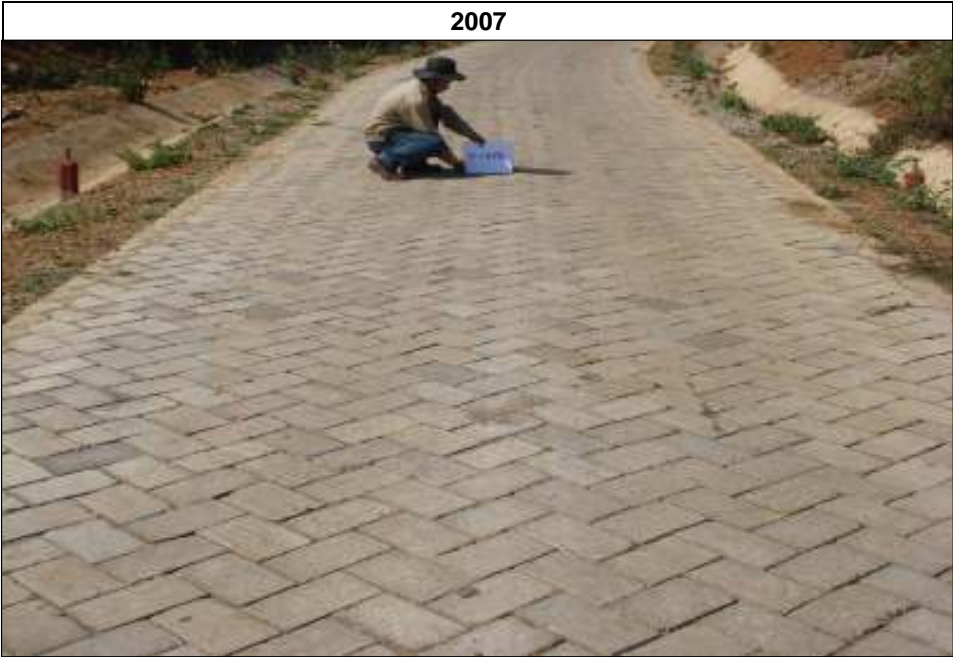
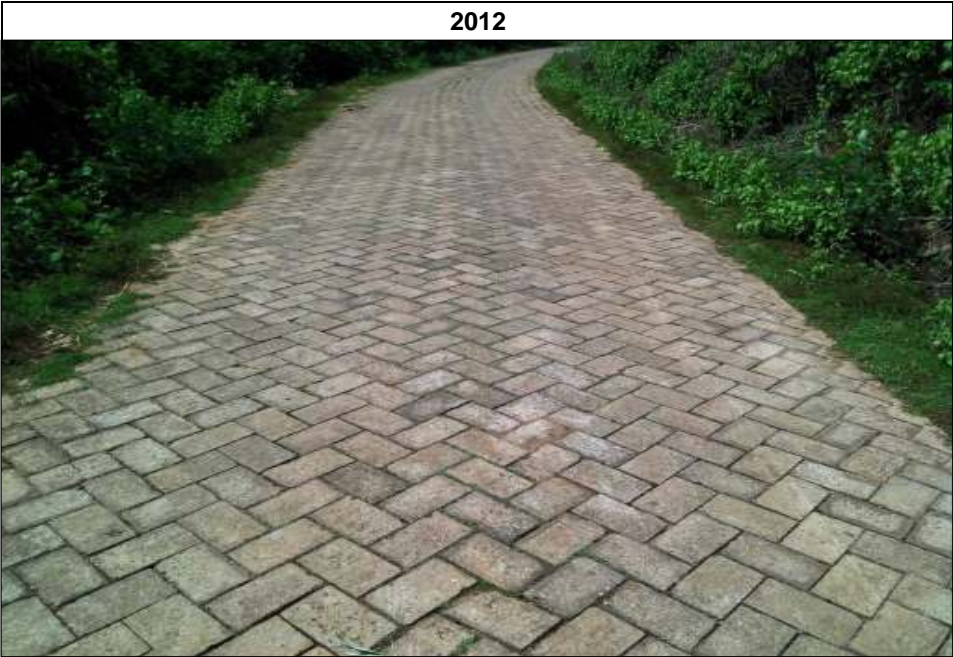
Road 5
Concrete Paving Blocks (1.045km)

| | 500.00 | 750.00 | 1000.00 | 1250.00 | 1500.00 | 1750.00 | 2000.00 | 2250.00 | 2500.00 | 2750.00 | 3000.00 | 3250.00 | 3500.00 | 3750.00 | 4000.00 | 4250.00 | 4500.00 | 4750.00 | 5000.00 | | | | | | Average Loss |
|---|---|---|---|---|---|---|---|---|---|---|---|---|---|---|---|---|---|---|---|--|--|--|--|--|---|
| Difference (2007 - 2009) | - | - | 18 | - | 28 | - | 23 | - | -1 | - | 10 | - | -5 | - | 1 | - | 0 | - | -45 | | | | | | 3 |
| Difference (2007 - 2012) | - | - | - | - | 31 | - | 25 | - | 29 | - | 54 | - | 39 | - | 43 | - | 13 | - | - | | | | | | 33 |

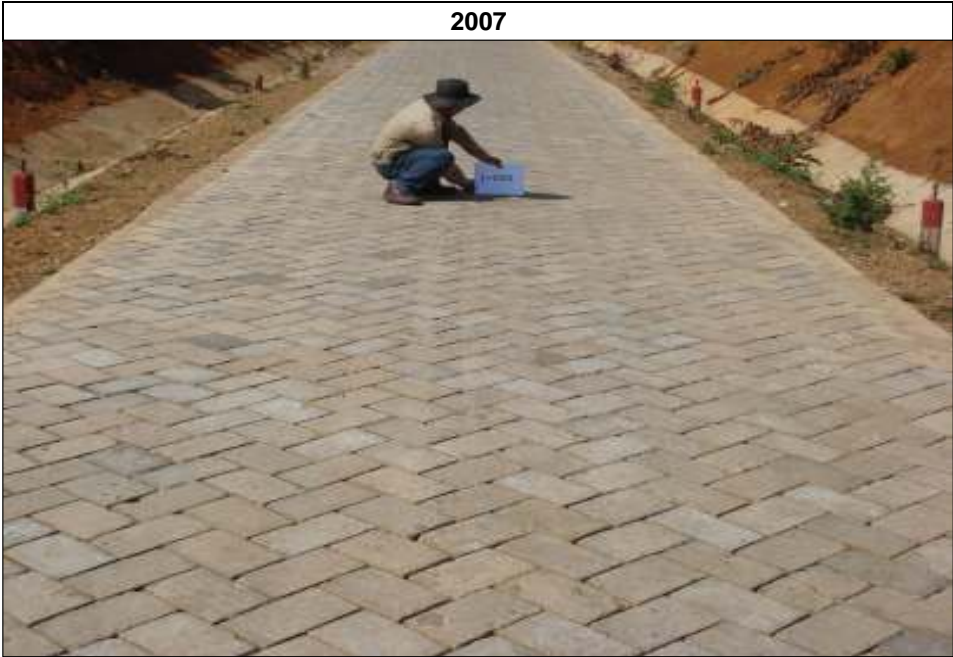
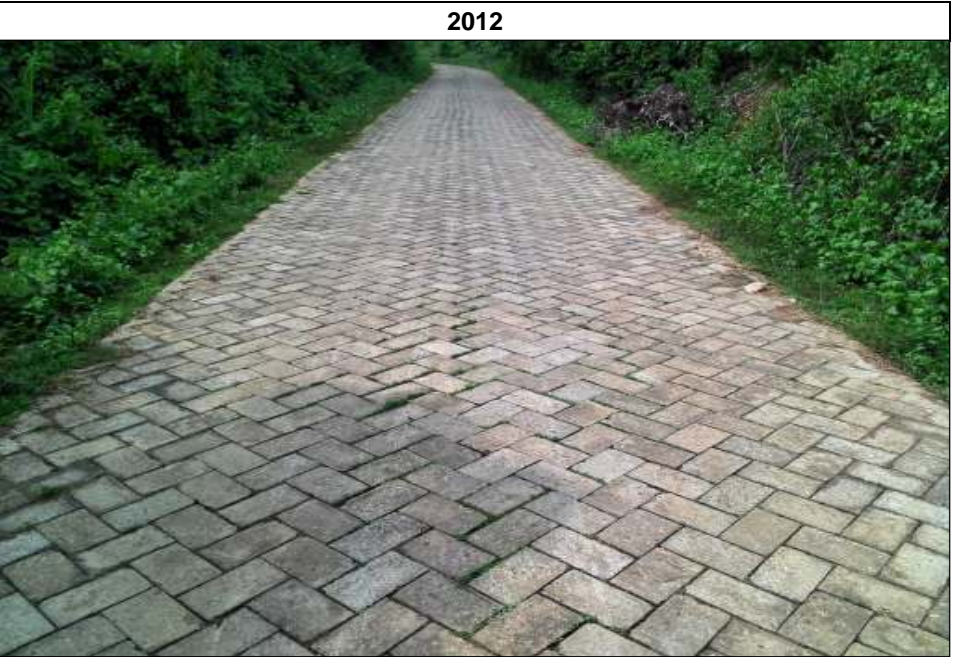
Road 5
Concrete Paving Blocks (1.275km)

| | 500.00 | 750.00 | 1000.00 | 1250.00 | 1500.00 | 1750.00 | 2000.00 | 2250.00 | 2500.00 | 2750.00 | 3000.00 | 3250.00 | 3500.00 | 3750.00 | 4000.00 | 4250.00 | 4500.00 | 4750.00 | 5000.00 | | | | | | Average Loss |
|---|---|---|---|---|---|---|---|---|---|---|---|---|---|---|---|---|---|---|---|--|--|--|--|--|---|
| Difference (2007 - 2012) | - | - | - | - | 48 | - | 65 | - | 53 | - | 33 | - | 38 | - | 33 | - | 39 | - | - | | | | | | 44 |

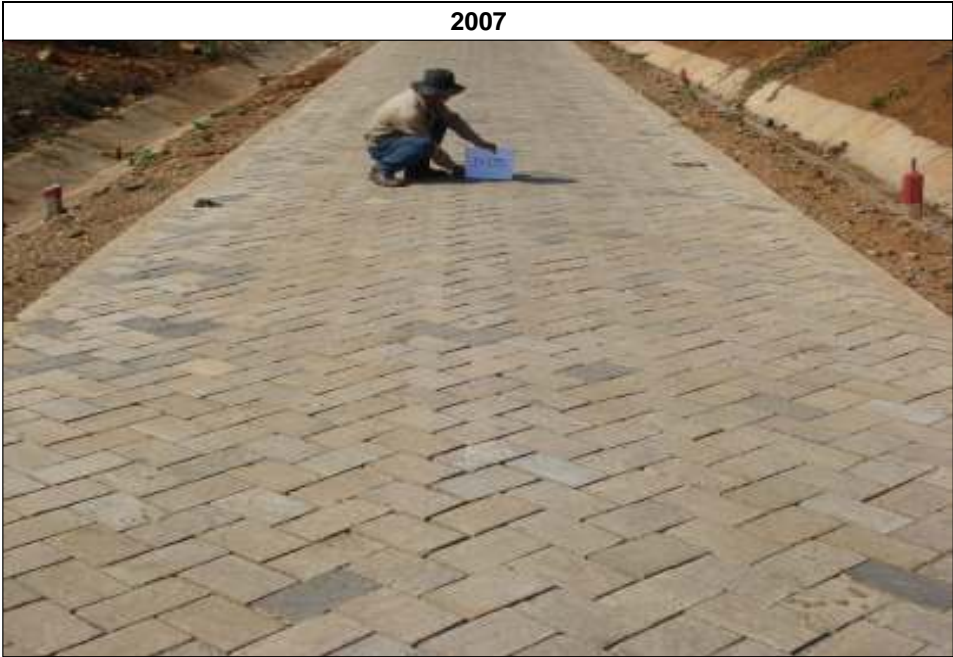
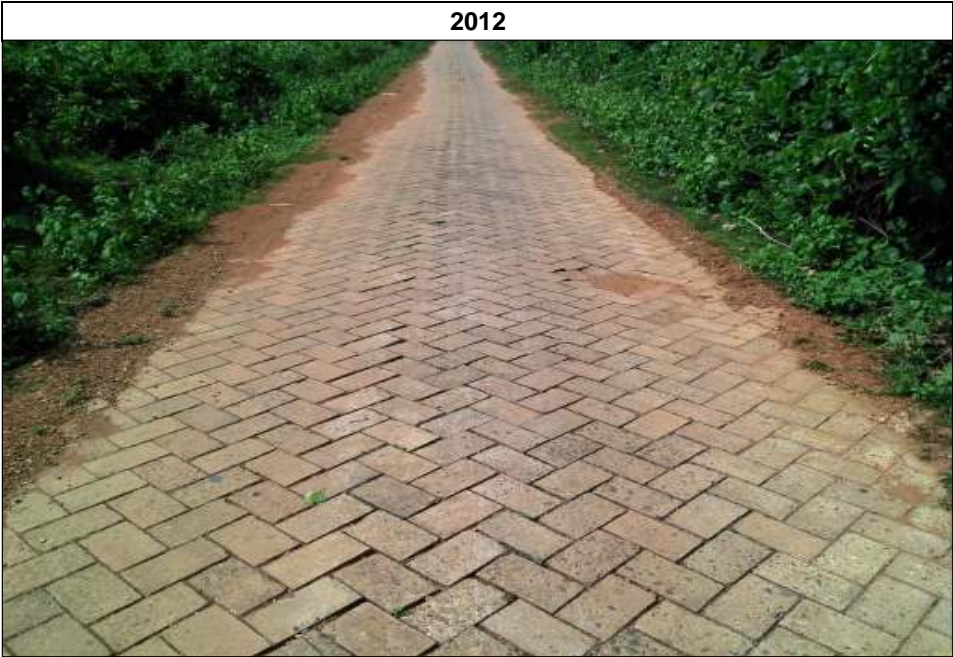
Road 5
Bamboo Concrete (2.025km)

| | 500.00 | 750.00 | 1000.00 | 1250.00 | 1500.00 | 1750.00 | 2000.00 | 2250.00 | 2500.00 | 2750.00 | 3000.00 | 3250.00 | 3500.00 | 3750.00 | 4000.00 | 4250.00 | 4500.00 | 4750.00 | 5000.00 | | | | | | Average Loss |
|---|---|---|---|---|---|---|---|---|---|---|---|---|---|---|---|---|---|---|---|--|--|--|--|--|---|
| Difference (2007 - 2009) | - | - | 47 | - | 43 | - | 54 | - | 39 | - | 43 | - | 47 | - | 43 | - | 18 | - | -85 | | | | | | 28 |
| Difference (2007 - 2012) | - | - | - | - | 49 | - | 57 | - | 59 | - | 63 | - | 65 | - | 59 | - | 21 | - | - | | | | | | 53 |

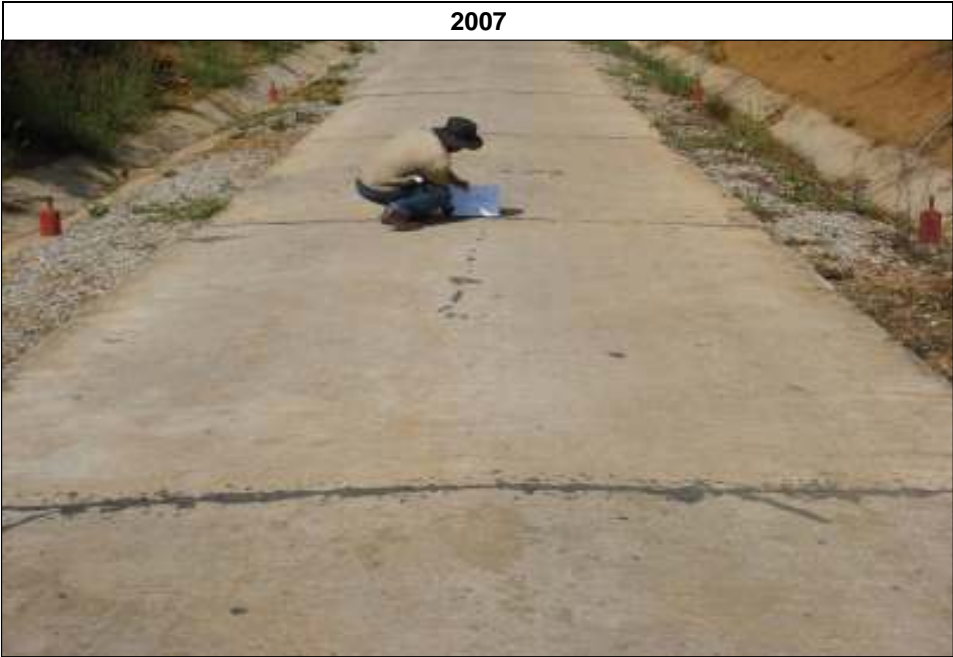
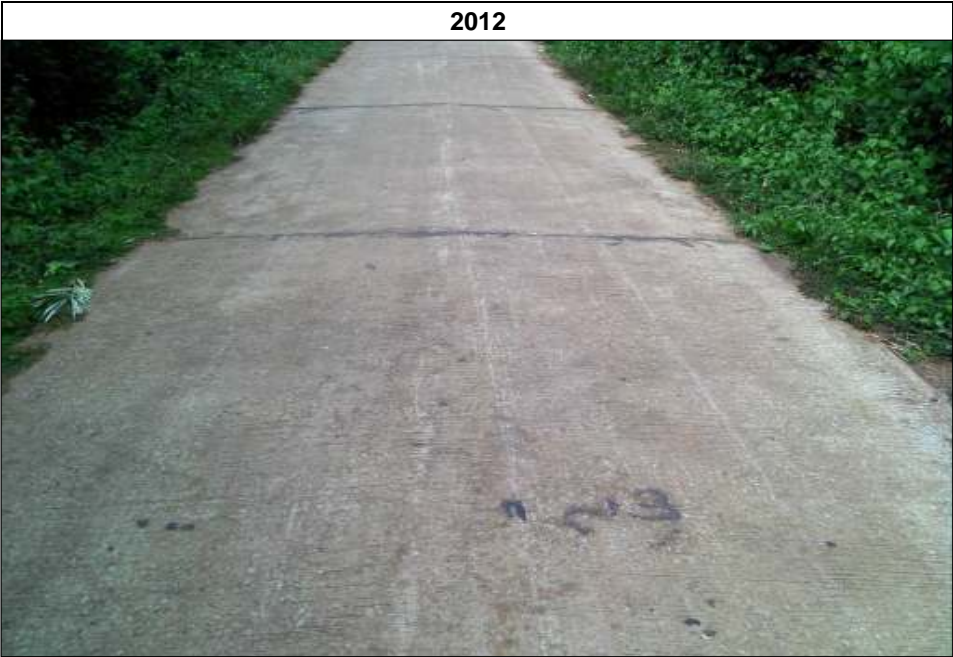
Road 5
Bamboo Concrete (2.095km)

| | 500.00 | 750.00 | 1000.00 | 1250.00 | 1500.00 | 1750.00 | 2000.00 | 2250.00 | 2500.00 | 2750.00 | 3000.00 | 3250.00 | 3500.00 | 3750.00 | 4000.00 | 4250.00 | 4500.00 | 4750.00 | 5000.00 | | | | | | Average Loss |
|---|---|---|---|---|---|---|---|---|---|---|---|---|---|---|---|---|---|---|---|--|--|--|--|--|---|
| Difference (2007 - 2009) | - | - | 4 | - | 3 | - | 7 | - | 15 | - | 7 | - | 6 | - | 5 | - | 21 | - | -54 | | | | | | 2 |
| Difference (2007 - 2012) | - | - | - | - | -1 | - | 2 | - | 15 | - | 19 | - | 15 | - | 8 | - | -27 | - | - | | | | | | 4 |

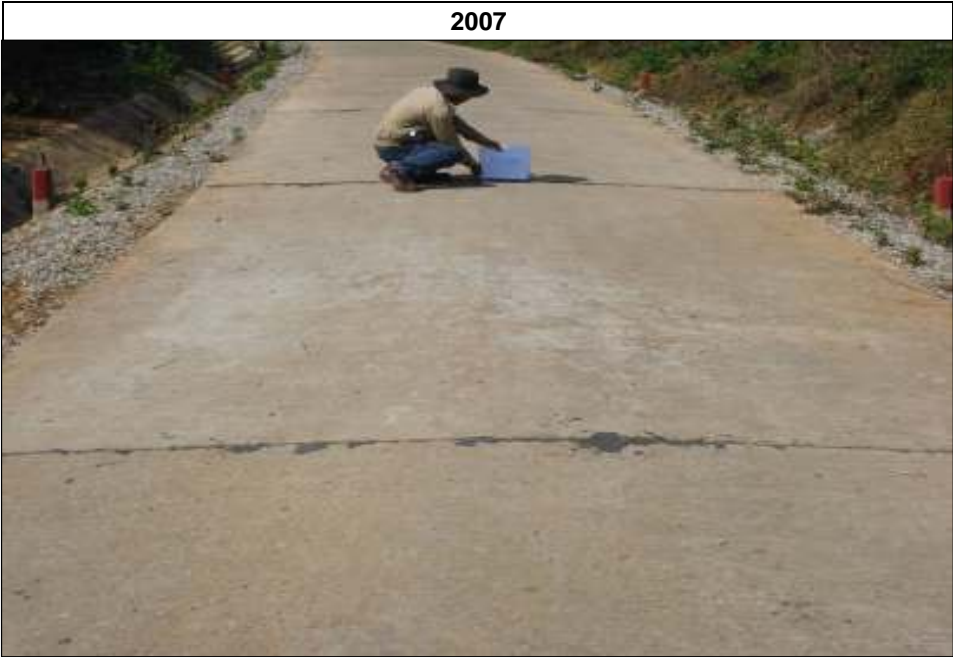
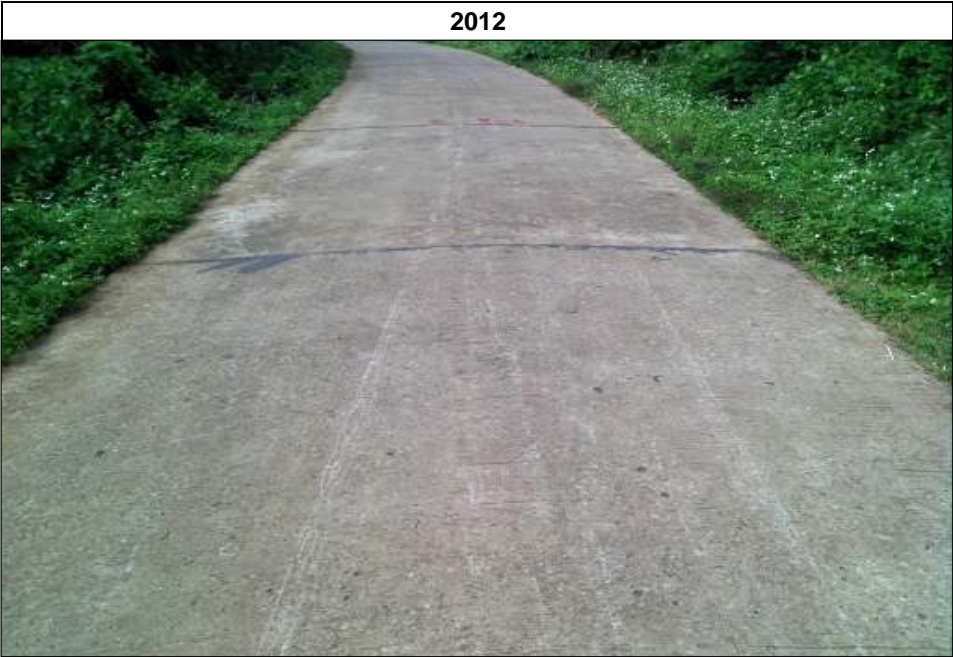
Road 5
Bamboo Concrete (2.355km)

| | 500.00 | 750.00 | 1000.00 | 1250.00 | 1500.00 | 1750.00 | 2000.00 | 2250.00 | 2500.00 | 2750.00 | 3000.00 | 3250.00 | 3500.00 | 3750.00 | 4000.00 | 4250.00 | 4500.00 | 4750.00 | 5000.00 | | | | | | Average Loss |
|---|---|---|---|---|---|---|---|---|---|---|---|---|---|---|---|---|---|---|---|--|--|--|--|--|---|
| Difference (2007 - 2012) | - | - | - | - | 2 | - | 9 | - | 18 | - | 31 | - | 24 | - | 21 | - | 3 | - | - | | | | | | 15 |
