The South East Asia Community Access Programme (SEACAP) Rural Roads

Monitoring Programme in Lao PDR
(SEACAP 17)

MONITORING REPORT

May 2013

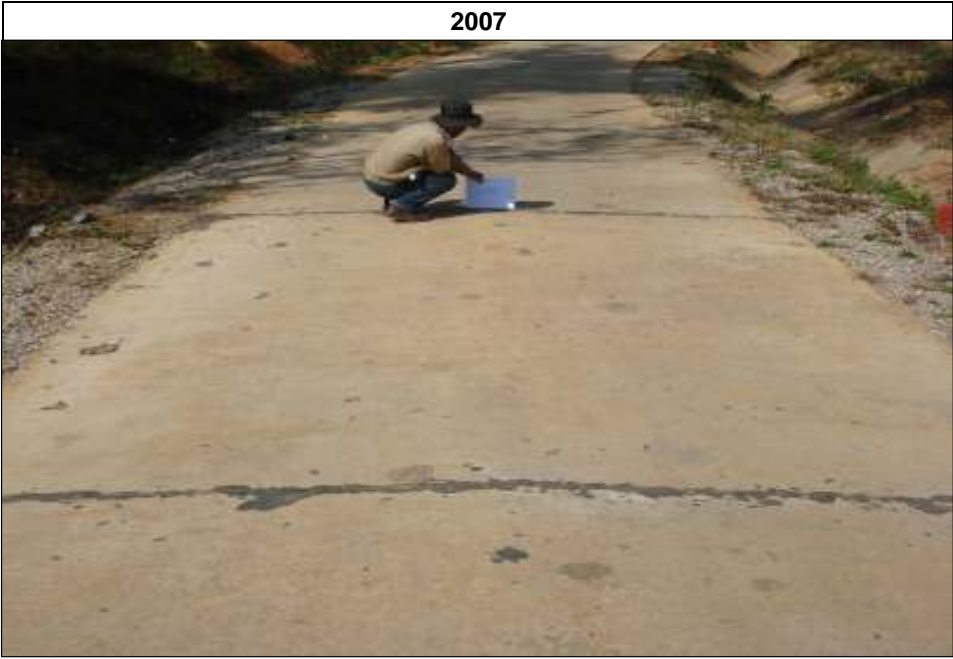
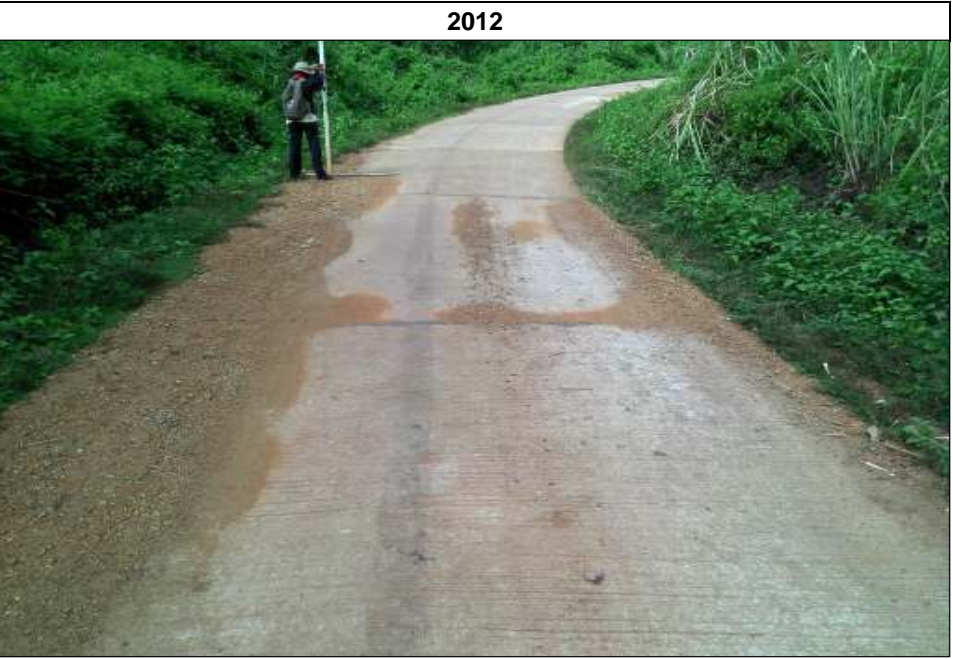
Road 5
Bamboo Concrete (2.445km)

| | 500.00 | 750.00 | 1000.00 | 1250.00 | 1500.00 | 1750.00 | 2000.00 | 2250.00 | 2500.00 | 2750.00 | 3000.00 | 3250.00 | 3500.00 | 3750.00 | 4000.00 | 4250.00 | 4500.00 | 4750.00 | 5000.00 | | | | | | Average Loss |
|---|---|---|---|---|---|---|---|---|---|---|---|---|---|---|---|---|---|---|---|--|--|--|--|--|---|
| Difference (2007 - 2012) | - | - | - | - | -28 | - | -13 | - | 8 | - | -6 | - | -10 | - | -13 | - | 20 | - | - | | | | | | -6 |

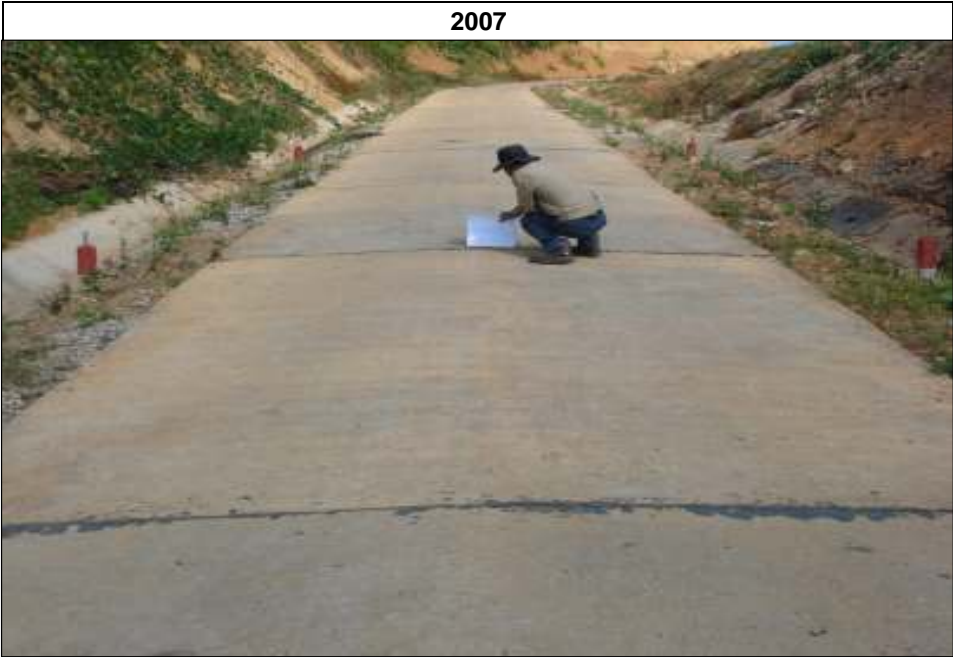
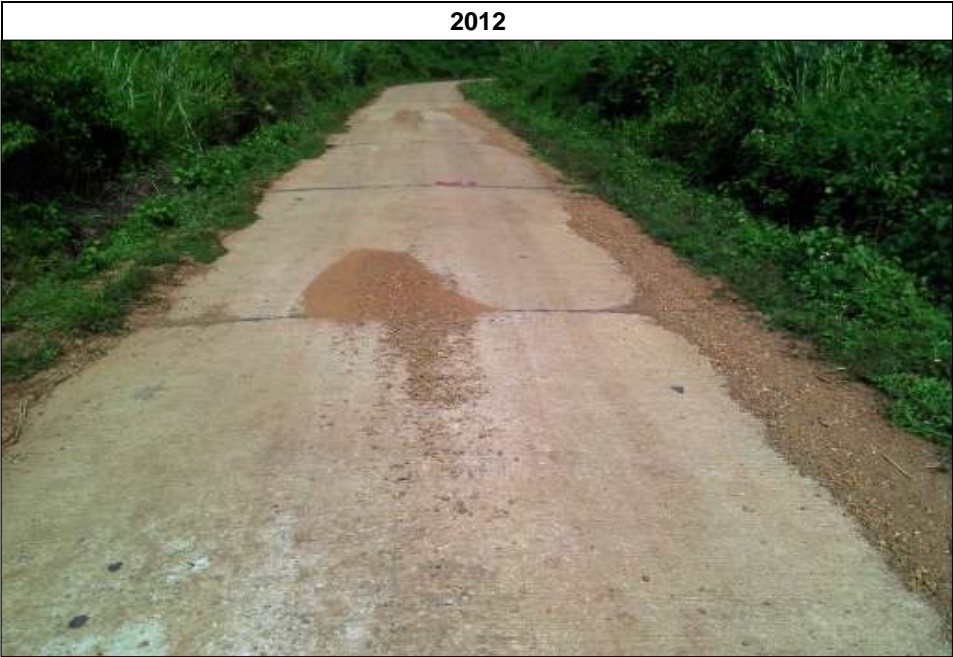
Road 5
Concrete Geocells (2.875km)

| | 500.00 | 750.00 | 1000.00 | 1250.00 | 1500.00 | 1750.00 | 2000.00 | 2250.00 | 2500.00 | 2750.00 | 3000.00 | 3250.00 | 3500.00 | 3750.00 | 4000.00 | 4250.00 | 4500.00 | 4750.00 | 5000.00 | | | | | | Average Loss |
|---|---|---|---|---|---|---|---|---|---|---|---|---|---|---|---|---|---|---|---|--|--|--|--|--|---|
| Difference (2007 - 2009) | - | - | 22 | - | 20 | - | 21 | - | 15 | - | 9 | - | 11 | - | 12 | - | 22 | - | -62 | | | | | | 8 |
| Difference (2007 - 2012) | - | - | - | - | 11 | - | 16 | - | 15 | - | 15 | - | 11 | - | -1 | - | -47 | - | - | | | | | | 3 |

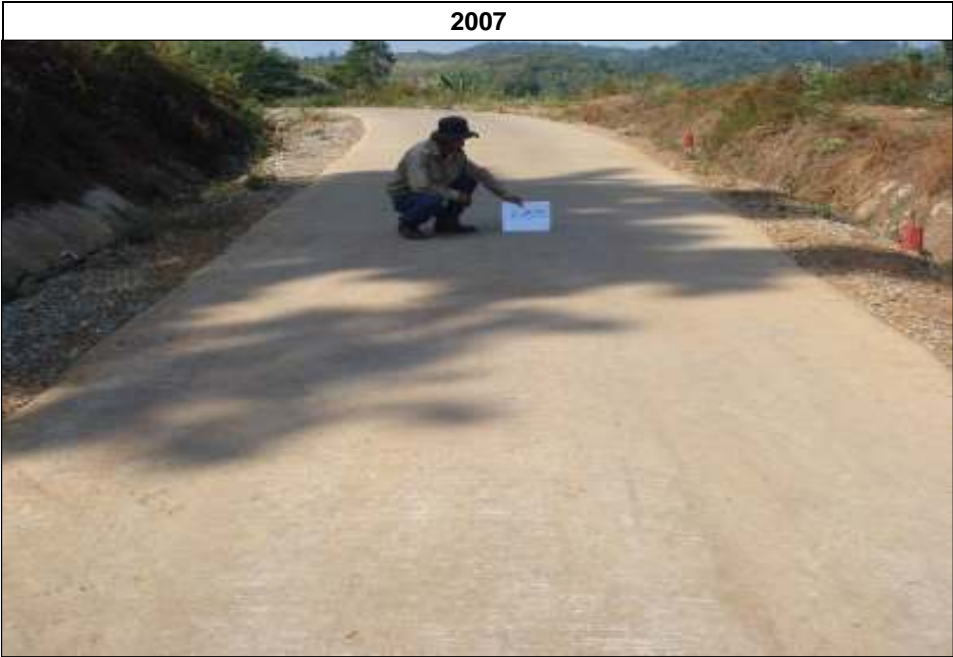
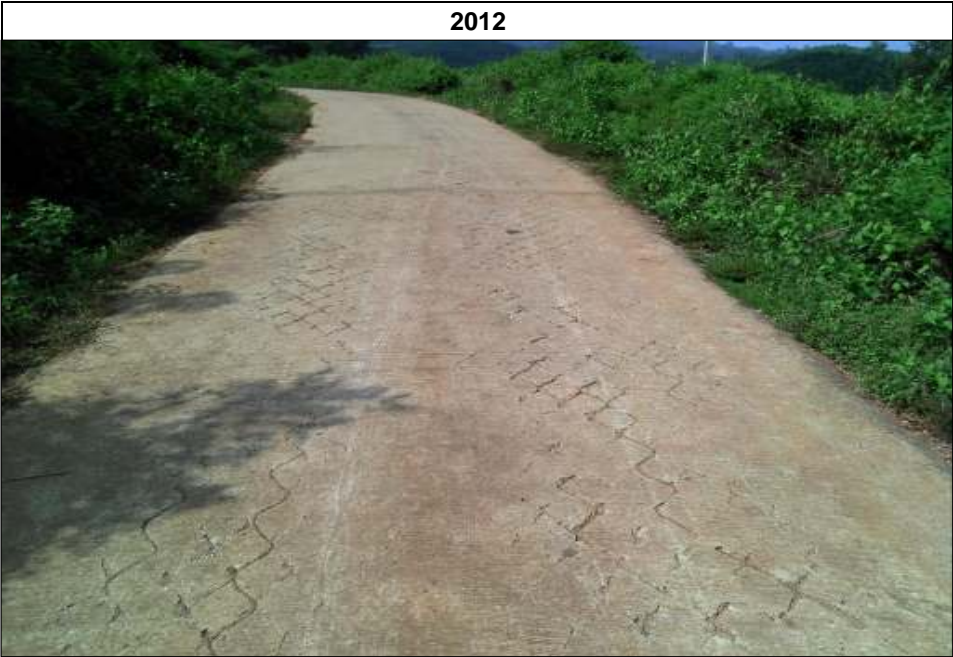
Road 5
Concrete Geocells (3.075km)

| | 500.00 | 750.00 | 1000.00 | 1250.00 | 1500.00 | 1750.00 | 2000.00 | 2250.00 | 2500.00 | 2750.00 | 3000.00 | 3250.00 | 3500.00 | 3750.00 | 4000.00 | 4250.00 | 4500.00 | 4750.00 | 5000.00 | | | | | | Average Loss |
|---|---|---|---|---|---|---|---|---|---|---|---|---|---|---|---|---|---|---|---|--|--|--|--|--|---|
| Difference (2007 - 2009) | - | - | 20 | - | 8 | - | 12 | - | 13 | - | 0 | - | -9 | - | -3 | - | 5 | - | 47 | | | | | | 10 |
| Difference (2007 - 2012) | - | - | - | - | 8 | - | 12 | - | 5 | - | 0 | - | -9 | - | -10 | - | -3 | - | - | | | | | | 0 |

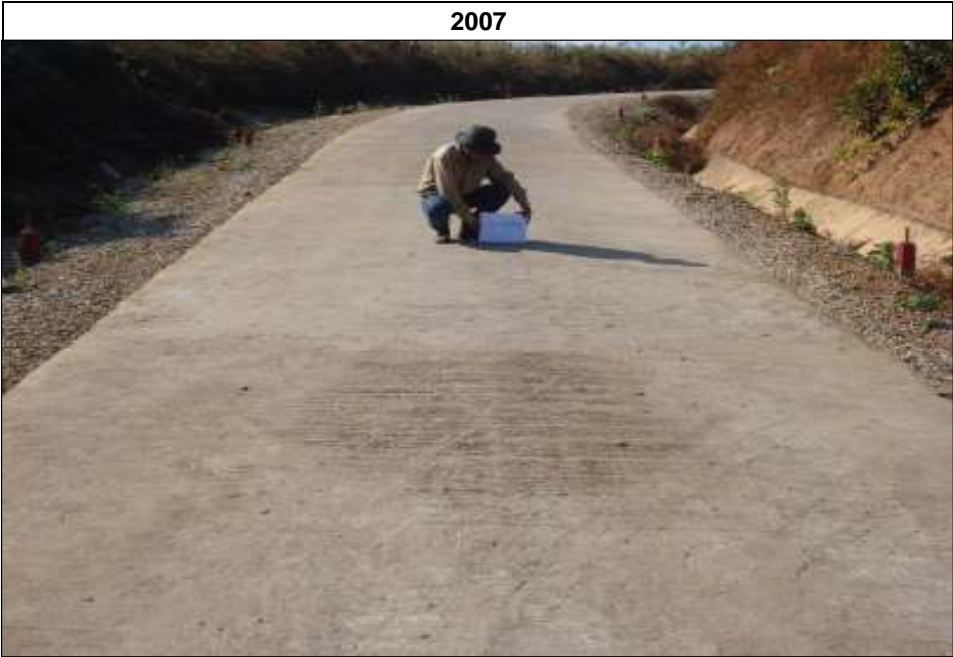
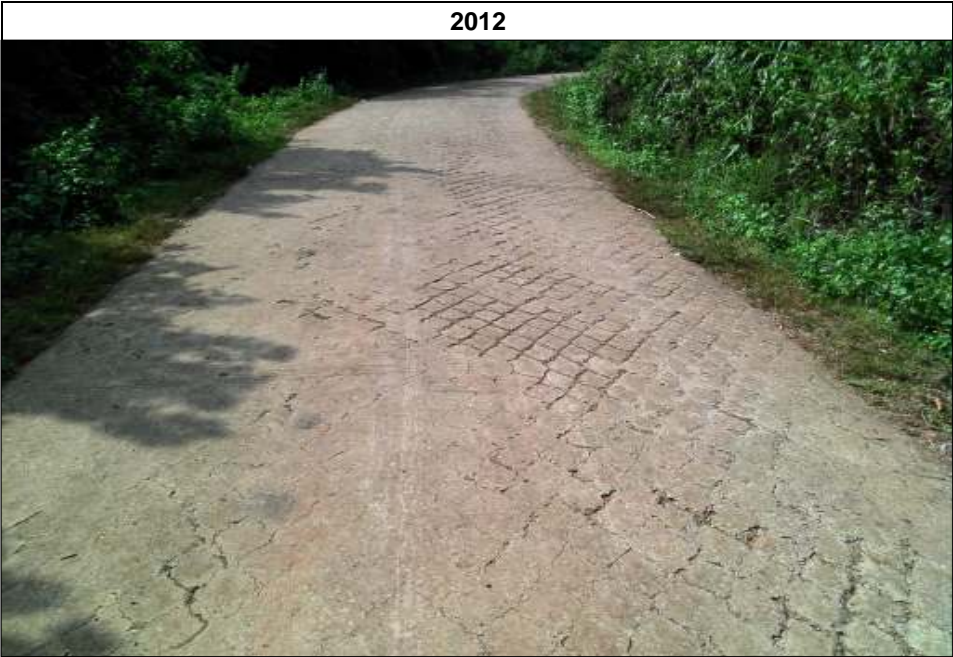
Road 5
Concrete Geocells (2.975km)

| | 500.00 | 750.00 | 1000.00 | 1250.00 | 1500.00 | 1750.00 | 2000.00 | 2250.00 | 2500.00 | 2750.00 | 3000.00 | 3250.00 | 3500.00 | 3750.00 | 4000.00 | 4250.00 | 4500.00 | 4750.00 | 5000.00 | | | | | | Average Loss |
|---|---|---|---|---|---|---|---|---|---|---|---|---|---|---|---|---|---|---|---|--|--|--|--|--|---|
| Difference (2007 - 2009) | - | - | 43 | - | 16 | - | 7 | - | 9 | - | 0 | - | 10 | - | 14 | - | 14 | - | 65 | | | | | | 20 |
| Difference (2007 - 2012) | - | - | - | - | 10 | - | 12 | - | 18 | - | 0 | - | -12 | - | -21 | - | -13 | - | - | | | | | | -1 |

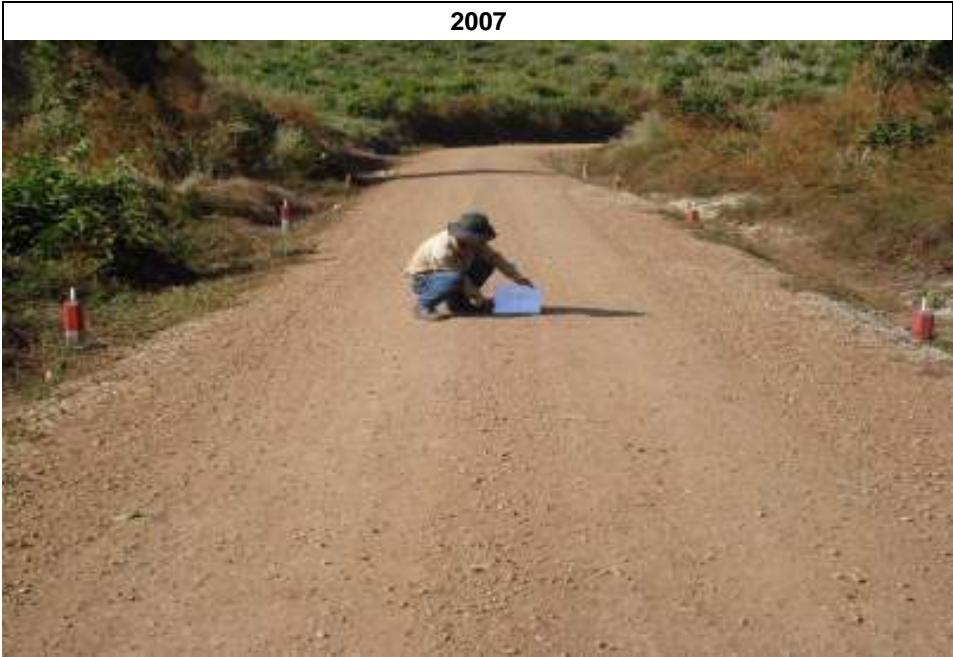
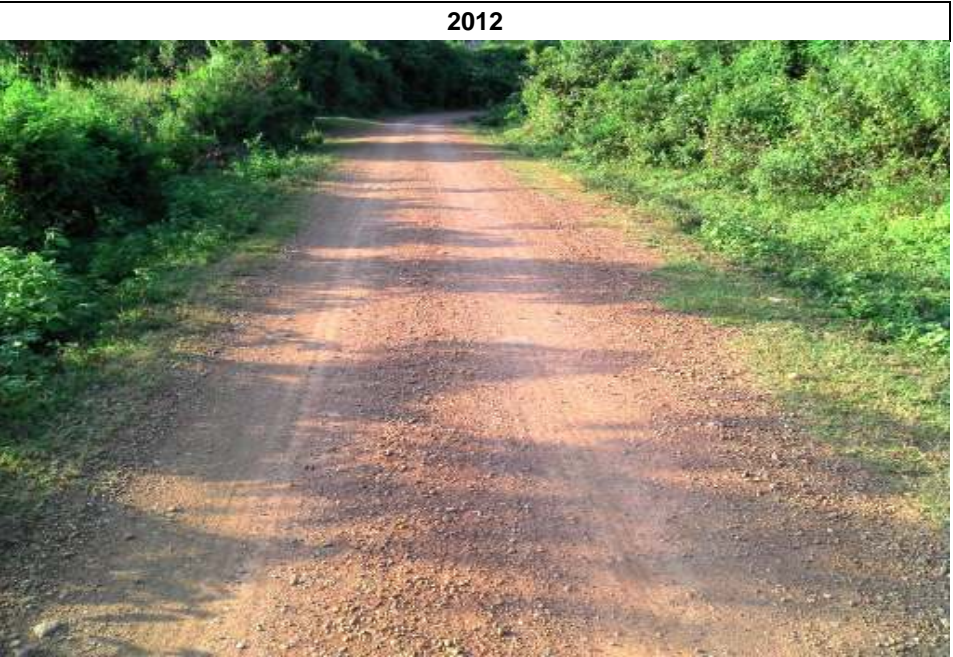
Road 5
Gravel (3.275km)

| | 500.00 | 750.00 | 1000.00 | 1250.00 | 1500.00 | 1750.00 | 2000.00 | 2250.00 | 2500.00 | 2750.00 | 3000.00 | 3250.00 | 3500.00 | 3750.00 | 4000.00 | 4250.00 | 4500.00 | 4750.00 | 5000.00 | | | | | | Average Loss |
|---|---|---|---|---|---|---|---|---|---|---|---|---|---|---|---|---|---|---|---|--|--|--|--|--|---|
| Difference (2007 - 2012) | - | - | - | - | 84 | - | 128 | - | 158 | - | 130 | - | 131 | - | 108 | - | 84 | - | - | | | | | | 118 |
| | | | | | | | | | | | | | | | | | | | | | | | | | 172 |

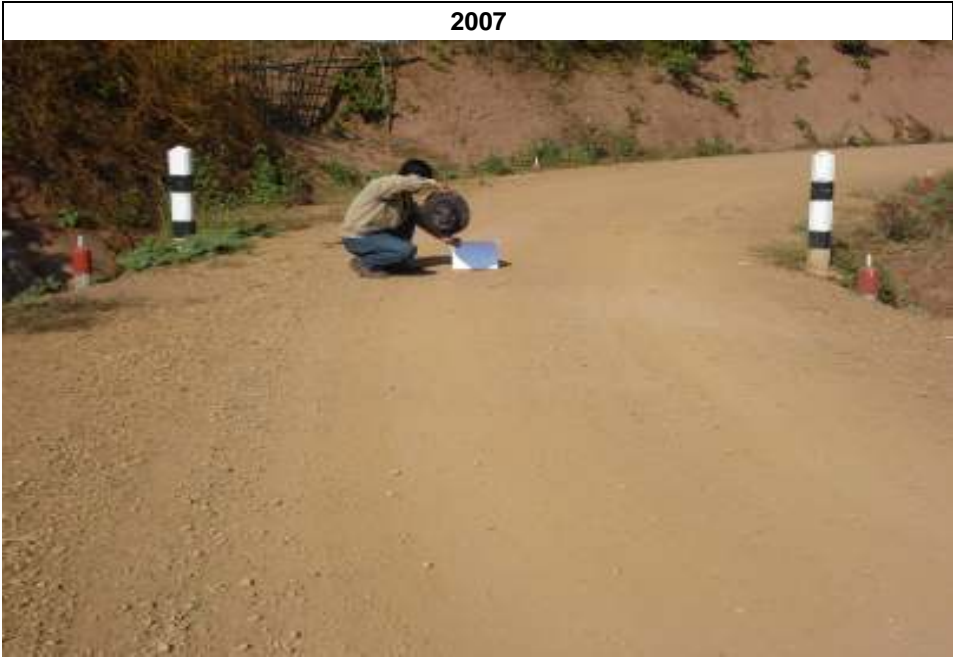
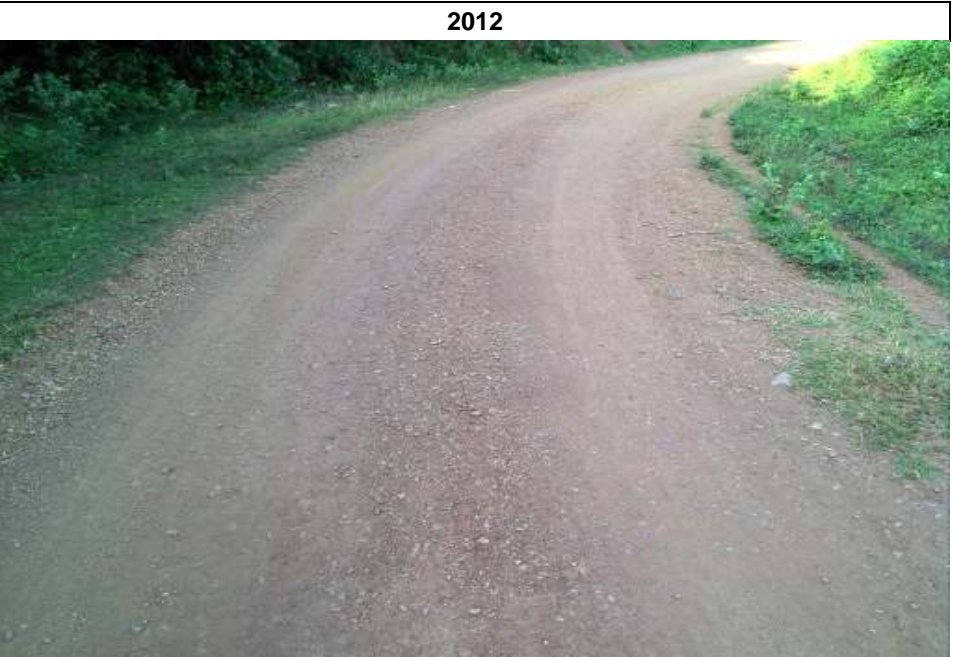
Road 8
Sand Seal (1.825km)

| | 500.00 | 750.00 | 1000.00 | 1250.00 | 1500.00 | 1750.00 | 2000.00 | 2250.00 | 2500.00 | 2750.00 | 3000.00 | 3250.00 | 3500.00 | 3750.00 | 4000.00 | 4250.00 | 4500.00 | 4750.00 | 5000.00 | | | | | | Average Loss |
|---|---|---|---|---|---|---|---|---|---|---|---|---|---|---|---|---|---|---|---|--|--|--|--|--|---|
| Difference (2007 - 2012) | - | - | - | - | 28 | - | 84 | - | 143 | - | 170 | - | 128 | - | 134 | - | 100 | - | - | | | | | | 112 |

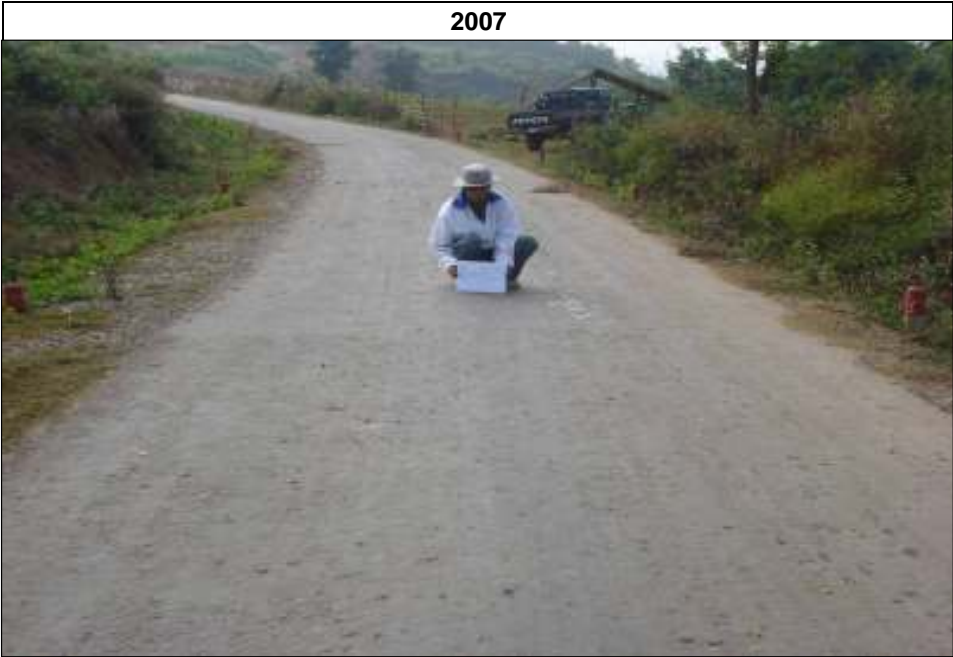
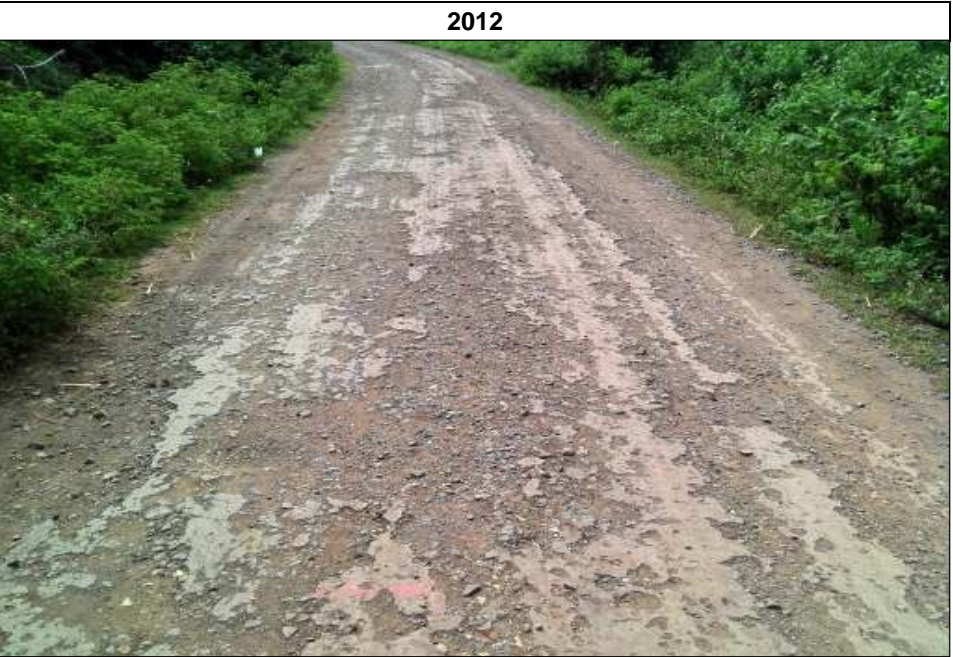
Sand Seal (1.895km)

| | 500.00 | 750.00 | 1000.00 | 1250.00 | 1500.00 | 1750.00 | 2000.00 | 2250.00 | 2500.00 | 2750.00 | 3000.00 | 3250.00 | 3500.00 | 3750.00 | 4000.00 | 4250.00 | 4500.00 | 4750.00 | 5000.00 | | | | | | Average Losses |
|---|---|---|---|---|---|---|---|---|---|---|---|---|---|---|---|---|---|---|---|--|--|--|--|--|---|
| Difference (2007 - 2012) | - | - | - | - | 15 | - | 4 | - | 12 | - | 32 | - | 34 | - | 38 | - | -2 | - | -42 | | | | | | 11 |

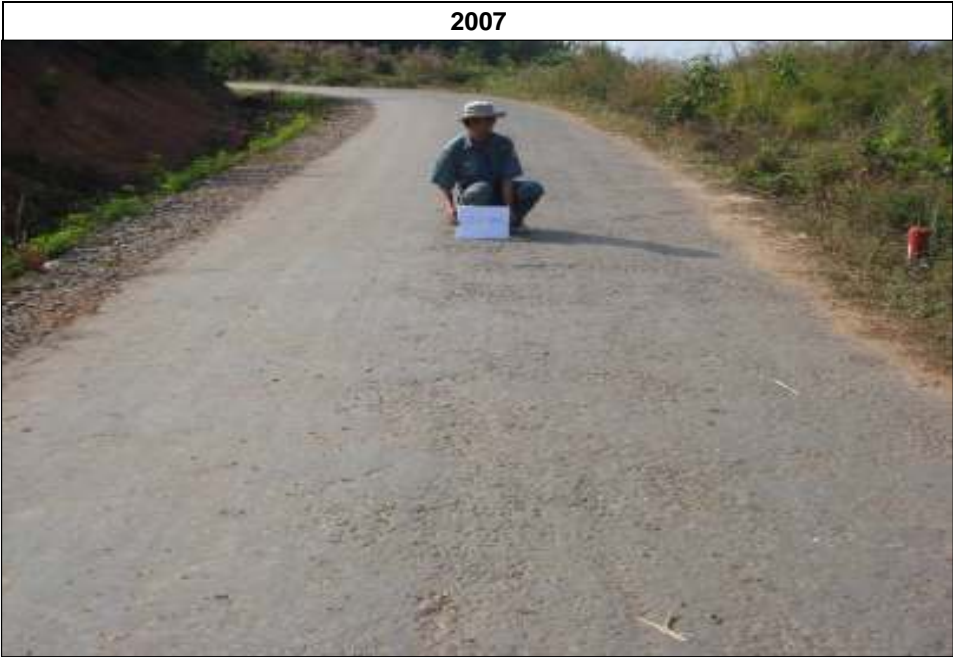
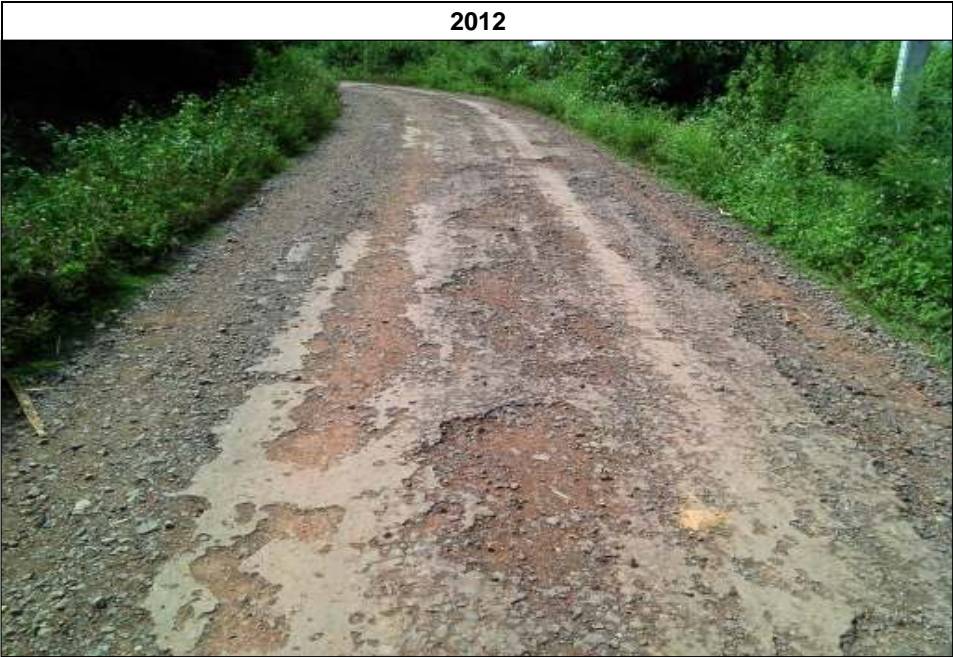
Road 8
Sand Seal (2.095km)

| | 500.00 | 750.00 | 1000.00 | 1250.00 | 1500.00 | 1750.00 | 2000.00 | 2250.00 | 2500.00 | 2750.00 | 3000.00 | 3250.00 | 3500.00 | 3750.00 | 4000.00 | 4250.00 | 4500.00 | 4750.00 | 5000.00 | | | | | | Average Losses |
|---|---|---|---|---|---|---|---|---|---|---|---|---|---|---|---|---|---|---|---|--|--|--|--|--|---|
| Difference (2007 - 2012) | - | - | - | - | 3 | - | 4 | - | 14 | - | 30 | - | 12 | - | 24 | - | 33 | - | -5 | | | | | | 14 |

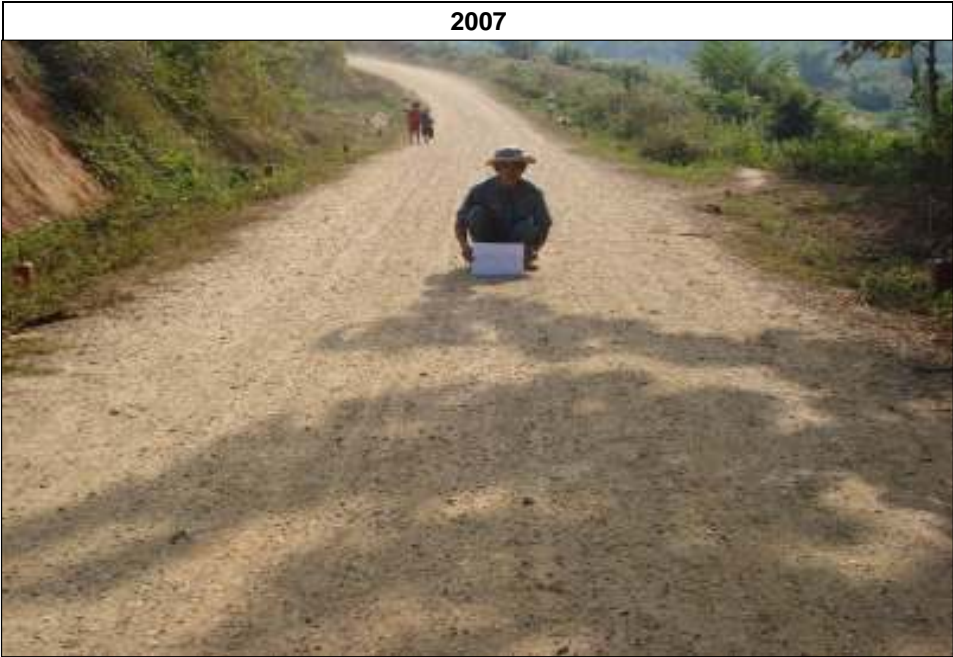
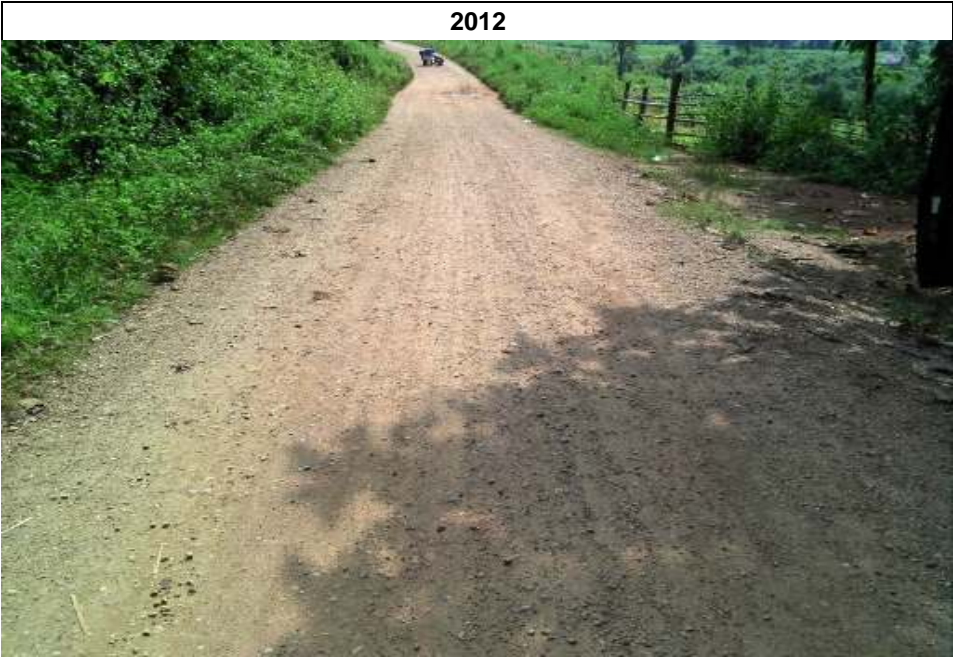
Gravel (2.225km)

| | 500.00 | 750.00 | 1000.00 | 1250.00 | 1500.00 | 1750.00 | 2000.00 | 2250.00 | 2500.00 | 2750.00 | 3000.00 | 3250.00 | 3500.00 | 3750.00 | 4000.00 | 4250.00 | 4500.00 | 4750.00 | 5000.00 | | | | | | Average Losses |
|---|---|---|---|---|---|---|---|---|---|---|---|---|---|---|---|---|---|---|---|---|--|--|--|--|---|
| Difference (2007 - 2012) | - | - | - | - | 42 | - | 41 | - | 51 | - | 60 | - | 37 | - | 25 | - | 23 | - | -16 | 33 | | | | | 33 |
