**African Community Access Programme
Project AFCAP/KEN/089**

**Research Project for Low Volume Sealed Roads in
Kenya (Kiambu, Central Region)**

Final Report

NORKEN (I) LTD

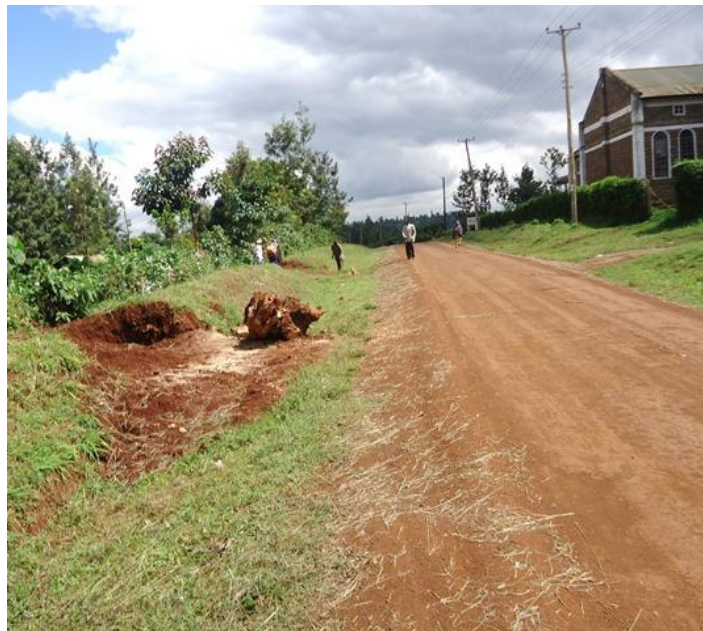
Trees and Stumps within the construction width were removed by labour. Stumps removal involved excavation to a depth more than 750mm and then cutting. The cut materials were then collected and disposed of away from the road reserve. Some were cut into pegs used during the setting out of various parts of the work. This activity is shown in below:

Photo 3-1: Stump removal during site clearing

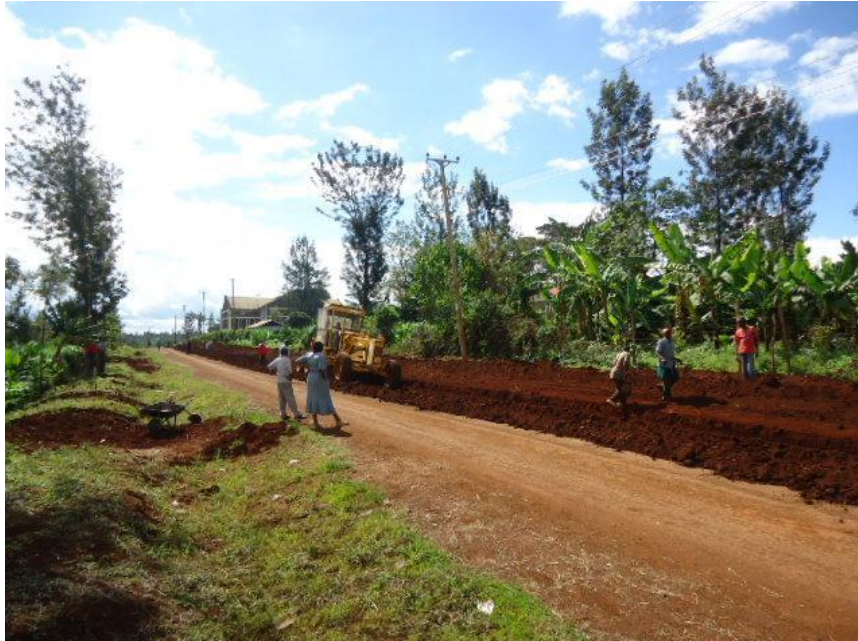
Photo 3-2: Top soil removal during stripping

The activity was done through a combination of labour and equipment. The equipment used was a motorized grader. Labour was only engaged on sections where the grader maneuverability was hampered due to lack of turning space. The grubbing was done over a width of 12 m. Top soil including grass and other unsuitable materials were deposited outside the cleared or working area as per the design profile. The following photos show the activity in progress and when completed.

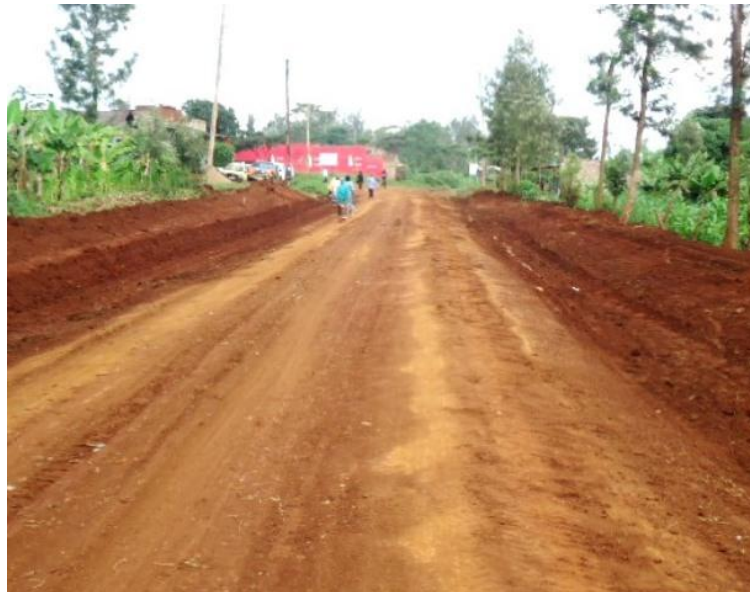
Photo 3-3: Section showing the process of stripping complete

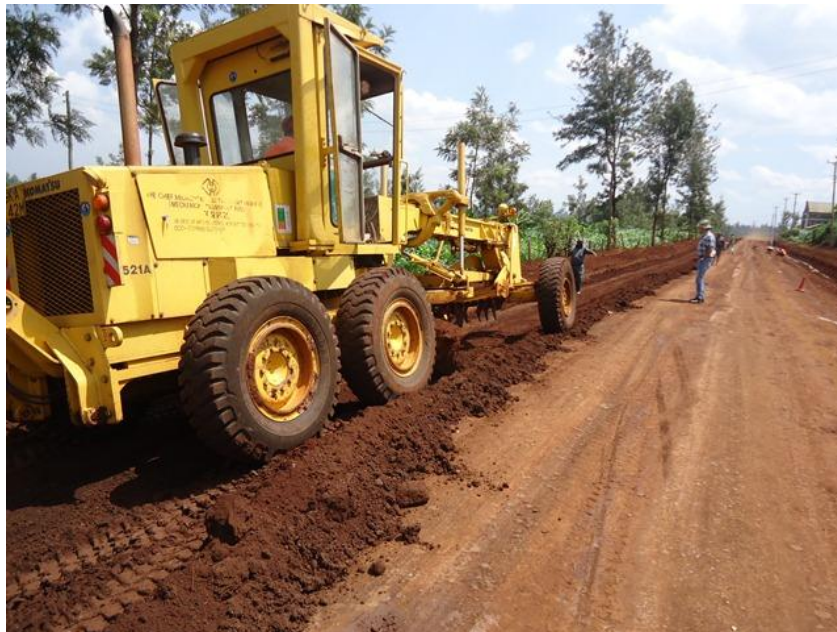
Photo 3-4: benching using a motor grader

Benching was done with heavy construction plant. The benches were 2 m wide either side of the existing pavement. They were back filled using in situ side borrow materials. This was processed into a homogeneous mix watered then shaped to level achieving thicknesses ranging between 180-250 mm before compacting using 10 T Bomag Roller. The benches were then tested for relative density both by sand replacement method and DCP. See materials Testing Results for the benches in details as shown in **ANNEX C** of this report.

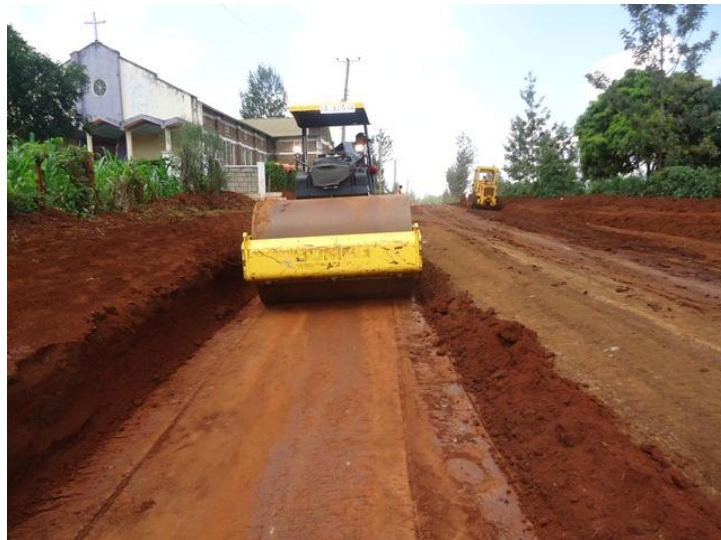
Photo 3-7: compaction on 1st layer RHS and processing on the LHS

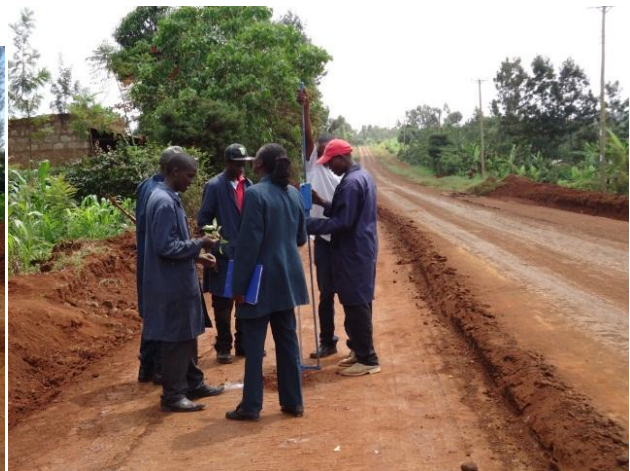
Photo 3-9: DCP test on the 1st layer bench

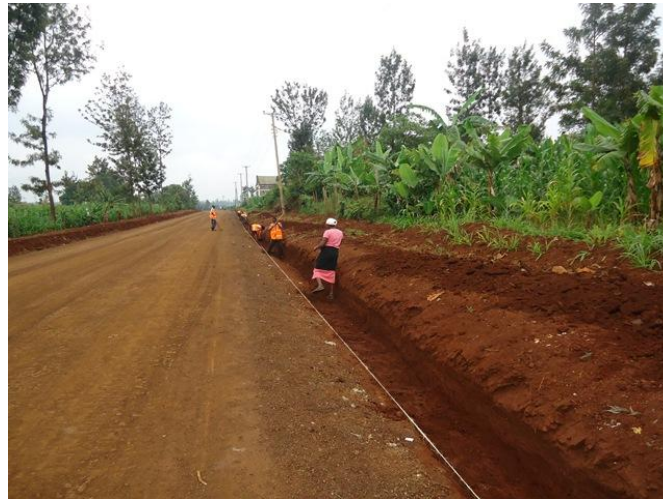
Photo 3-14: ditch formation in progress

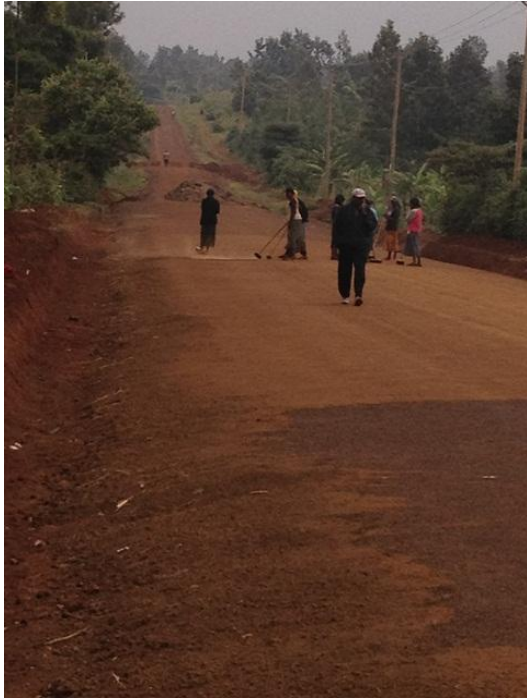
Photo 3-17: Brooming the compacted base surface

The cutback bitumen was applied using labour. The equipment used was a locally modified hand sprayer. Before the application the surface was prepared by sweeping all loose remnants of soil/gravel or other foreign materials. The centre line was re-established for setting out road width for priming.

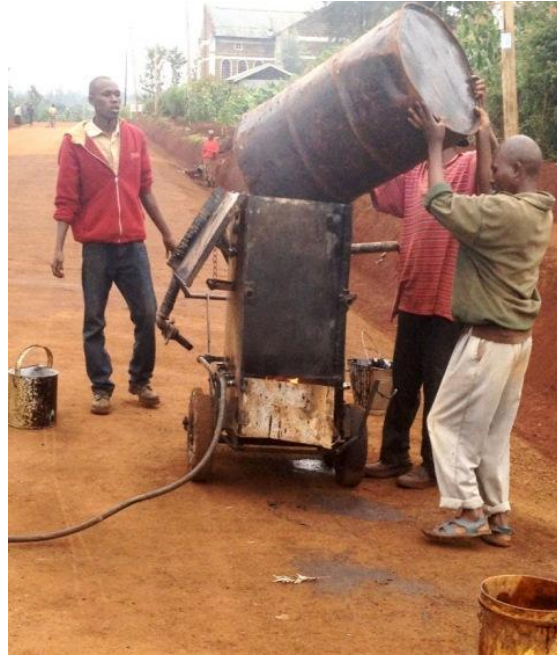
Photo 3-18: an improvised hand lance sprayer

(NB; it's done from center towards the edge)

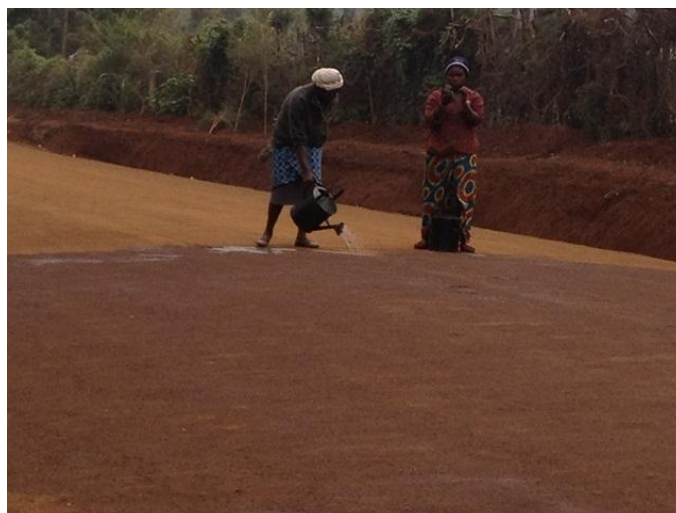
Photo 3-19: watering the broomed surface lightly using a free flow can

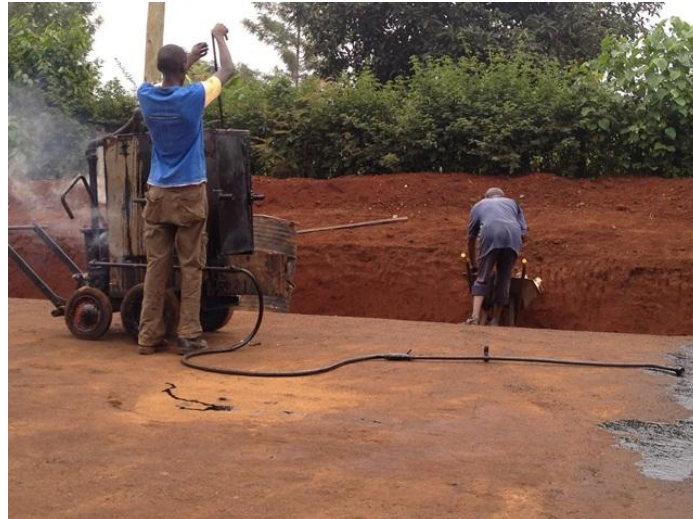
Photo 3-20: a thermometer fitted in the modified hand lance sprayer ensures the primer is applied at controlled temperature

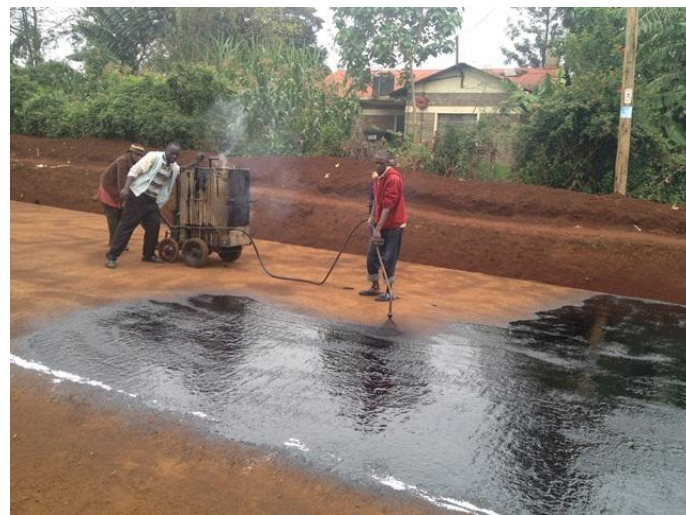
Photo 3-21; priming process in action

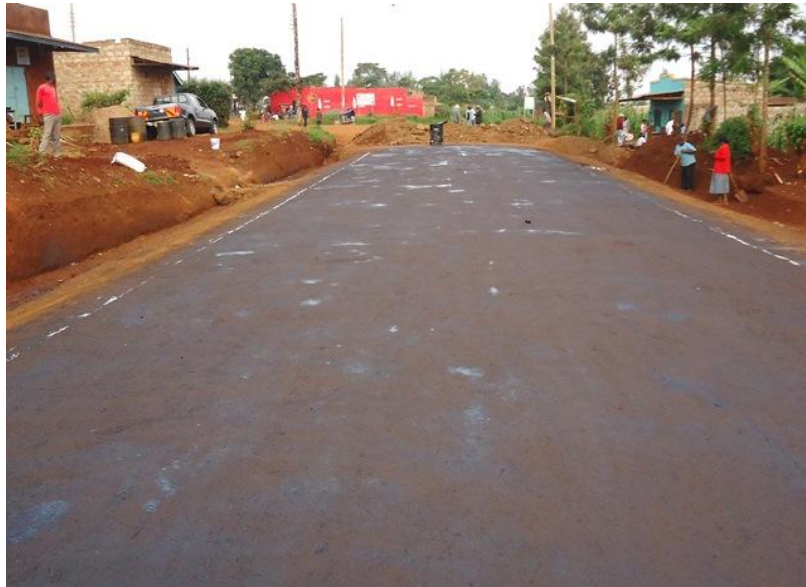
Photo 3-22: a section after 24hrs of priming. It was left further to dry for another 48hrs or more before surfacing for the MC 30 to penetrate fully

The surface was left to dry and penetrate for at least 72hrs and over before application of surface treatment depending on the prevailing weather condition.

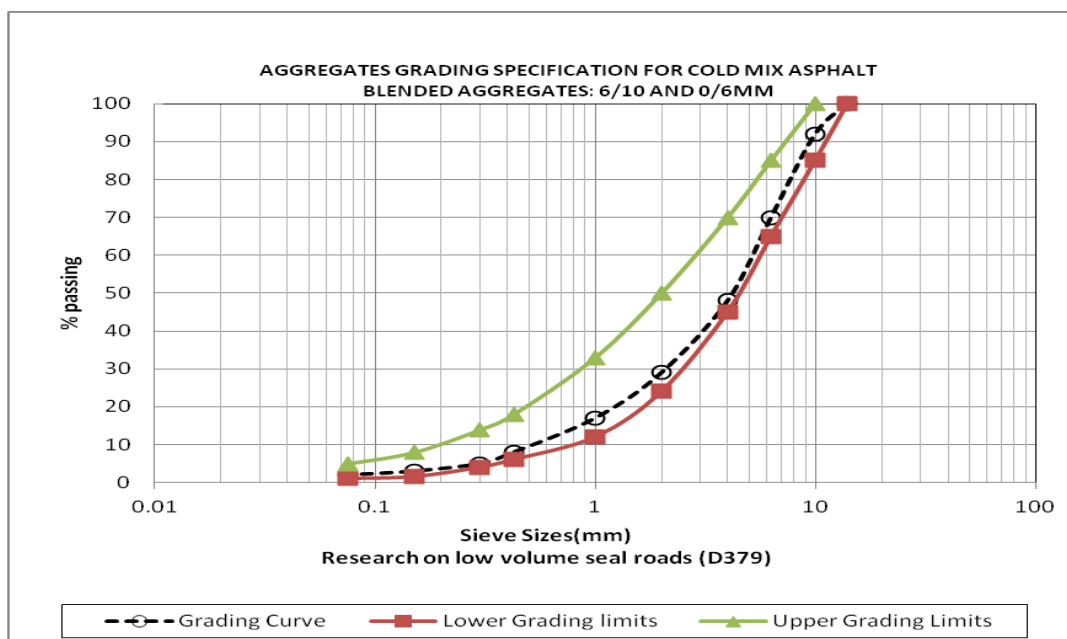
Figure 4: Graph illustrating the grading envelope and achieved grading for the cold mix aggregates

The grading is within the required envelope, but it would be preferred to be closer to the upper limit. This resulted in a fairly open surface texture lacking in fines.

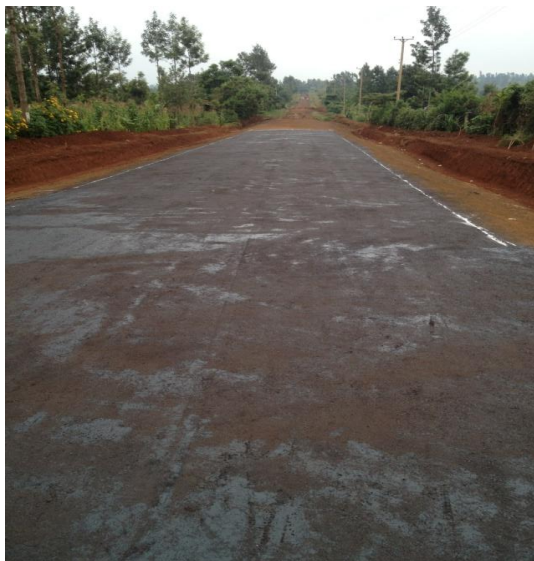
Photo 3-23: primed section ready for sealing

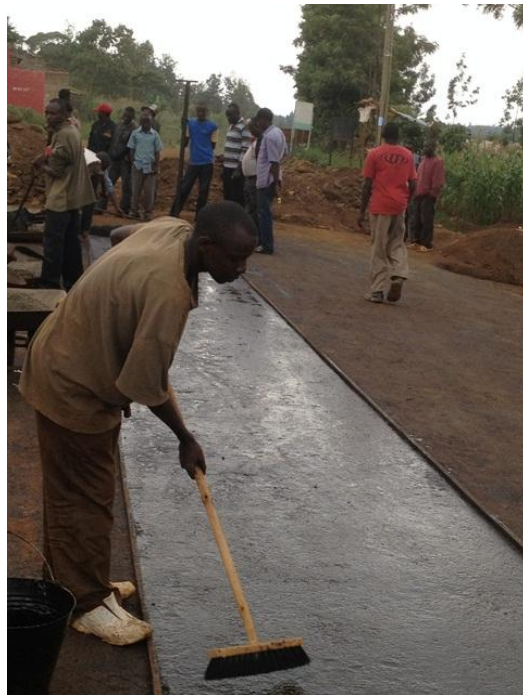
Photo 3-24: application of a dilute tack coat A-4

A thin tack coat of 1:6 diluted A4 Anionic Stable Grade emulsion was then spread on the area between the guide rails using watering can and soft brooms and allowed to set and dry before the mixing and placing of the asphalt commenced.

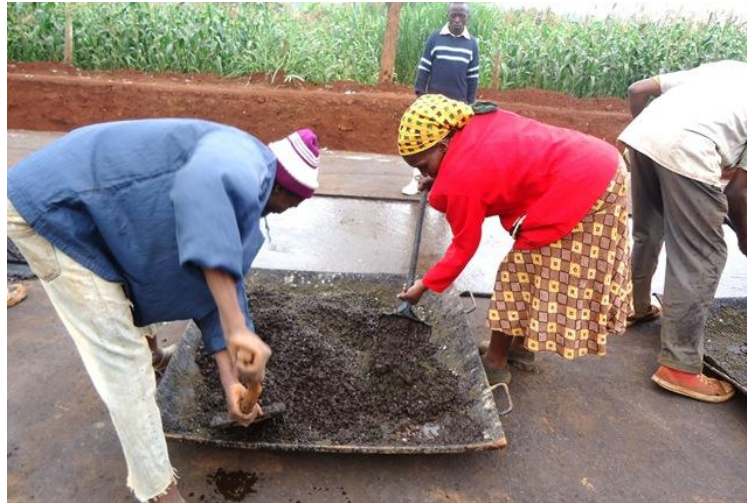
Photo 3-25: mixing of the cold mix asphalt using square nosed spades

The mixing is best done with square nosed spades (See ANNEX B, for the photo) to ensure that material in the corners of the tray are properly mixed with the rest. The photo below shows the aspects of this activity.

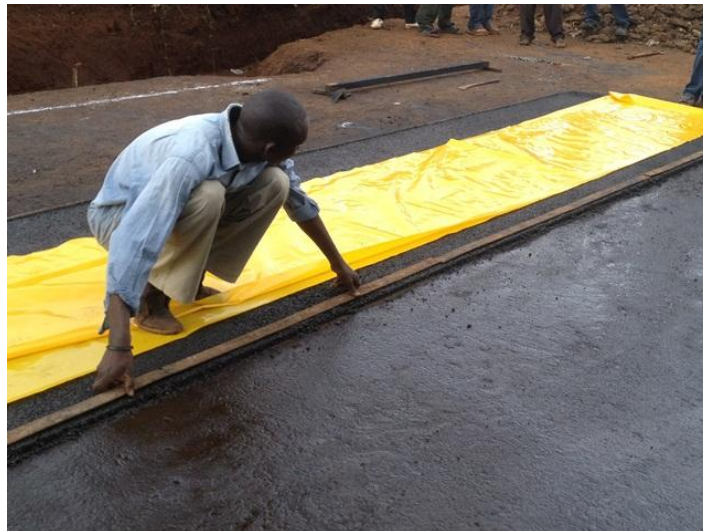
This was achieved by placing 6 mm mild steel flat bar (**SEE ANNEX B** for the specification) on top of the compacted asphalt and 20mm guide rails on the other edge of the strip as illustrated below;

Photo 3-29: allowance for the construction of the adjacent strip by placing 6mm flat bar on top of the compacted asphalt (NB; use of plastic cover to protect damaging the fresh layer surface)

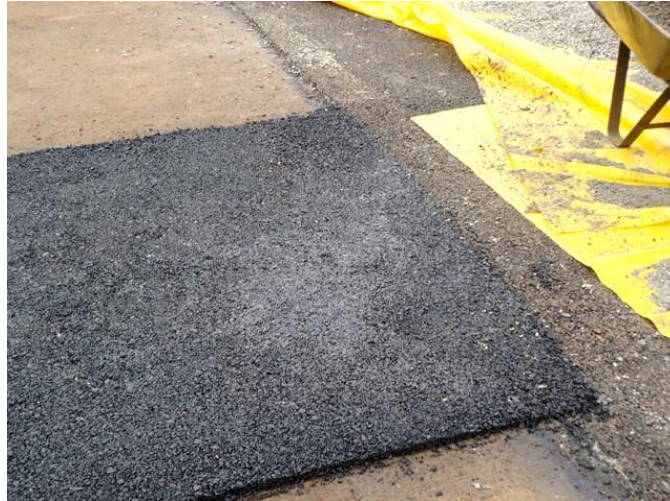
Longitudinal and transverse joint are potential weak spots in the asphalt surfacing. Extra care was therefore taken to ensure tight joints and good bonding between the old and new asphalt.

Photo 3-30: illustration of trimmed joints of a new layer adjacent to an old layer

All joints were neatly trimmed and any foreign matter (mud, dust, animal droppings etc.) removed before the new asphalt was laid against the joint.

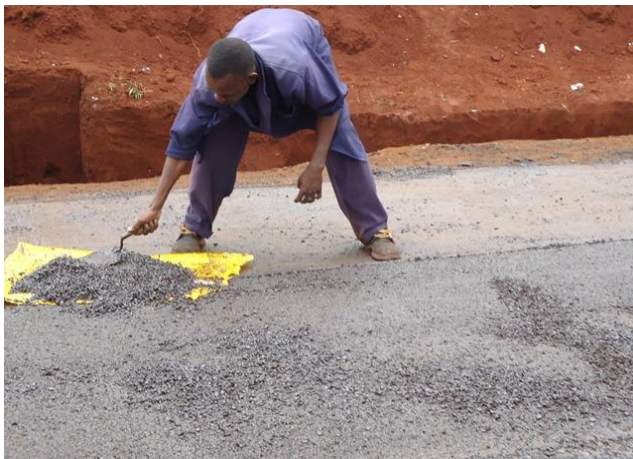
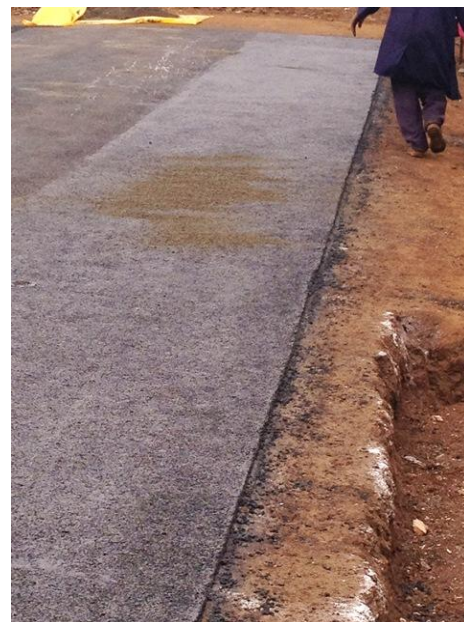
After construction all joints were inspected, and where there was a slight “gap” in the joint, a small amount of emulsion was applied in the gap and crusher dust spread on top to properly seal the joint.

Photo 3-31: spreading of fresh cold mix to correct openings **Photo 3-32: crusher dust used to seal joints**

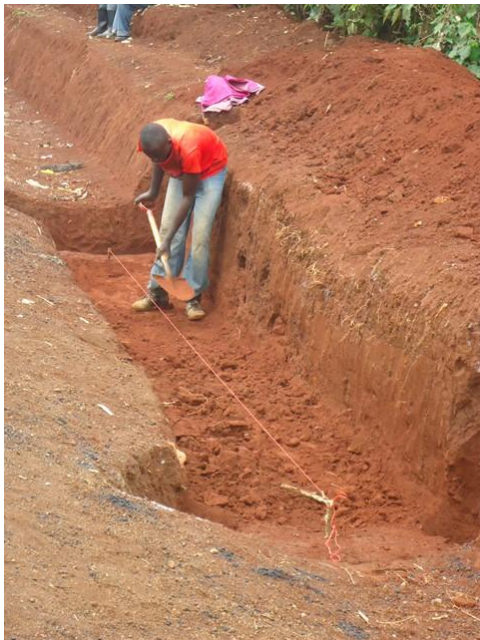
Photo 3-33: trench excavation for culvert bed

- Access culverts were constructed using culvert ring 600mm diameter, 1.0 m long capable of interlocking.
- The excavation length varied as shown in the above table but was complete for bed and footed aprons. (see attached drawings in **ANNEX B** for culvert foundations)
- The beds were then laid by using class 20/25 mix concrete and the apron using the same mix
- The rings were then positioned by interlocking and sealing any space in between using cement sand mortar of mix ratio 1:3.
- False work using properly joined timber were then constructed taking into consideration the thickness of surround & wing walls/headwalls
- Surround and head/wing walls were then placed using class 20/25 concrete vibrated and steel finished.
- Curing was to commence immediately for seven days but the false works were removed after 12 hours.

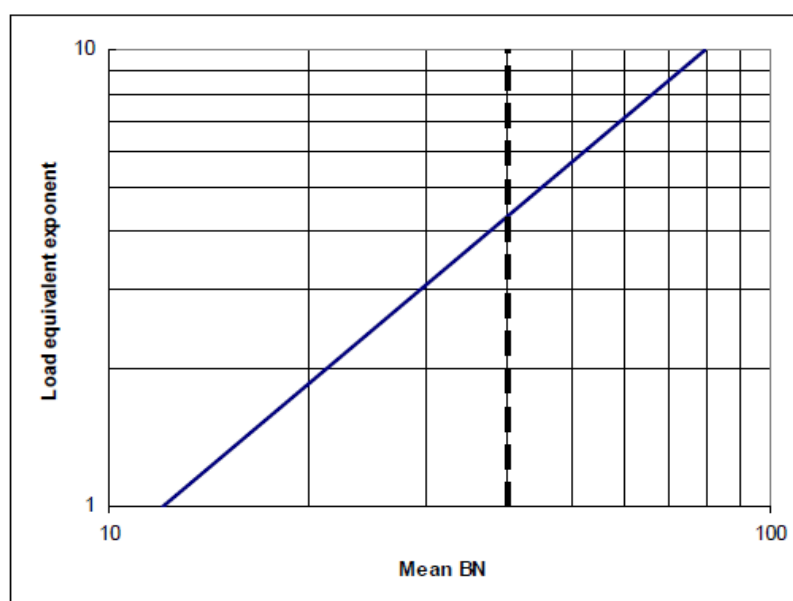
Figure 10: Relationship between pavement balance number and Power Exponent "n"

Figure 10 below shows the relationship between the pavement balance number (BN) and the “n” exponent more likely to be related to that pavement structure.

According to the above the new pavement is a well-balanced deep structure. From the BN100 value of 21.7 in table 17 and the relationship between BN100 and “n” in figure 11, a more realistic value for “n” would be as low as 2.0. However, it is not recommended to use “n” values lower than 3.

The Balance Number (BN) represents the percentage of the DCP strength of the pavement to a certain depth. Pavements with a high BN100 (approaching a BN of 80) are considered to be shallow whilst those with low BN values are considered to be deep. A relationship between the BN100 value and the “n” exponent used to calculate the load equivalency factor has also been found with shallower pavements being more susceptible to high loads (i.e., a higher n exponent) than deep pavements.

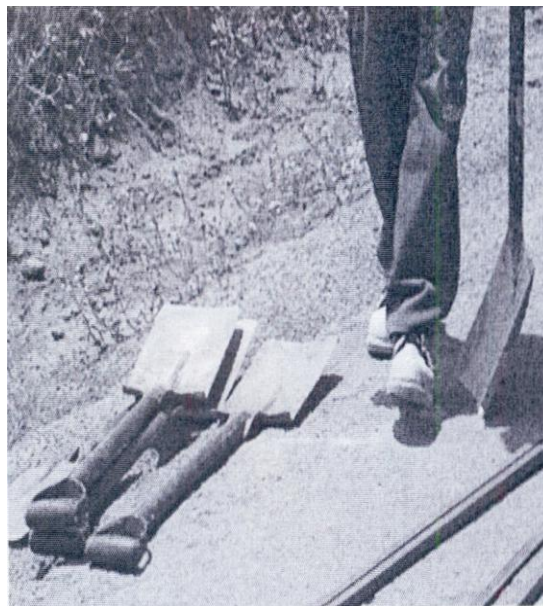
Photo 0-2: square nosed mixing spades
